## ENVIRONMENTAL MONITORING REPORT 02 – HOUSE CONSTRUCTION

OUTENIKUASBOSCH, FARMS OUTENIKUASBOSCH 149 AND HARTENBOSCH  
217, HARTENBOS

**MOS20/455/02**

**ENVIRONMENTAL MONITORING REPORT NO 02 – HOUSE CONSTRUCTION  
JUNE 2020**

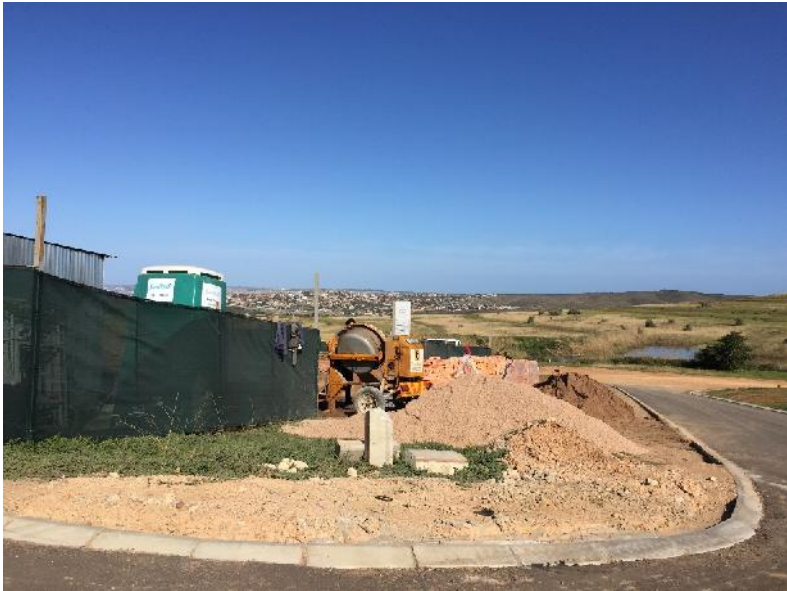
| The following items require action and need to be reported back to the ECO within 14 days | | |
|---|---|---|
| 6590 (43) | <p> ) Construction material stockpile area (outside of the demarcated erf) must be demarcated appropriately, to ensure that the game does not wander into this area and potentially injure themselves.<br/> ) All areas used for storage (including outside of the demarcated erf) must be fully rehabilitated before construction is completed.<br/> ) Environmental Plan must still be submitted to the ECO.<br/> ) Environmental Induction was done with all staff members on-site on the 30<sup>th</sup> of June 2020. </p> <p><i>Construction material stockpile must be demarcated.</i></p> | Igno van Rooyen |

| <b>Actionable Items Arising from Inspection</b> | | |
|---|---|---|
| 6590 (43) | Construction material outside of the erf must be demarcated appropriately. | Igno van Rooyen |

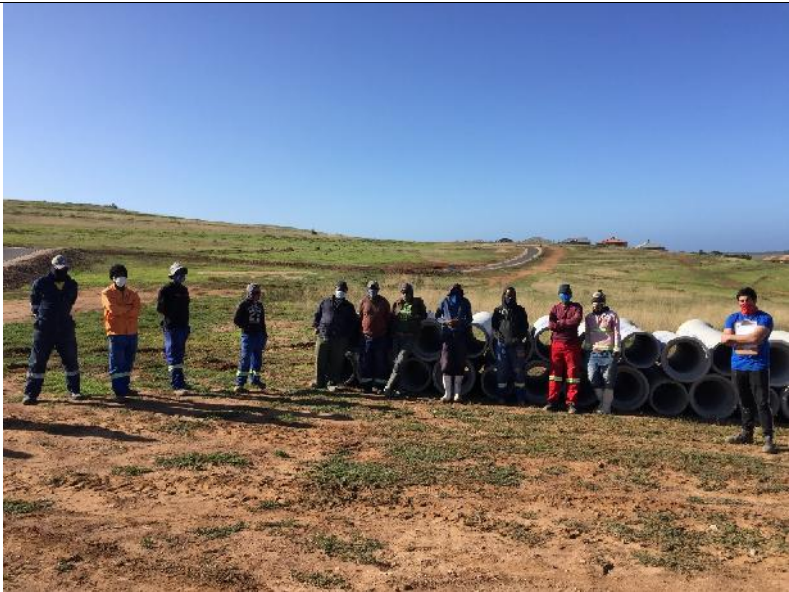
| | <p><i>Environmental Induction was done with all staff members on site.</i></p> | |

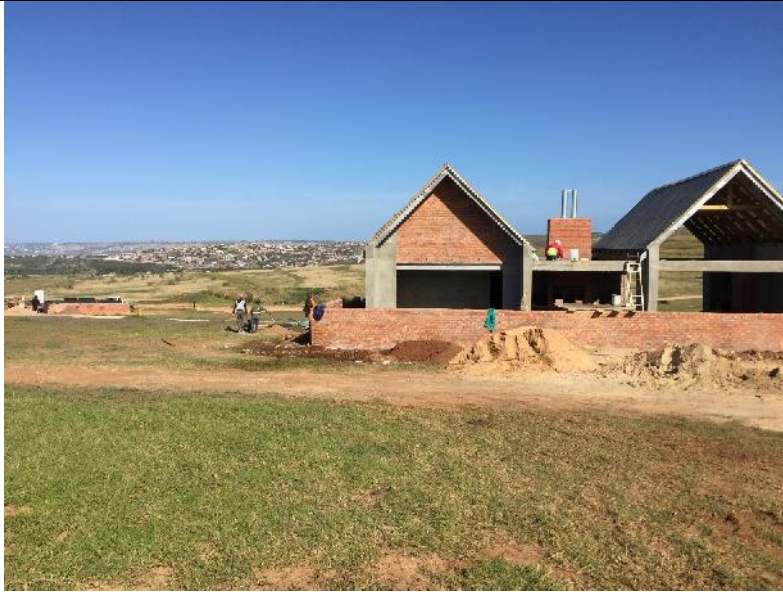
| <b>6639 (92)</b> | <p> ) Construction material stockpile area (outside of the demarcated erf) must be demarcated appropriately, to ensure that the game does not wander into these areas and potentially injure themselves.<br/> ) All areas used for storage (including outside of the demarcated erf) must be fully rehabilitated before construction is completed.<br/> ) The green shade netting demarcation has been taken down since the majority of the boundary walls have been built.<br/> ) A water leak was noted during site inspection on the 25<sup>th</sup> June 2020 and it was reported to the staff members on-site and Deon. Deon informed the ECO that the plumber was already notified. </p> | Francois Pretorius |

*Construction material to be demarcated appropriately.*

| <b>Actionable Items Arising from Inspection</b> | | |
|---|---|---|
| 6639 (92) | Construction material outside of the erf must be demarcated appropriately. | Francois Pretorius |

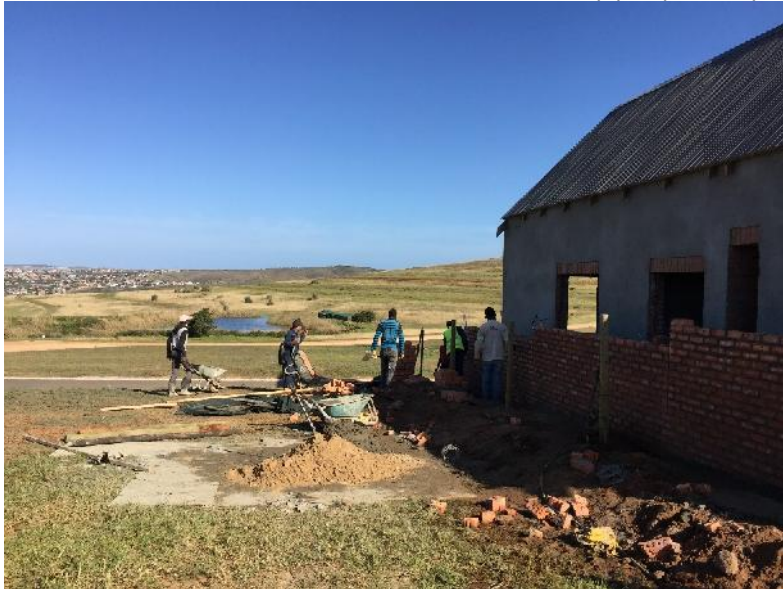
*Construction rubble to be disposed of at an authorised waste disposal facility, and the area must be rehabilitated.*

Rehabilitation entails removing any leftover construction material (to be disposed of at an authorised waste disposal facility), placing topsoil on the affected area(s) and sow an indigenous grass seed mixture. The topsoil may not be compacted as this would decrease the seed germination success. It is advised that the topsoil must be raked loose (by hand) and watered once the seeds have been sown. The ECO will monitor the vegetation growth on an ongoing basis. The construction of erven checklist can only be completed once the ECO is satisfied with the rehabilitation. Please note that the construction of erven checklist is required for occupation.
