## ANNEXURE A – SITE PHOTOGRAPHS

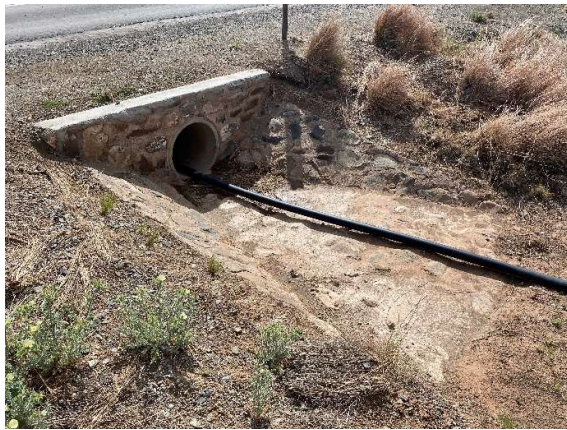
Culvert upgrading includes repaired concrete structures, stone-pitching, and vegetation clearing.

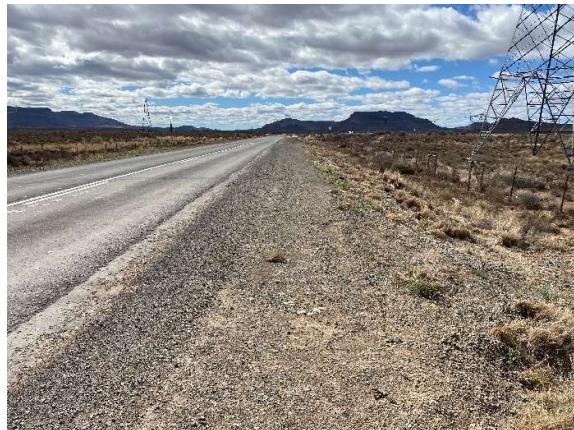
Cleared road reserve at Km 44 on TR 16/8 where vegetation within the road reserve was removed.

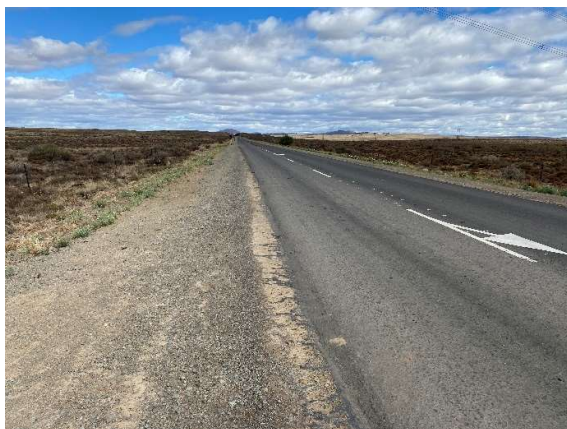
Condition of the completed road surface and road reserve along the TR 16/8.

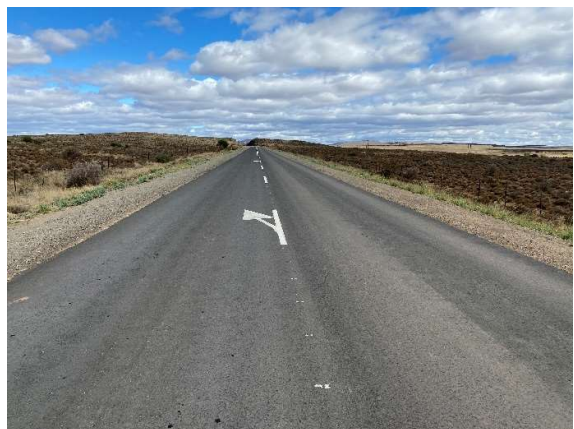
Condition of the completed road surface and road reserve along the TR 16/8.

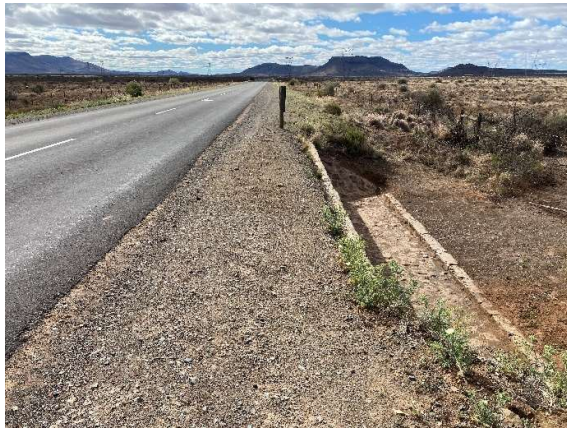
Upgraded culvert at Km 44.69 on TR 16/8 with repaired concrete and stone-pitching, daylighting and vegetation clearance.

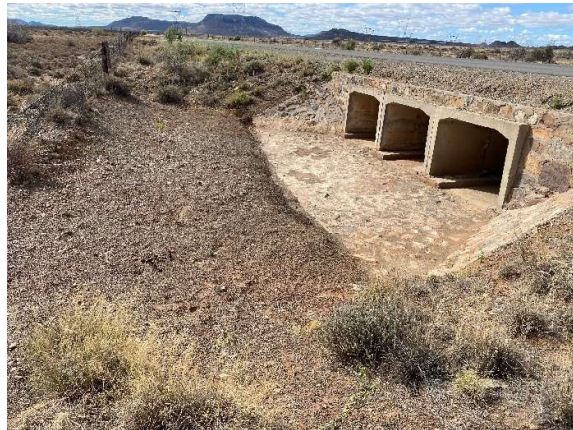
Upgraded culvert at Km 44.69 on TR 16/8 with repaired concrete and stone-pitching, daylighting and vegetation clearance.

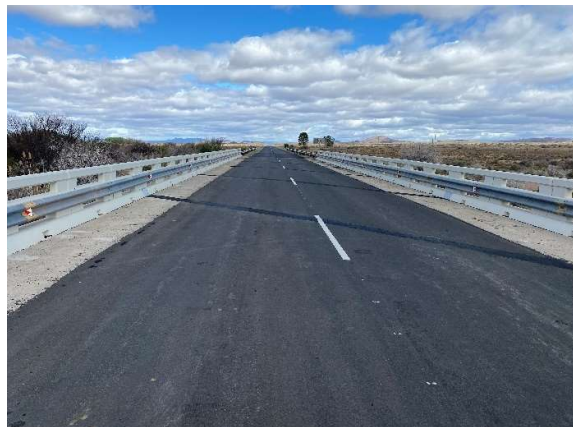
Bridge deck resealed, joints installed, with concrete and pier repairs.

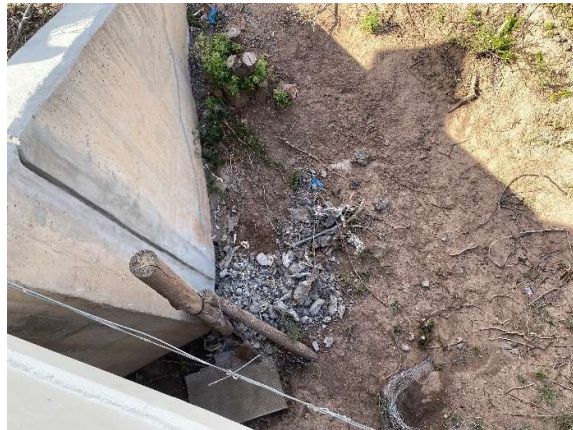
Cement and rubble observed in the riverbed at the Gabriel River bridge.

The ECO provided this photographic proof on the 26<sup>th</sup> of November that the concrete spills in the Gabriel River has been removed.

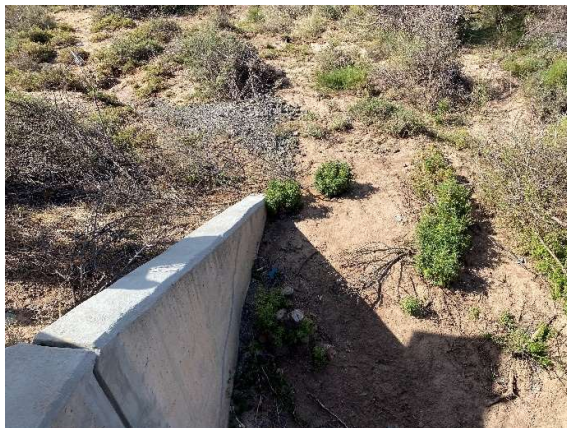
Concrete repairs at piers and wingwalls at the Gabriel River bridge.

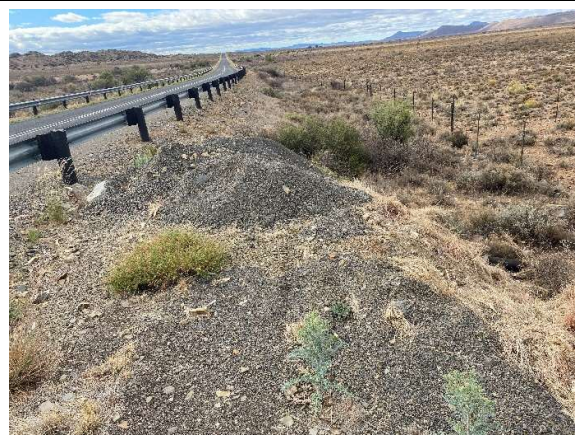
Small stockpile of stones to be removed at the new guardrail installation along the TR 16/9.

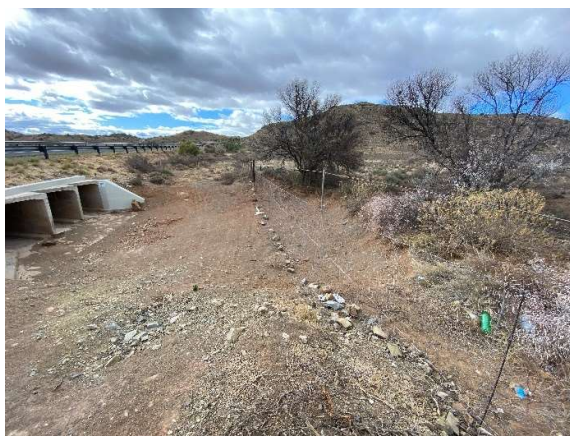
Upgraded box culvert 11425 at km24.45 along the TR16/9.

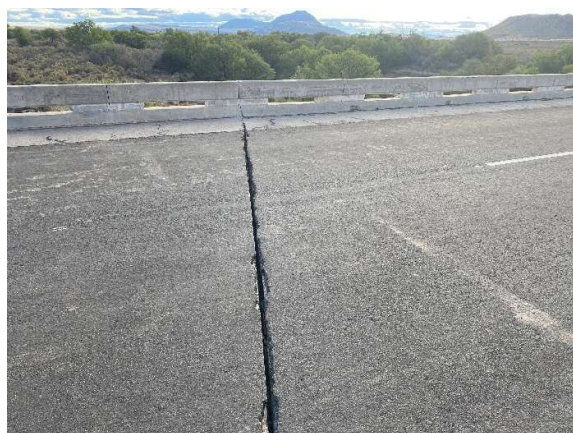
Buffalo River bridge deck where seals between the joints have been removed in preparation for bridge upgrades.

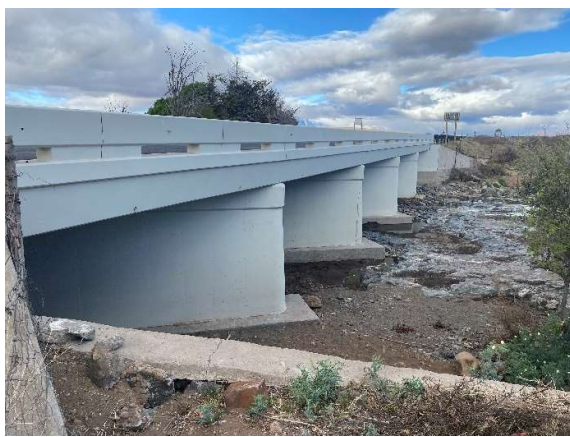
Ultkyk River bridge 4615: bridge deck resealed, joints and handrails installed, concrete repairs completed.

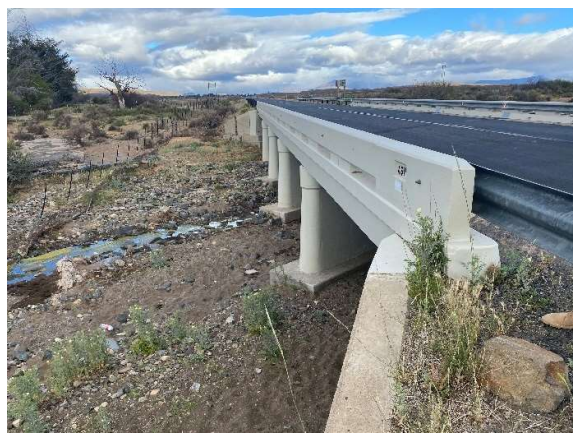
Ultkyk River bridge 4615: bridge deck resealed, joints and handrails installed, concrete repairs completed.
