## COMPLETION REPORT OF CIVIL SERVICES INSTALLATION - PHASE 10

OUTENIKUASBOSCH, FARMS OUTENIKUASBOSCH 149 AND HARTENBOSCH  
217, HARTENBOS

**MOS22/455/44**

**May 2022**

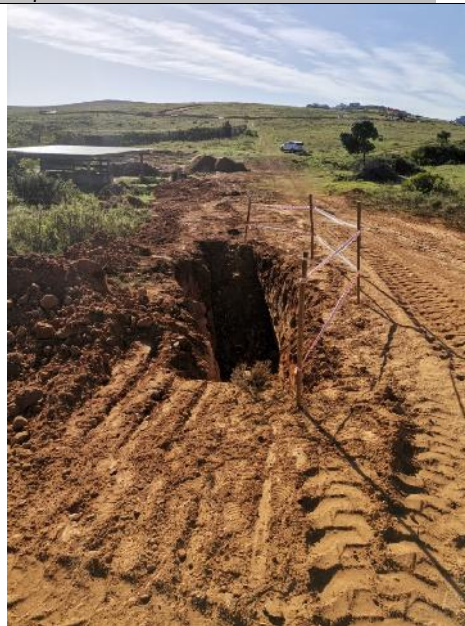
2021.03.31 – No-Go demarcation for deep excavations

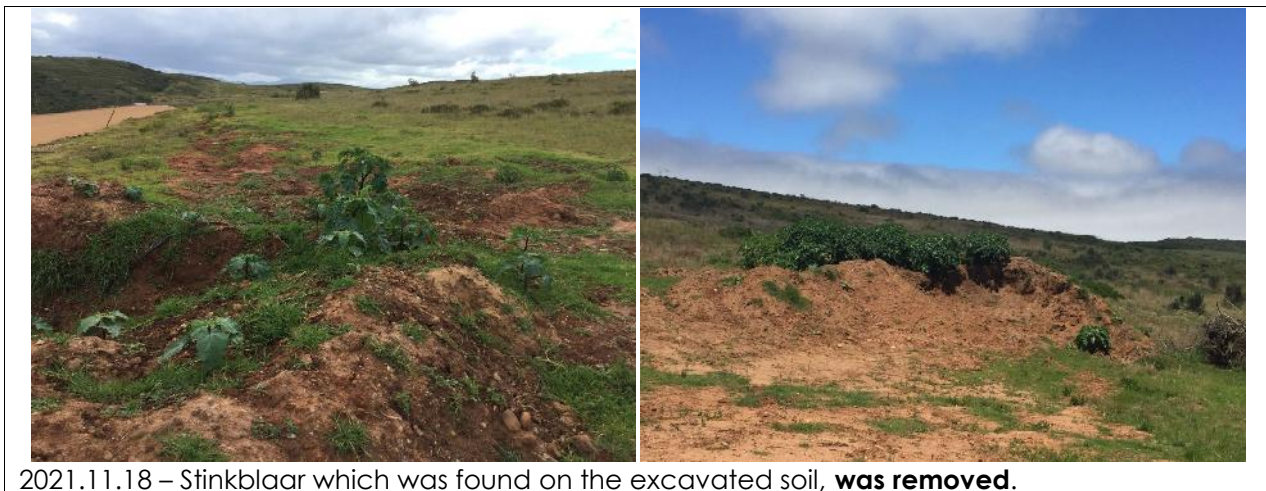
2021.11.18 – Stinkblaar which was found on the excavated soil, **was removed.**

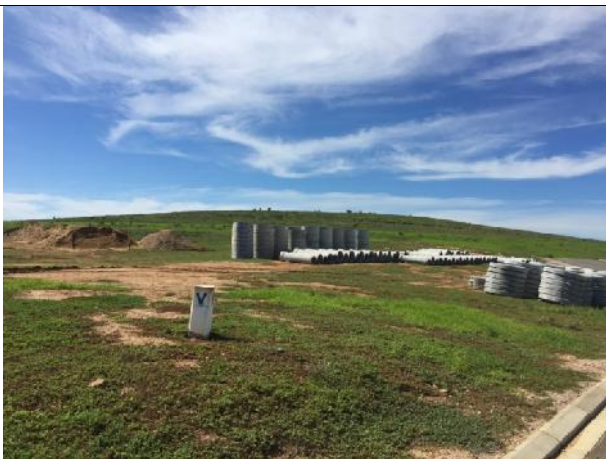
2021.04.07 – The construction material storage area was located in a future development zone

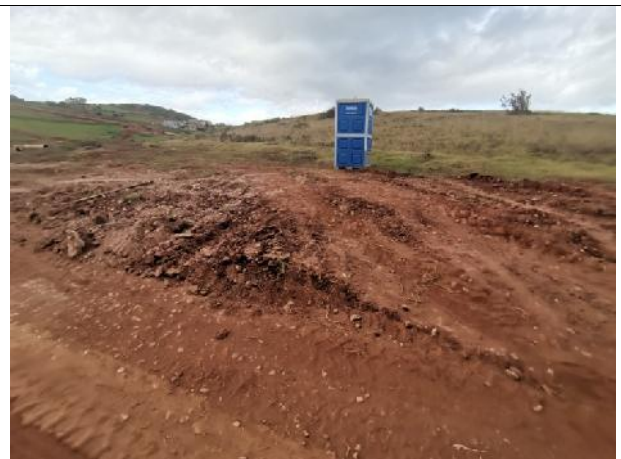
2021.06.23 – Phase 10 contractor providing a portable chemical toilet for the staff.

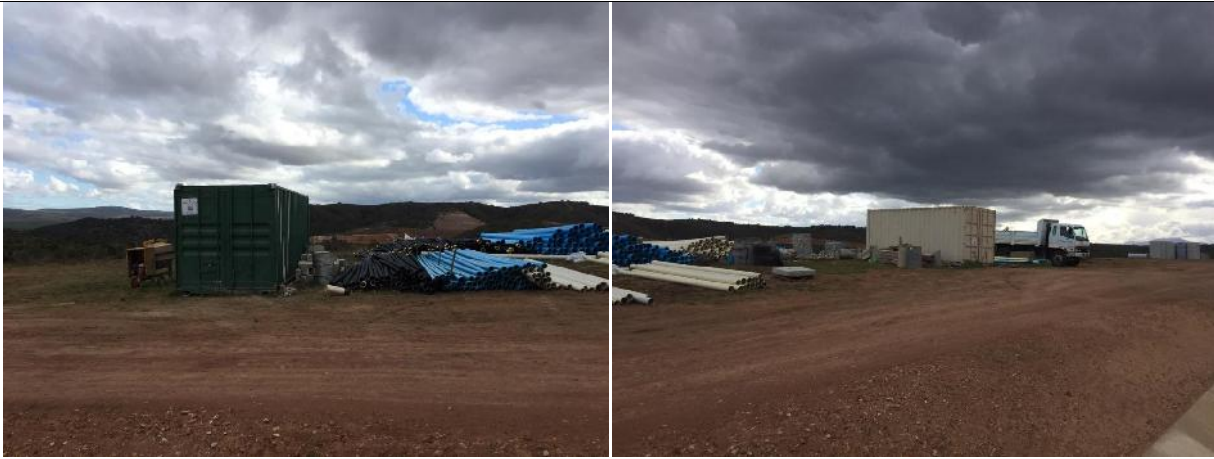
2022.05.20 - The construction site camp was located in a future development zone

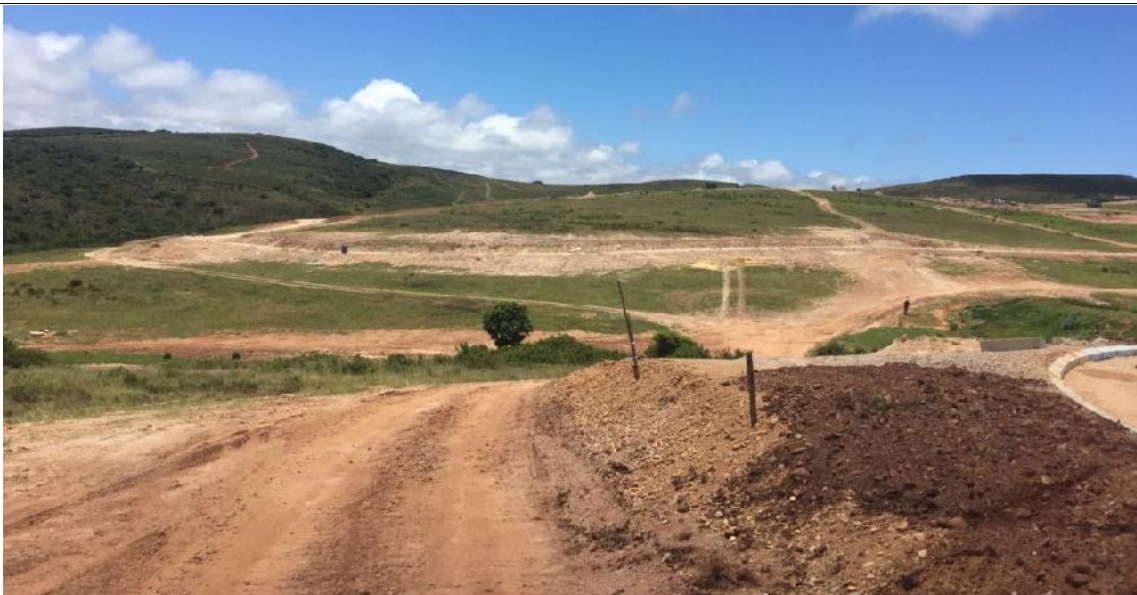
2021.12.09 – Temporary haul route during the construction of the main access road to Phase 10 (photo taken in December 2021)

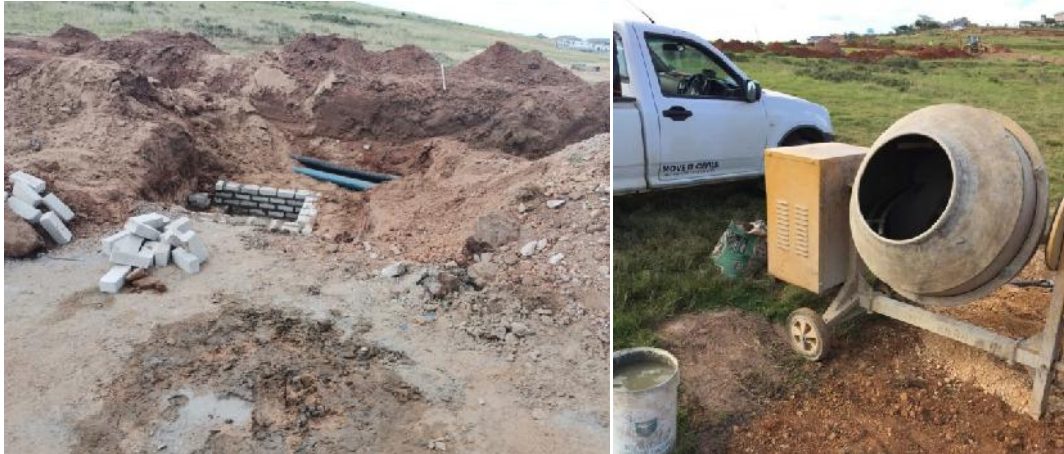
2021.06.23 – The cement mixing area was within the proposed surfaced road section and no contaminated soil was noticed (photo taken June 2021).

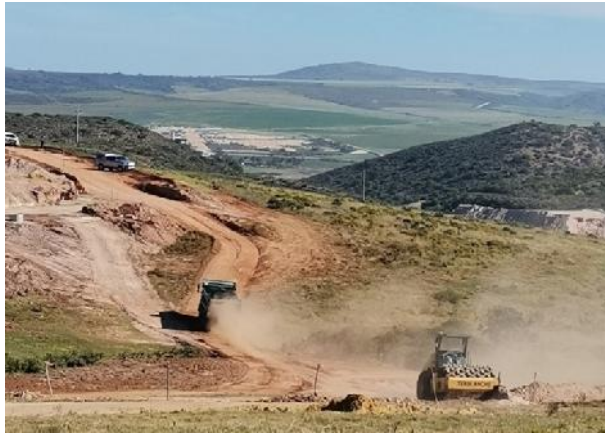
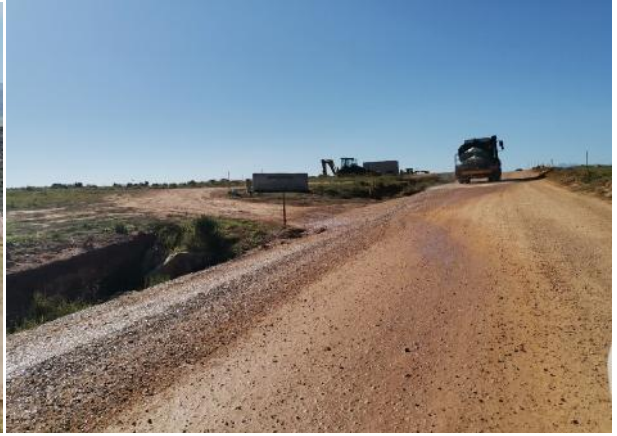
2021.09.08 – Water was sprayed on the roads to minimize the dust (photo taken September 2021).

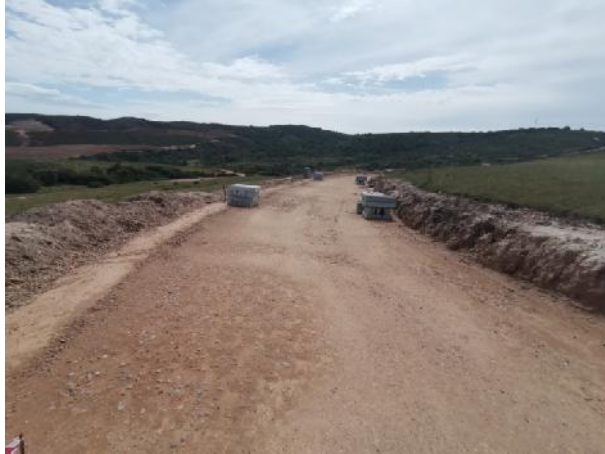
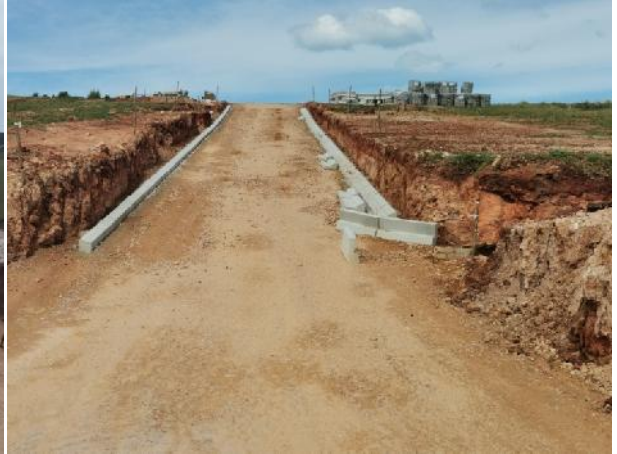
2021.10.22 – The progress on the installation of the curbs in phase 10 (photo was taken in October 2021).

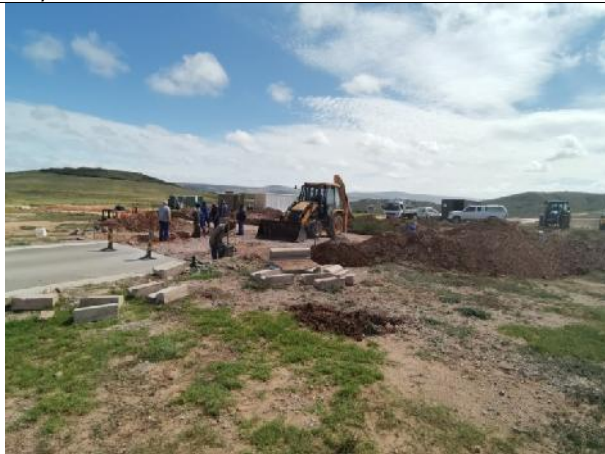
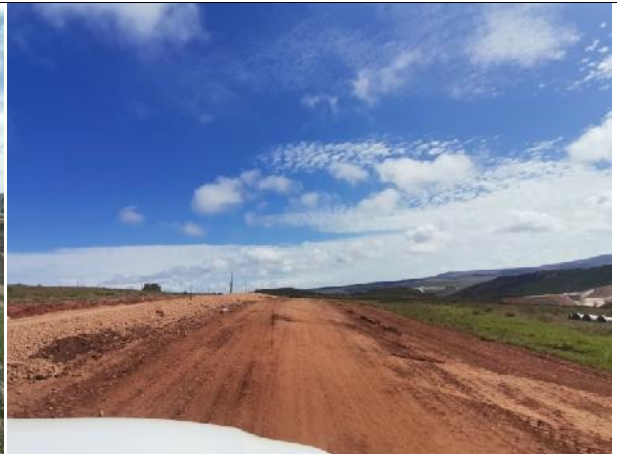
2021.11.11 – Progress with the construction of the internal roads (left) and temporary haul road (right) (photos were taken in November 2021)

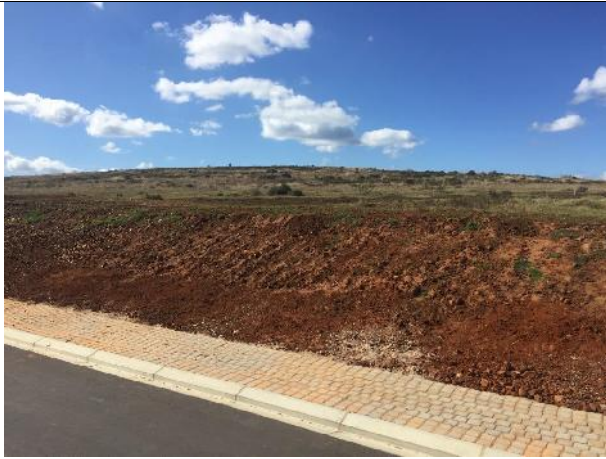
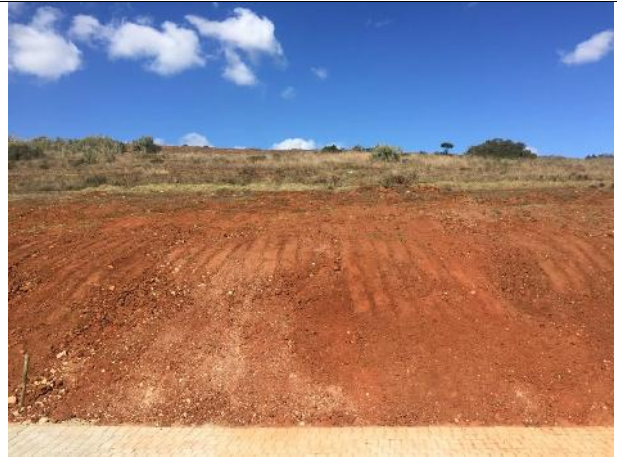
2022.04.29 – Vertical shaping was done as opposed to horizontal. This was reported to the contractor and **rectified** – the steep slopes **must now be seeded** with the indigenous grass seed mixture to prevent soil erosion.

The steep road verges are to be shaped with horizontal grader lines to prevent vertical erosion and then seeded with the indigenous grass seed mixture.

Equal parts of: **2g/m<sup>2</sup>** Kweek grass (*Cynodon dactylon*) seed and **2g/m<sup>2</sup>** Oulandsgras/Weeping Love Grass (*Eragrostis curvula*) seed (approximately **4g/m<sup>2</sup>**) that is to be spread over loosely raked soil.

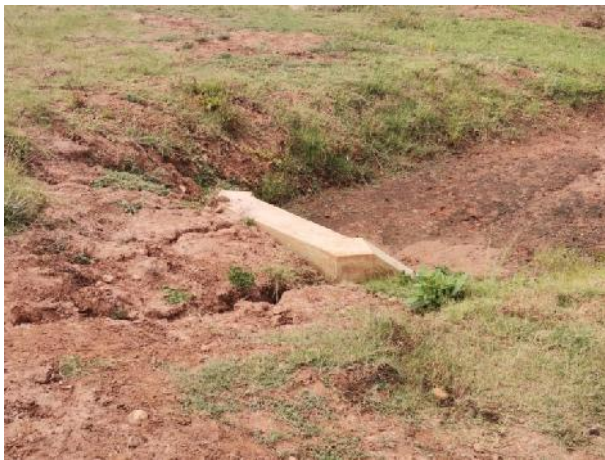
2022.01.27 – Stormwater outlet in phase 10 requires additional rehabilitation (see Section 7) - **the estate management must continue with rehabilitation** (photo taken in January 2022)

- Create small soil or stone berms across to slow the flow of the surface water;
- Sow the indigenous grass seed mixture on the side slopes and above the structure areas;
- Mulch filled onion bag (or similar) pegged along the contours, to the side slopes (where steep)
- Estate Management - ongoing maintenance of the stormwater outlets is to be done.

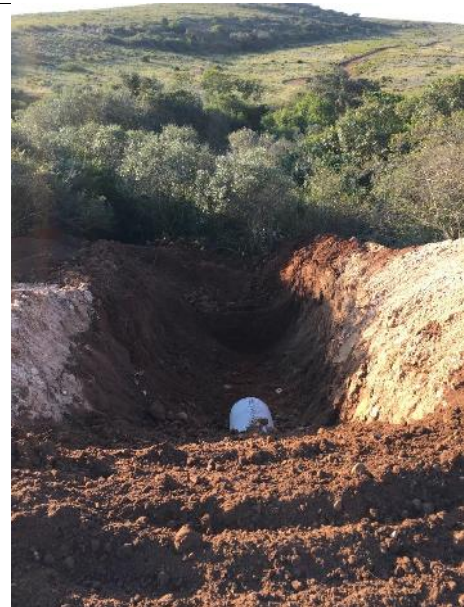
2021.08.25 – Stormwater outlet (phase 10) in progress

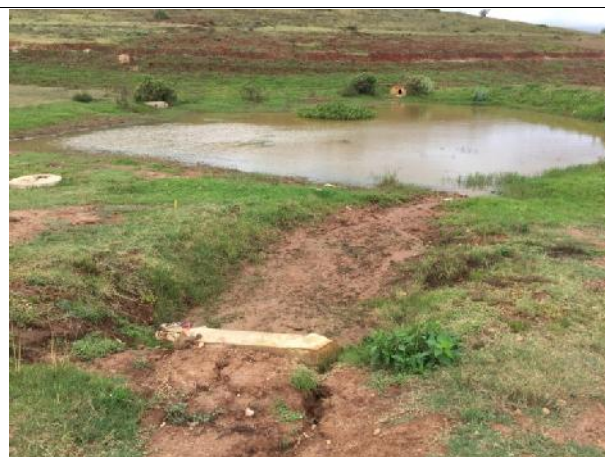
2022.03.23 – Stormwater outlet in phase 10 (left) requires additional rehabilitation recommended (see Section 7) – (photo taken in March 2022)

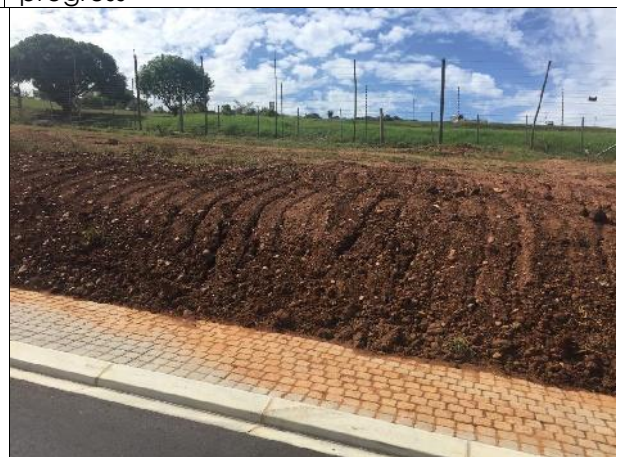
**The steep road verges were shaped with horizontal grader lines to prevent vertical erosion and must now be seeded with the indigenous grass seed mixture.**

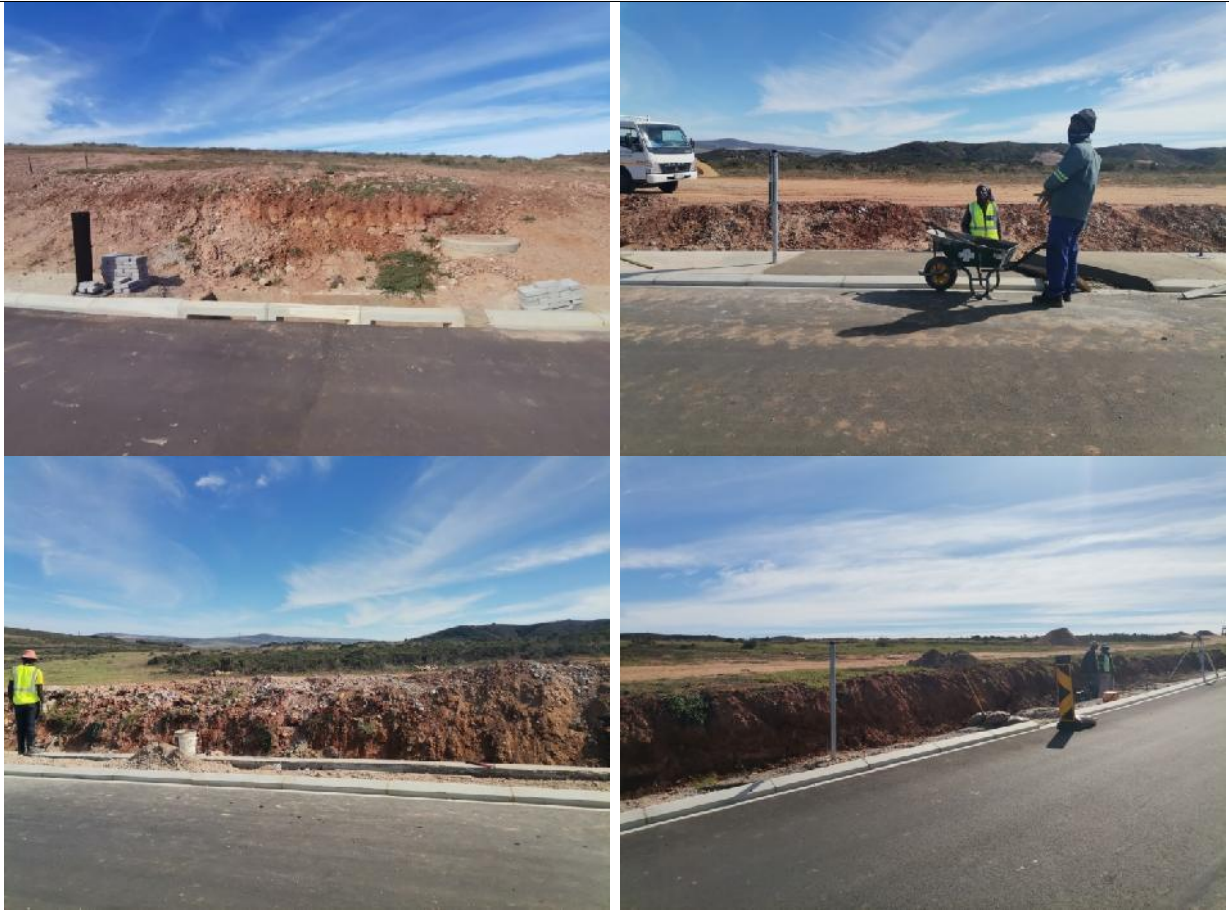
2022.04.20 – Progress with the construction of the stormwater channel of Mafunyane Street (photo taken April 2022)
