## ANNEXURE A – SITE PHOTOGRAPHS

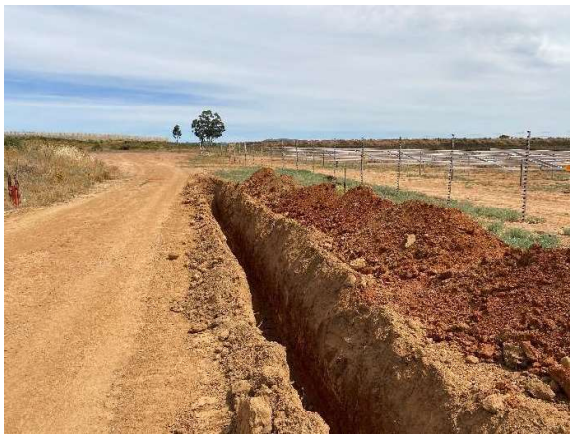
Excavated trenches for implimenting groundwater control measures.

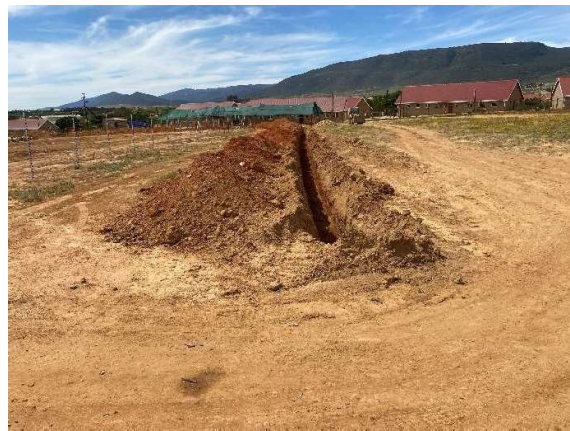
Excavated trenches for implimenting groundwater control measures.

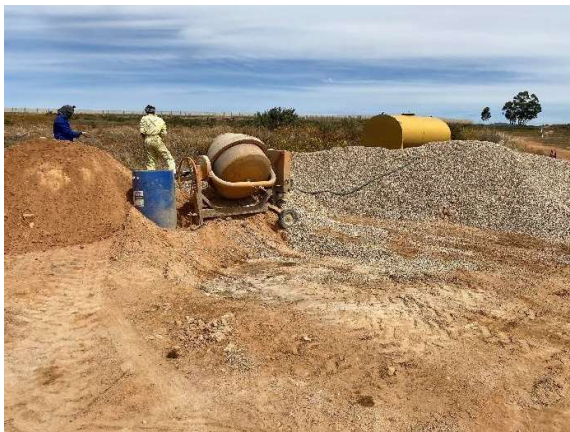
Cement batching active for the construction of the solar panel footings and control stations.

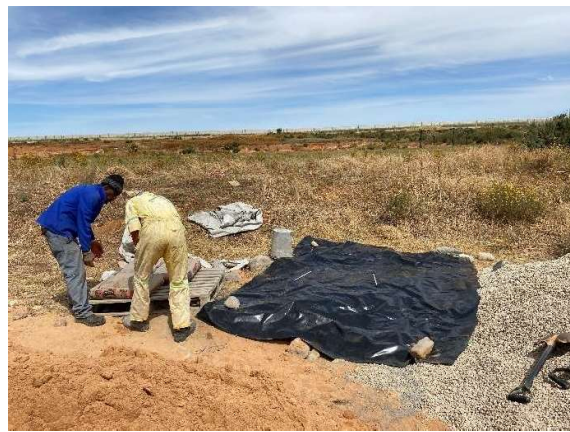
Impermeable builders plastic sheeting used during cement batching.

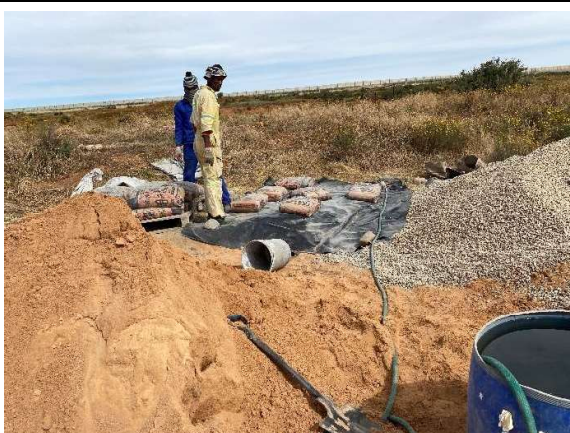
Impermeable builders plastic sheeting used during cement batching.

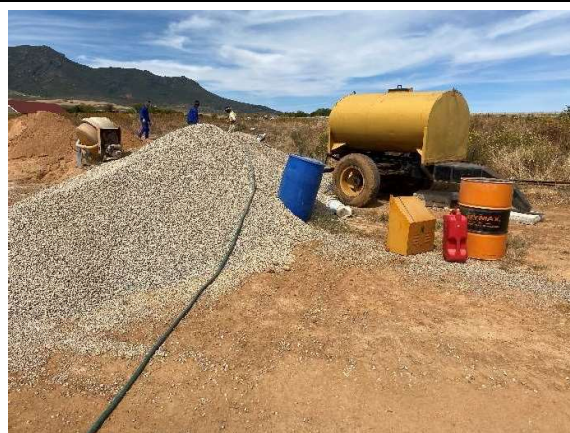
Water truck available for dust suppression.

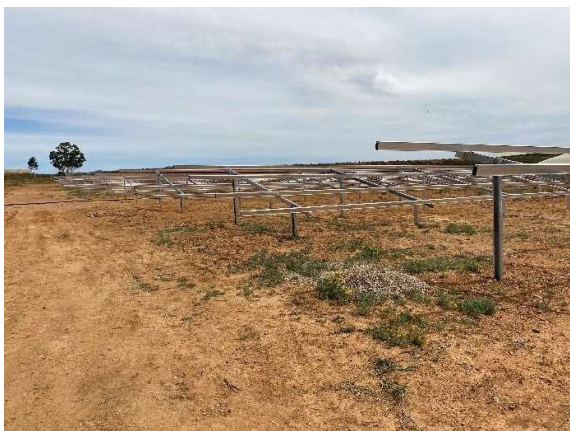
Condition of the newly installed solar panel footings and frame structures.

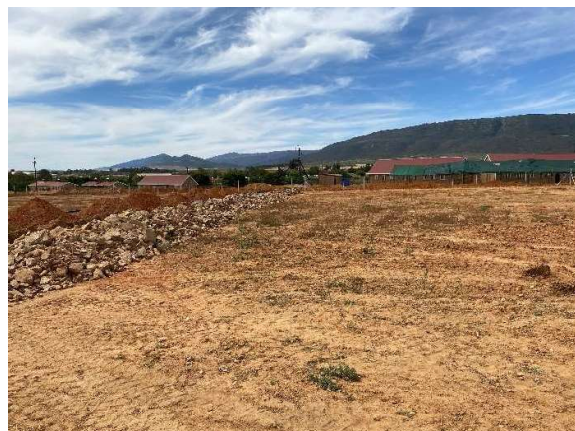
Condition of the site seen towards the north with a channel being lined with rocks for groundwater control.

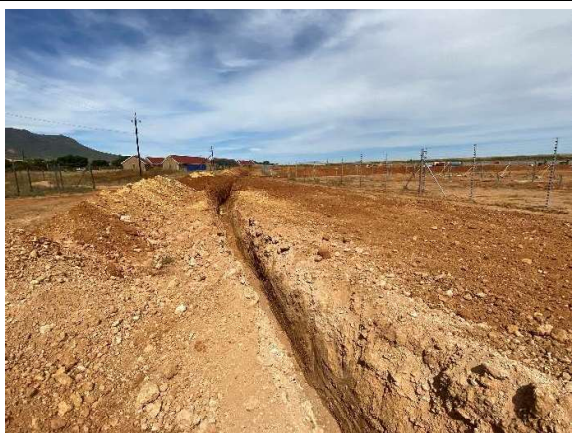
Groundwater cutt-off trenches along the northern boundary conveying groundwater towards the west.

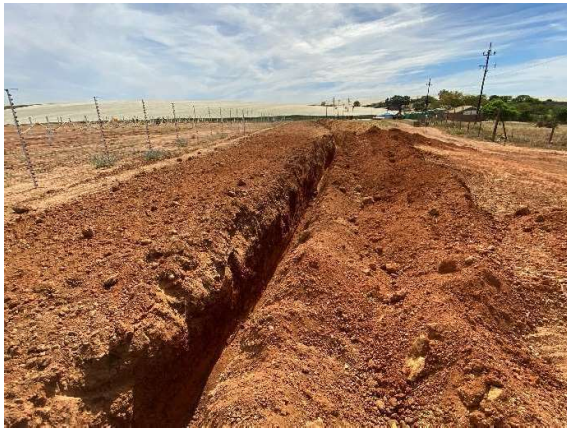
Groundwater cutt-off trenches along the northern boundary conveying groundwater towards the west.

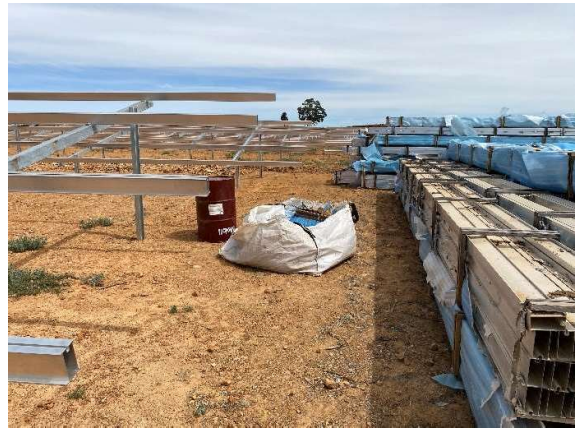
Structural material stored on-site with a bag for plastic storage.

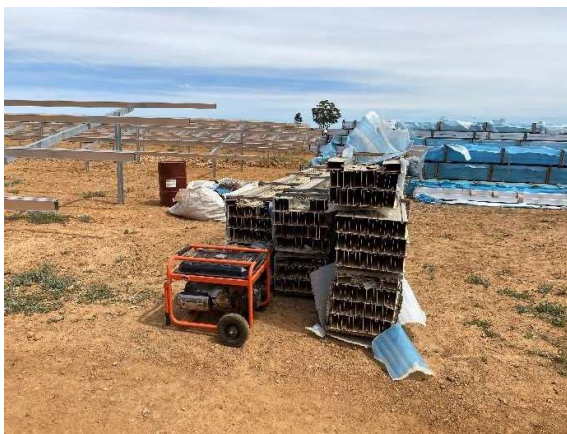
Structural material stored on-site with a generator. No drip tray in place.

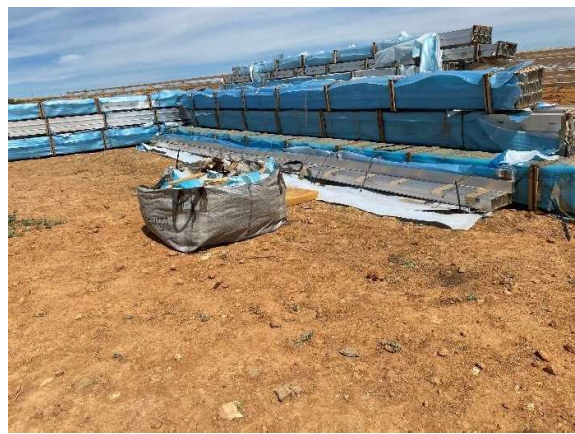
Structural material stored on-site with a bag for plastic storage.

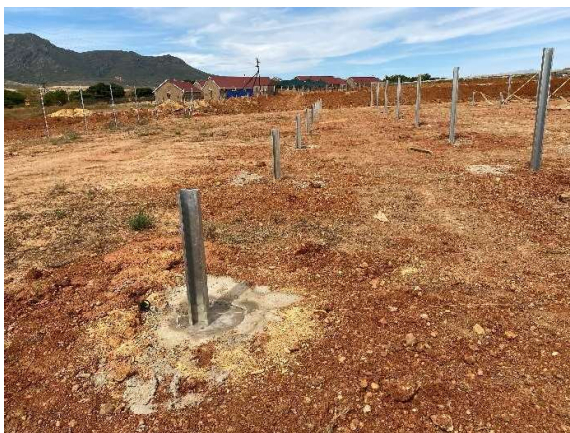
Concrete cast footings in place. Dry concrete remains are removed once concrete has set.

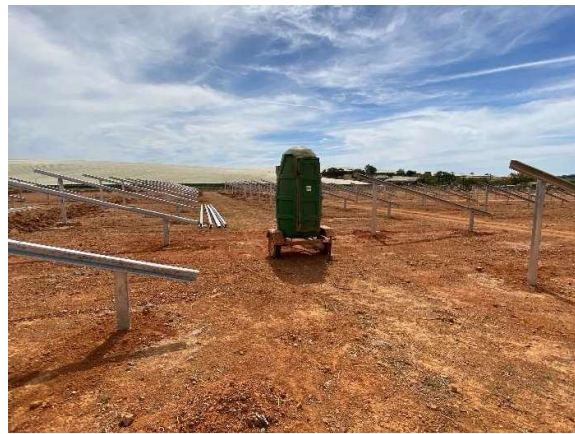
A portable chemical toilet is in place on-site.

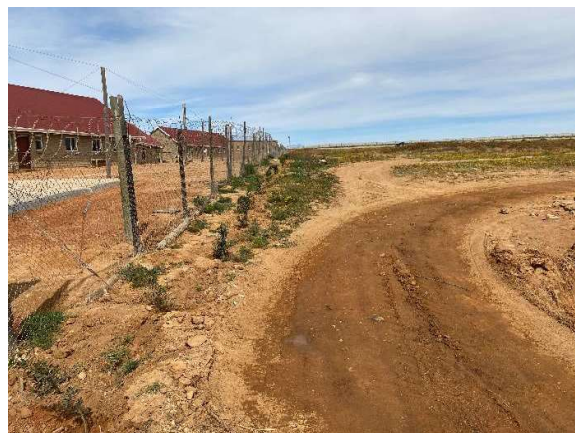
Watering of gravel access roads on site towards the northern boundary.

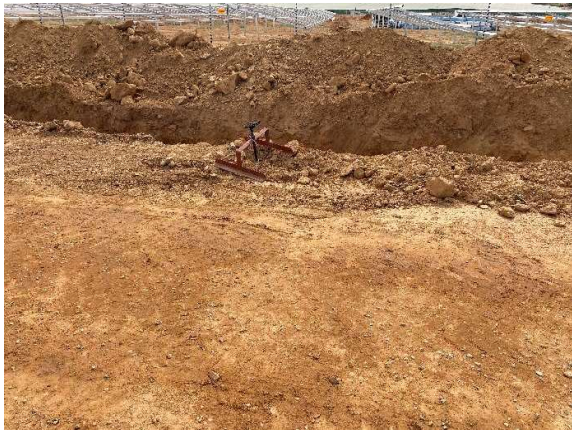
A rotating sprayer on site for dust suppression.

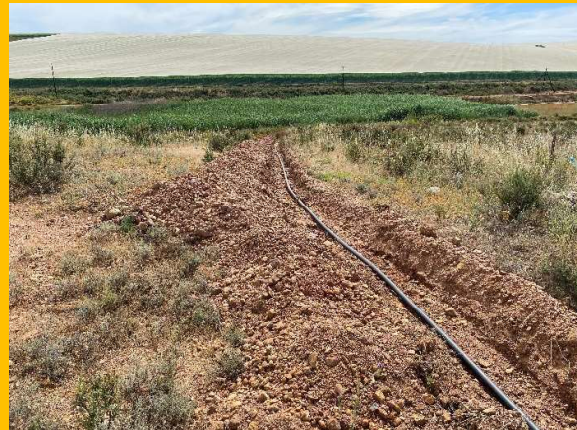
A water pipeline connecting to an existing pipeline within the no-go area, although outside the wetland boundary.
