# ANNEXURE A – SITE PHOTOGRAPHS

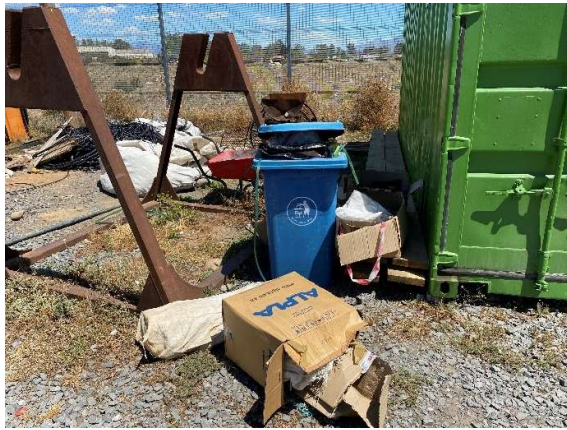
Litter bin within the contractors camp with litter discarded on the side due to overflow.

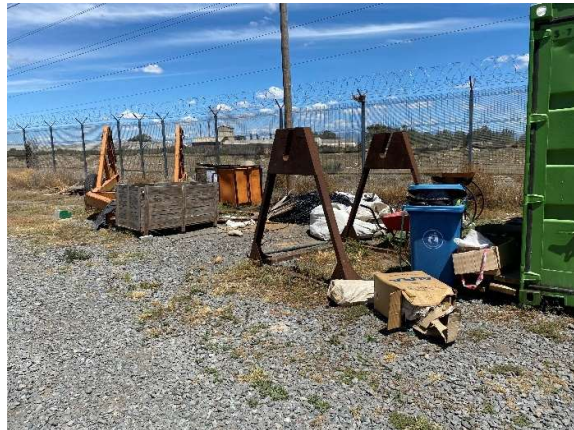
Litter bin within the contractors camp with litter discarded on the side due to overflow.

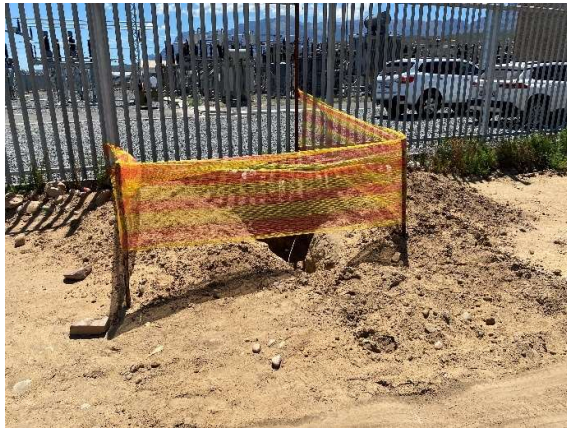
Excavations for future lines, appropriately demarcated.

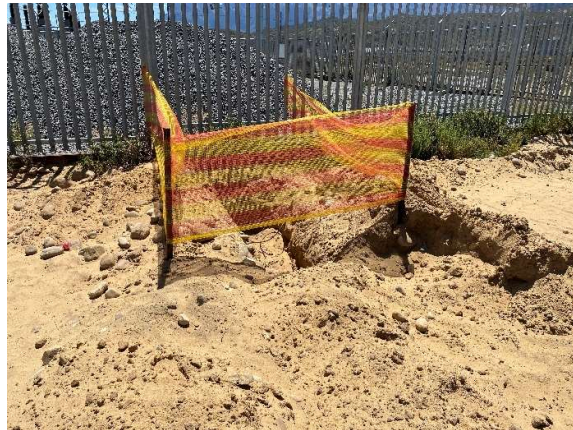
Excavations for future lines, appropriately demarcated.

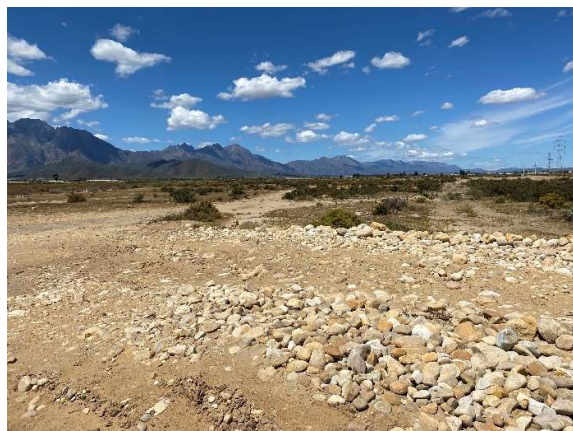
The condition of the site as seen from Pylon 5 east towards Pylon 6, note the excavated rock substrate.

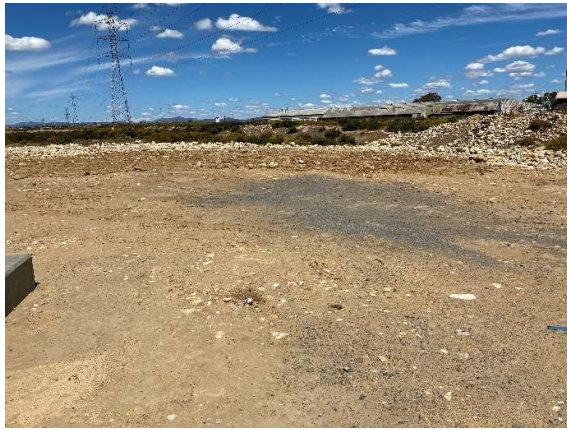
The condition of the site as seen from Pylon 5 east towards Pylon 6, note the excavated rock substrate.

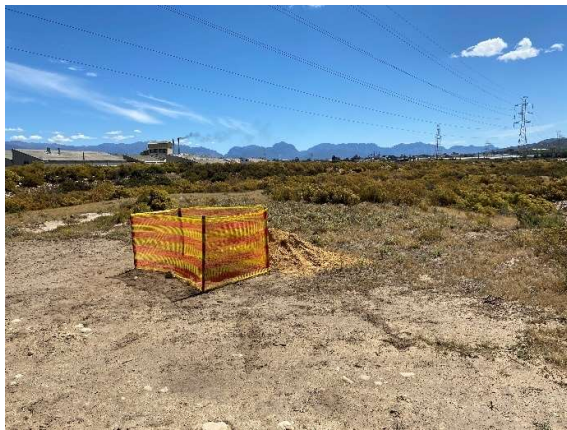
Test holes along the route near pylon 5, sufficiently demarcated.

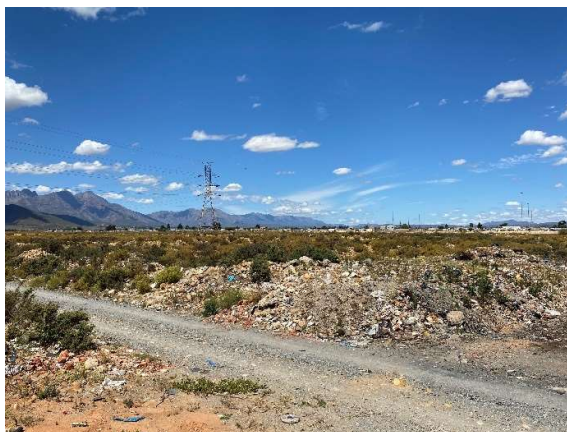
North of Raymond Pollet Drive where the area was used as a waste dumping area

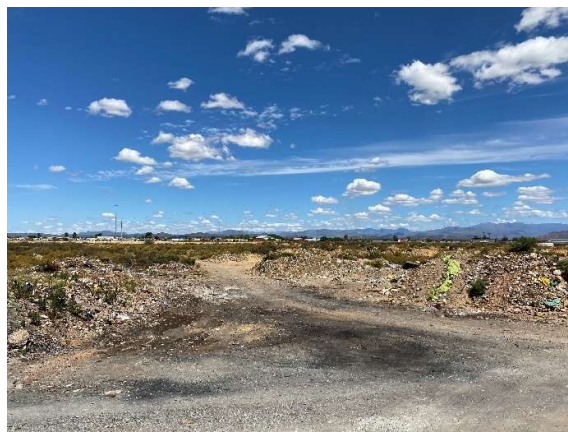
North of Raymond Pollet Drive where the area was used as a waste dumping area.

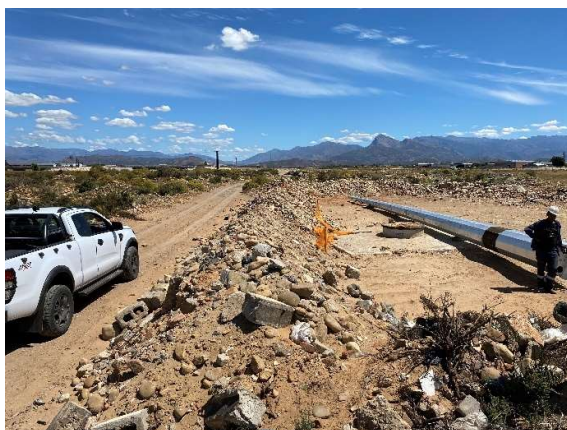
From pylon 8 as seen towards the south showing the derelict condition of this specific area.

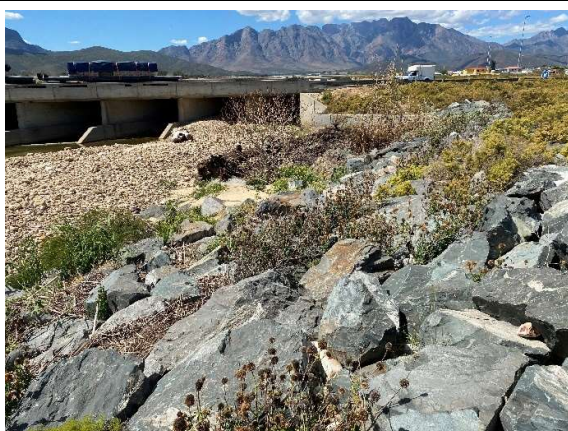
The condition of the Hex River and its banks immediately downstream of Robertson Road (R60).

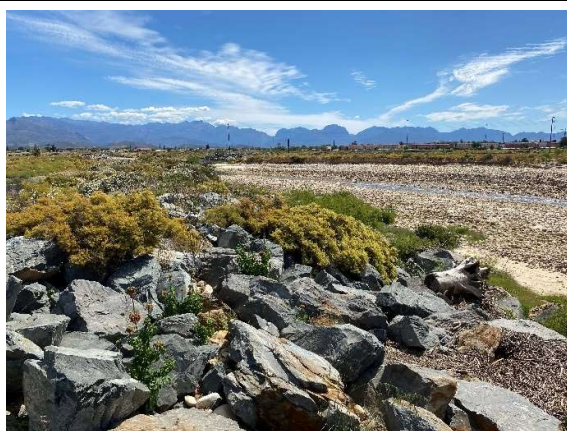
The condition of the Hex River and its banks immediately downstream of Robertson Road (R60).

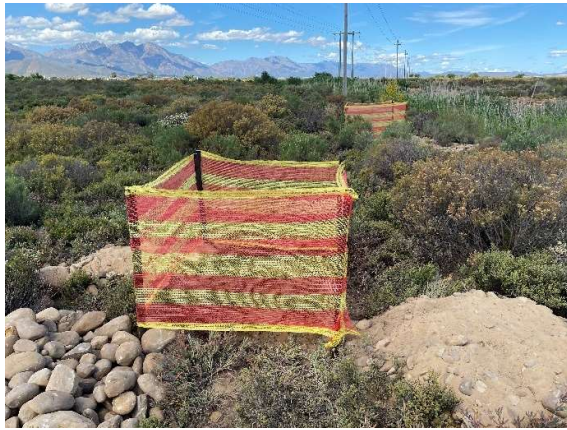
Test hole excavations along the route between pylons 18 and 21 sufficiently demarcated and limited.

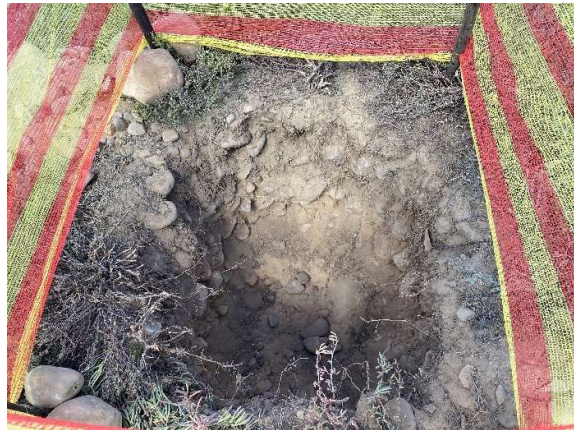
Test hole excavations along the route between pylons 18 and 21 sufficiently demarcated and limited.

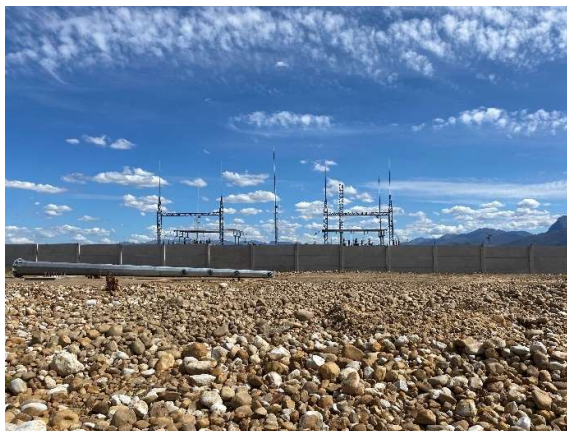
Completed pylon footing 21 and the pylon. Note the excavated rocks present at most excavations.
