**THE UPGRADE OF PROTEA AND MAINTENANCE TO WAARBURGH ROAD NEAR  
JOOSTENBERG VLAKE, WESTERN CAPE**

Contract No: C1049.03

**FORMAL ECO AUDIT REPORT**

8 August 2024

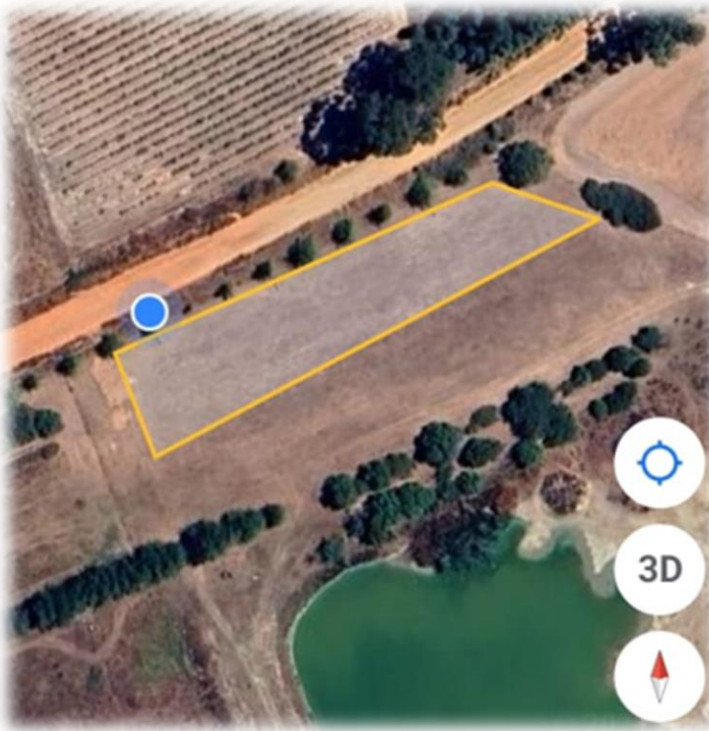
| Spoil Area No. | Comment | ECO Recommendation |
|---|---|---|
| 2. | <p><b>Spoil Area 2 along DR1098 at Approx km8.3</b></p> | <p>According to google earth it is unsure of the site</p> |

Existing farmland with only short grass present, it is unsure if the site was lawfully cleared in the preceding 10 years, but no evidence of indigenous vegetation was noted during the visit. The proposal is to spoil clean material removed from the cuttings and to spread the existing topsoil over the area. Only the area should be used as indicated below.

was cleared in the preceding 10 years. No indigenous vegetation was available during the visit as seen on the photograph. Only the area should be used as seen left.

Permission letter, prior to spoiling, and happy letter, after spoiling, is required from property owner.

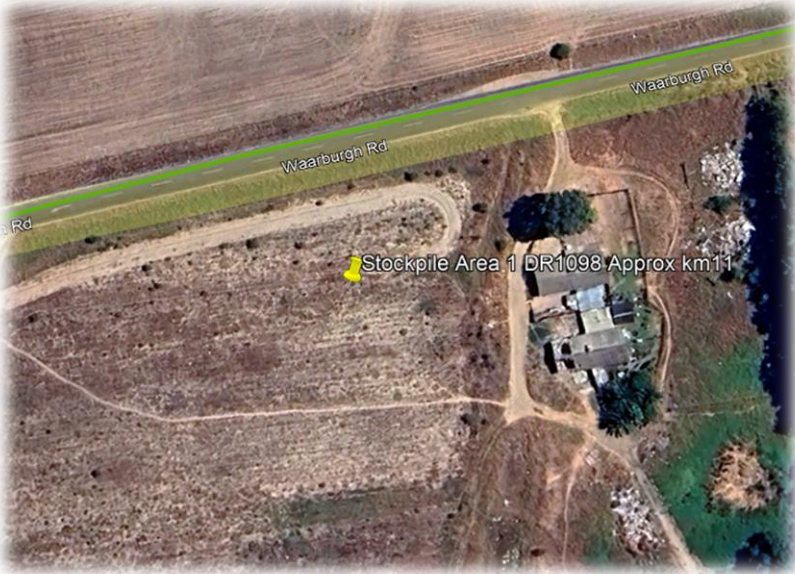
| Stockpile Area No. | Comment | ECO Recommendation |
|---|---|---|
| 1. | <p><b>Stockpile Area 1 on DR1098 at approx. km11 (LHS)</b></p> <p>Existing farmed area.</p> <p>According to google earth, the area has recently been used for farming (plough land)</p> <p>The contractor already used the area during the 1<sup>st</sup> ECO visit and area was not scanned prior to the start of using the area.</p> | <p>Permission letter, prior to stockpiling, and happy letter, after stockpiling, is required from property owner.</p> |

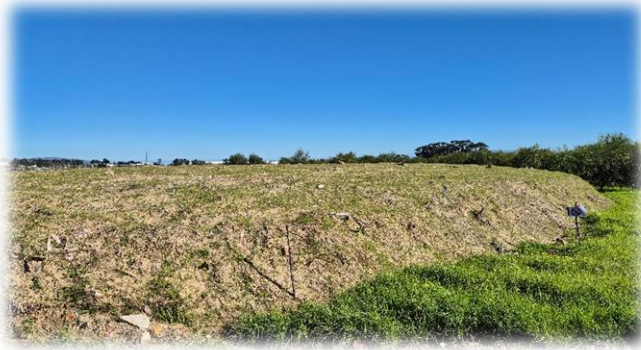
Topsoil has been stripped at a few locations along the site and currently stockpiled at Stockpile Area 1 and 2 above.

It is important to keep record of where topsoil from different sections is stockpiled to ensure the correct topsoil is returned to the same area.

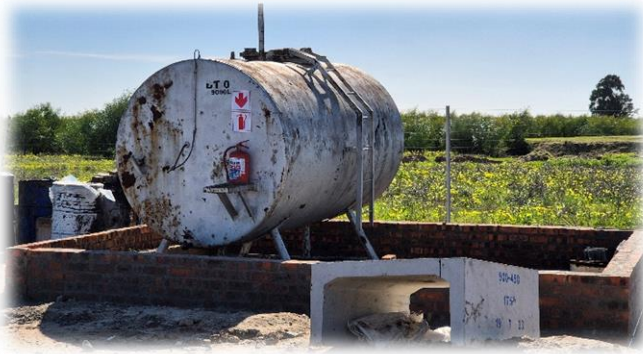
Stockpile Area 2 has been identified to be used as bitumen handling area. The contractor is advised to please ensure impermeable area is created underneath the bitumen tanks to prevent bitumen spills, the bunded wall underneath the tanks has been completed. The contractor confirmed verbally that the bunded area could store 10% more than the capacity of the tank.

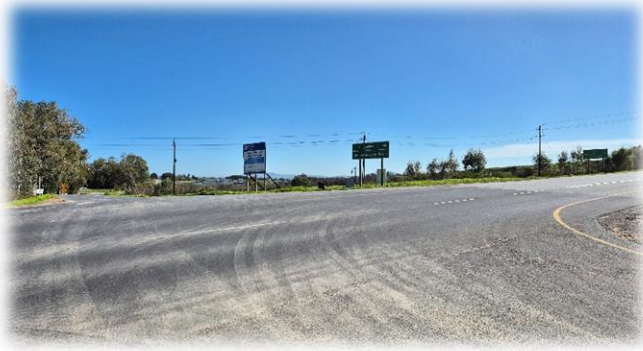
The road surface at the Klipheuwel Intersection was clean during the audit, please ensure that areas to the stockpile and spoil sites are kept clean from mud/sand to prevent the material being a danger to traffic.

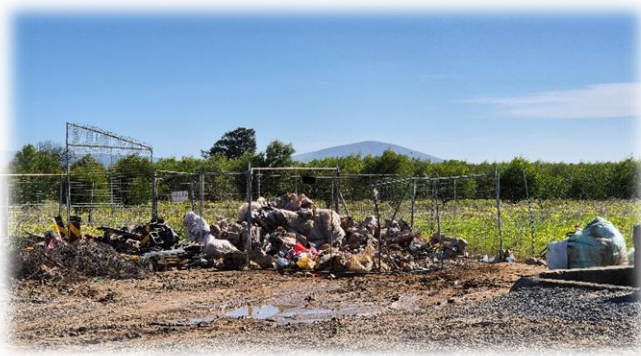
A litter structure was noted at Stockpile Area 2. The contractor is advised to regularly please remove litter from the litter structure to be disposed at a registered landfill site. Please forward proof of appropriate disposal to the ECO and ER.

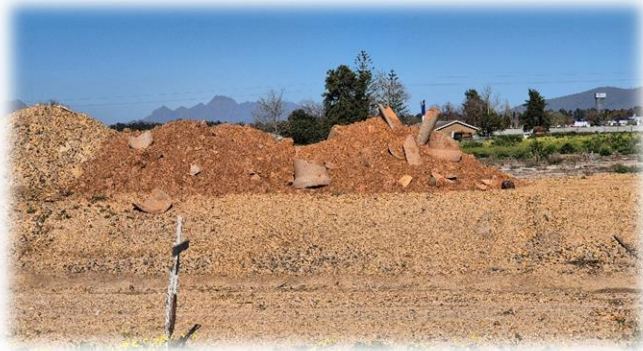
Rubble was noted to be stockpiled on the berm, the contractor is again advised that no rubble may be spoiled on site and must be removed.

The contractor was advised to please ensure that the rubble is disposed appropriately if not reused on site. Please forward rubble disposal receipts to the ECO for record keeping.

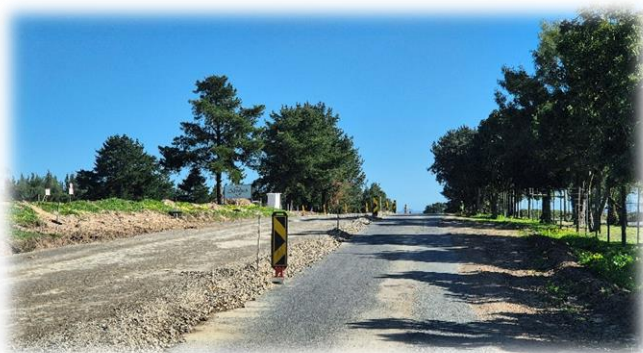
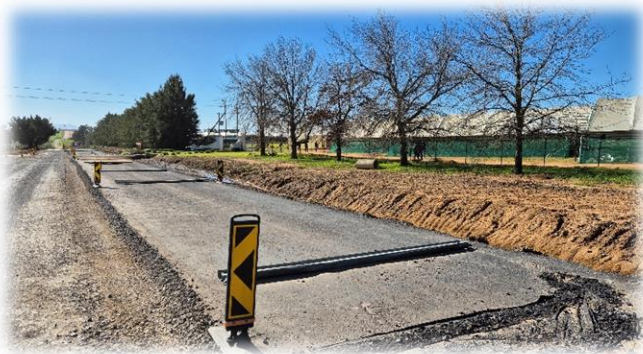
Layer works have commenced on the 1<sup>st</sup> sections of the road, progress was very slow during July due to the rainy conditions.
