## ANNEXURE A – SITE PHOTOGRAPHS

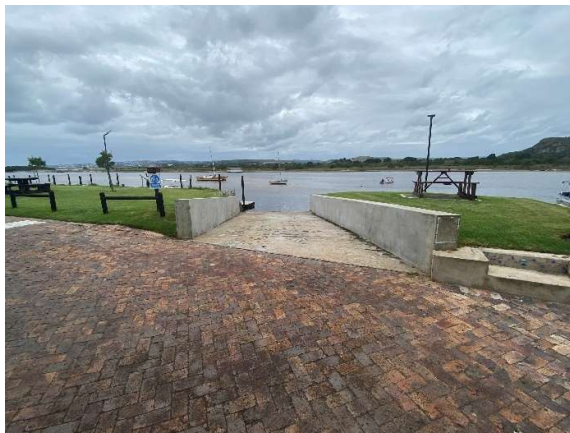
Condition of the slipway from the road-side.

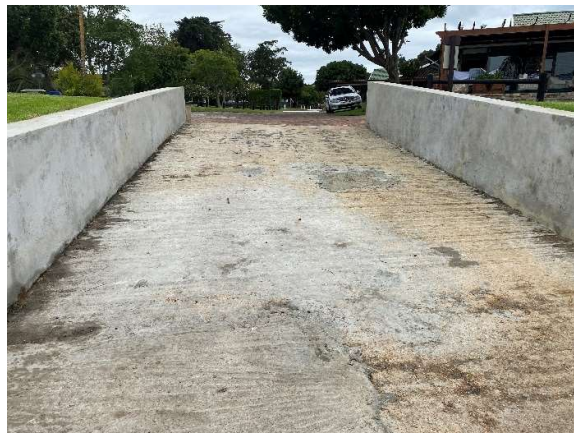
Condition of the slipway.

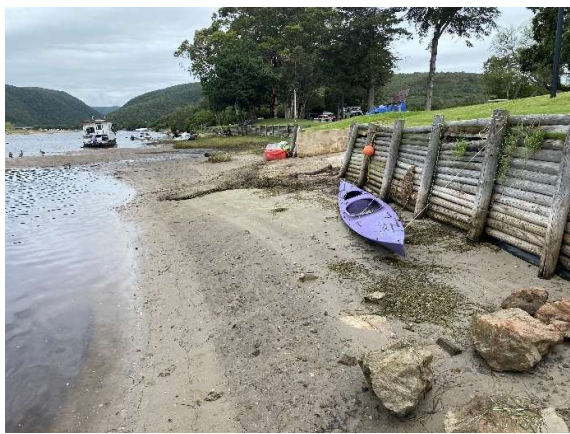
Bottom of the slipway during low tide as seen towards the north.

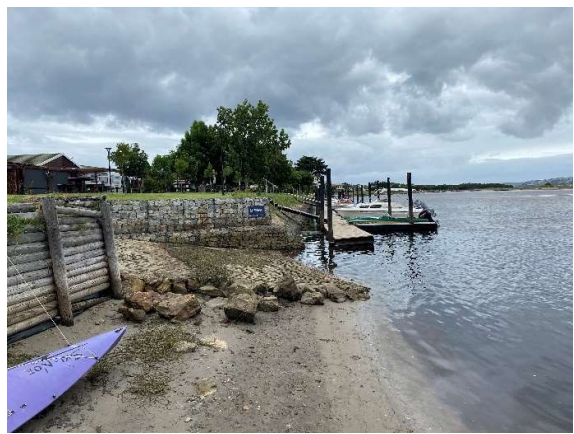
Bottom of the slipway during low tide as seen towards the south.

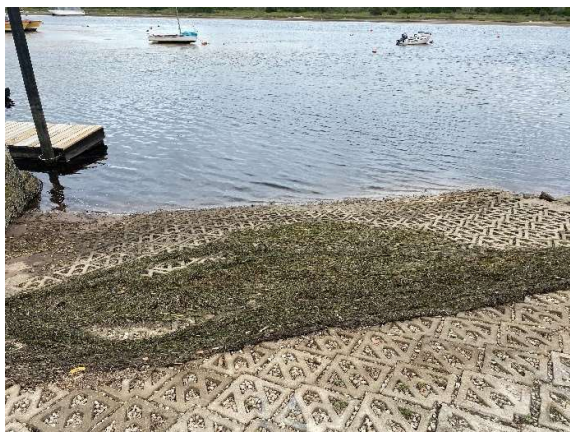
Vegetation debris at the bottom of the slipway.

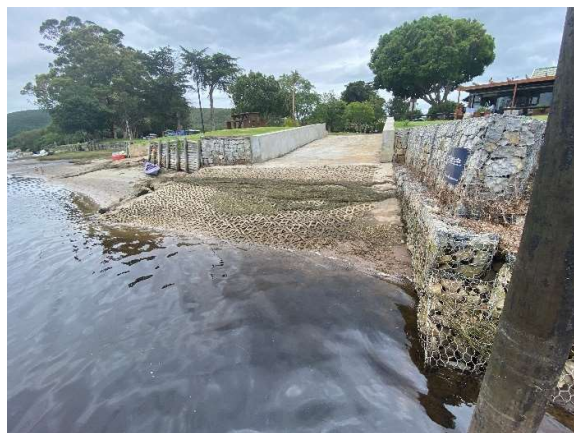
Condition of the slipway.

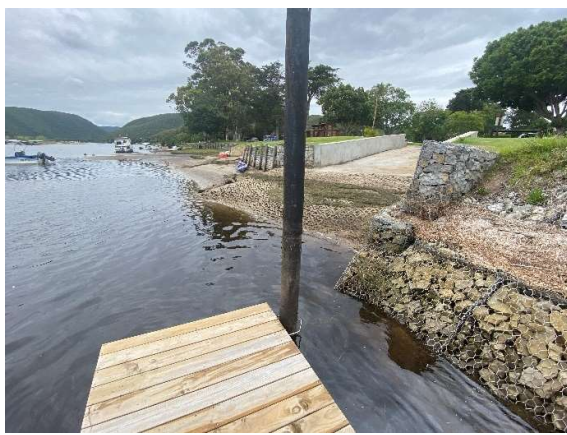
The northern end of the jetty showing the completed layers of the .

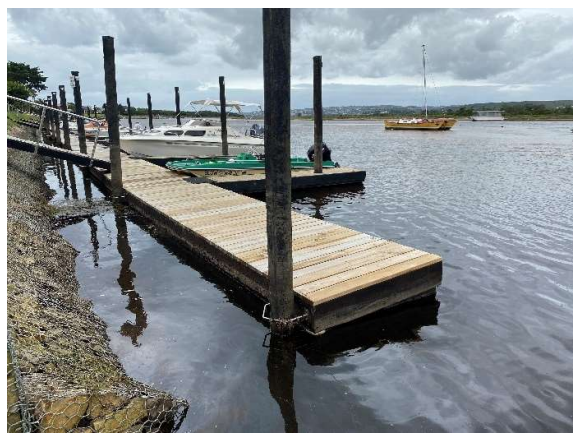
Weinstalled mooring poles.

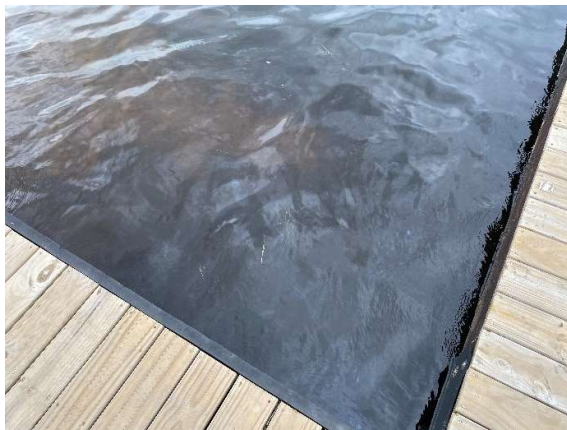
Established *Zostera* along the base.

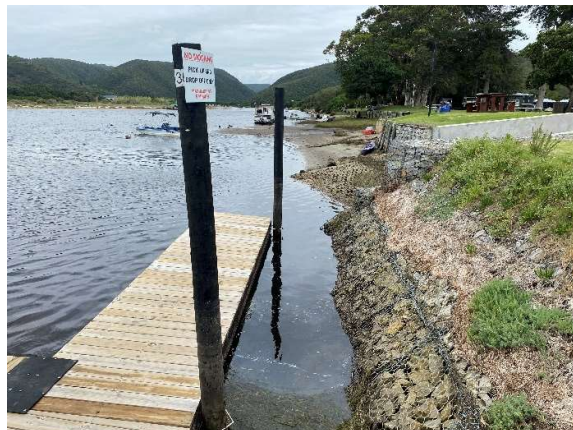
Successfully installed mooring poles.

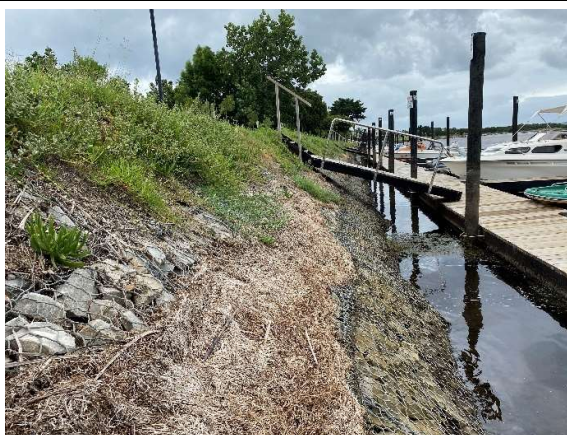
Revegetated reno-matresses.

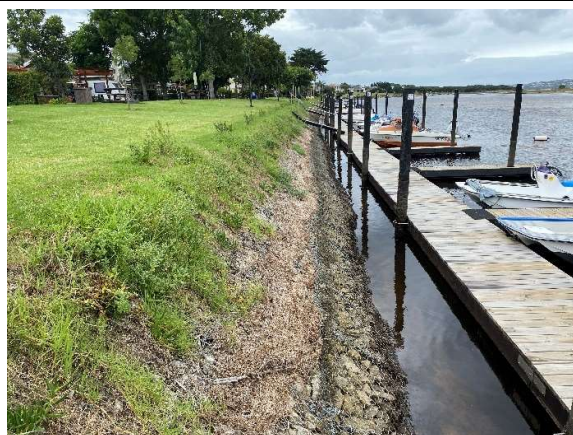
Revegetated reno-matresses.

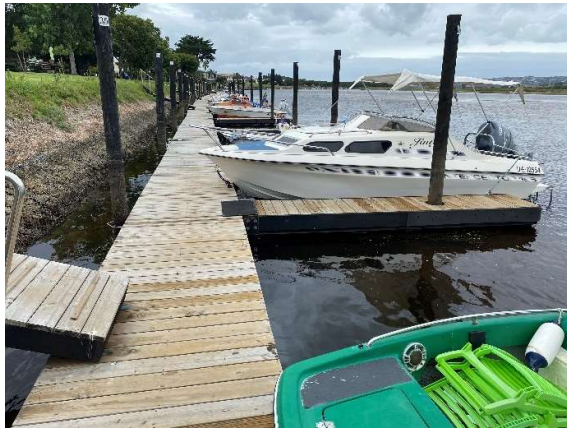
Completed jetty showing the gang-plank, jetty and fingers as seen towards the south.

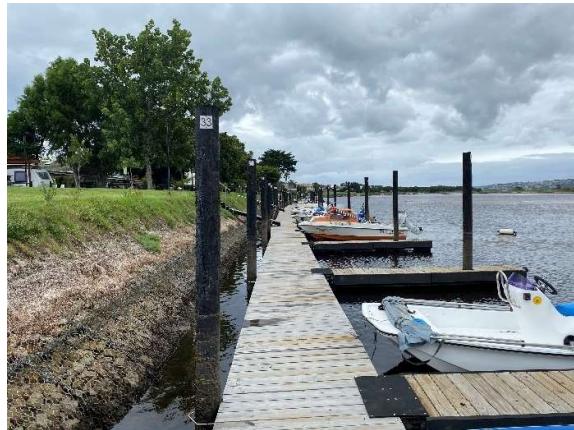
Successfully completed and operational jetty as seen towards the south.

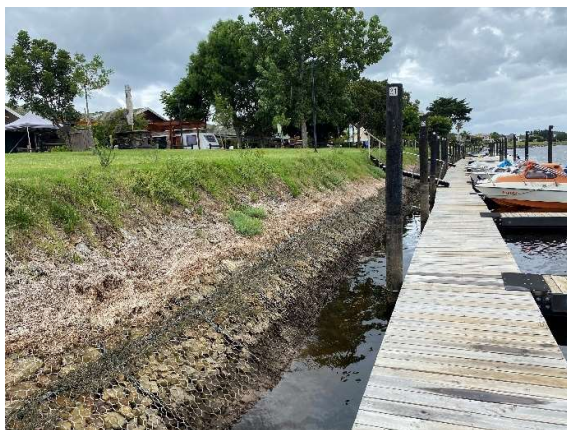
Revegetated reno-matresses.

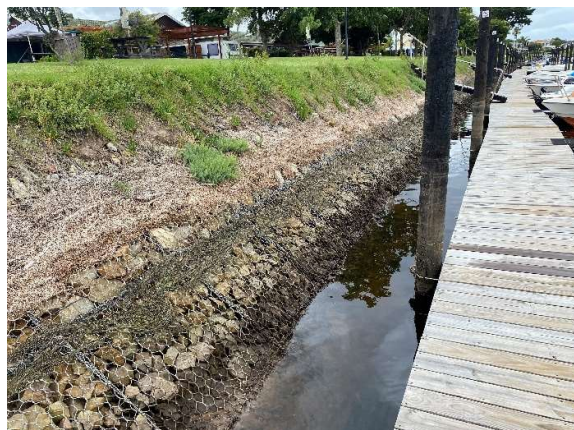
Revegetated reno-matresses.

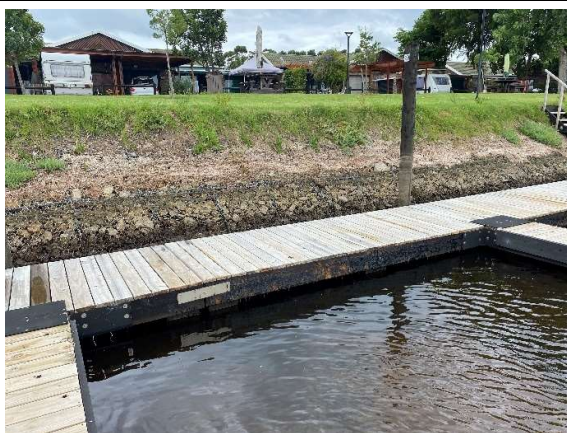
The 5m gap in between the mooring fingers.

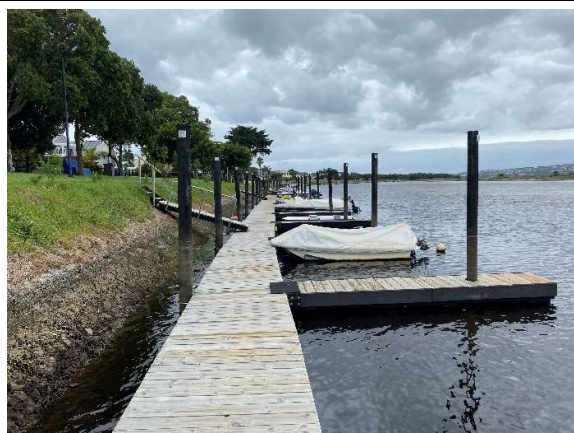
Successfully completed and operational jetty as seen towards the south..

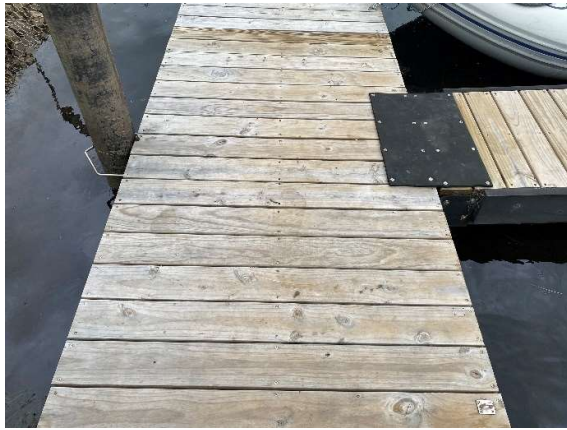
Attached floating jetty and mooring finger.

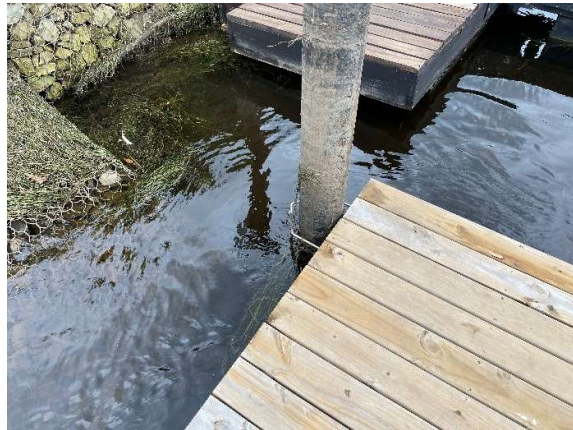
The southern end of the San Marino jetty and the northern end of the Blue Waters River Estate jetty.

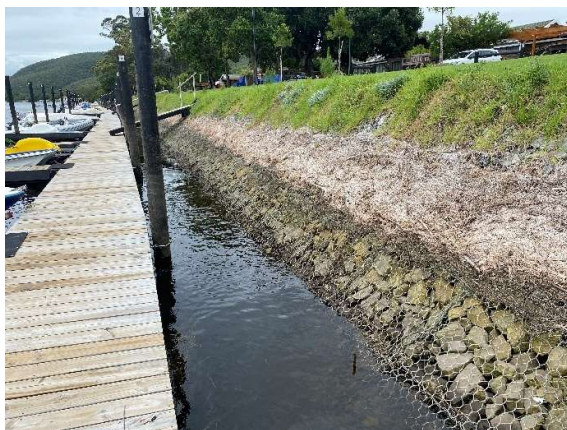
Condition of the jetty and the reno-matresses on low tide as seen towards the north.

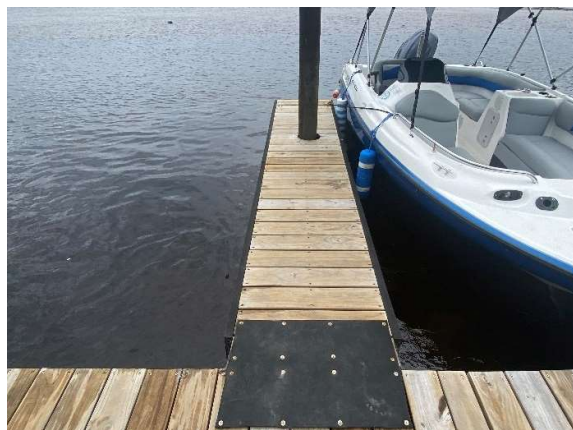
Attached floating jetty and the 4-meter-long by 0.7-meter-wide mooring finger.

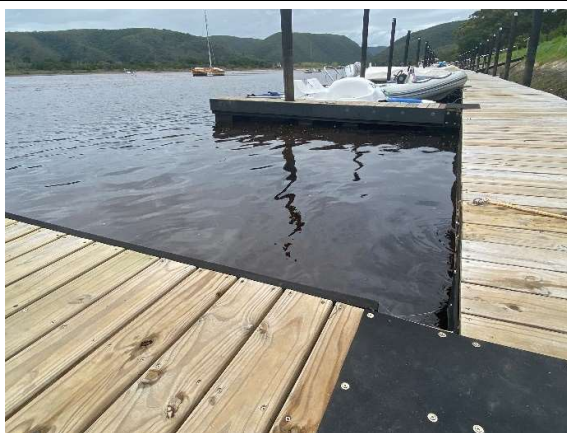
Attached floating jetty and mooring fingers with the 5m gap as seen towards the north.

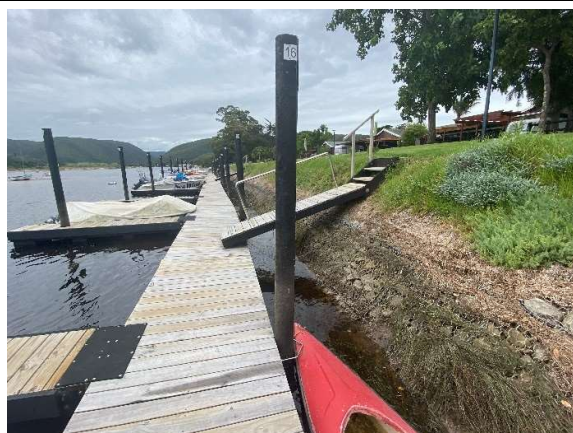
Condition of the jetty showing the gang-planks on low tide as seen towards the north.

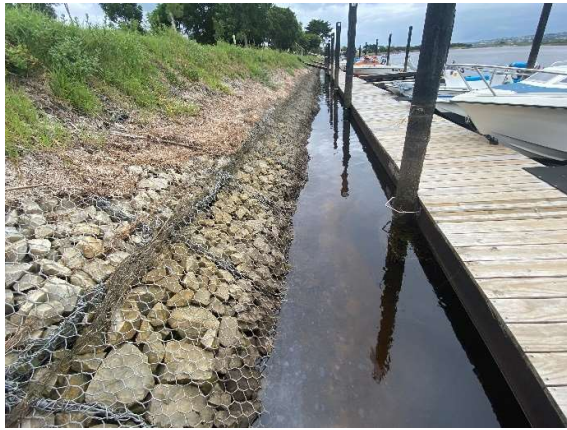
Reno-mattress toe at the bottom of the riverbank.

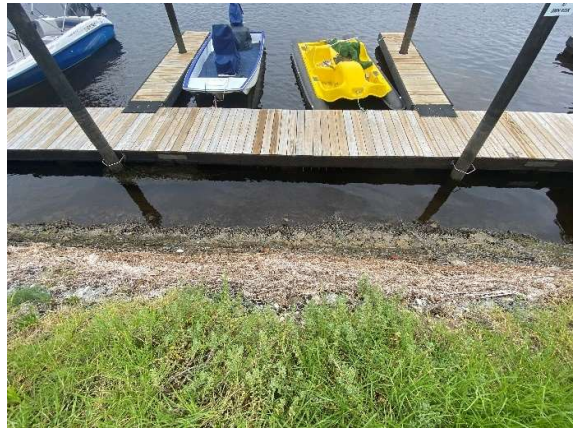
Rehabilitation of the riverbank.

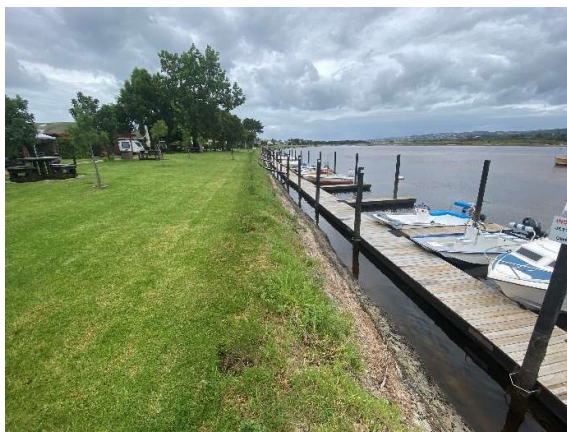
Rehabilitation of the riverbank.

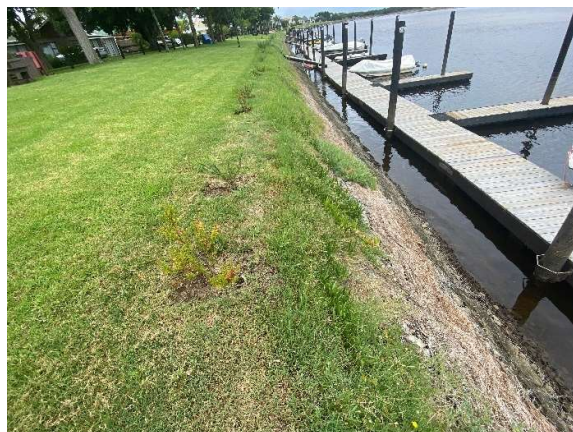
Rehabilitation of the riverbank.

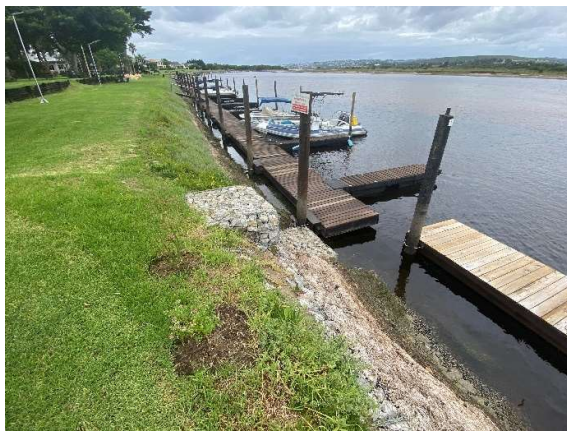
Tie-in point with Blue Waters.

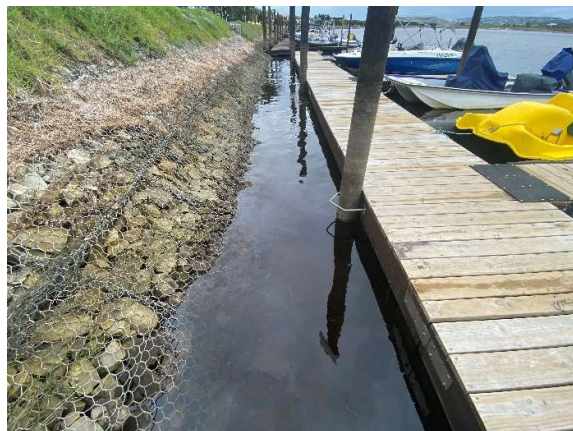
Reno-mattress toe at the bottom of the riverbank.
