# THE PROPOSED DEVELOPMENT OF A PRIMARY DWELLING AND ASSOCIATED STRUCTURES AND INFRASTRUCTURE ON ERF 4716, GROOT BRAK RIVER.

EXTERNAL ENVIRONMENTAL AUDIT REPORT IN TERMS OF REGULATION 34 OF THE NEMA EIA REGULATIONS, 2014 (AS AMENDED).

DEA&DP EIA REF. NO. 16/3/3/1/D6/17/0020/22  
NEAS REF. NO. WCP/EIA/0001142/2022

15 May 2025

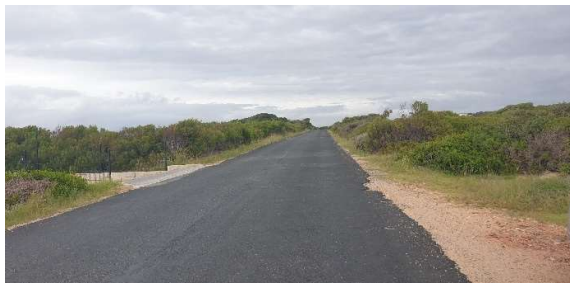
Access to the site along the MR6817/Ottosrust.

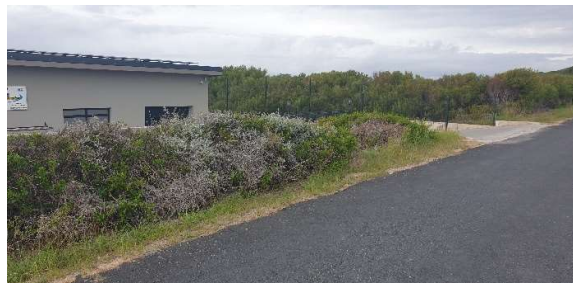
Outside landscaping of natural vegetation on the western boundary of the property, the majority of the site contains Rooikrans.

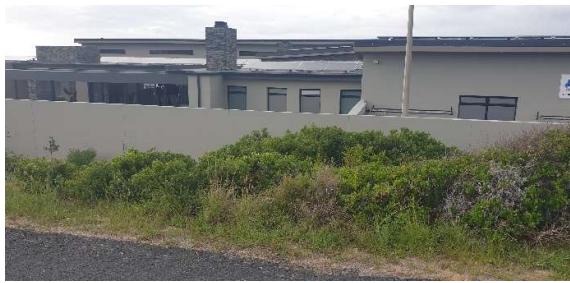
Outside landscaping of natural vegetation on the western boundary of the property.

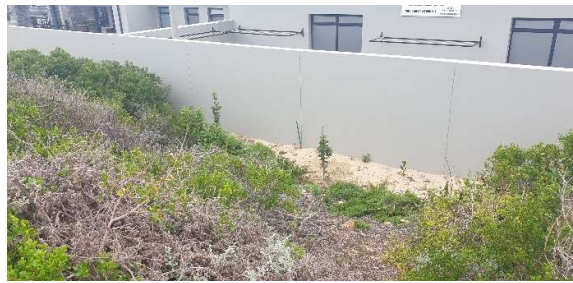
Milkwood trees were planted on the western boundary of the property.

- The applicant took corrective action by purchasing and planting multiple Milkwood trees both on and adjacent to the property to compensate for the loss. These trees also function as screening vegetation, aligning with the visual specialist's recommendations.
- The contractor was issued a non-compliance penalty, and instead of a monetary fine, the following corrective measures were imposed:
  - The contractor was required to purchase either three (3) x 20-liter Milkwood trees or five (5) x 4-liter Milkwood trees (*Sideroxylon inerme*).
  - The newly planted and rescued Milkwood trees must be nurtured (compost, food, and water) for the remainder of the construction phase, ensuring their successful establishment.

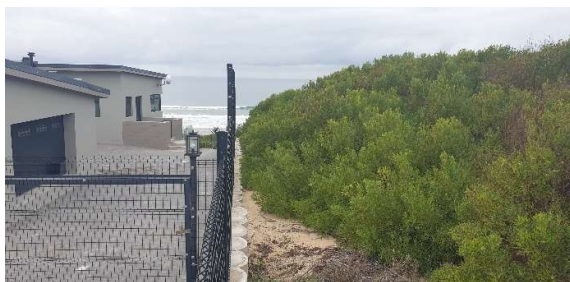
The southern boundary of the property, where one of the sewage conservancy tanks is located.

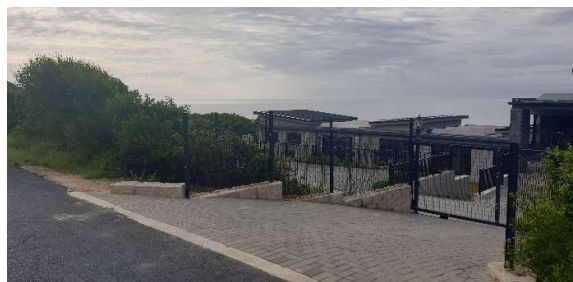
Entrance to the property towards the northeast.

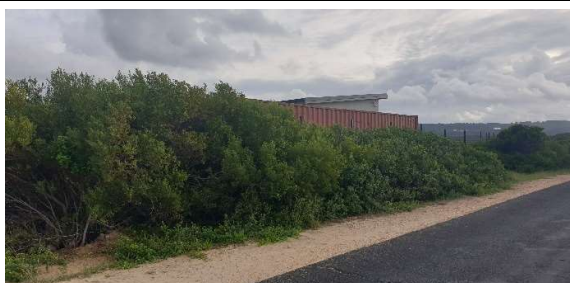
Natural vegetation adjacent to the outbuilding which is utilised as a storage area.

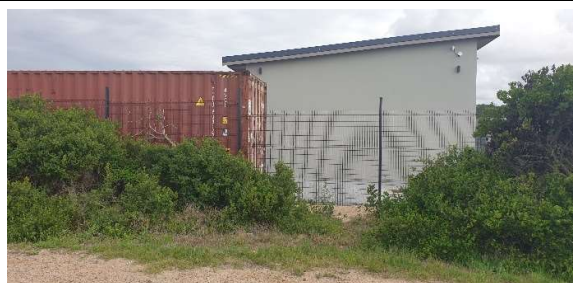
Boundary fence of the outbuilding across from the property.

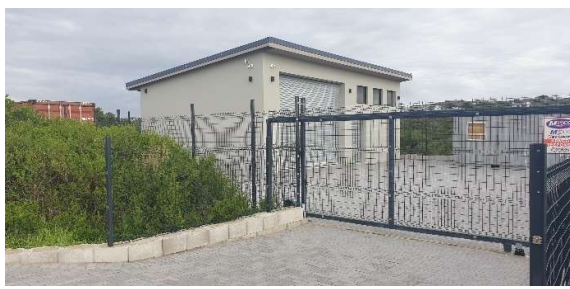
Outside access to the outbuilding (garage site).

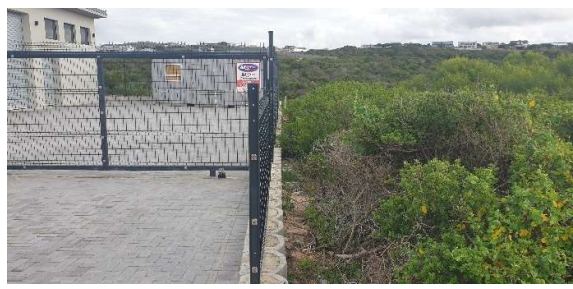
Vegetation corridor north of the outbuilding (garage site).

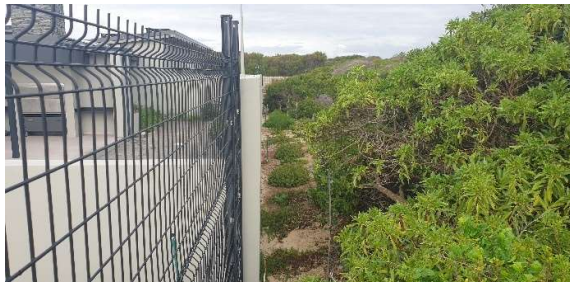
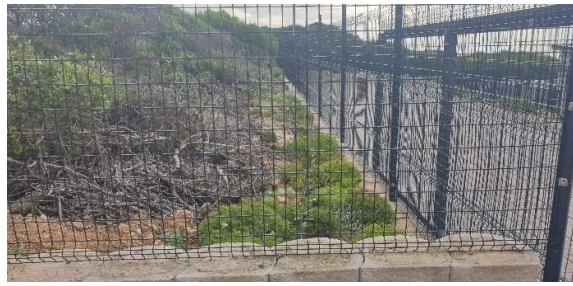
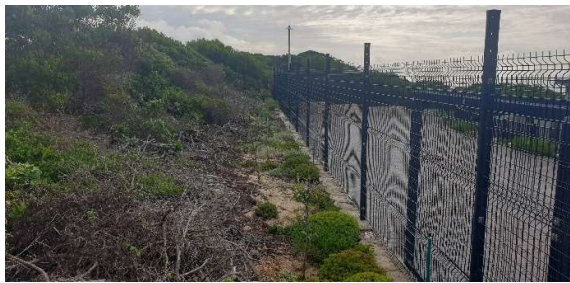
Outside landscaping of natural vegetation on the western boundary of the property. Milkwood trees have been planted for screening and conservation efforts.

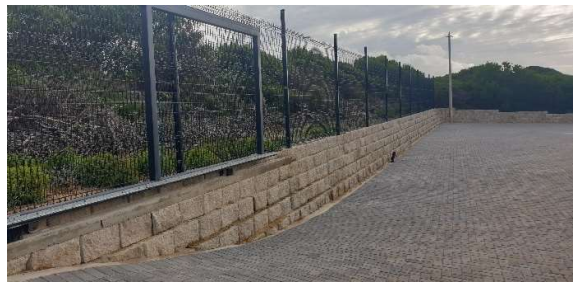
The western boundary of the property. Milkwood trees have been planted for screening and conservation efforts.

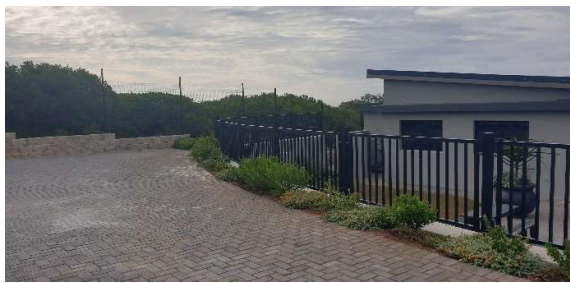
Condition of landscaping inside the premises.

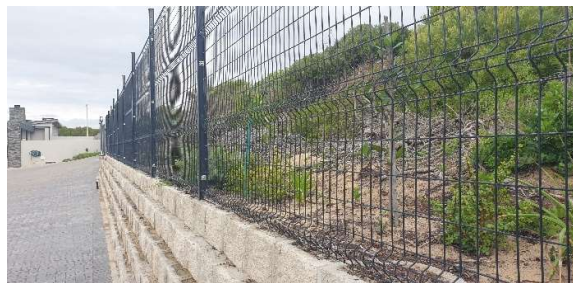
The western boundary of the property. Milkwood trees have been planted for conservation efforts.

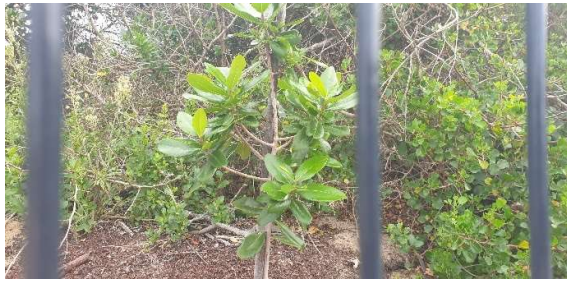
Milkwood tree planted inside the premises.

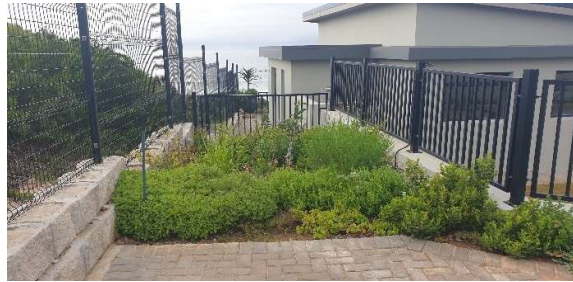
Condition of landscaping inside the premises.

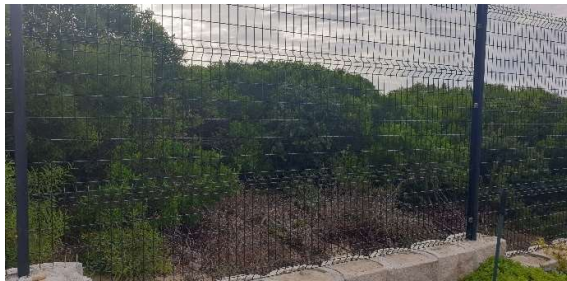
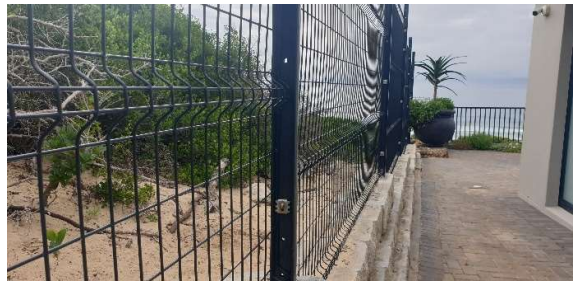
Condition of the natural vegetation corridor towards the north of the site.

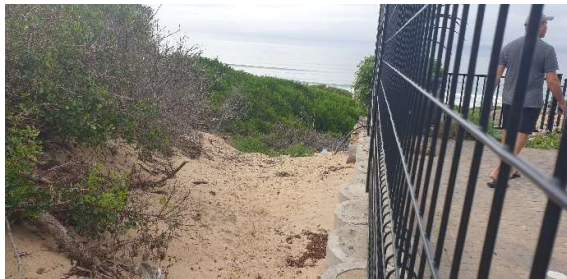
Condition of the natural vegetation corridor towards the north of the site where the stormwater outlet is located.

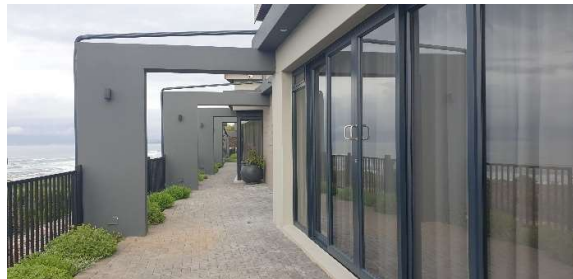
Eastern boundary of the property.

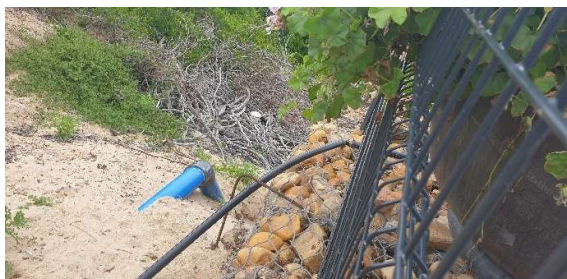
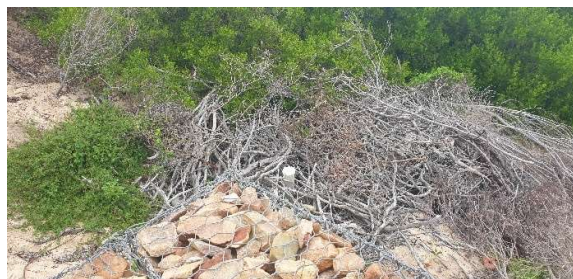
Stormwater installation towards the east of the site.

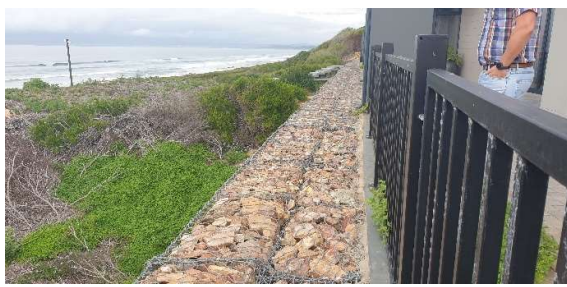
In addition, stormwater dissipation infrastructure has been installed below the gabion structure and remains in good condition, effectively managing runoff and preventing erosion.

Gabion retention wall on the eastern property boundary.

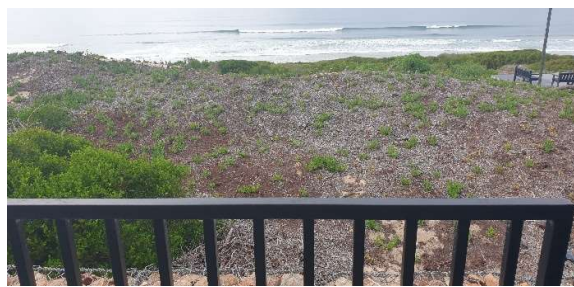
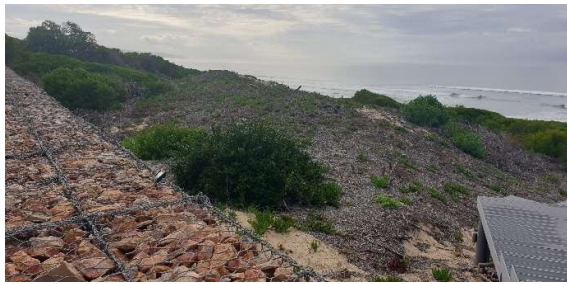
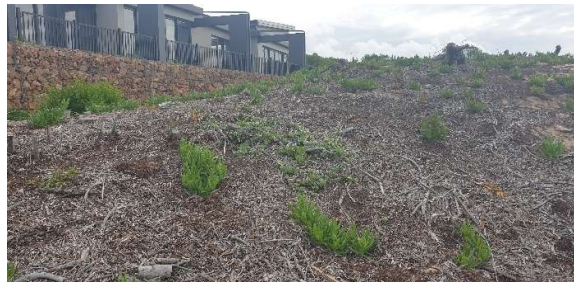
Rehabilitation of dune slopes towards the east with vygies.

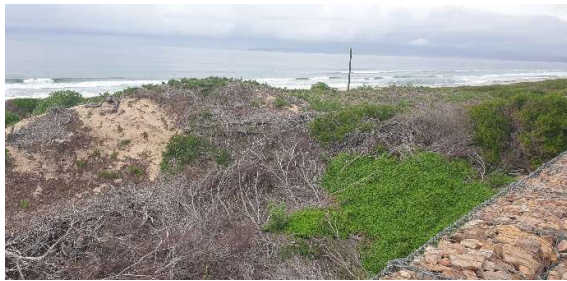
Cleared Rooikrans towards the east.

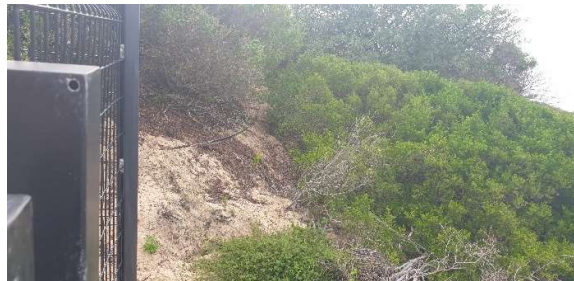
Stormwater outlet on the northern section of the property.

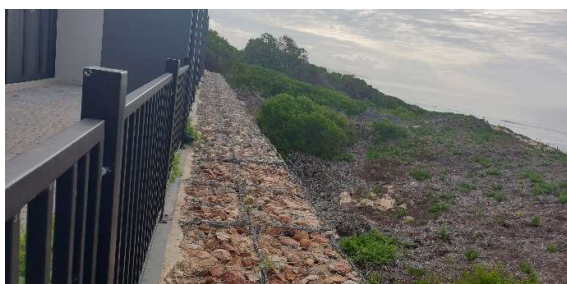
Gabion retention wall and rehabilitated dunes.

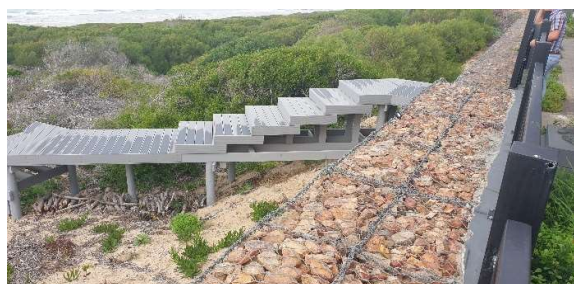
Broadwalk towards the south east.

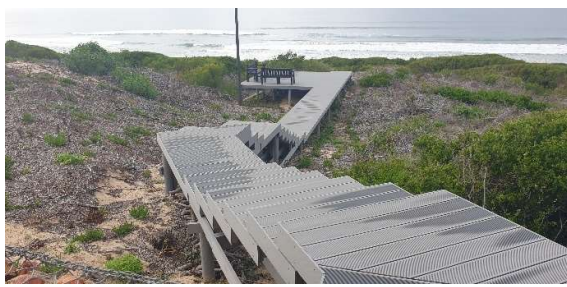
Condition of the broadwalk.

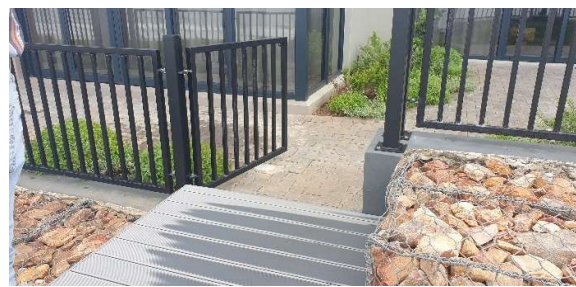
Access gate to the broadwalk.

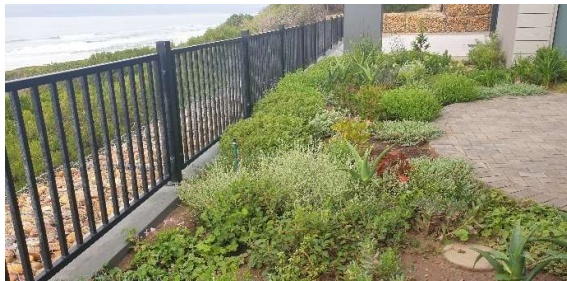
Landscaping with indigenous vegetation.

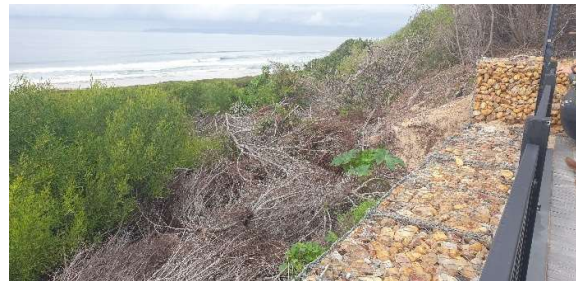
Southeastern section of the property.

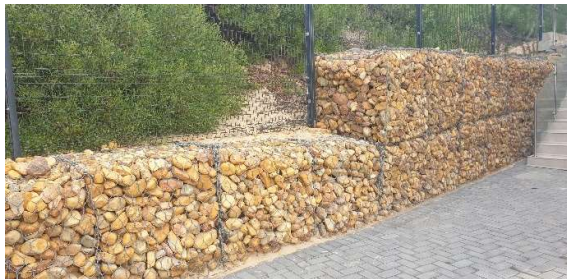
Gabion retention wall towards the south end of the property.

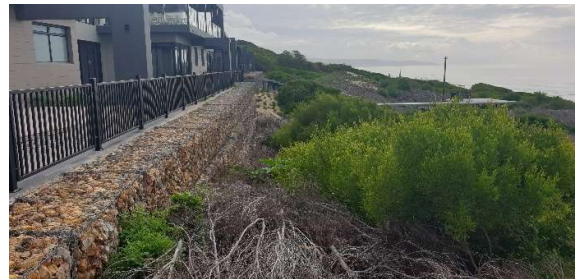
Condition of the gabion retention wall on the eastern boundary of the property.

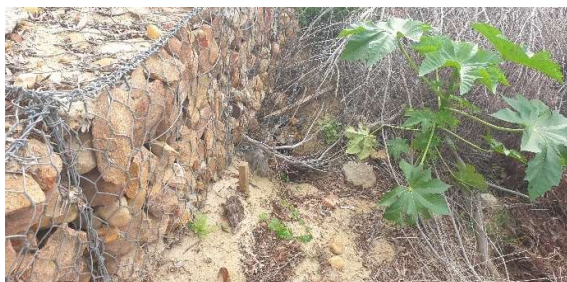
Surveyor peg still in place.

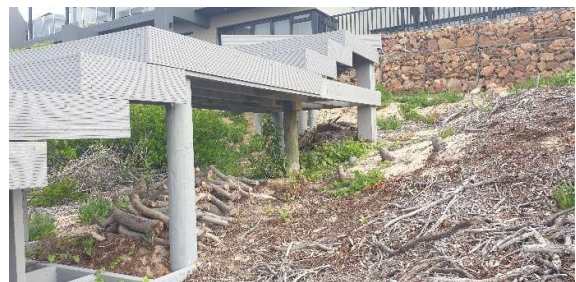
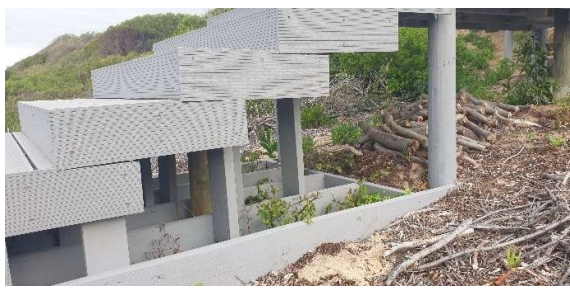
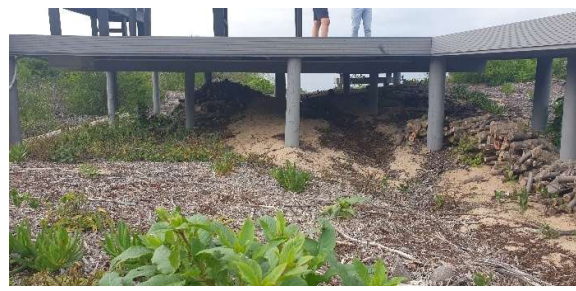
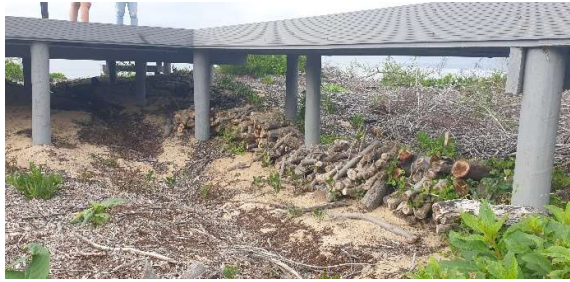
Condition of the broadwalk. Cleared Rooikrans being used for firewood.

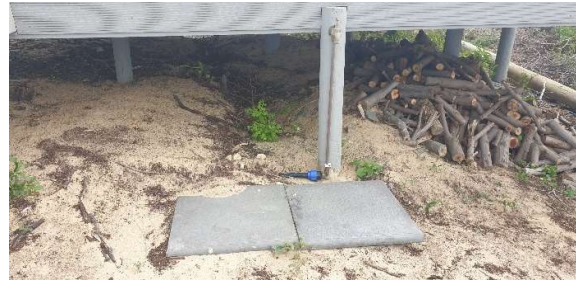
Washing station for sand and other organic debris at the broadwalk. Cleared Rooikrans being used for firewood.

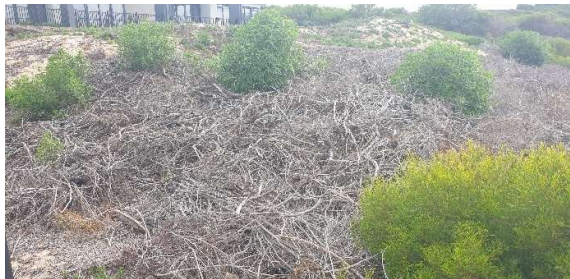
Cleared Rooikrans towards the east of the property on the sandy dunes.

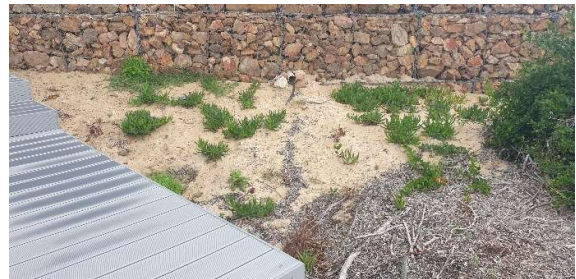
Rehabilitation of the eastern section of the property.

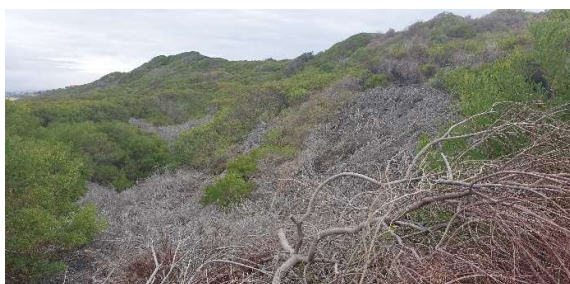
Condition of the remainder of the property and natural vegetation, majority alienated with Rooikrans.

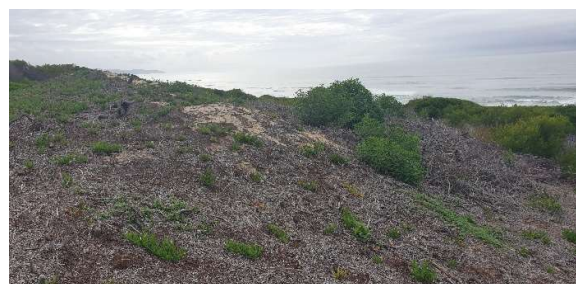
Condition of rehabilitated dunes towards the east of the site.

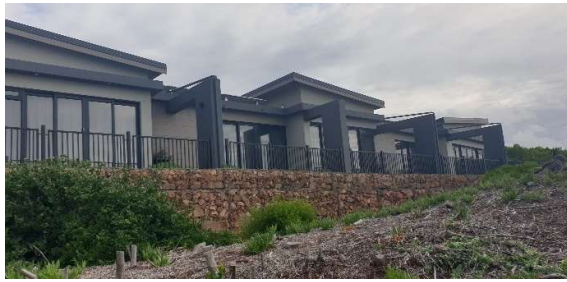
Condition of the single residence towards the north.

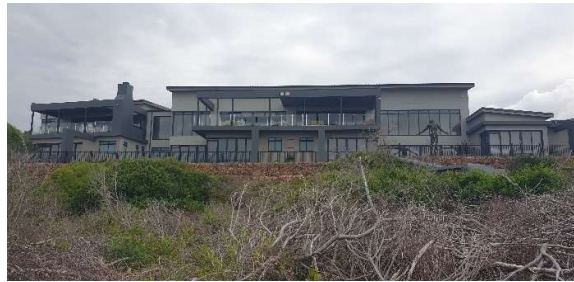
Condition of the single residence towards the west.
