### ENVIRONMENTAL MONITORING REPORT #1

*Erf 4716, Grootbrak, Willie Nel*

**MOS23.1136.25**

**May 2023**

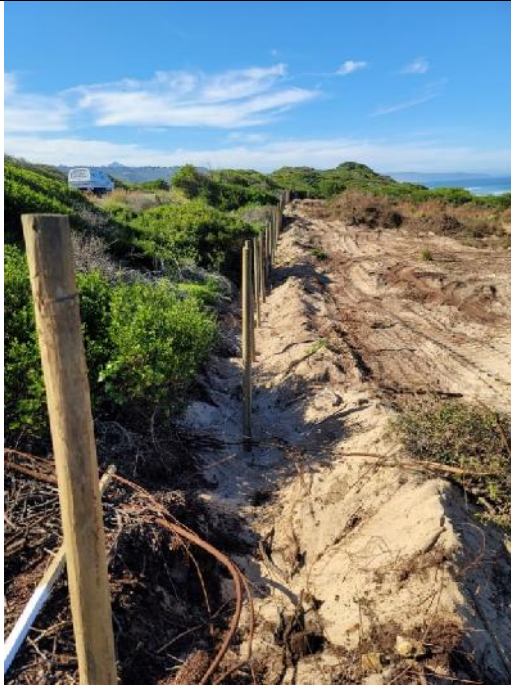
2023.05.10 – Demarcation of the disturbance footprint is clearly indicated, and no-go areas are visible.

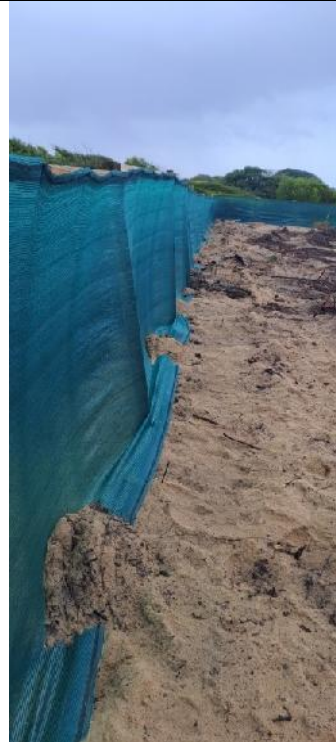
2023.05.12 – Shade netting doubles as a silt fence, ensuring that soil erosion is minimized.

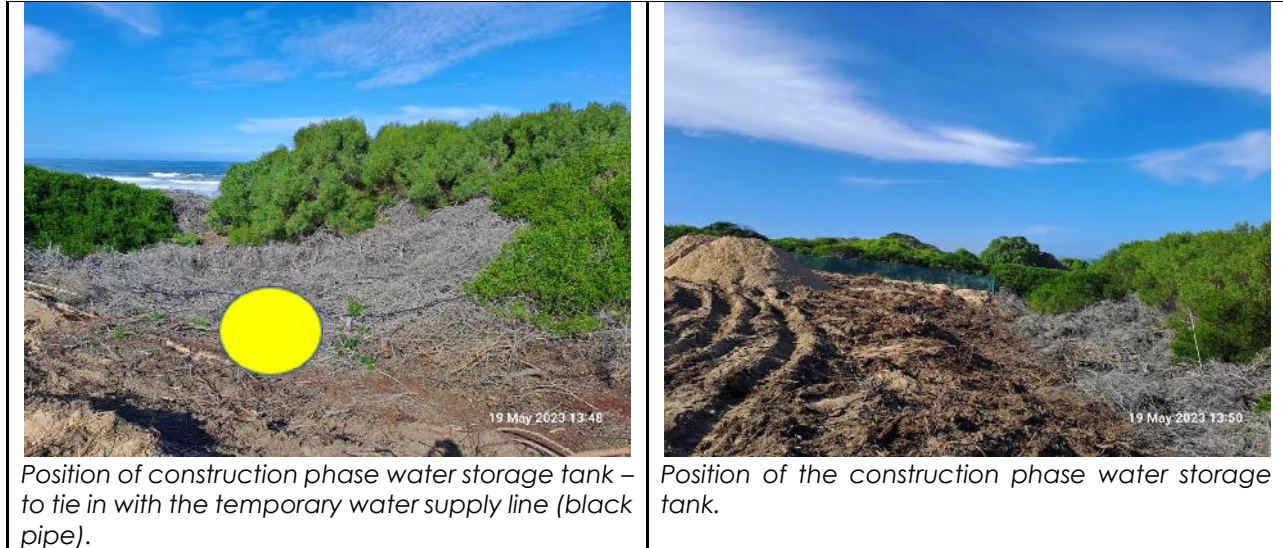
The contractor has not executed the method statement. This installation will be monitored and reported on when complete.

- ) **ONLY** remove cut branches of the surface area of the water tank, **by hand**.
- ) Place water tank on the existing surface (no need to excavate or level).
- ) Demarcate the area with shade netting to prevent entering the NO-GO area.
- ) Disconnect and remove the water tank once no longer required.
- ) Rehabilitate the area (if required – ECO to recommend).

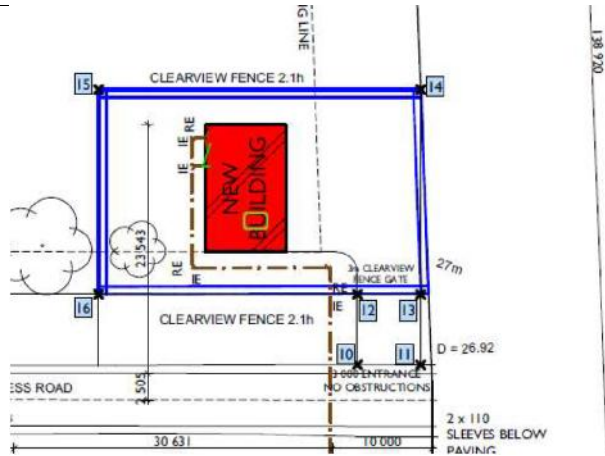
There is a single multi-stemmed Milkwood tree in the footprint of the garage (northern section) that will be transplanted under a NFA license. The NFA license application was submitted on **4 May 2023**.

2023.05.04 – Map indicating the position of the milkwood tree. This map was included in the NFA application.

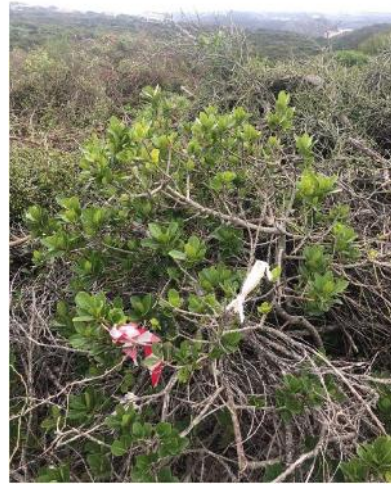
2023.05.04 – milkwood tree in the garage area demarcated.

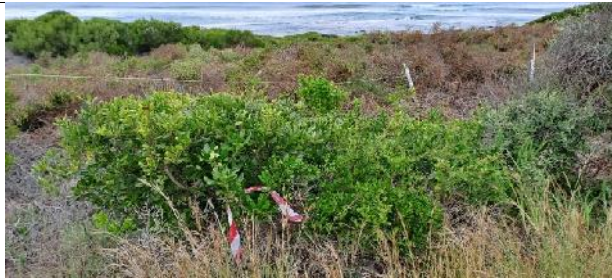
2023.05.04 – Cheesewood tree marked. This tree is outside of the demarcated disturbance footprint (twine behind the tree).

This tree is not to be removed or harmed throughout the entire duration of construction.

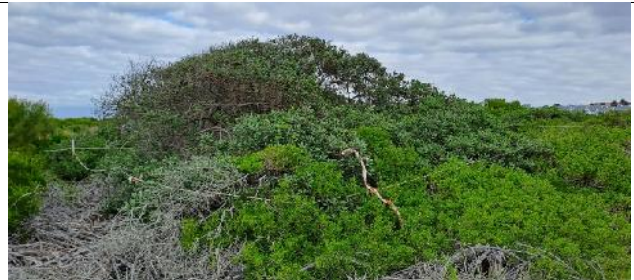
2023.05.04 – Milkwood cluster (north of the bisecting road).

This tree cluster will remain undisturbed.

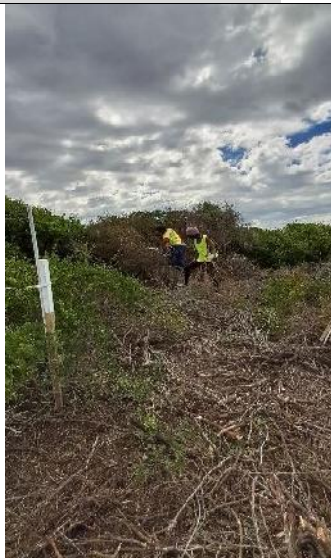
2023.04.25 – Clearing of vegetation by hand within the footprint

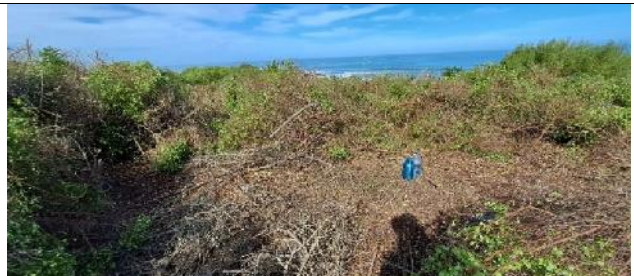
2023.04.25 – Vegetation within the footprint was cleared by three staff members of HillLand Environmental. Using pangas and a chainsaw.

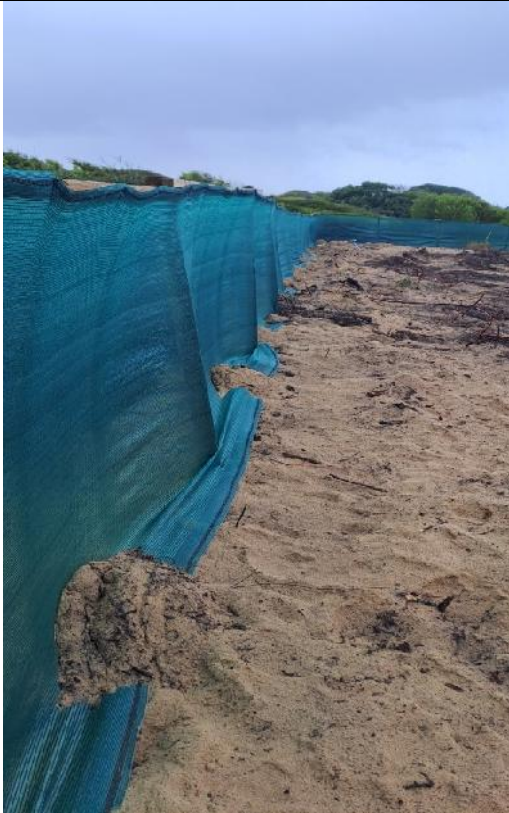
The no-go demarcation doubles as a silt trap – the bottom 200mm of the shade netting is buried into the soil to limit silt movement under the fence.

2023.05.12 – the bottom 200mm of the shade netting is buried to act as silt trap.

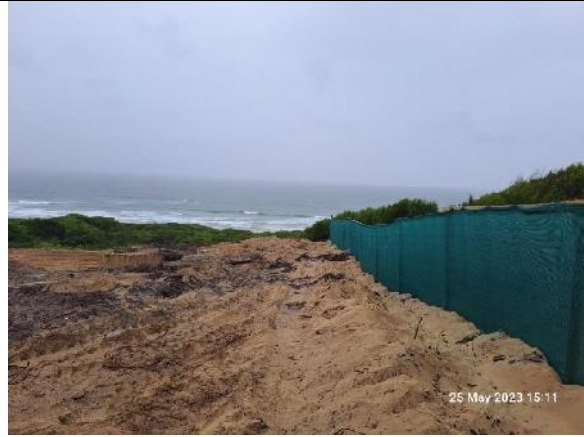
2023.05.25 – western no-go fence.

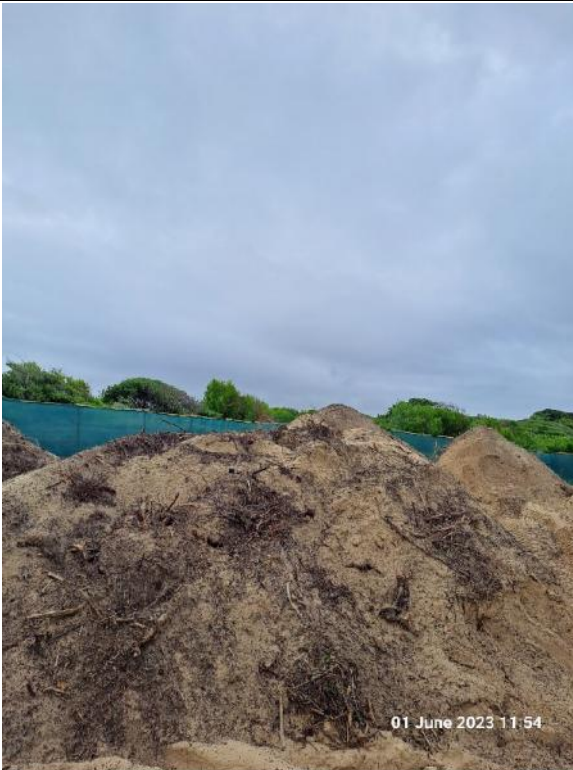
Topsoil stockpile

Topsoil (upper organic layer) was rescued and stockpiled for later use during rehabilitation. The building contractor must ensure that the topsoil is kept separate from any other subsoil or construction material to prevent contamination.
