### ENVIRONMENTAL MONITORING REPORT # 3 FOR Erf 4716, GROOT BRAKRIVIER

**ERF 4716, GROOTBRAK, WILLIE NEL  
ENVIRONMENTAL MONITORING REPORT NO 3  
JULY 2023**

## **Environmental Monitoring Report No. 3**

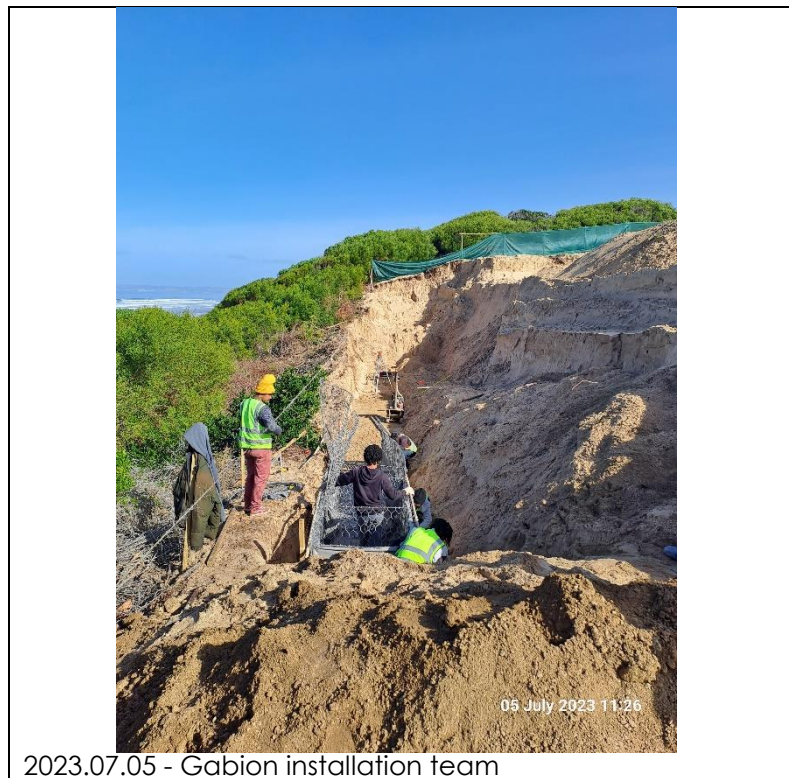
- Environmental induction was done with the gabion installation team on the 5<sup>th</sup> of July 2023.

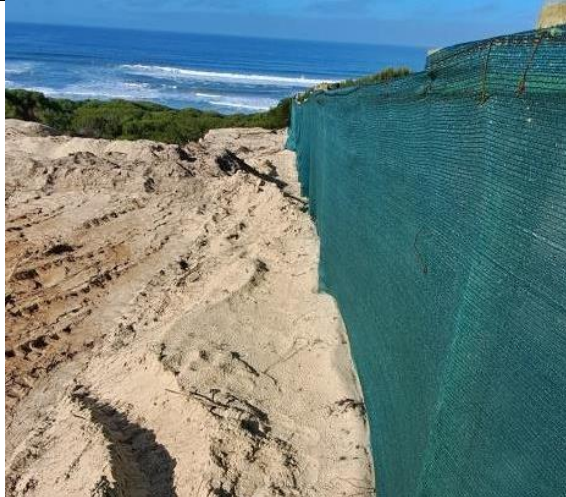
(2023.07.13) The contractor maintains the shade net demarcation.

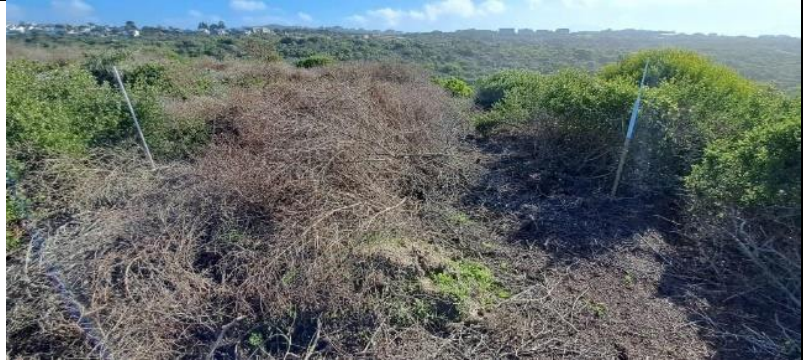
(2023.07.13) Still waiting for the NFA license before any vegetation clearing and demarcation of the northern section can start.

There is a single multi-stemmed Milkwood tree in the footprint of the garage (northern section) that will have to be relocated with an NFA license. The NFA license application was submitted on 4 May 2023 – **still waiting for the NFA license and ECO is following up regularly.**

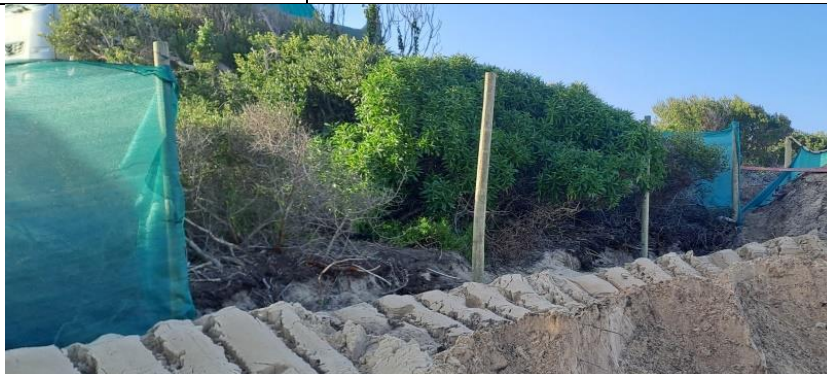
- Installation of the demarcation of the housing footprint (south of MR6817) was done and is maintained.
- Theft of the demarcation material remains an ongoing issue.
  - o Incidents should be reported to the local authorities as and when it occurs.

(2023.07.27) Section of the demarcation was stolen during the reporting period.

Theft of the demarcation material remains an ongoing problem and should be reported to SAPS and Mossel Bay law enforcement. The disturbance footprint is demarcated with green shade netting and maintained.

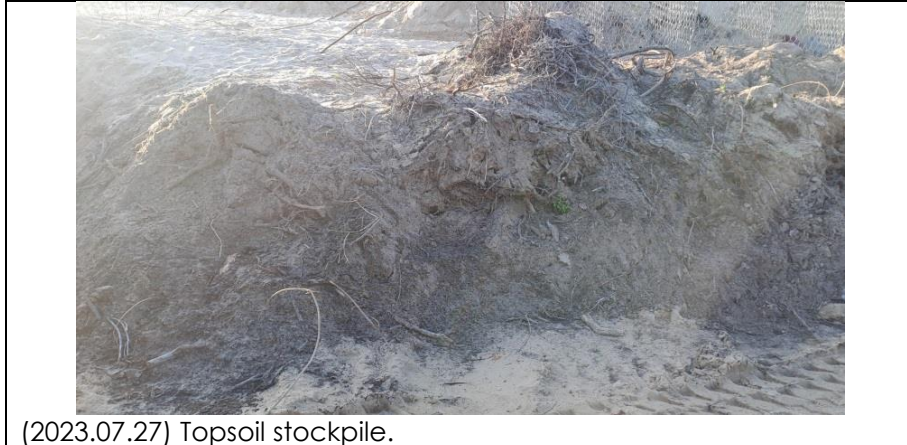
Installation of the gabion retaining wall (southern boundary) started on 5 July 2023 and will double as erosion protection for the duration of the construction phase.

- No soil erosion issues noted during the reporting period.

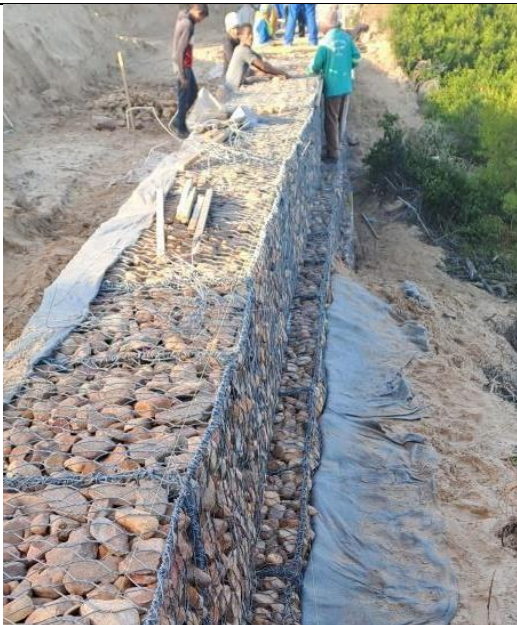
(2023.07.27) – gabion retainer installation progress.

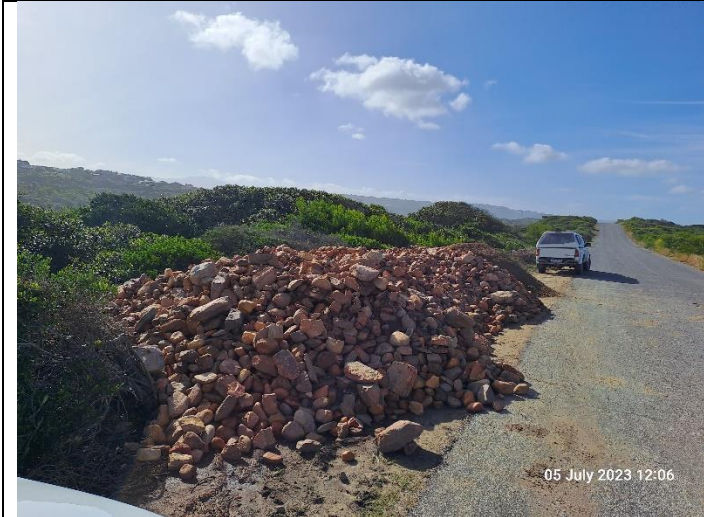
The gabion stone is delivered with a tipper which cannot access the site – too sandy, and therefore delivers the stone in the road reserve. The contractor then moves the material to the demarcated site.

(2023.07.05) Gabion stone is delivered in the road reserve.

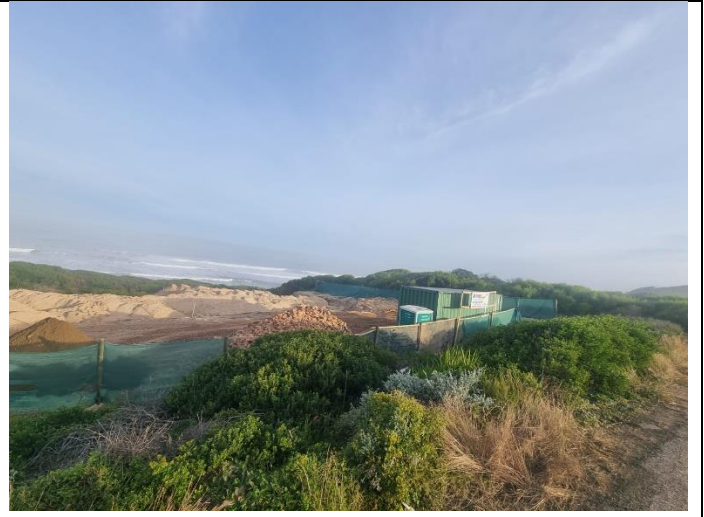
(2023.07.06) gabion stone is moved and stockpiled within the demarcated area.
