### ENVIRONMENTAL MONITORING REPORT # 5 FOR Erf 4716, GROOT BRAKRIVIER

**ERF 4716, GROOTBRAK, WILLIE NEL  
ENVIRONMENTAL MONITORING REPORT NO 5  
September 2023**

## **Environmental Monitoring Report No. 5**

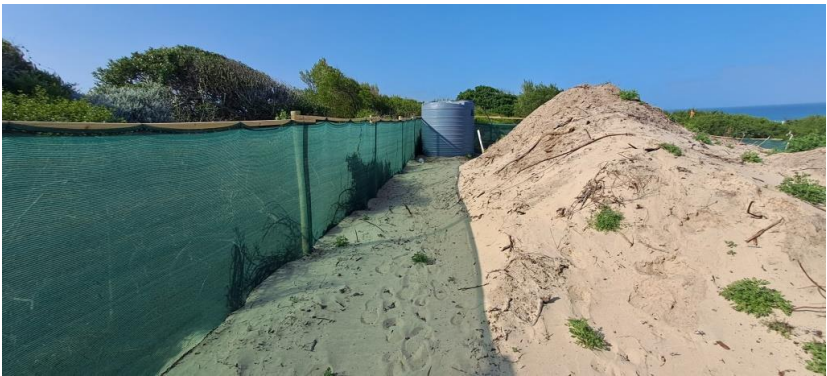
| Photographic record | Comments and requests |
|---|---|
| | <p>Demarcation around the site is to the satisfaction of the ECO and clearly visible.</p> <p>Foot/wheel-barrow path is demarcated with wooden planks.</p> |

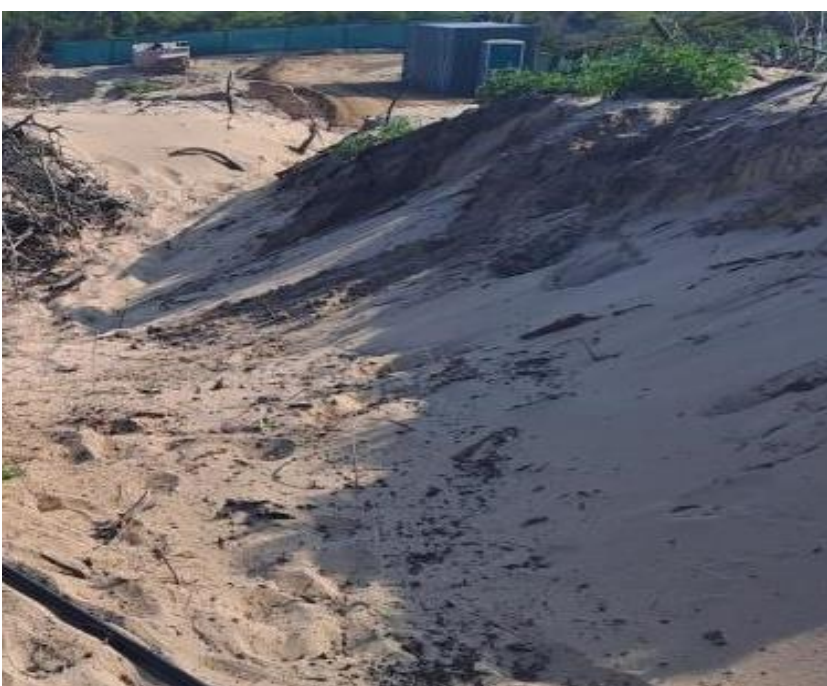
| Photographic record | Comments and requests |
|---|---|
| | <p>Vegetation is starting to grow on the topsoil stockpile which will help with potential dust.</p> |

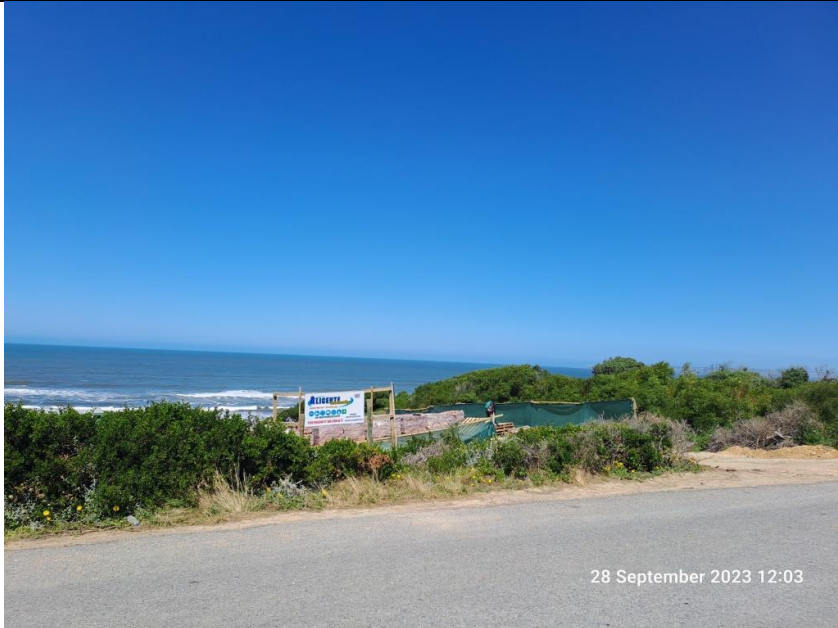
No additional access points have been established.

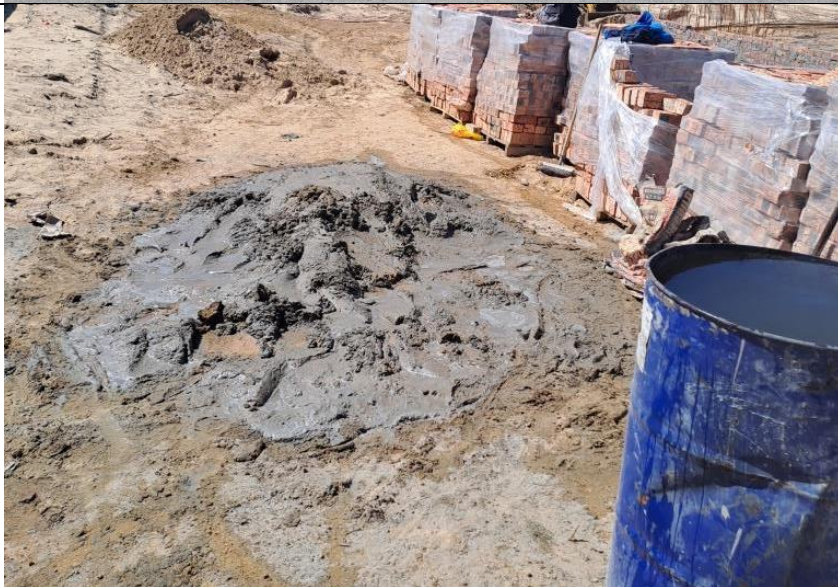
| Concrete batching takes place on an impermeable surface to prevent any soil related contamination. | | | Mixing is done in the swimming pool area – i.e., permanent disturbance area. | Suitable bunding is required to prevent accidental pollution of the undeveloped areas. |

Concrete / cement mixing is done in the swimming pool area – permanent disturbance area.

Suitable bunding such as sandbags, wooden planks, plastic lining etc. is required when mixing cement/concrete to prevent accidental pollution of the natural vegetation.
