### ENVIRONMENTAL MONITORING REPORT # 7

#### *Erf 4716, GROOT BRAKRIVIER*

**November & December 2023**

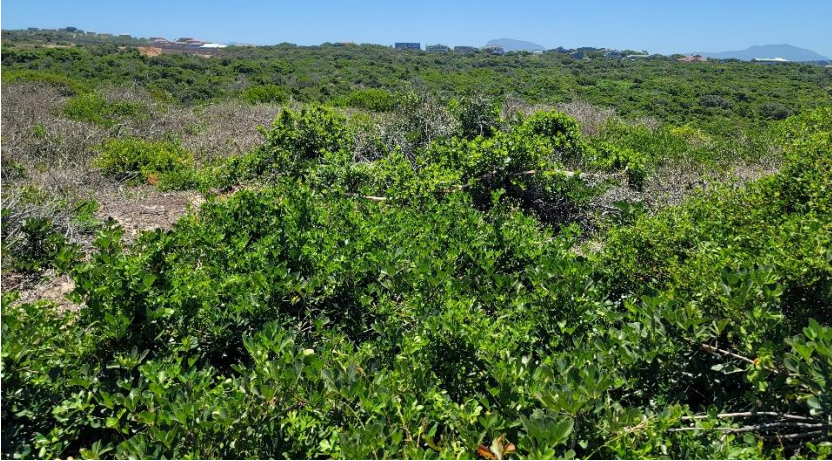
| Photographic record | Comments and requests |
|---|---|
| | <p>Milkwood tree to be transplanted, contractor to notify ECO.</p> |

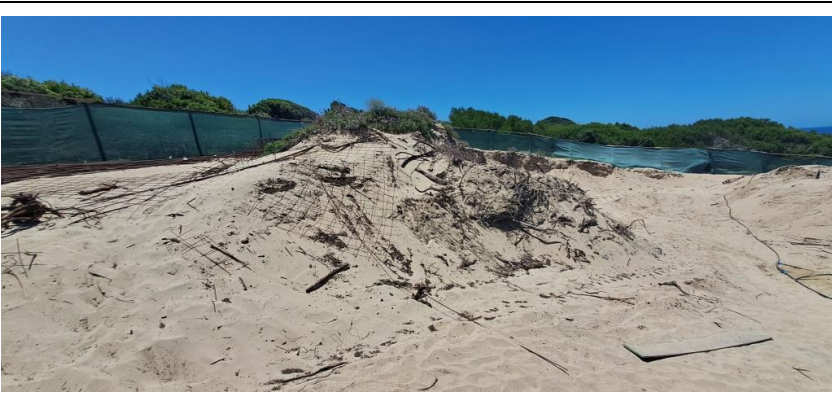
| Photographic record | Comments and requests |
|---|---|
| | <p>Topsoil stockpile in the disturbance footprint.</p> <p>Ongoing reminder to keep the topsoil stockpile free from listed invasive alien plants and <b>building material</b>.</p> |

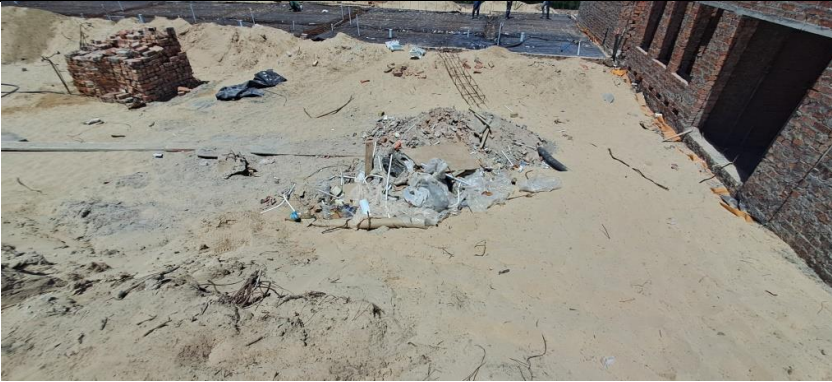
| Photographic record | Comments and requests |
|---|---|
| | <p>The waste and building rubble storage area next to the container had to be removed due to construction progression.</p> <p>Waste is still being gathered and removed.</p> <p><u>Request:</u></p> <p>The ECO request regular toolbox talks regarding litter picking. Chicken parades are suggested to keep the surrounding footprint free from litter.</p> |

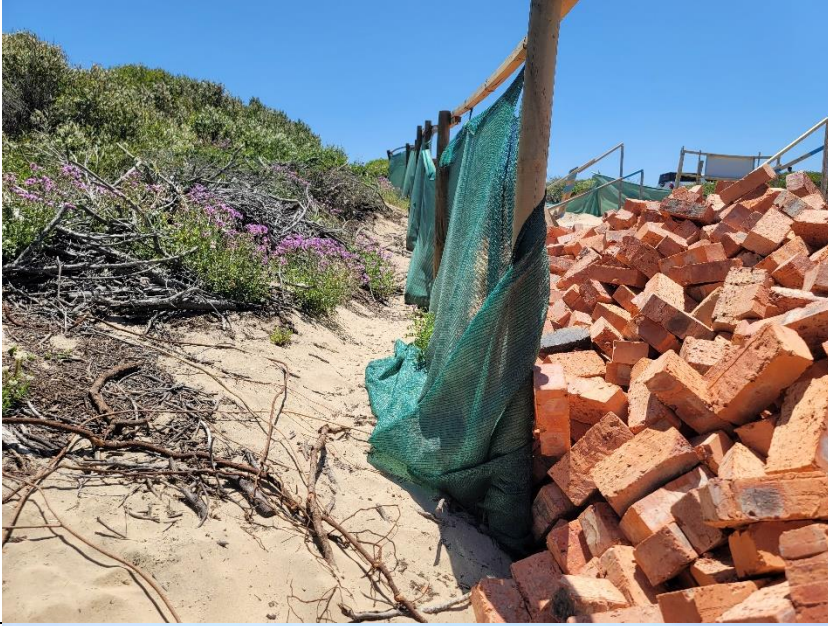
No-go demarcation in place. The contractor is requested to re-install the demarcation up to the gabion wall to prevent accidental damage or disturbance to the no-go area.

No-go demarcation is in place and generally well maintained, the small section between the gabion wall and no-go fence is still to be re-installed. Cement batching is on a non-permeable surface (house footprint). Litter is managed on site and regular litter picking (chicken parades) is recommended.

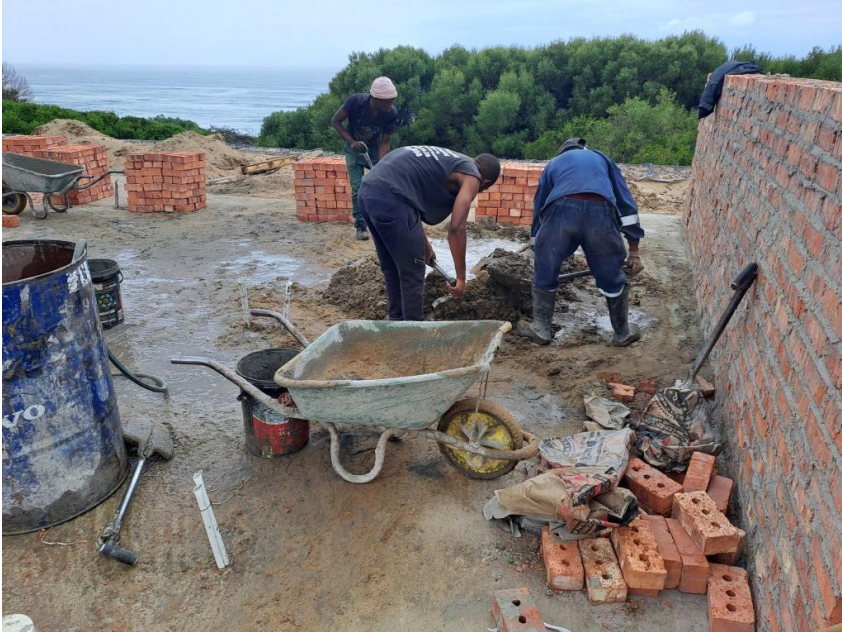
Concrete batching on top of building foundation.
