### ENVIRONMENTAL MONITORING REPORT # 9

#### *Erf 4716, GROOT BRAKRIVIER*

**March 2024**

**ERF 4716, GROOTBRAK, WILLIE NEL  
ENVIRONMENTAL MONITORING REPORT NO 9  
Report period: March 2024**

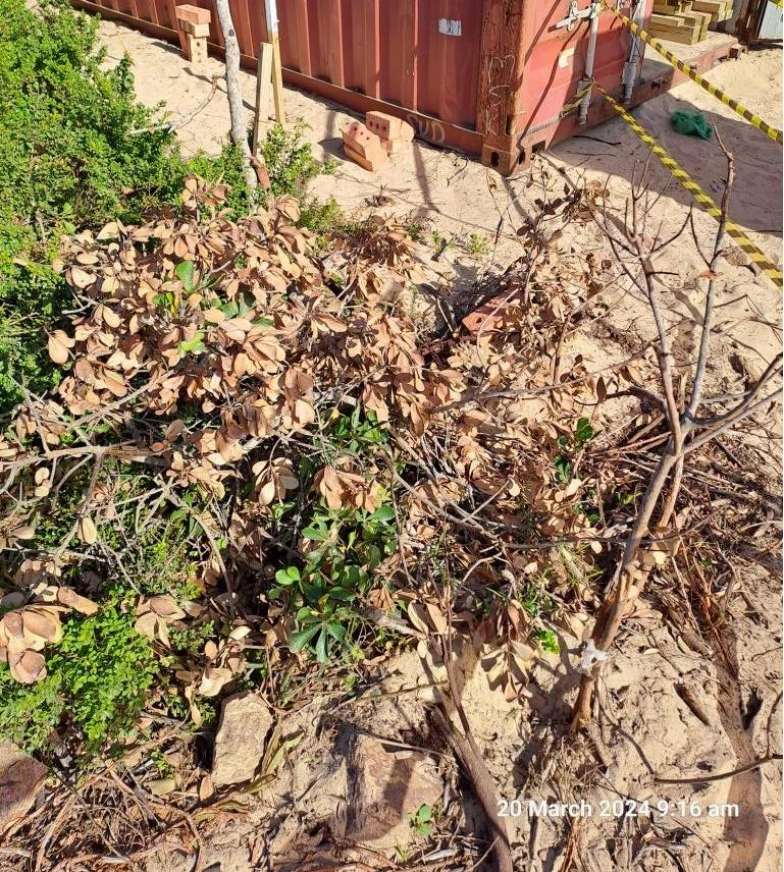
| Photographic record | Comments and requests |
|---|---|
| | Ongoing care for the rescued milkwoods – water and compost. |

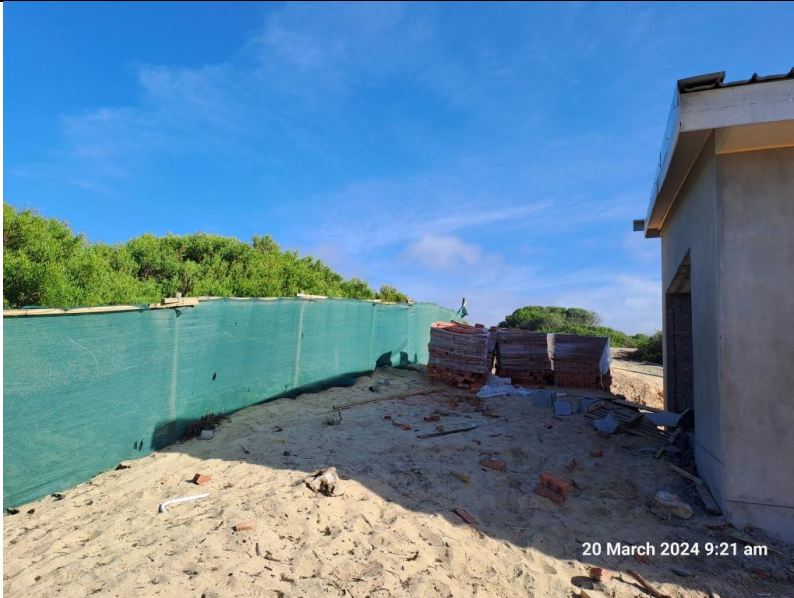
No-Go demarcation of the main house construction area in place.

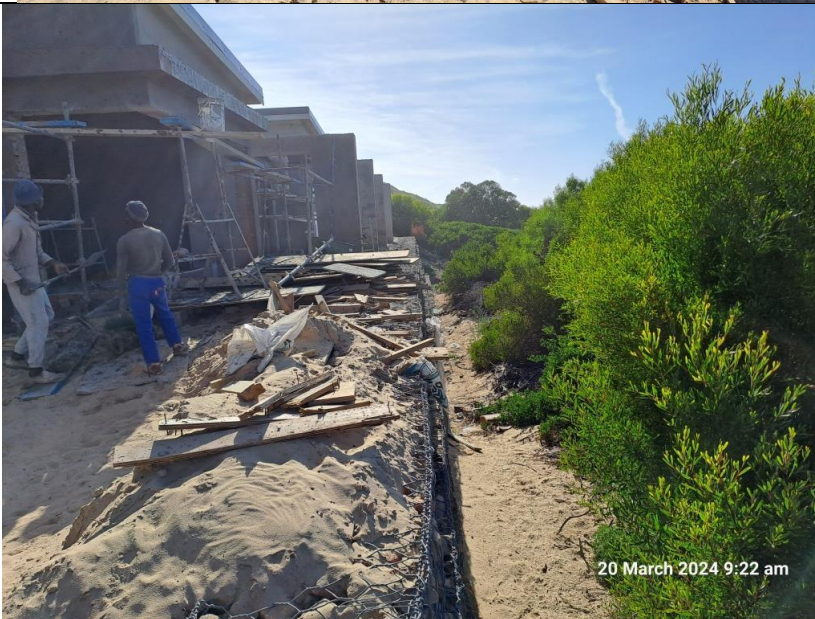
Southern gabion protection.

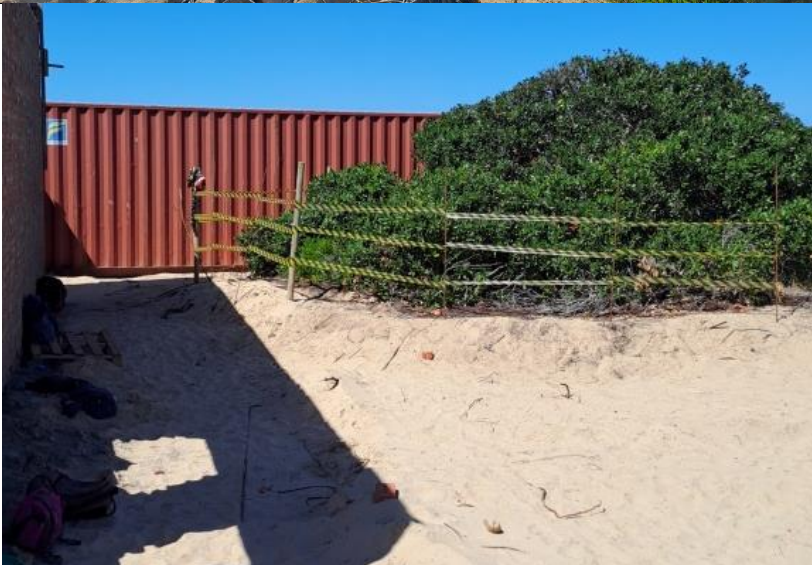
Danger tape No-Go demarcation has been installed around the garage construction site.

No-go demarcation around main house construction site is in place and well maintained. No-Go demarcation around the garage construction site was installed after a penalty was issued to the contractor - silt fence on the northern no-go edge of the garage site still required. Ongoing care for the rescued trees – water and compost. Additional litter bins/skids are required and regular litter picking (chicken parades) is required. Removal of alien plants must continue.

| <b>Demarcation of NO-GO area</b> | | | | |
|---|--|--|---|---|
| All construction activities must be restricted to the demarcated areas to ensure that no further disturbance into the surrounding vegetation. | | | <p>Main house construction site is clearly demarcated.</p> <p>Garage site demarcation (danger tape) has been installed. No encroachment noted, however silt fencing is still required on the northern edge of the garage site no-go area to avoid accidental spill-over.</p> | Garage site silt fencing required. |
