### ENVIRONMENTAL MONITORING REPORT # 10

#### *Erf 4716, GROOT BRAKRIVIER*

**April 2024**

## **Environmental Monitoring Report No. 10**

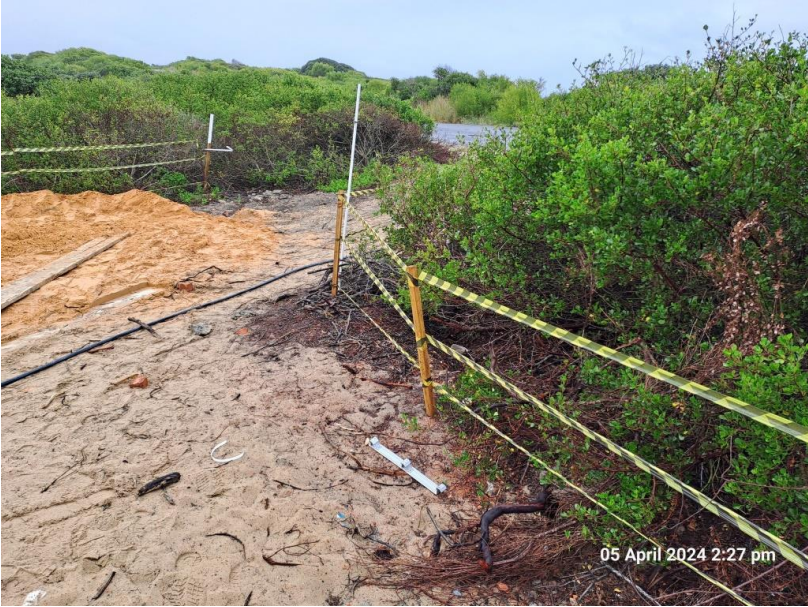
| Photographic record | Comments and requests |
|---|---|
| | Demarcation of the garage site. |

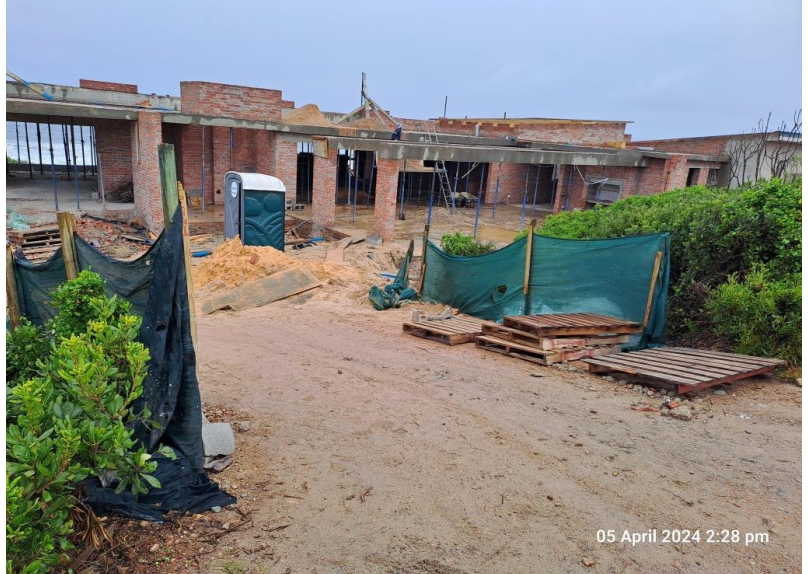
| Photographic record | Comments and requests |
|---|---|
| | No-Go demarcation on the roadside of the house construction area in place. |

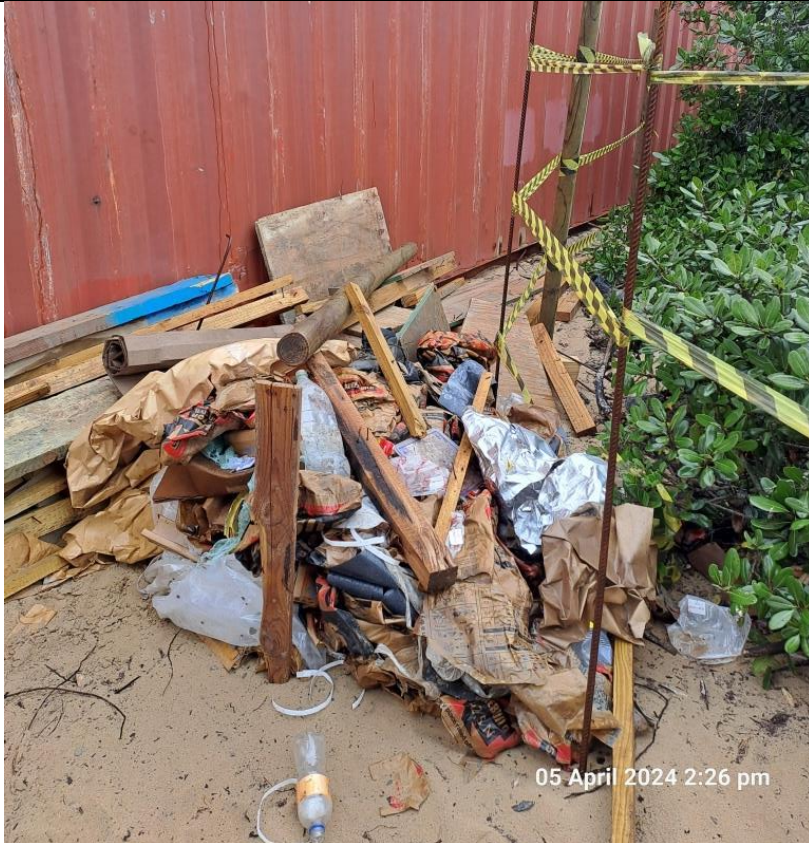
Skip(s) or bin(s) are required for the litter and building rubble to prevent spread into the no-go areas.

| A fenced-off area must be created within the campsite for refuse and waste management. | | | | The contractor was request during this reporting period to conduct regular litter picking, supply a suitable bin/skip for the site and ensure that the bin(s)/skip(s) are regularly emptied. | Regular litter picking to be done and a suitable bin/skip to be brought to the site. |

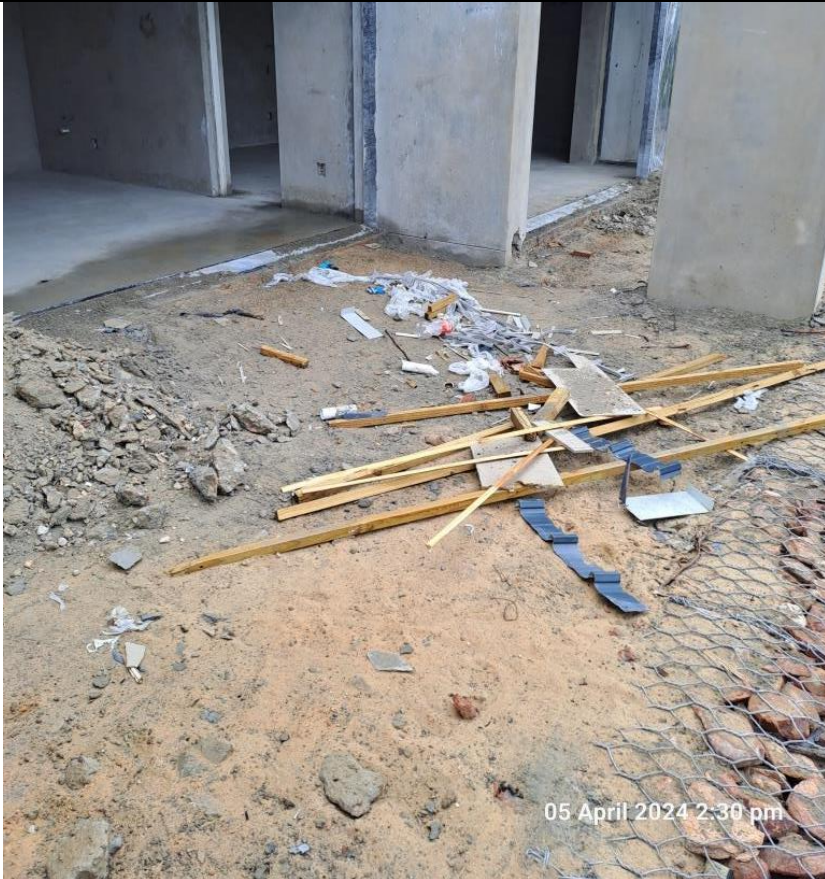
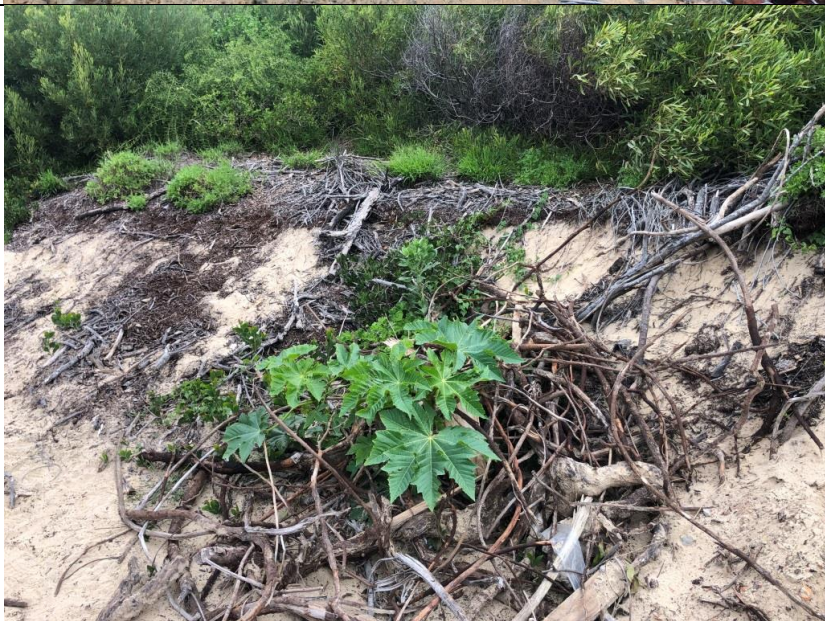
Ongoing – invasive alien plants to be removed.

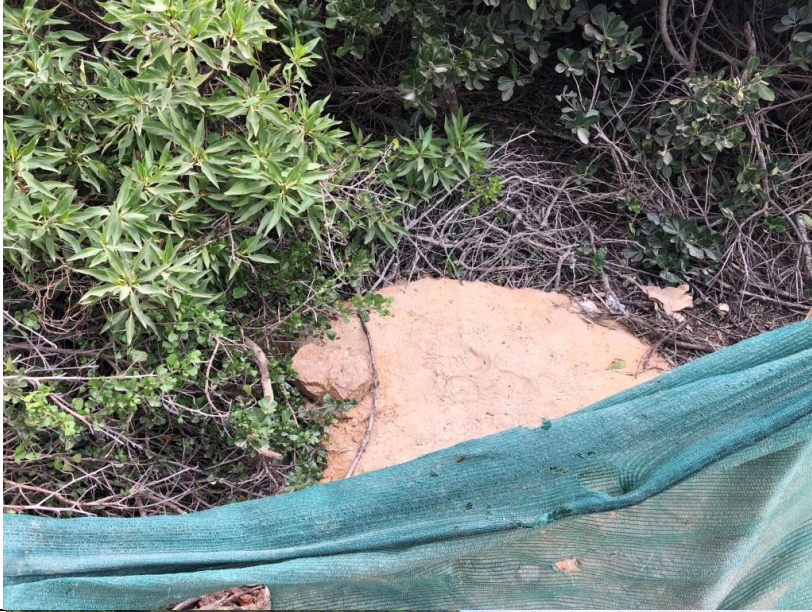
Building material must not get spilt past the No-Go demarcation.

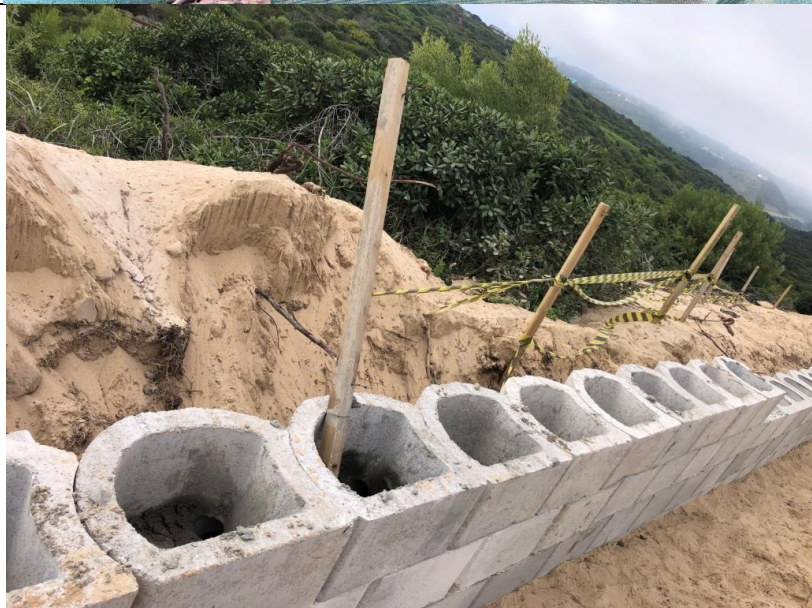
Garage site – installation of the retaining blocks will act as the silt trap and onto which the clear-vu fence will be installed.
