### ENVIRONMENTAL MONITORING REPORT # 11

#### *Erf 4716, GROOT BRAKRIVIER*

**May 2024**

**ERF 4716, GROOTBRAK, WILLIE NEL  
ENVIRONMENTAL MONITORING REPORT NO 11  
Report period: May 2024**

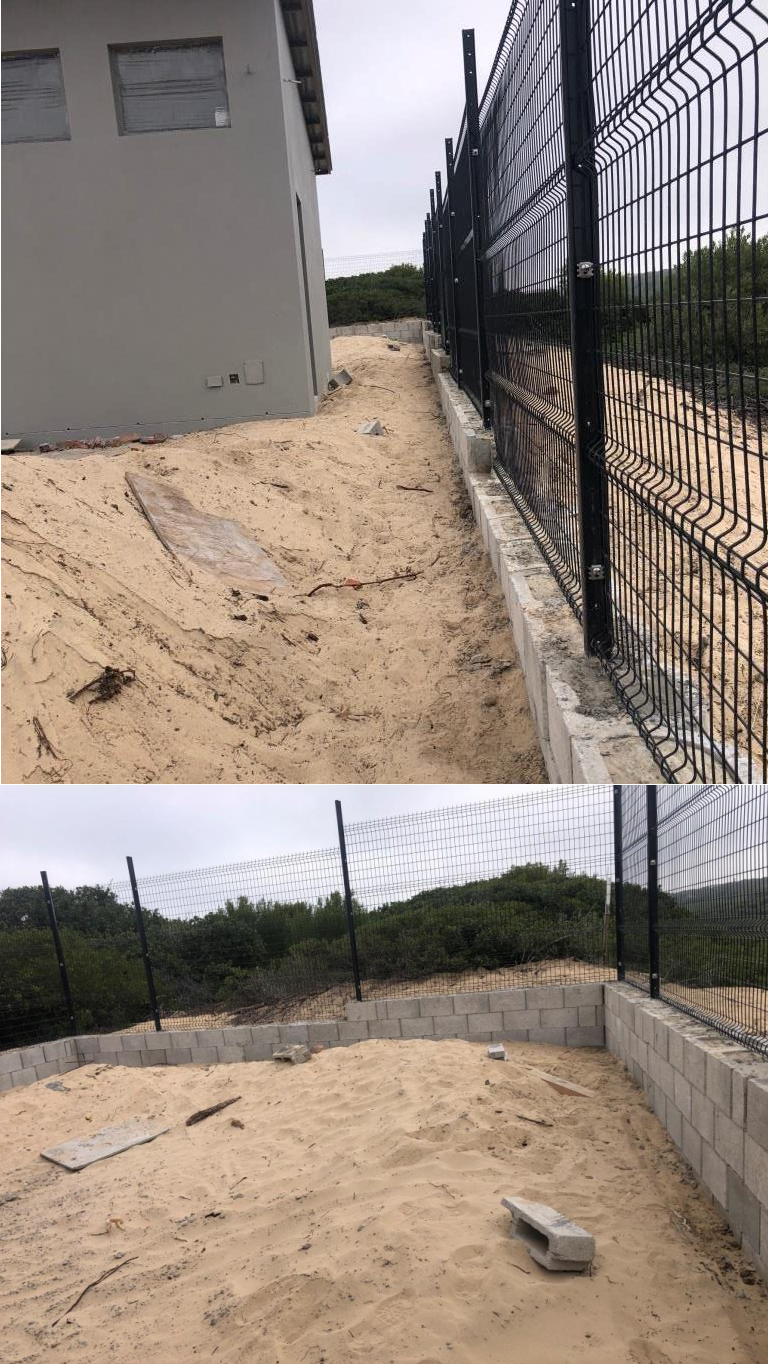
| Photographic record | Comments and requests |
|---|---|
| <p>(09.05.24)</p> | <p>The garage site has been fenced off with ClearVu fencing.</p> |

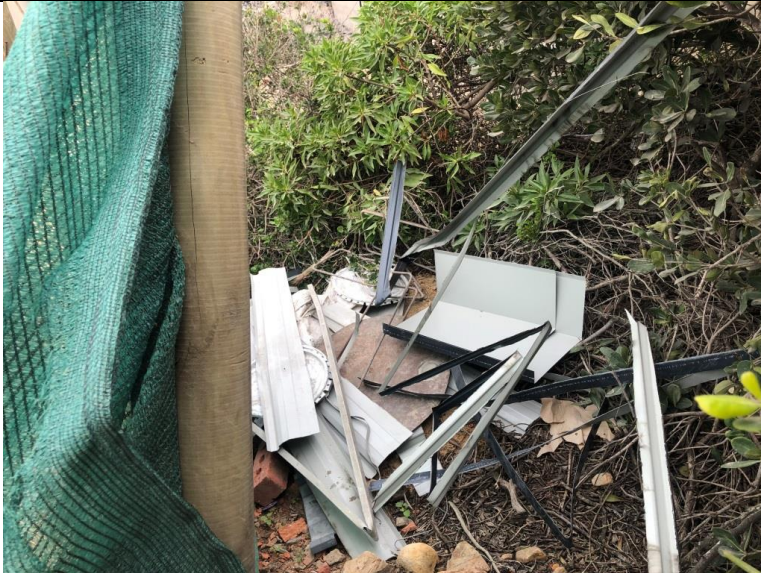
(09.05.24)

Building rubble in the "no-go" area has been removed.

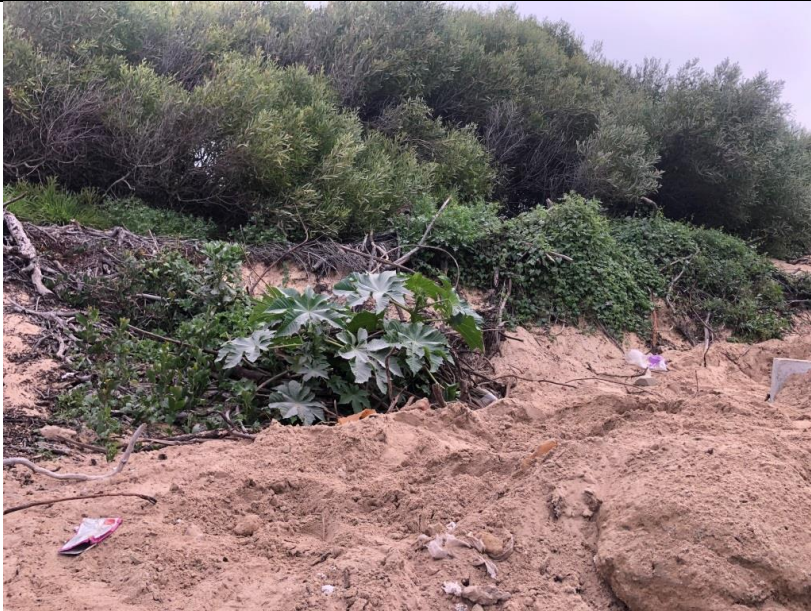
(09.05.24)

Alien plants need to be continuously removed throughout the construction period.

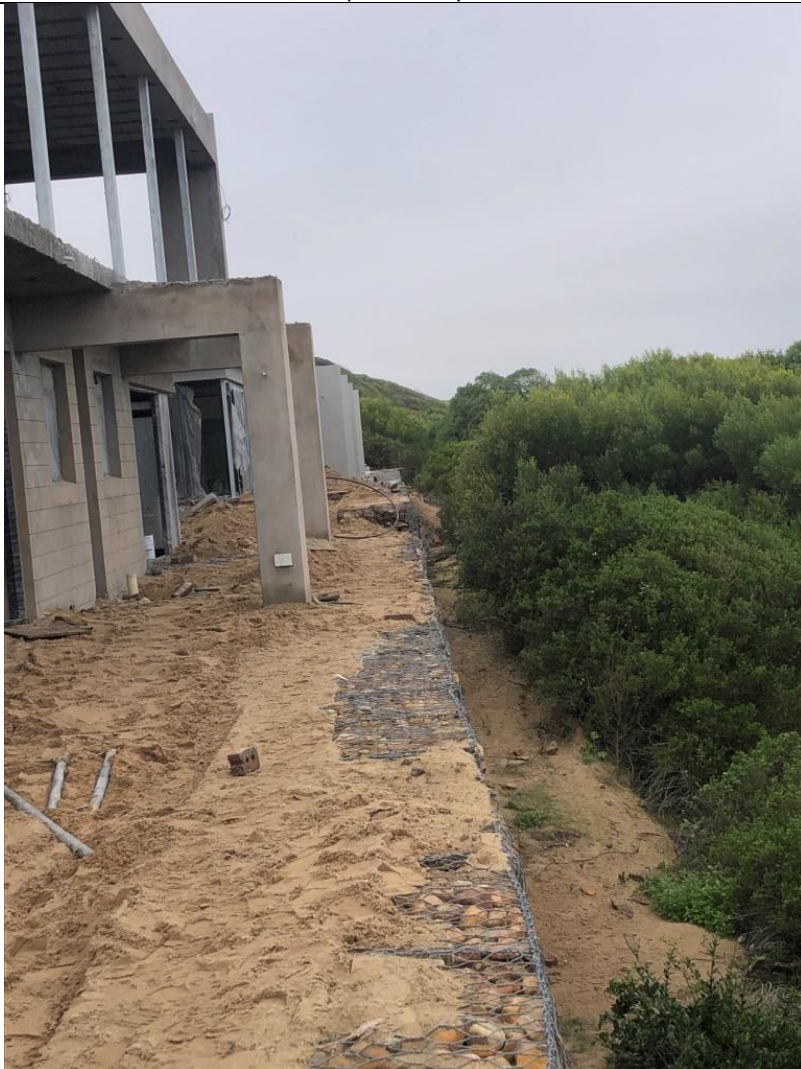
(09.05.24)

No-Go area in front of the house is clean and no litter or construction rubble noted.

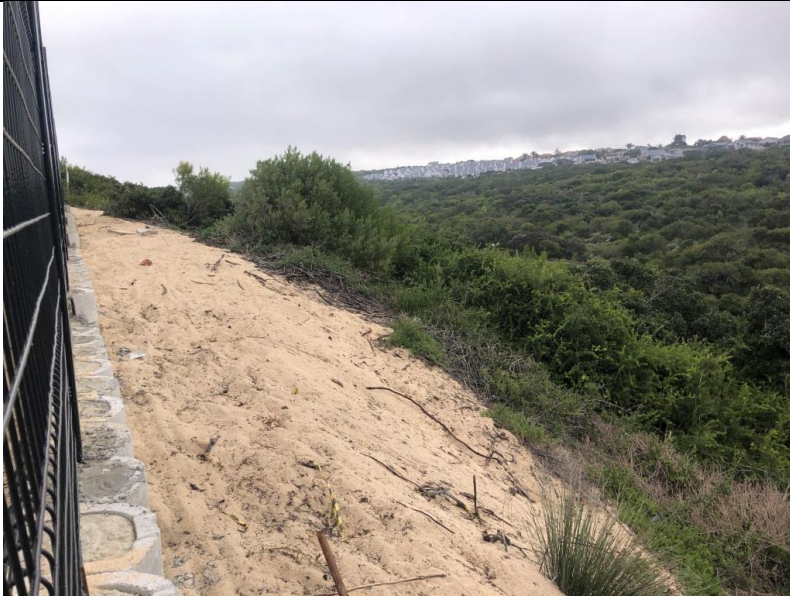
(09.05.24)

Sand spilling over the No-Go demarcation fence line has been pulled back into the working zone to the satisfaction of the ECO – no remaining environmental issues.

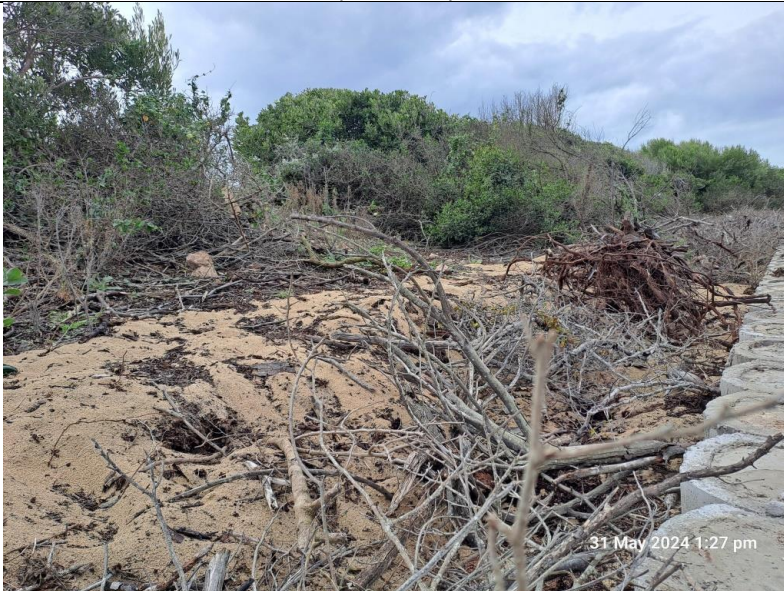
The bare areas around the garage site have been brush packed to protect the exposed areas from erosion and promote revegetation.
