**ENVIRONMENTAL MONITORING REPORT # 13**  
**FOR**  
**Erf 4716, GROOT BRAKRIVIER**

**MOS24/1136/38**

**July & August 2024**

**ERF 4716, GROOTBRAK, WILLIE NEL  
ENVIRONMENTAL MONITORING REPORT NO 13  
Report period: July & August 2024**

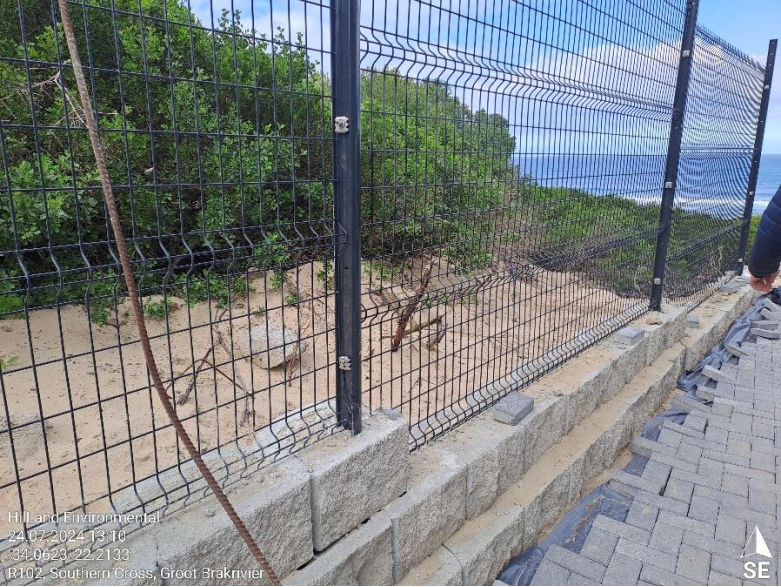
| Photographic record | Comments and requests |
|---|---|
| <p>Hill and Environmental<br/>24.07.2024 13:10<br/>34.0623, 22.2133<br/>R102, Southern Cross, Groot Brakrivier</p> <p>SE</p> | <p>The garage and house site has been fenced off with ClearVu fencing.</p> |

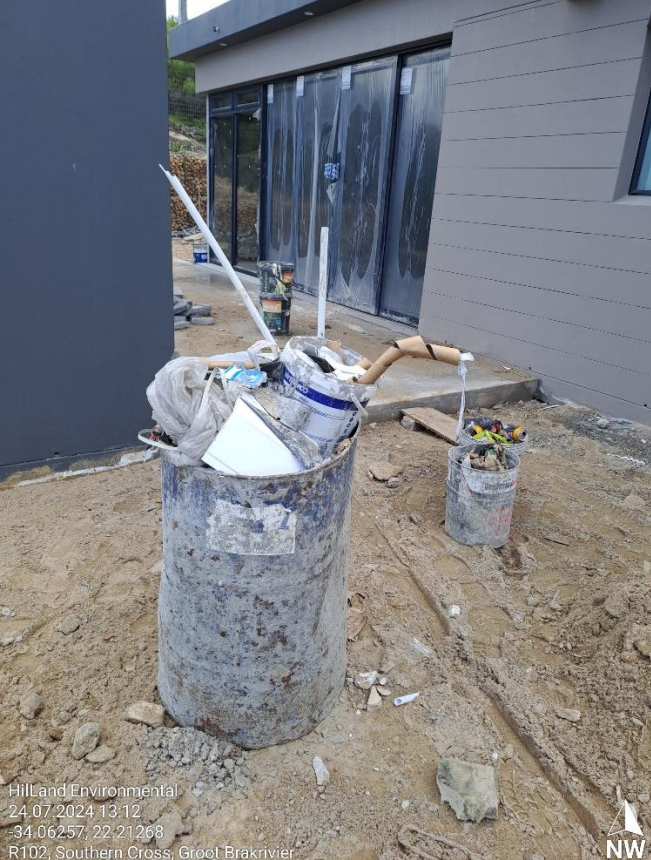
| Photographic record | Comments and requests |
|---|---|
| <p>Hill and Environmental<br/>24.07.2024 13:12<br/>34.06257, 22.21268<br/>R102, Southern Cross, Groot Brakrivier</p> <p>NW</p> | <p>Bins are on site.</p> |

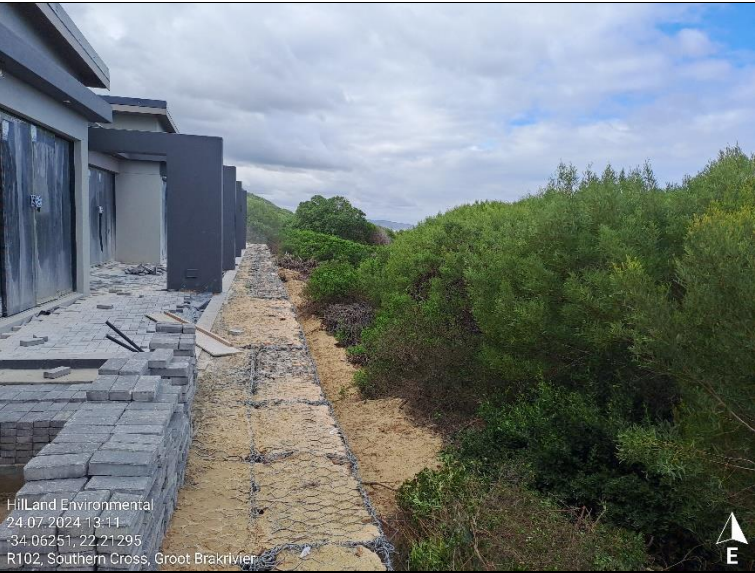
| <p>Hilland Environmental<br/>24.07.2024 13:11<br/>34.06251, 22.21295<br/>R102, Southern Cross, Groot Brakrivier</p> | <p>No-Go area in front of the house is clean and no litter noted during this site inspection.</p> |

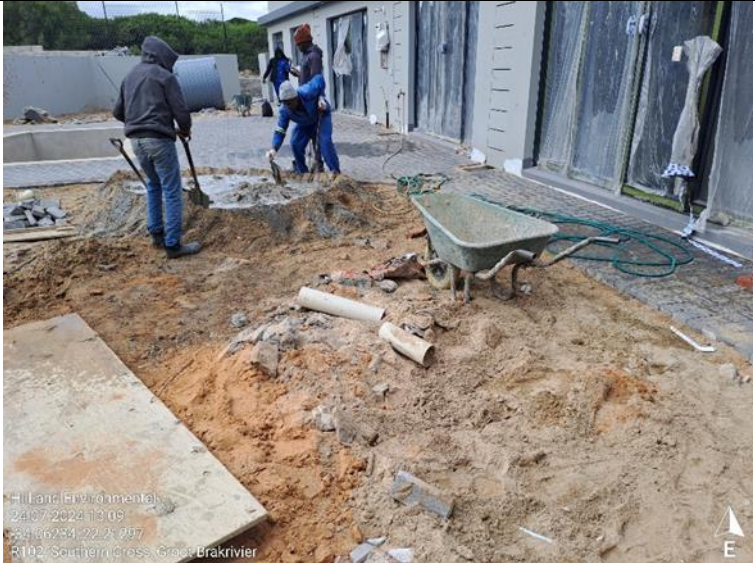
| <p>Hilland Environmental<br/>24.07.2024 13:09<br/>34.06251, 22.21297<br/>R102, Southern Cross, Groot Brakrivier</p> | <p>Concrete / cement mixing is done in the swimming pool area – permanent disturbance area.</p> <p>Suitable bunding is required when mixing cement/concrete in any other area, to prevent accidental pollution of the natural vegetation.</p> |

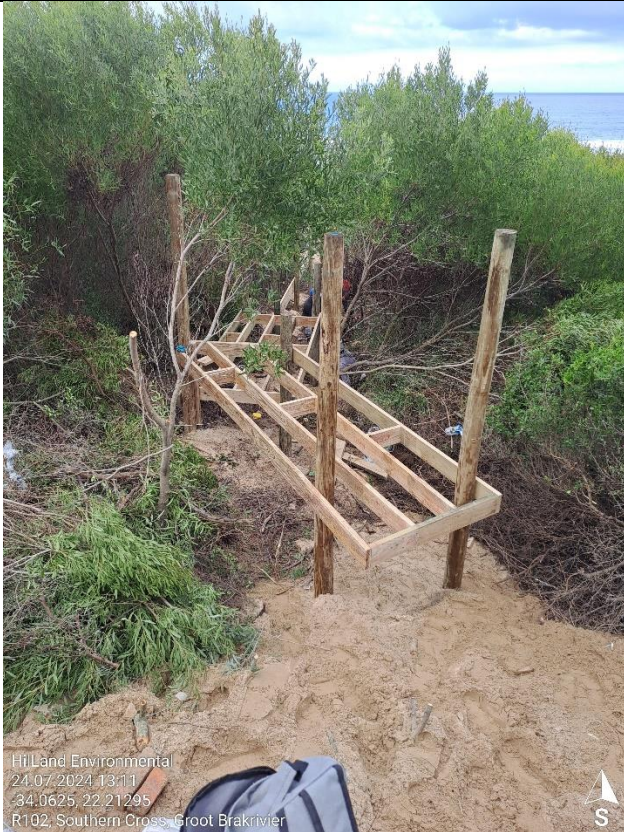
The construction of the deck and walkway has commenced.

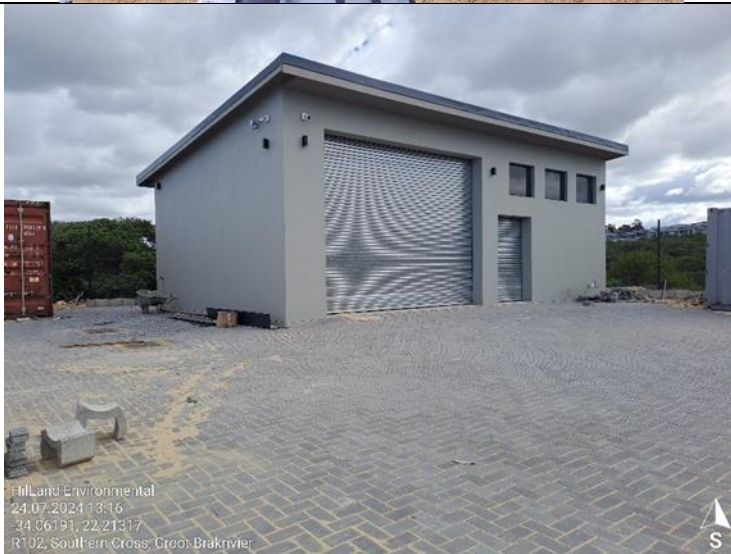
The garage building, fence and paving is complete.

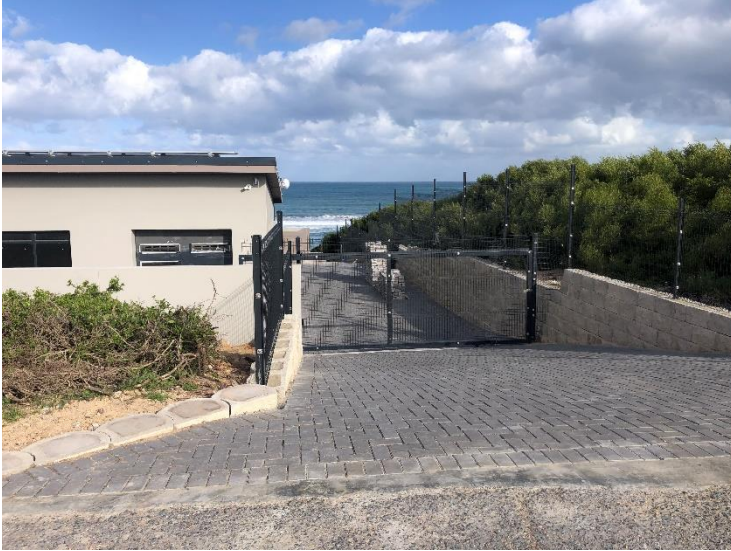
(28.08.2024)

Fence installed.

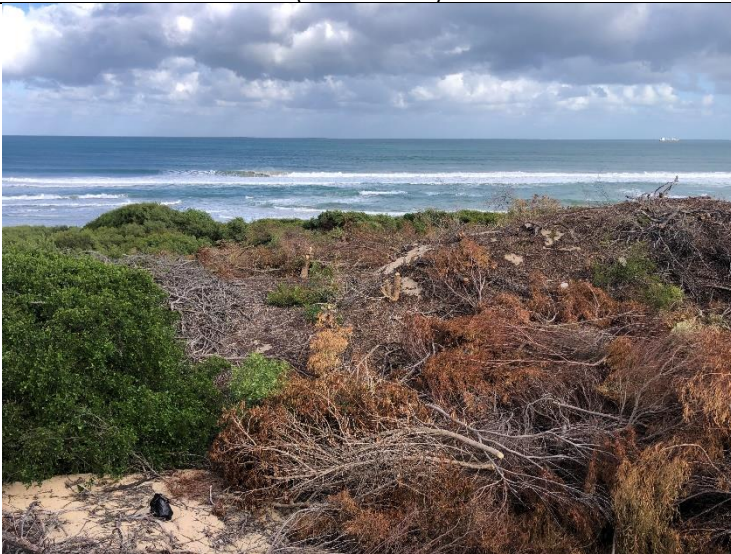
(28.08.2024)

Alien clearing started. Cut alien vegetation is brush packed.

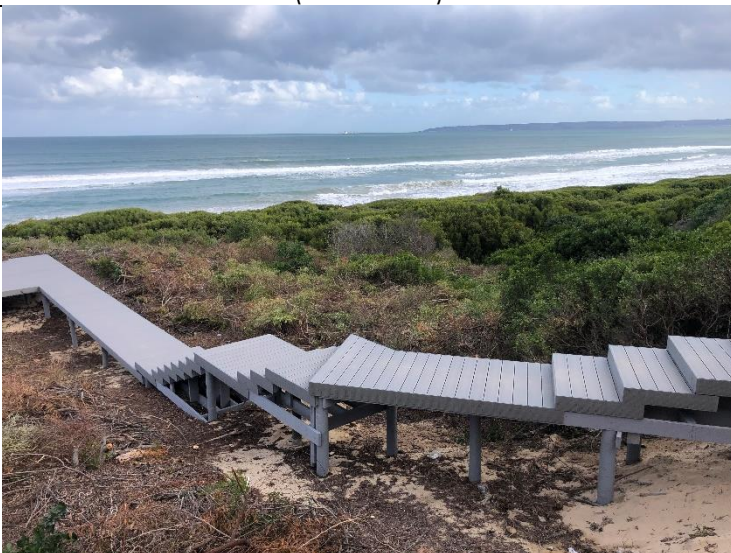
(28.08.2024)

Construction of the deck and walkway is complete.
