## APPENDIX A – SITE PHOTOGRAPHS

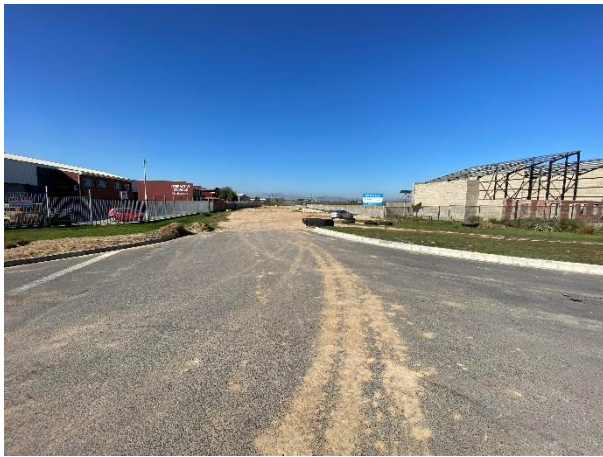
Access to the site off Darwin Road as seen towards the site. Some sand from the site is evident at the time.

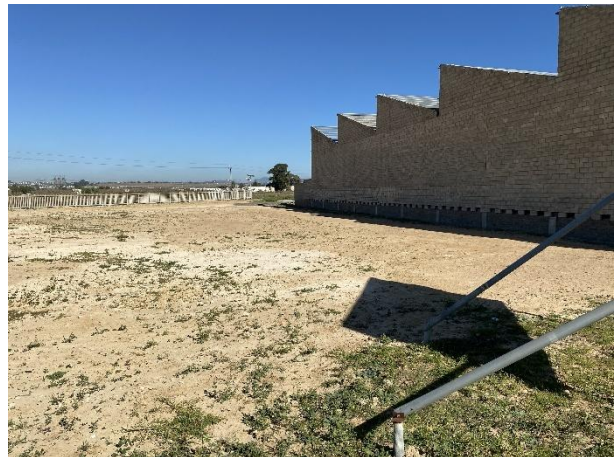
The previous temporary stormwater pond has been decommissioned and filled in.

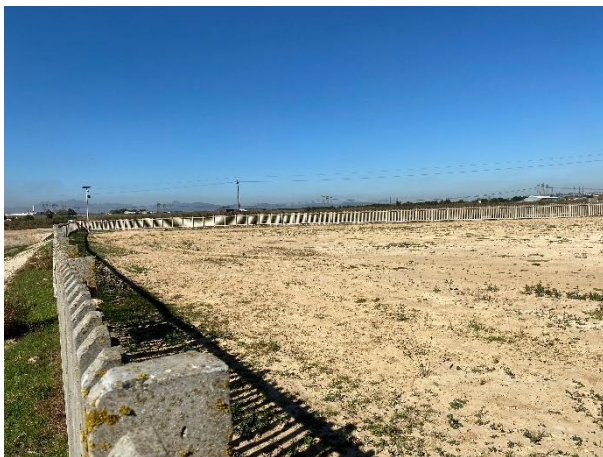
The previous temporary stormwater pond has been decommissioned and filled in.

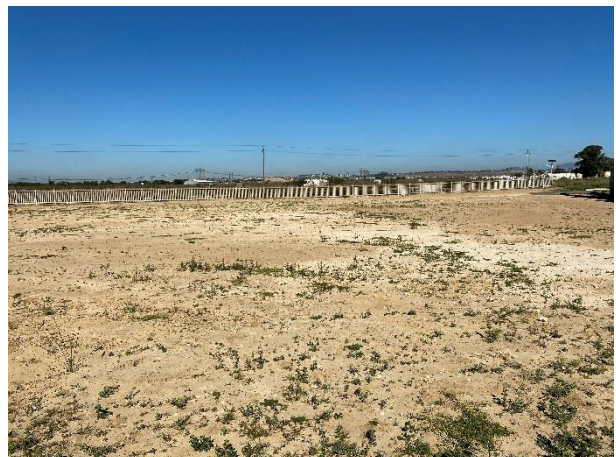
The previous temporary stormwater pond has been decommissioned and filled in.

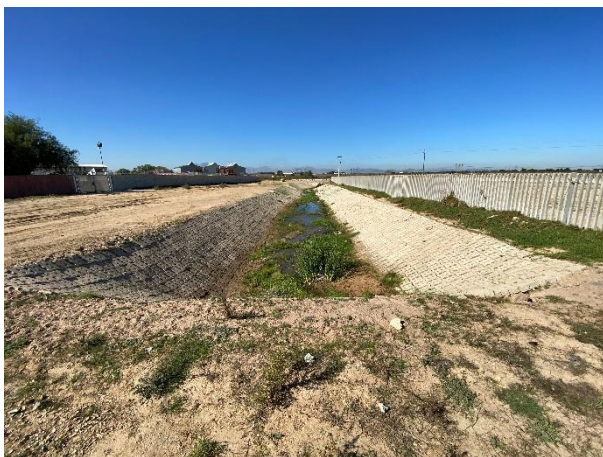
Construction and enlargement of Channel 1 along the existing outlet channel of the temporary pond.

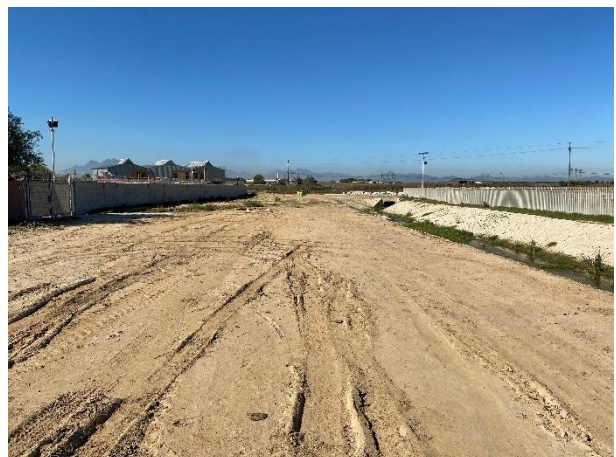
Darwin road reserve extension as seen towards the southeast.

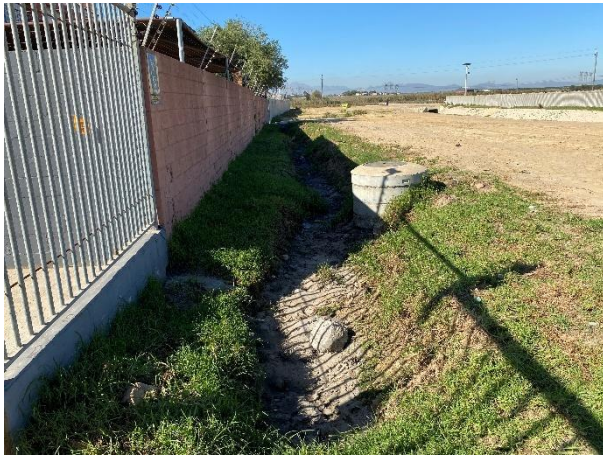
Roadside channels within the road reserve of Darwin Road.

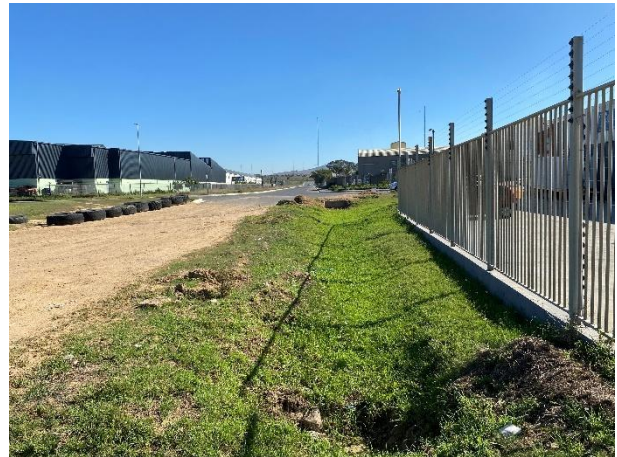
Roadside channels within the road reserve of Darwin Road.

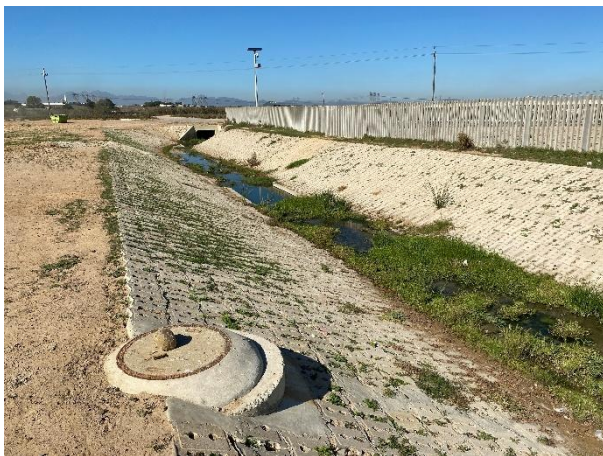
Construction and enlargement of Channel 1 along the existing outlet channel of the temporary pond.

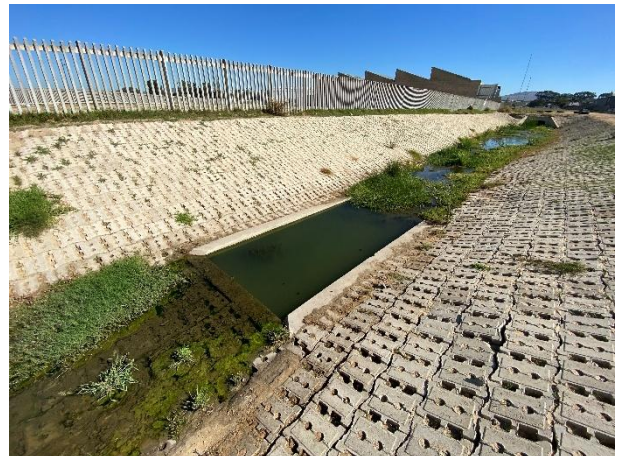
Central channel cunettes constructed along the enlarged Channel 1 to assist in low-flow conveyance and drainage.

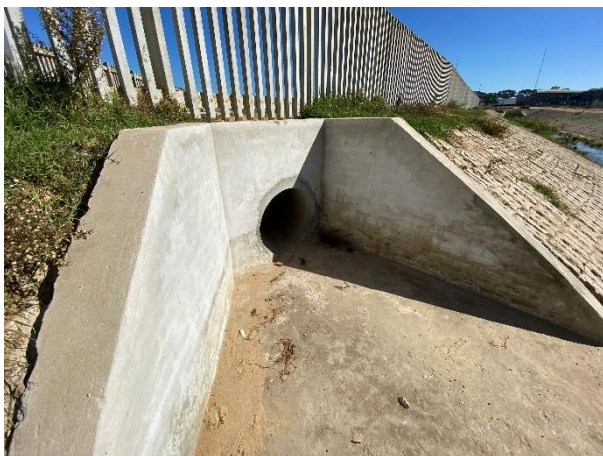
The stormwater culvert currently serving as an overflow diversion towards the decommissioned temporary pond.

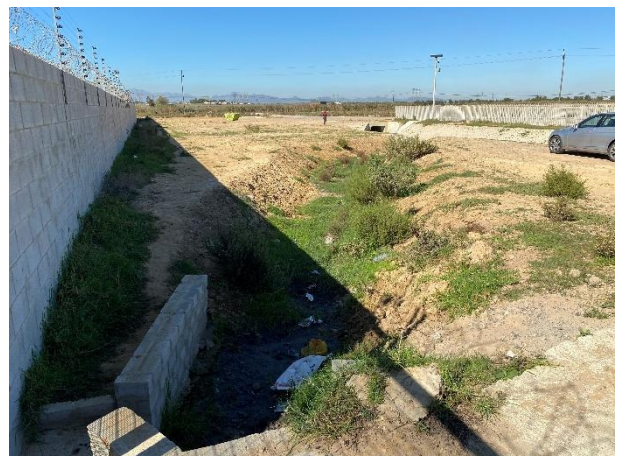
Roadside stormwater culvert channels within the road reserve of Darwin Road.

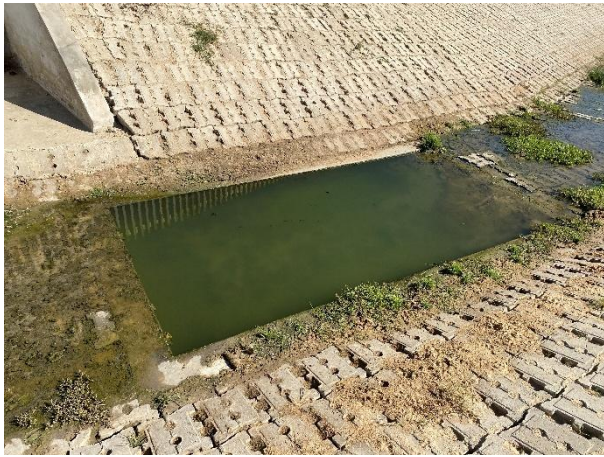
Central channel cunettes constructed along the enlarged Channel 1 to assist in low-flow conveyance and drainage.

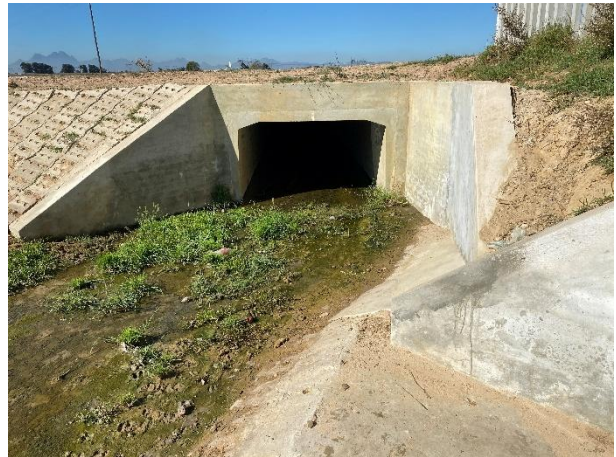
Culvert headwall along Channel 1 underneath Brass Avenue gravel access road.

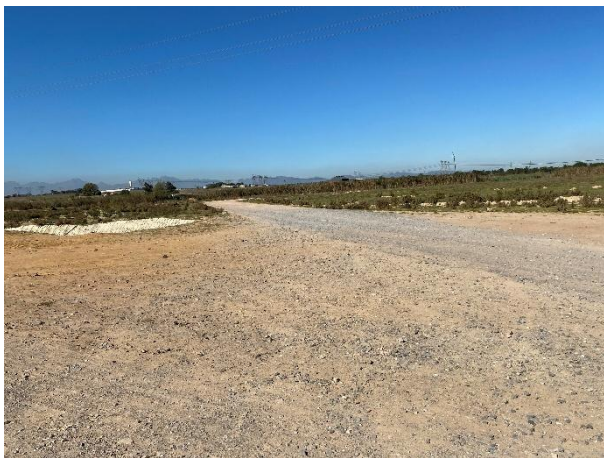
Brass Avenue gravel access road as seen towards the southeast.

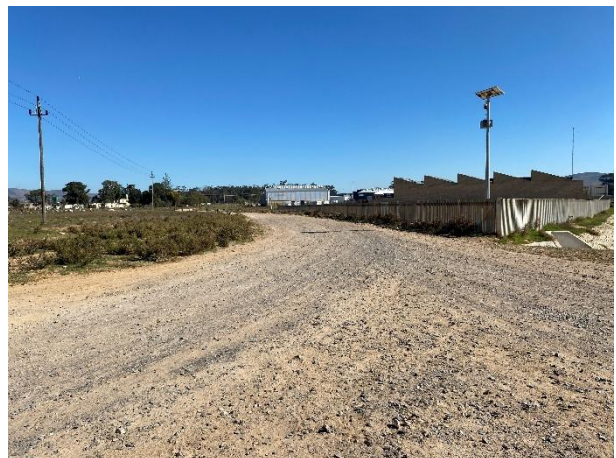
Brass Avenue gravel access road as seen towards the west.

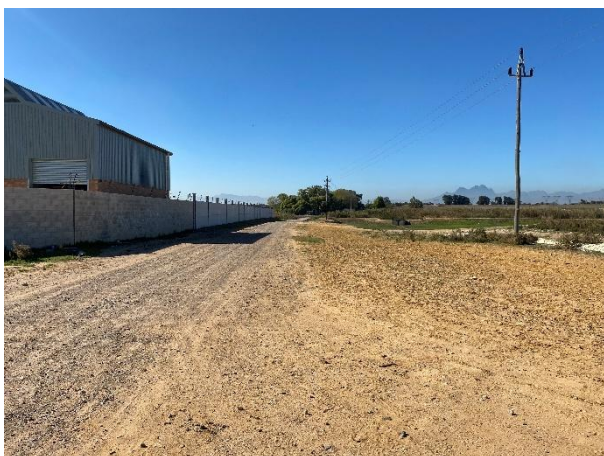
From Brass Avenue gravel road as seen towards the southeast towards the Mosselbank River.

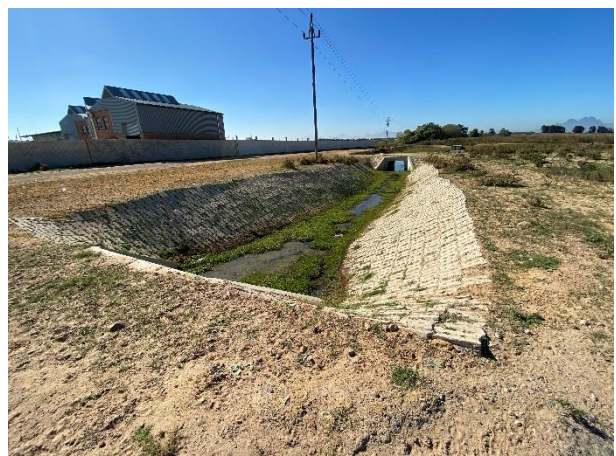
Channel 2 towards the box culvert inlet to the new wet pond forebay as seen towards the east.

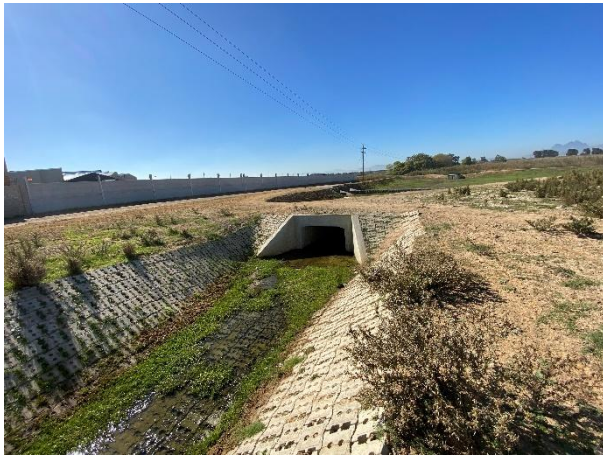
New box culvert inlet to the new dry pond forebay as seen towards the east.

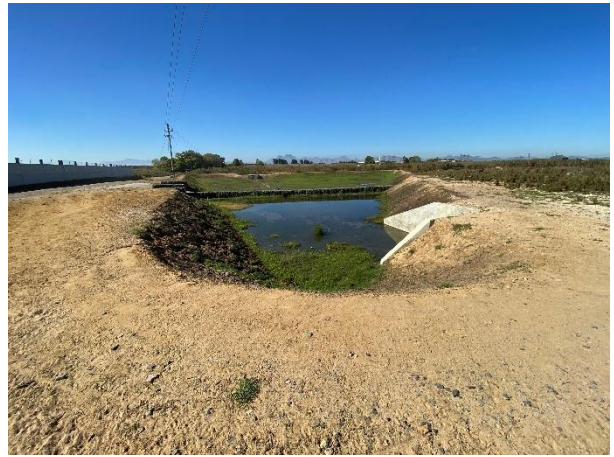
The new dry stormwater pond as seen from the west towards the east.

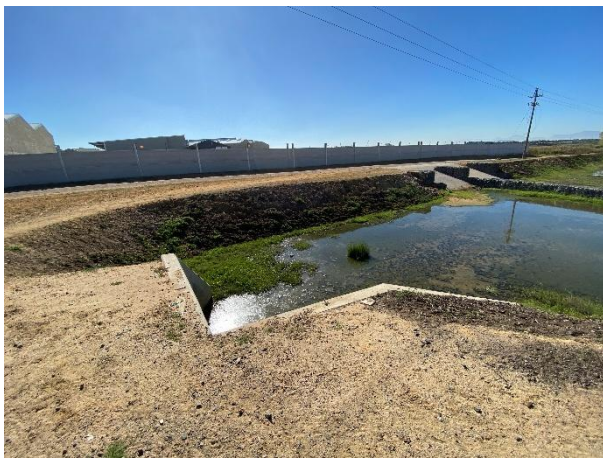
The new dry pond forebay.

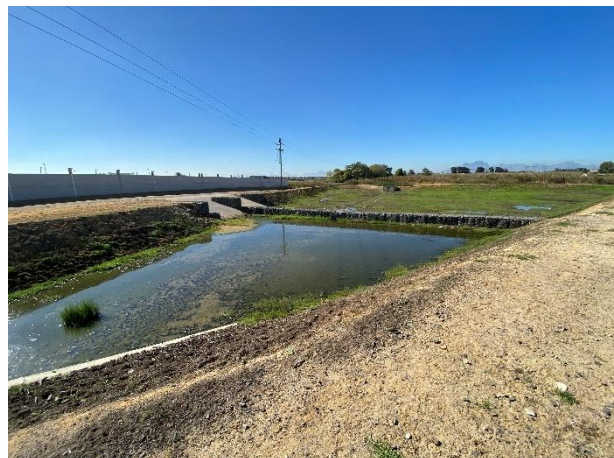
The new dry pond forebay.

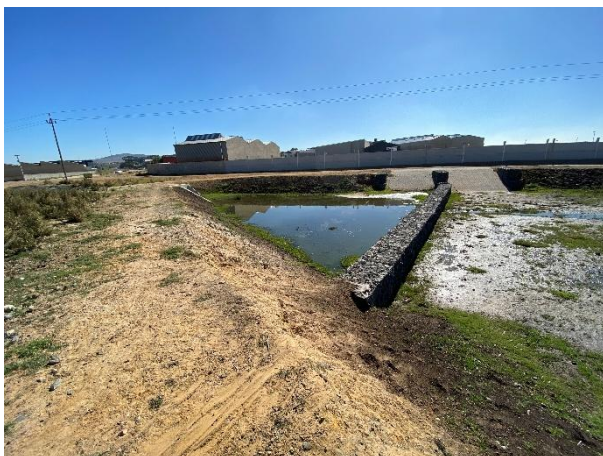
The new dry pond forebay.

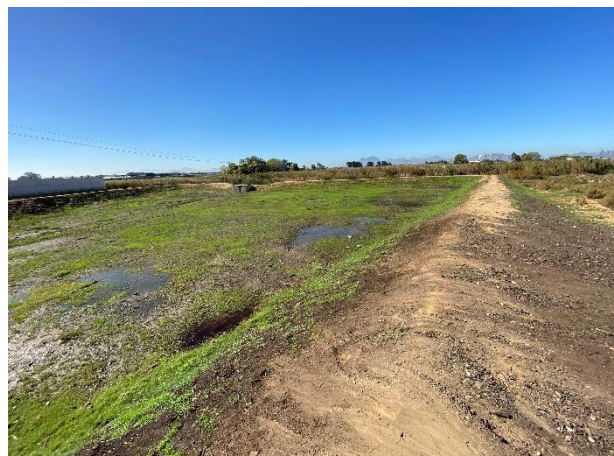
The new dry stormwater pond.

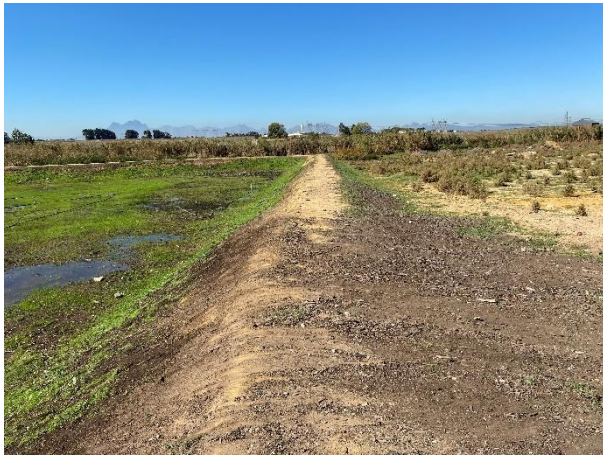
Along the southern boundary of the new pond, showing the composted banks.

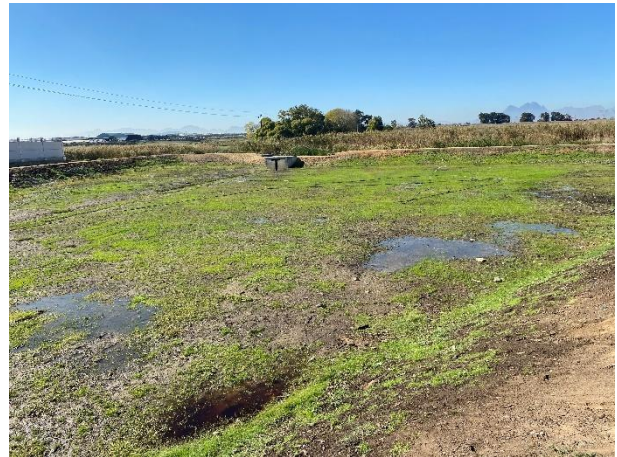
The permanent pool of the regional pond being irrigated, seeded with Bermuda grass.

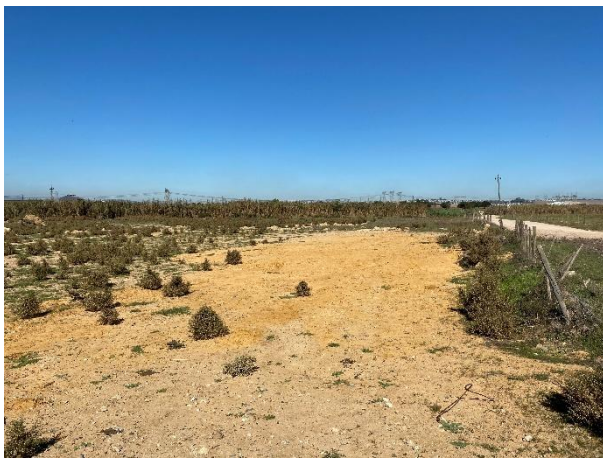
The condition of the temporary stockpile area as seen immediately south of the new pond towards the south.

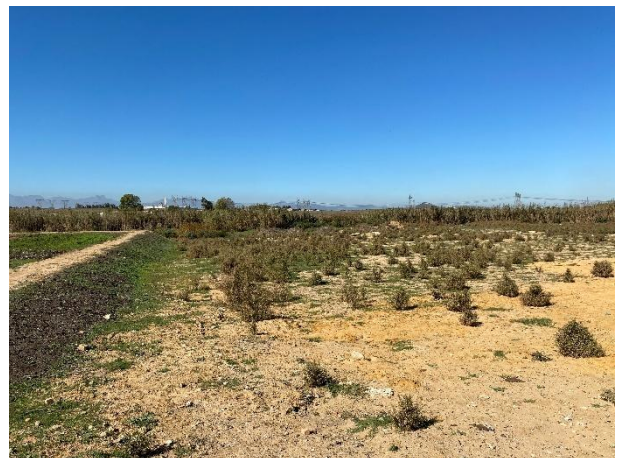
The condition of the temporary stockpile area as seen immediately south of the new pond towards the south.

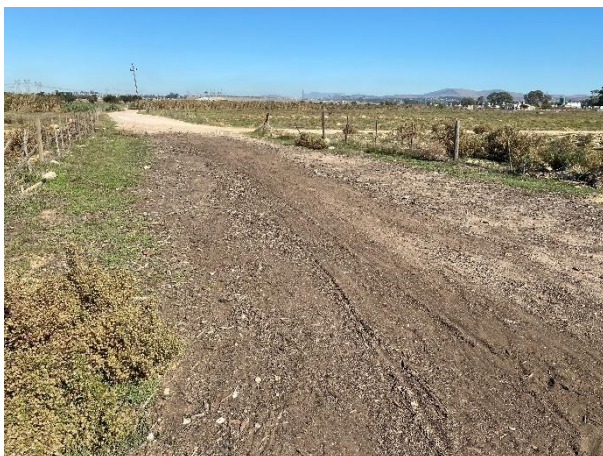
Composted and rehabilitated temporary access road.

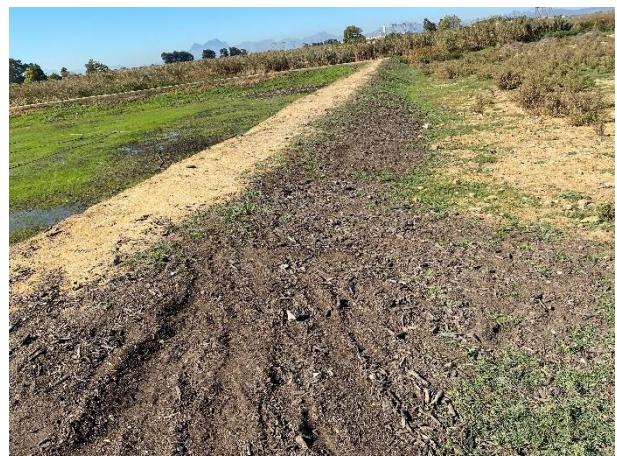
Along the southern boundary of the new pond, showing the composted banks.

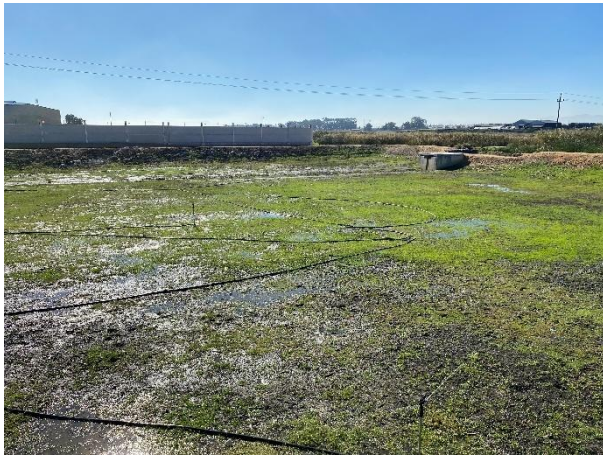
The permanent pool of the regional pond being irrigated, seeded with Bermuda grass.

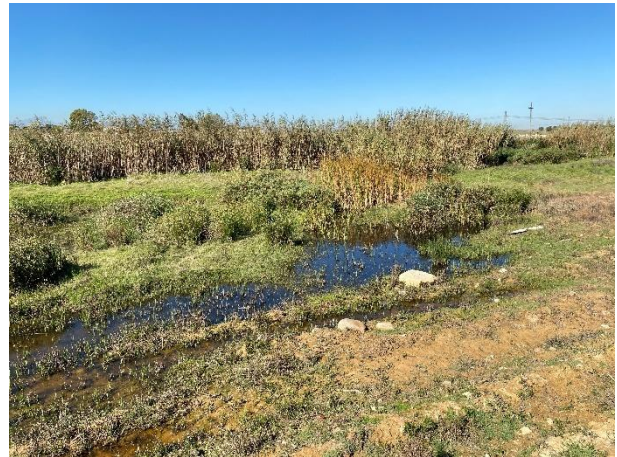
Condition of the wetland area of the Mosselbank River.

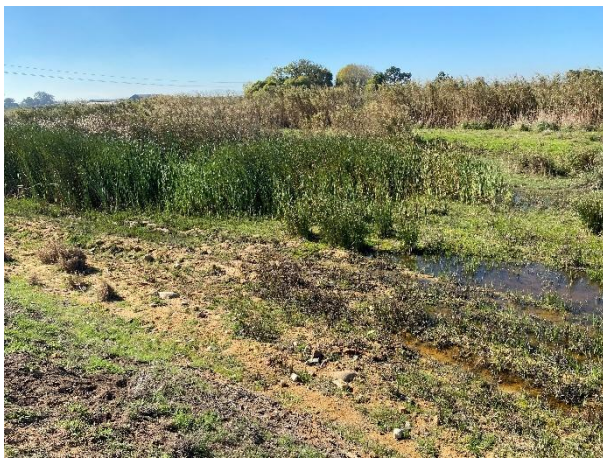
Condition of the wetland area of the Mosselbank River.

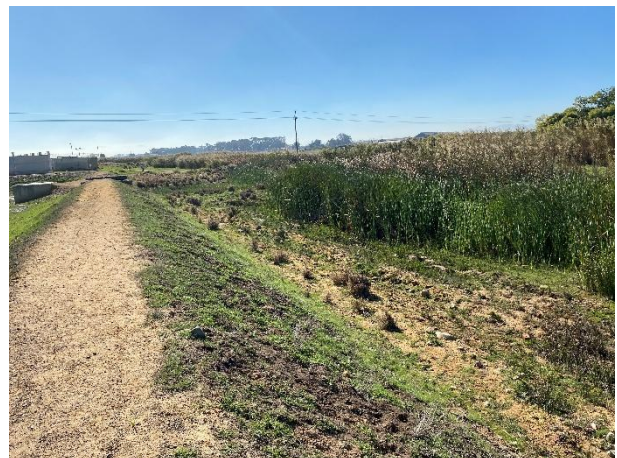
Eastern embankment of the dry regional pond adjacent to the wetland area of the Mosselbank River.

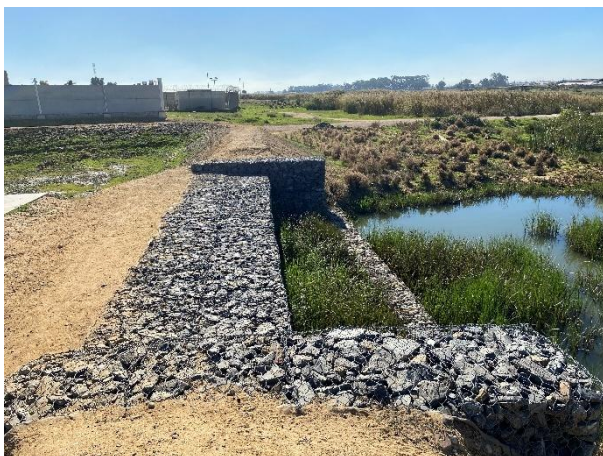
Gabion spillway drop structure with stilling basin as seen towards the east.

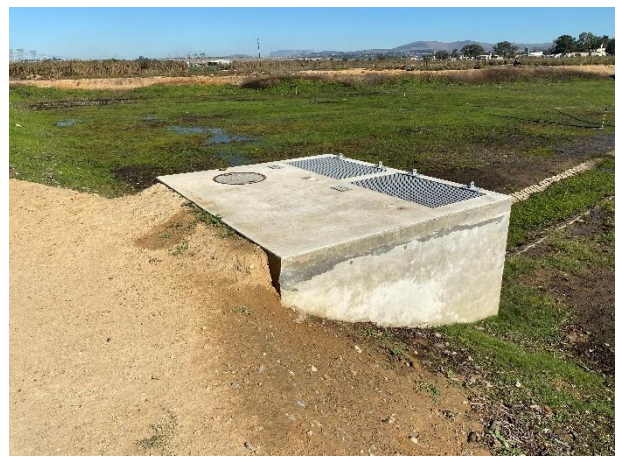
Outlet structure with weir openings and flapgate.

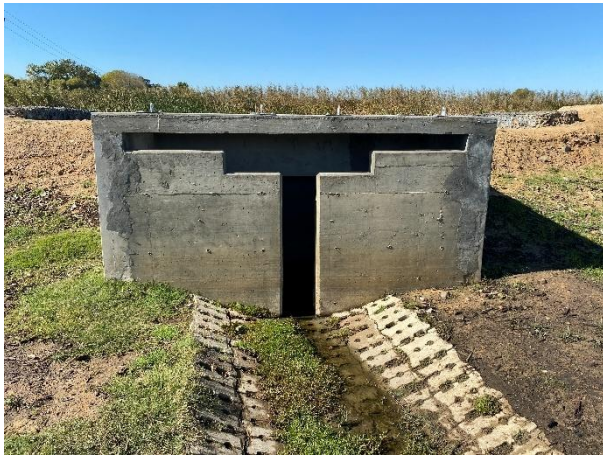
Outlet structure with weir openings and flapgate.

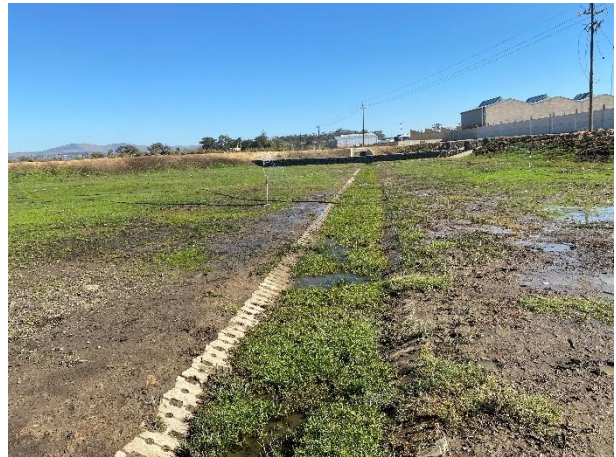
The permanent pool of the regional pond being irrigated, seeded with Bermuda grass.

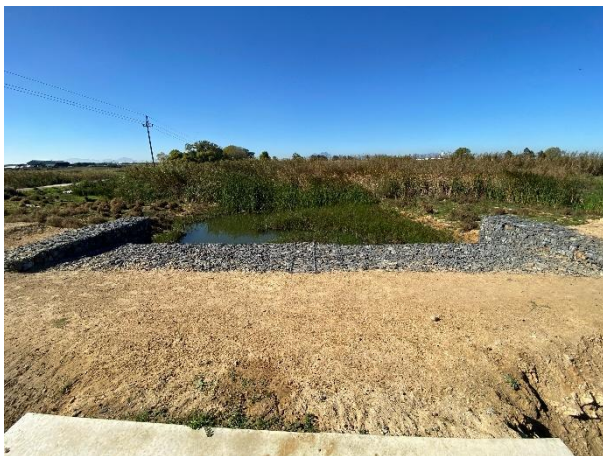
Gabion spillway drop structure with stilling basin.

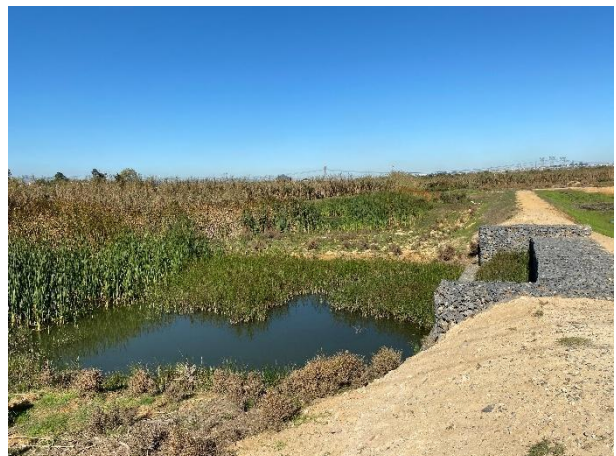
Gabion spillway drop structure with stilling basin as seen towards the south.

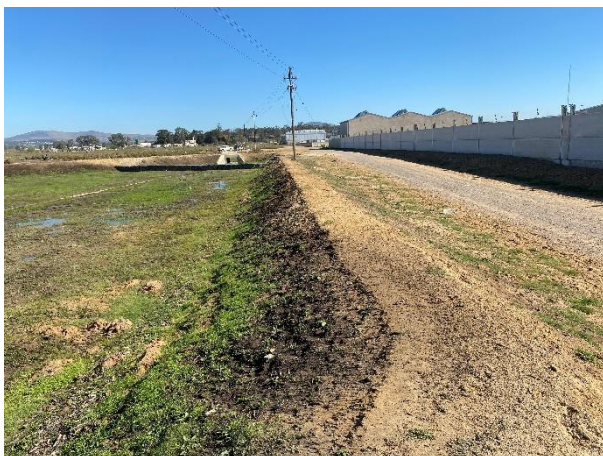
Condition of the embankment along Brass Avenue gravel road.

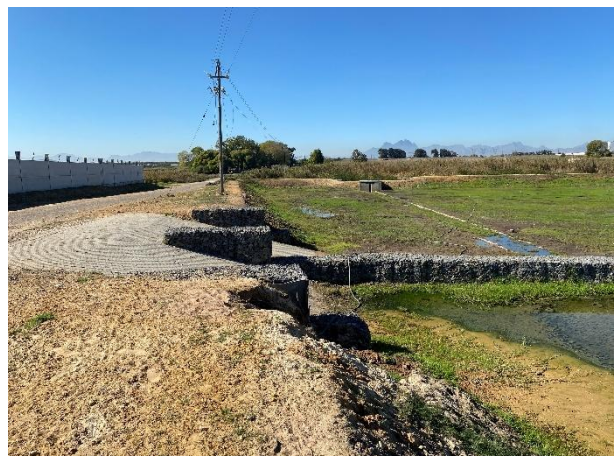
Forebay access ramp.
