**THE DEVELOPMENT OF A REGIONAL STORMWATER POND AND ASSOCIATED  
INFRASTRUCTURE ON UNREGISTERED ERF 2001, ERF 1991 AND WITHIN A  
PORTION OF THE ROAD RESERVE OF DARWIN ROAD, FISANTEKRAAL**

**FORMAL ECO AUDIT REPORT**

9 September 2024

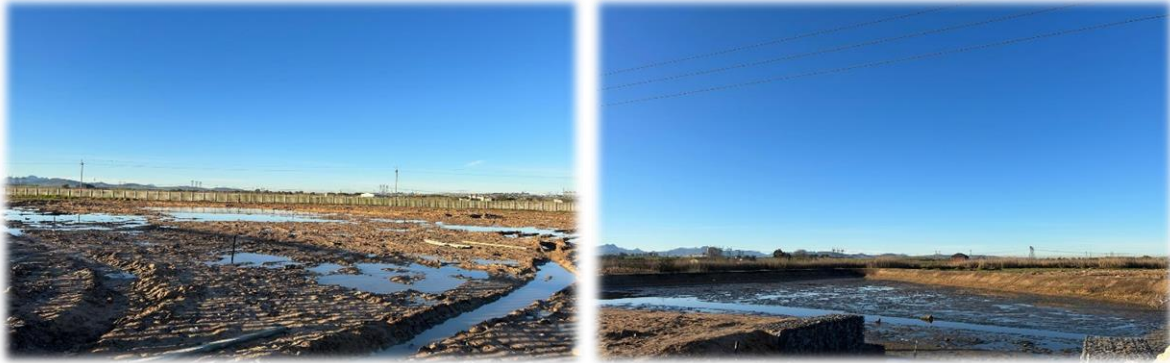
No works were seen outside of the construction footprint.

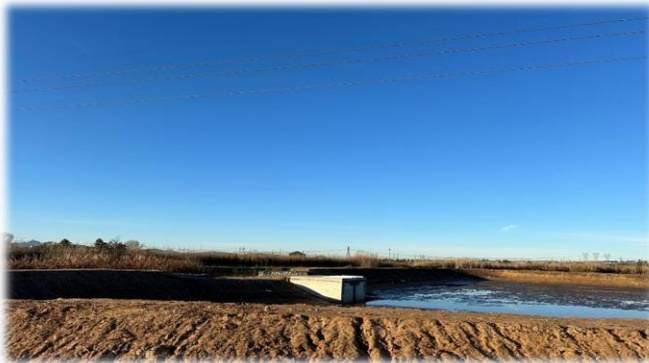
Topsoil has been placed back on site and is sufficient.

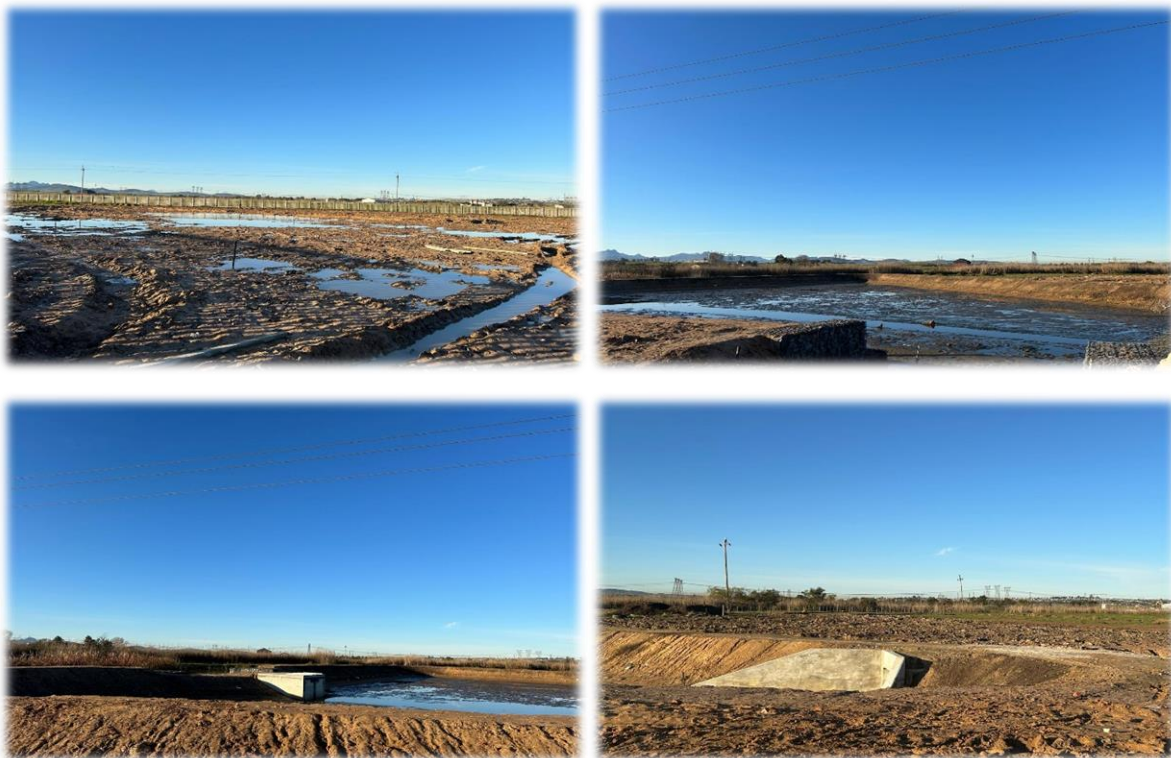
The contractor was finished with the works during the audit.
