**PERIODIC MAINTENANCE OF TR 83/1, KM 25.78 TO  
KM 34.00 AND KM 48.50 TO KM 58.00, TR 83/2 FROM  
KM 0 TO KM 11,16 AND KM 15.25 TO KM 23.01, MR  
365 FROM KM 0 TO KM 14.12, AND TR 31/5 FROM  
KM 0.42 TO KM 0.90, BETWEEN RIVERSDALE TO  
LADISMITH, WESTERN CAPE.**

**FINAL CLOSURE EXTERNAL ENVIRONMENTAL AUDIT  
REPORT IN TERMS OF REGULATION 34 OF THE NEMA  
EIA REGULATIONS, 2014 (AS AMENDED).**

DEA&DP Ref: 16/3/3/1/D5/16/0005/22

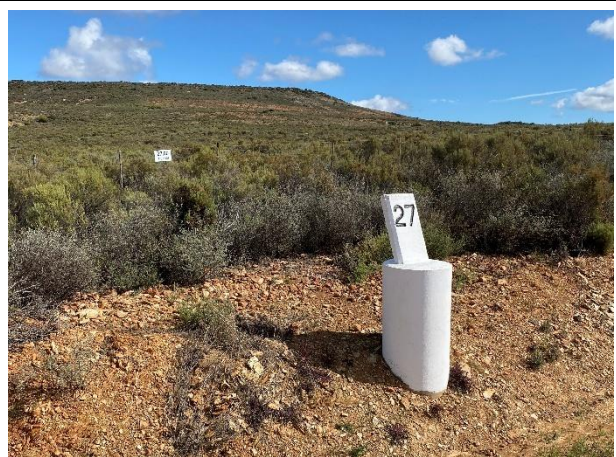
Condition of the newly surfaced road and road reserve at TR 83/1 km 27.

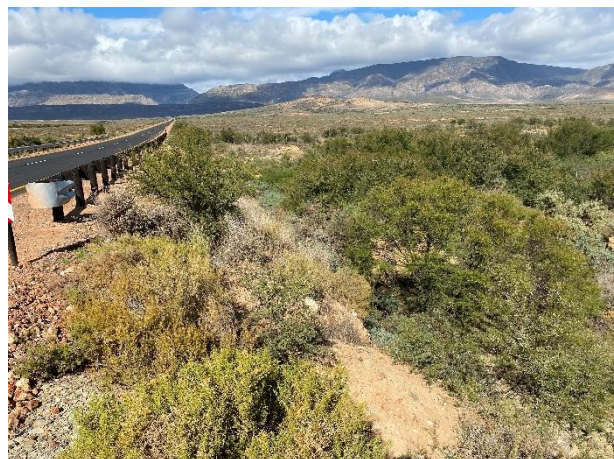
Condition of the newly surfaced road and road reserve at TR 83/1 km 29.

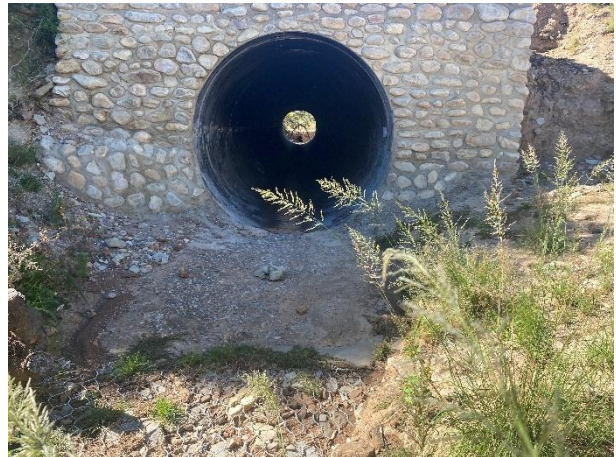
Condition of the newly surfaced road and road reserve at TR 83/1 km 30.

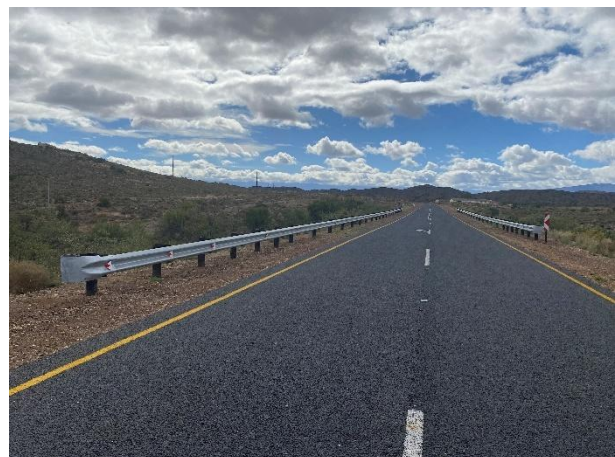
Condition of the newly installed guardrails and road surface at Culvert 10089.

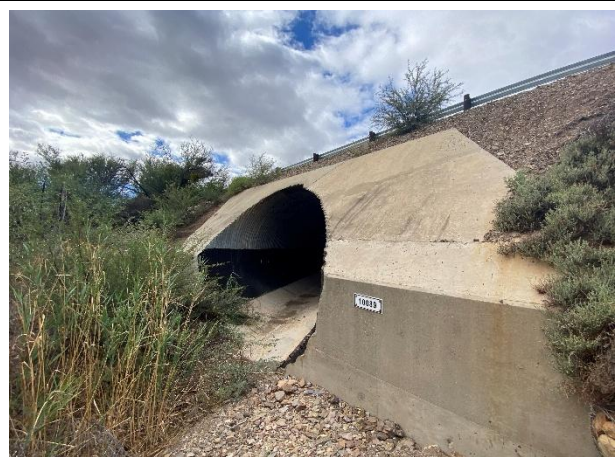
Sloping headwall sealed by injection, and cracks cut back and repaired using a cementitious repair compound.

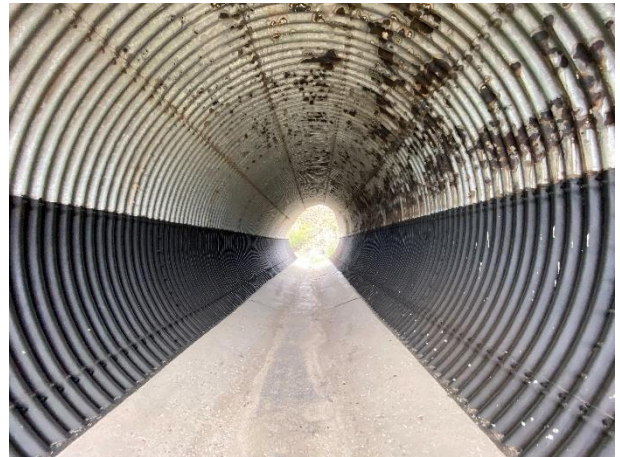
Clearance of the Armco barrel walls and the painting of affected corroded areas.

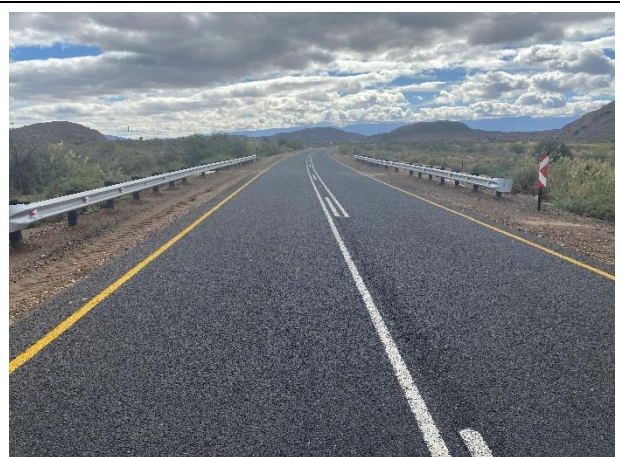
Condition of the newly installed guardrails and road surface at Culvert 10867.

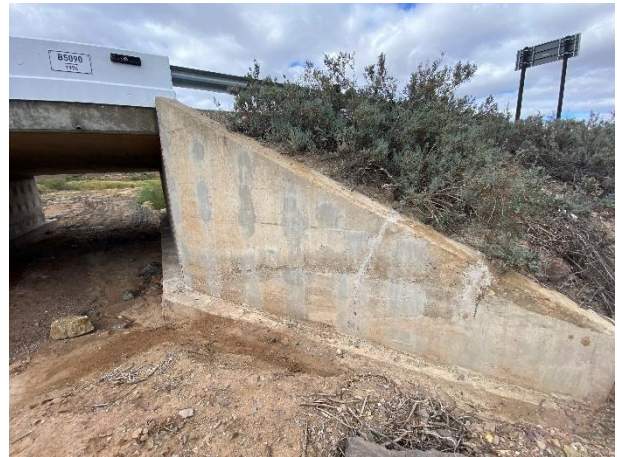
Repairing of cracks on the wingwalls and headwalls.

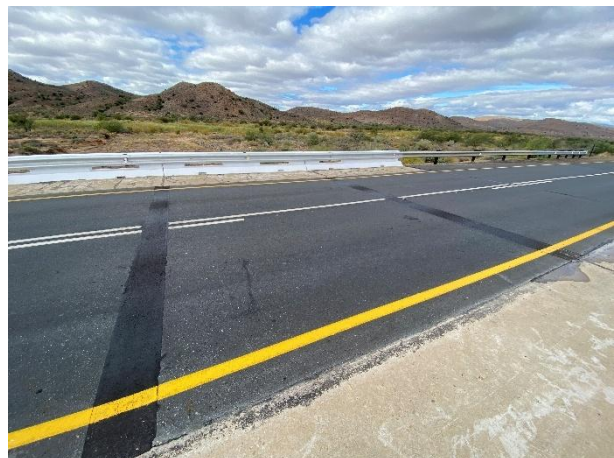
Replaced expansion movement joints.

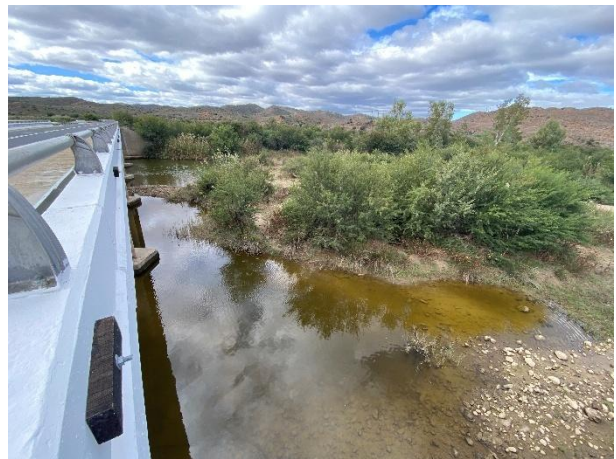
Concrete spalling repaired with an epoxy repair mortar.

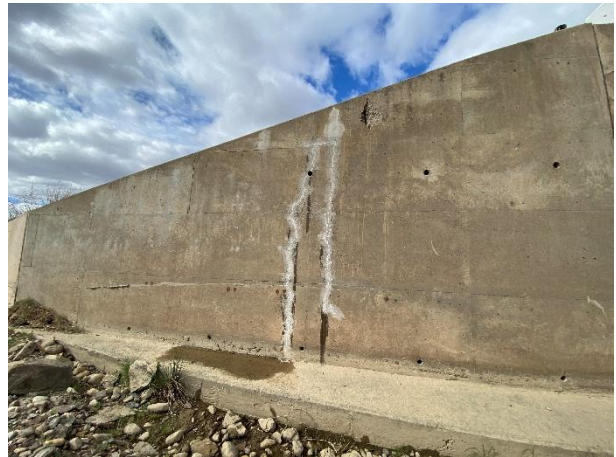
Repairs of vertical and horizontal cracks.

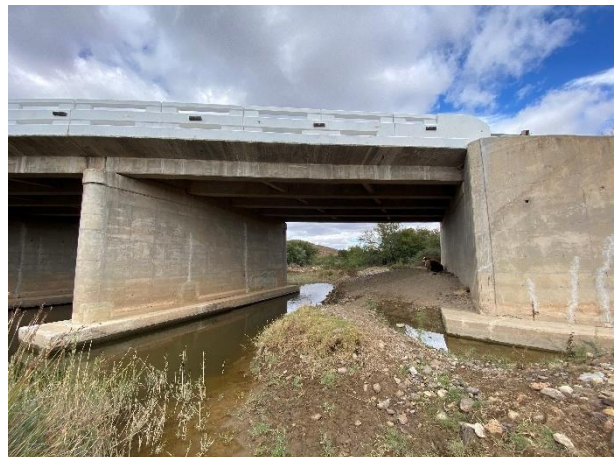
Repairs of vertical and horizontal cracks.

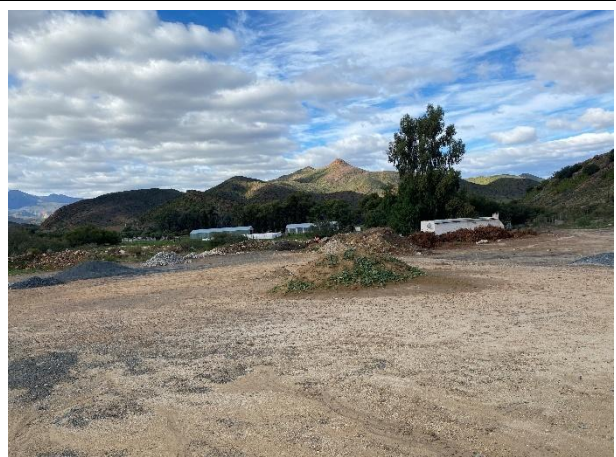
Condition of the construction camp with remained material stockpiles.

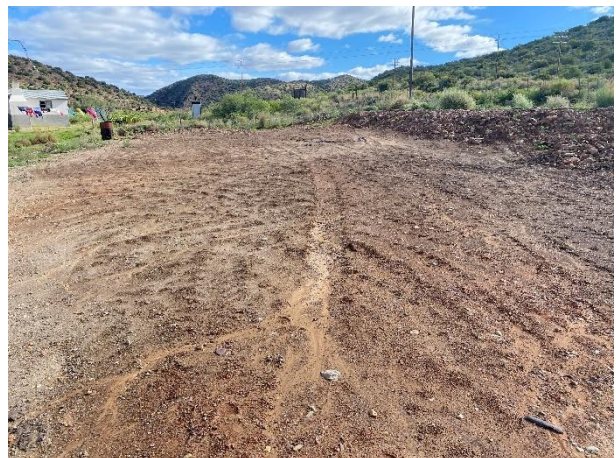
Condition of the former bitumen storage area within the construction camp.

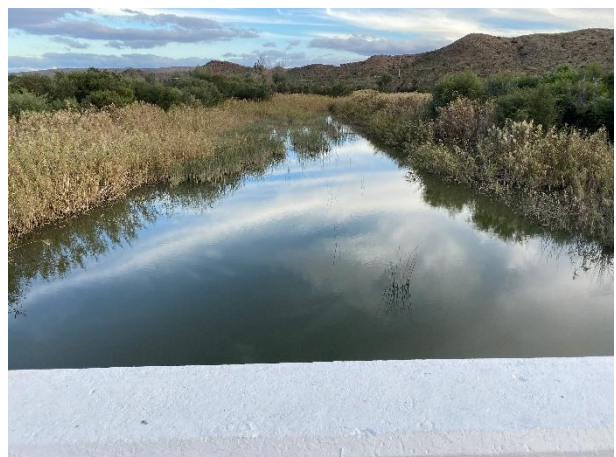
Overgrown vegetation due to the recent rainfall.

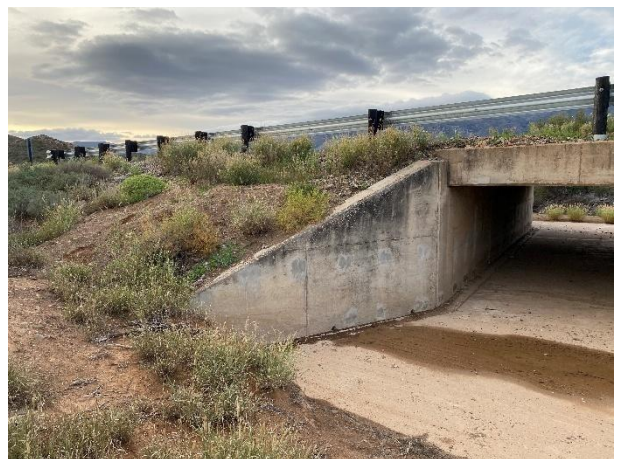
Repairs of vertical and horizontal cracks.

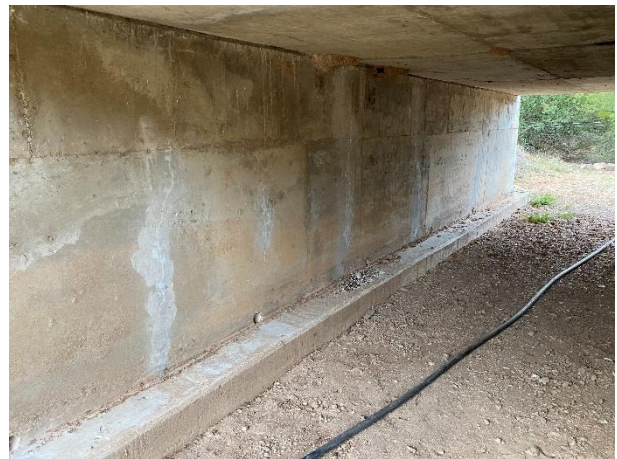
Cracks repaired with a cementitious repair compound.

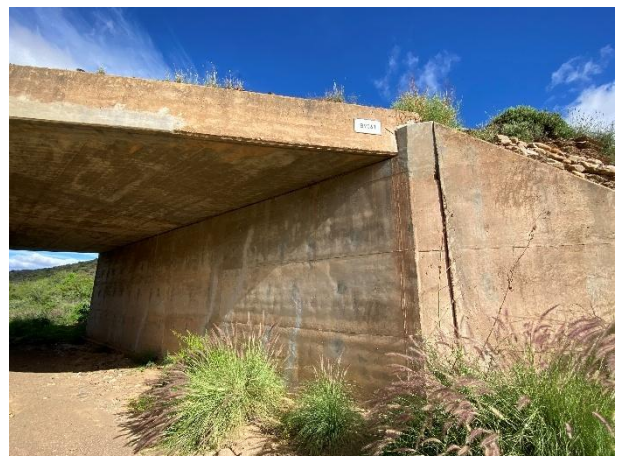
Repairs of vertical and horizontal cracks.

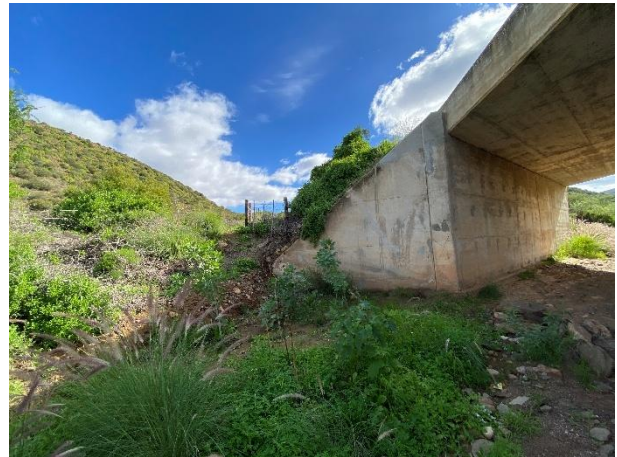
Repairs of vertical and horizontal cracks on the wingwalls.

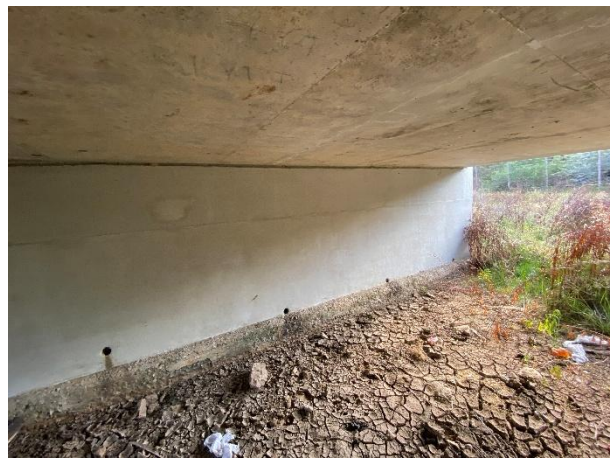
Concrete spalling and cracks repaired with an epoxy repair mortar.

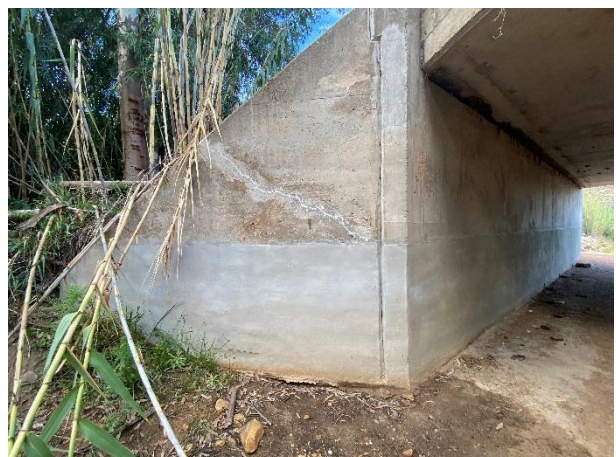
Repaired vertical and horizontal cracks in the abutment, piers, and wingwalls.

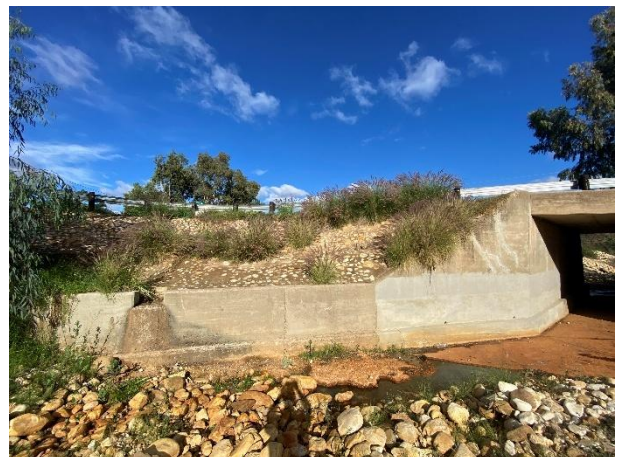
Repaired vertical and horizontal cracks along with concrete spalling in the abutment, piers, and wingwalls.

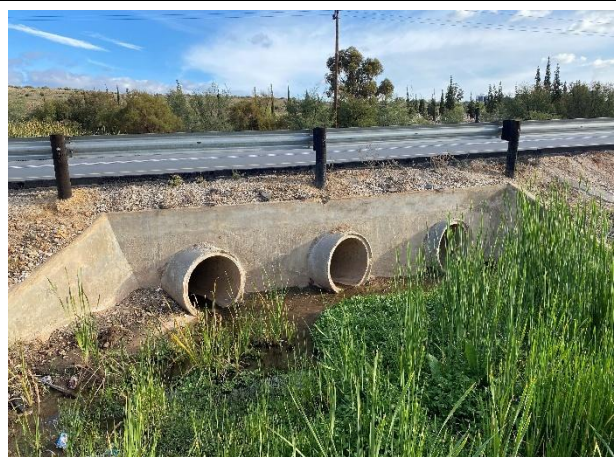
Repaired culvert.
