## APPENDIX A – SITE PHOTOGRAPHS

Culvert 10875: TR 83/1 at km 26.24

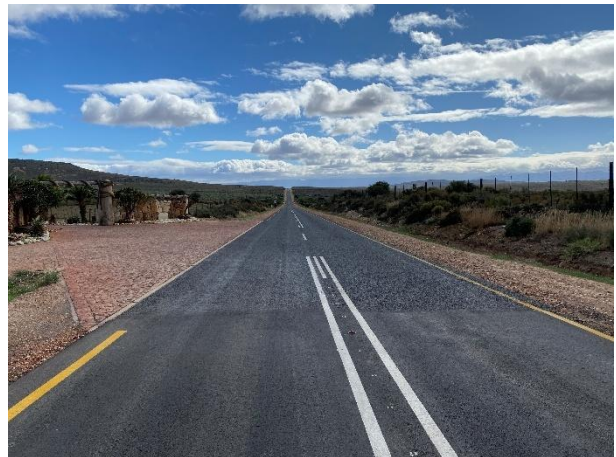
Condition of the road reserve at TR 83/1 km 25.78.

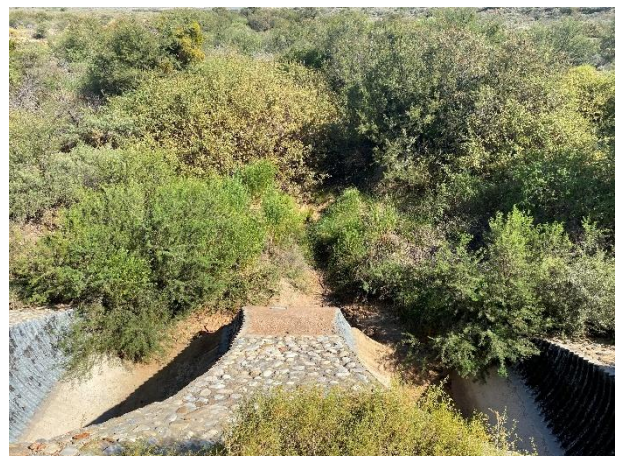
Condition of the vegetation along Culvert 10874.

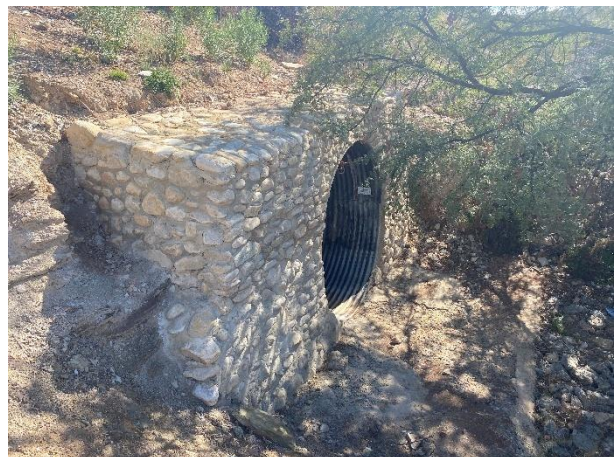
Condition of the vegetation surrounding Culvert 10692 at km 30.63

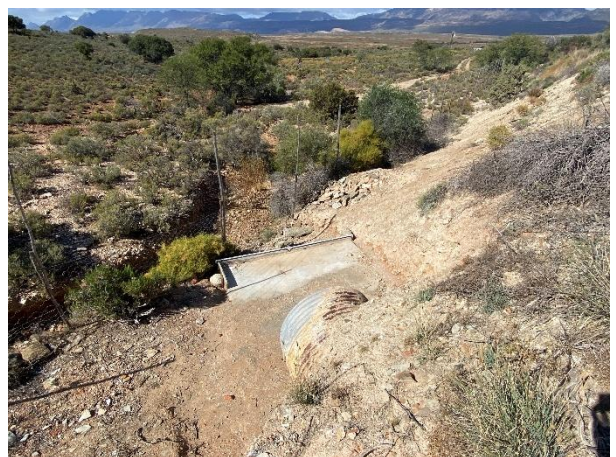
Gabion steps extending downward from the culvert to stabilise the slope and manage water flow.

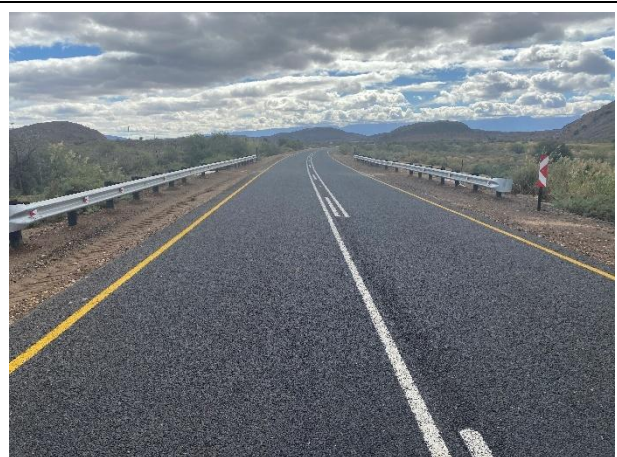
km 52 marker off TR 83/1.

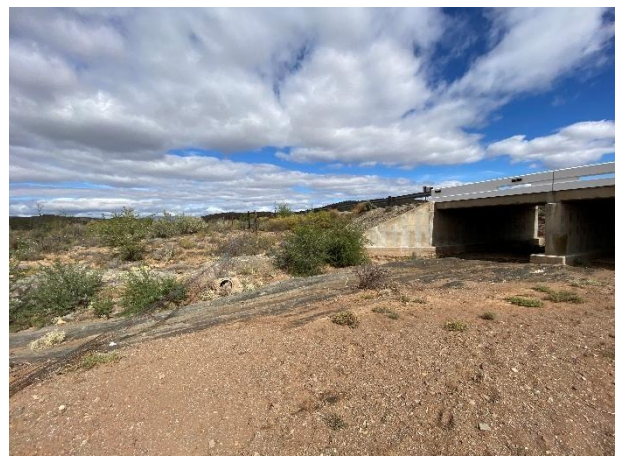
Condition of the vegetation surrounding the bridge.

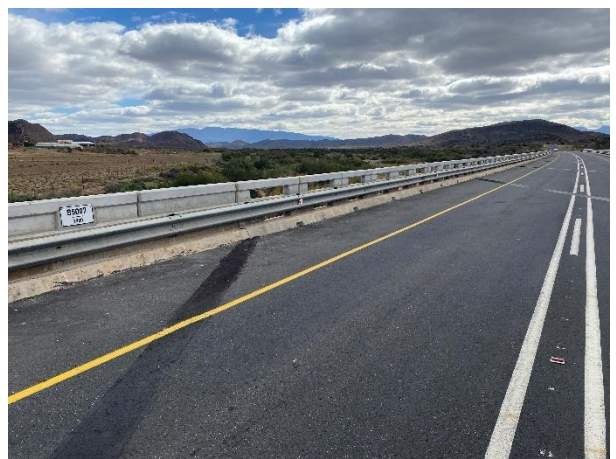
Condition of the vegetation surrounding the bridge. Fencing in place.

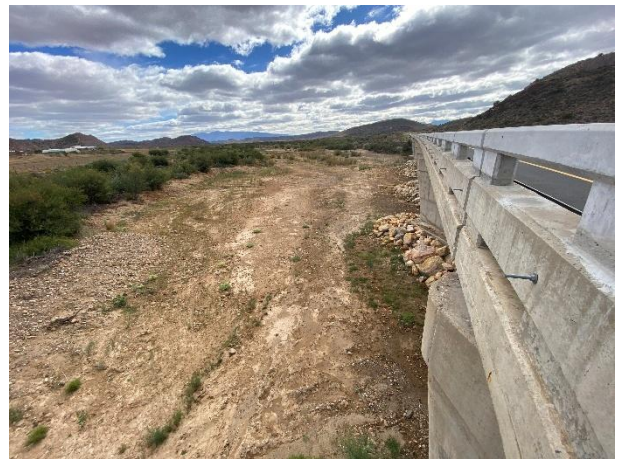
Condition of the vegetation surrounding the bridge.

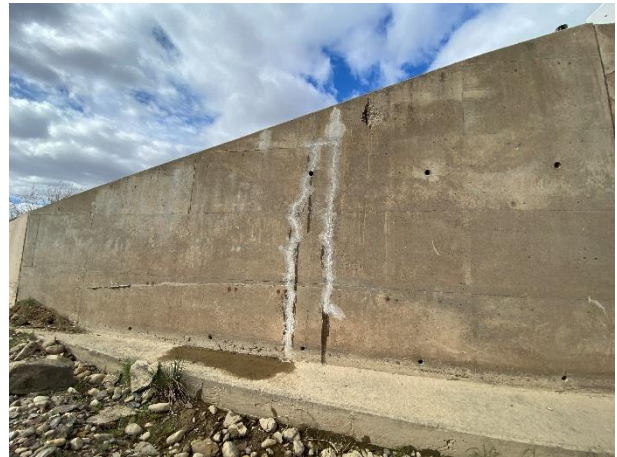
Condition of Bridge 4837.

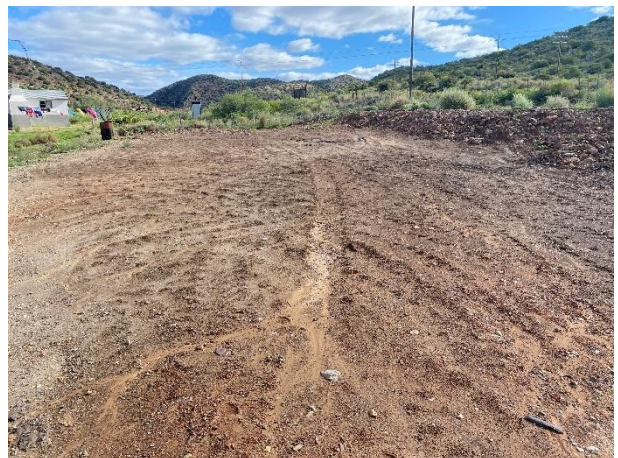
Remaining material stockpiles at the construction camp.

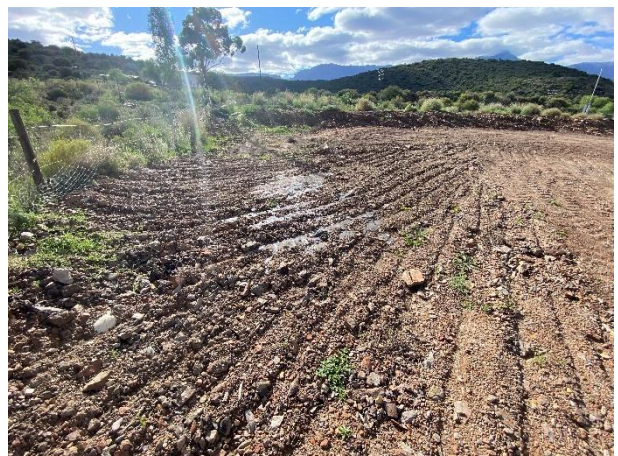
Condition of the former bitumen storage area within the construction camp.
