**PROPOSED REPAIR AND UPGRADE OF THE EXISTING  
DEGRADED STORMWATER INFRASTRUCTURE ALONG MAIN  
ROAD ("MR") 269 AT KM 4.95 AND KM 5.67 AND ALONG  
DIVISIONAL ROAD ("DR") 1257 AT KM 1.47, HEMEL & AARDE  
VALLEY, BETWEEN SANDBAAI AND CALEDON.**

**EXTERNAL ENVIRONMENTAL AUDIT REPORT IN TERMS  
OF REGULATION 34 OF THE NEMA EIA REGULATIONS,  
2014 (AS AMENDED).**

DEA&DP AMENDED EIA REF. NO.  
16/3/3/5/E2/15/1016/21

27 June 2025

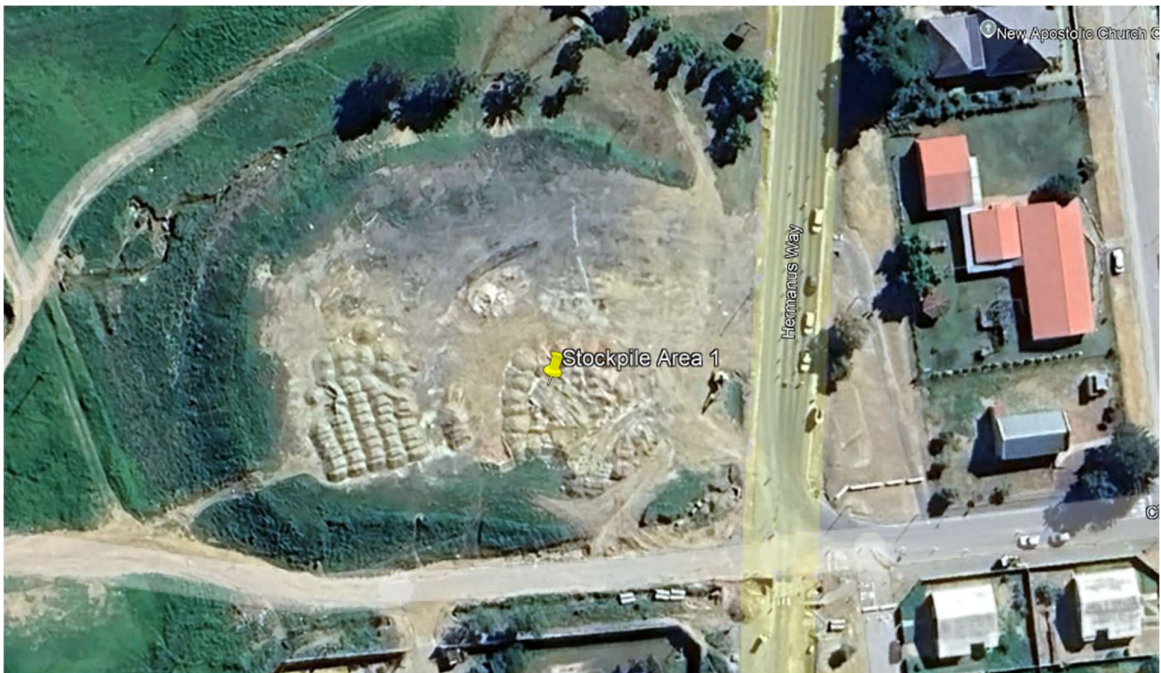
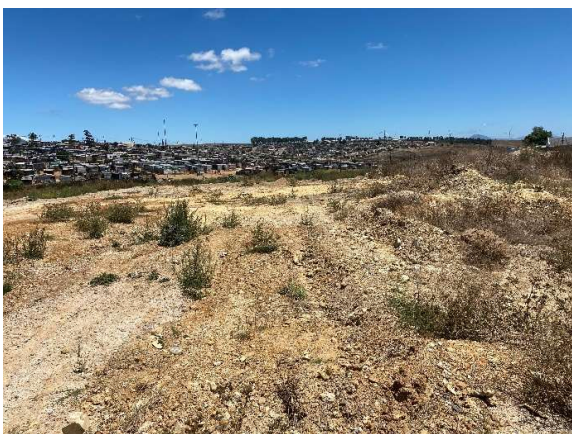
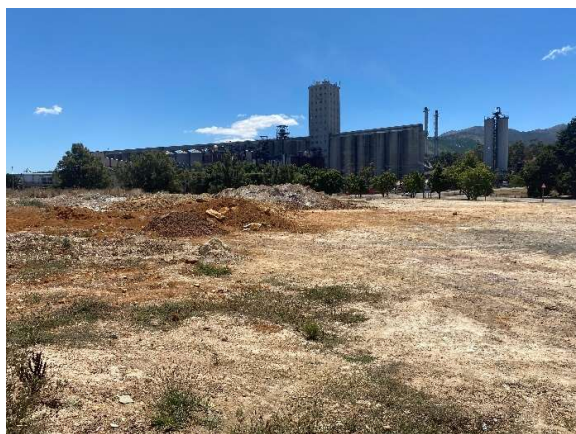
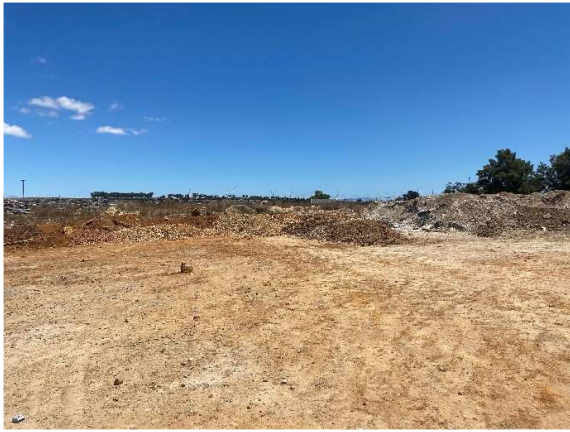
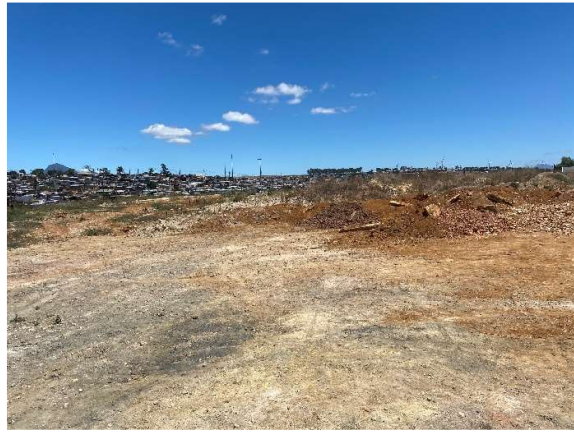
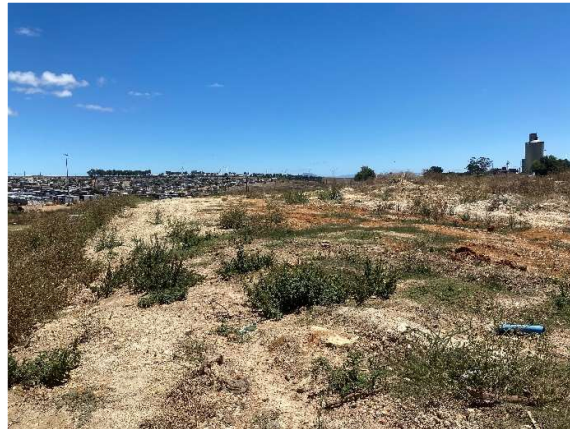
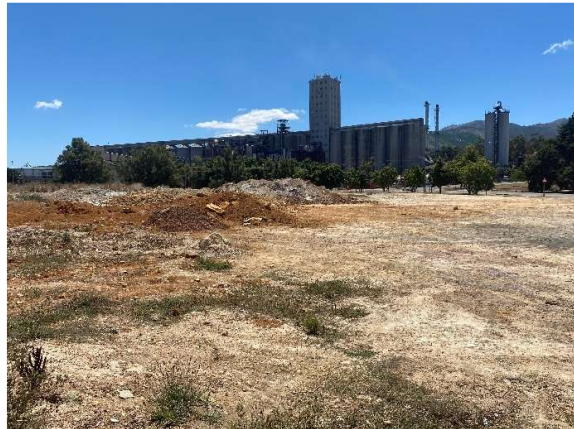
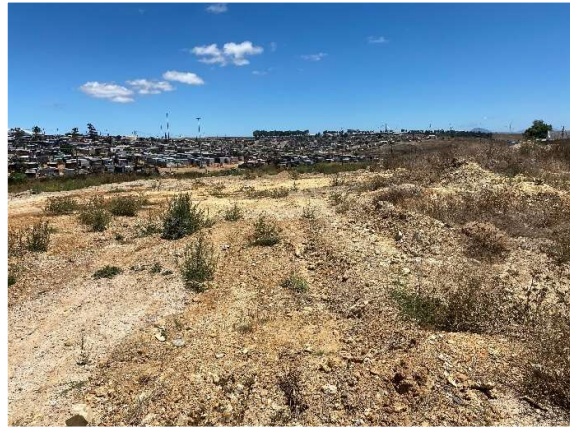
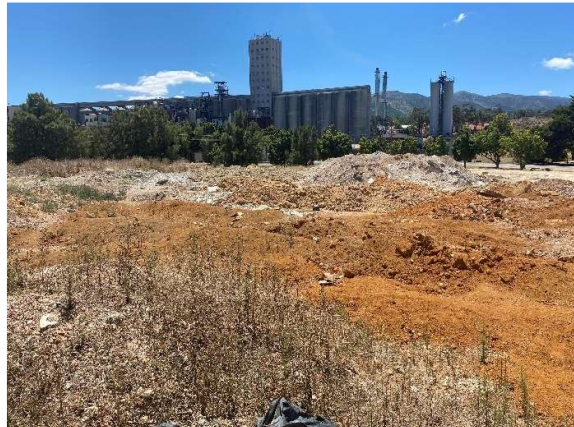
### Stockpile Area 1 on Hermanus Way

Stockpile area 1 is located immediately north of the site camp area off Hermanus Way. It is noted that this area has historically been utilized for material stockpiling of this nature.

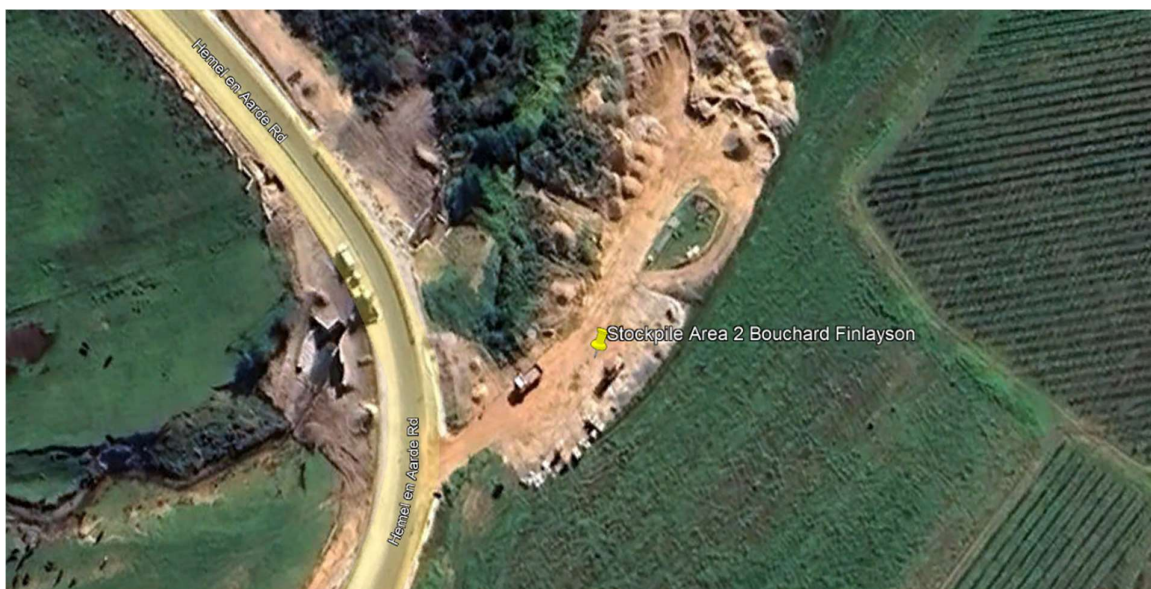
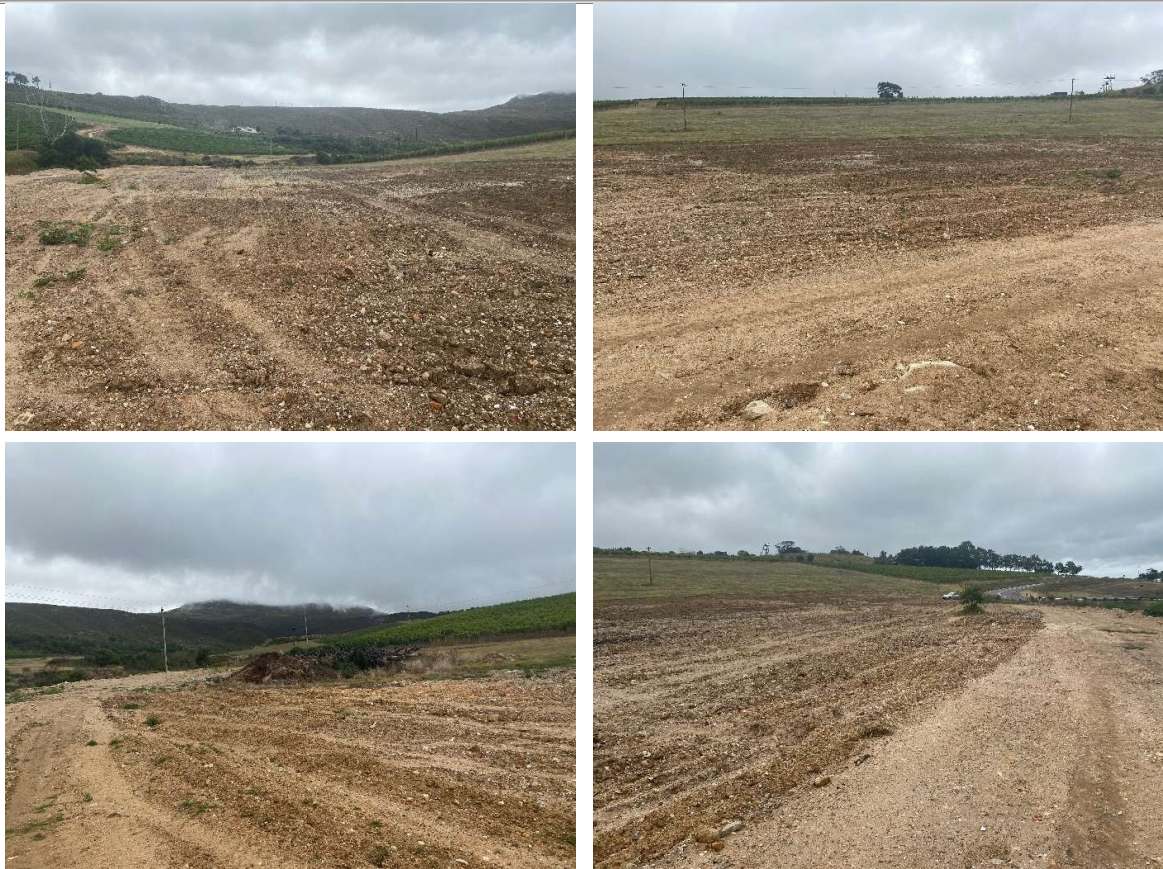
### Stockpile Area 2 at Culvert Km 5.67

Stockpile area 2 was located on existing agricultural fields along the Hemel and Aarde Road where the works were to be undertaken near the box culvert at Km 5.67. All stockpiled material has been removed, and the soil has been ripped as per the EMPr requirement.

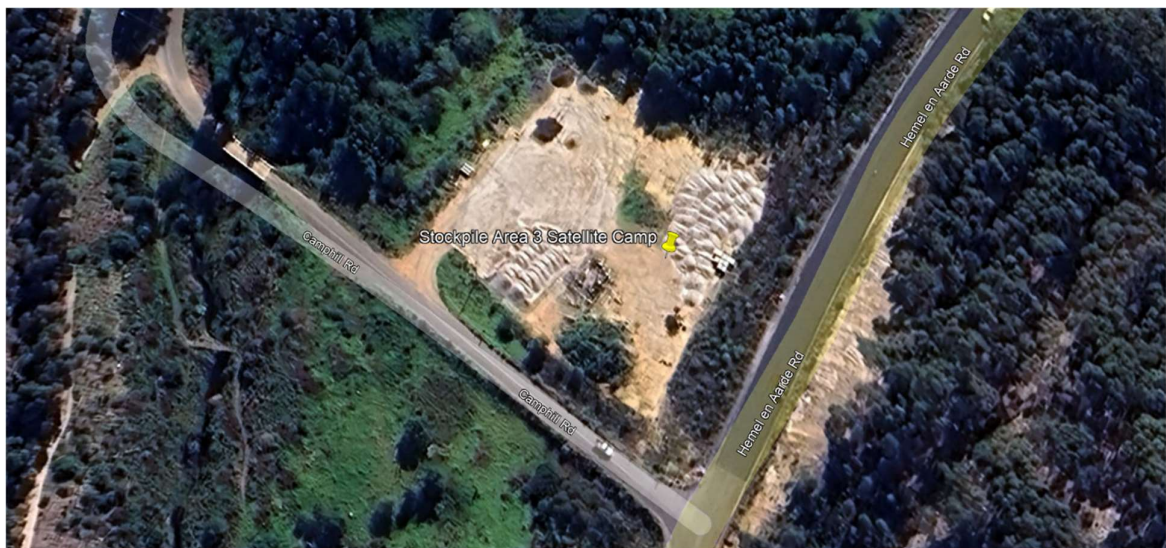
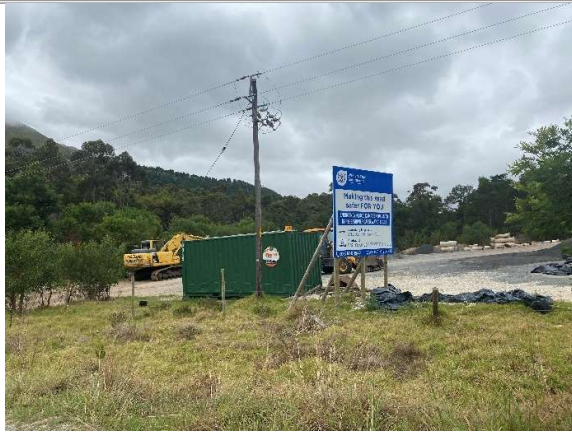
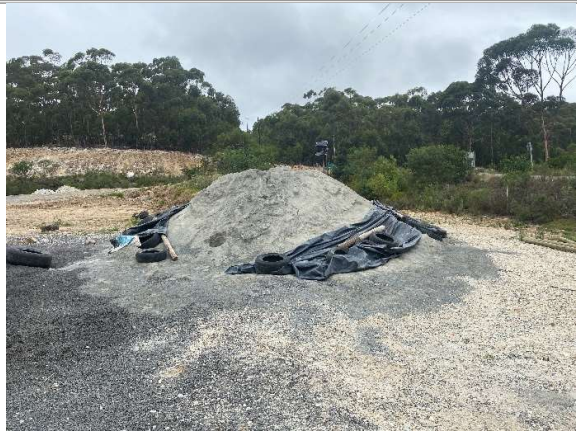
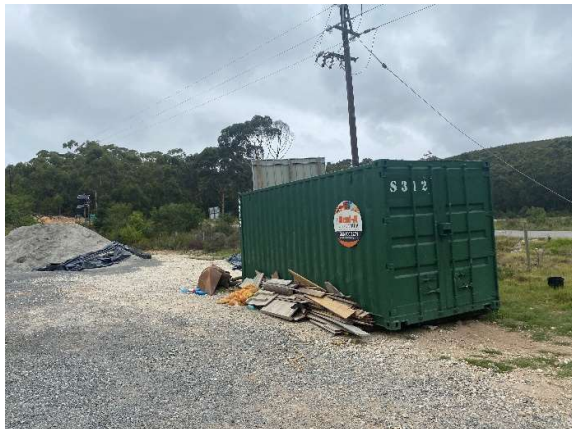
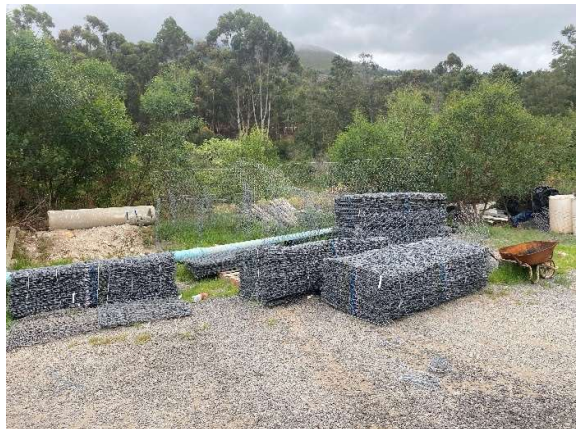
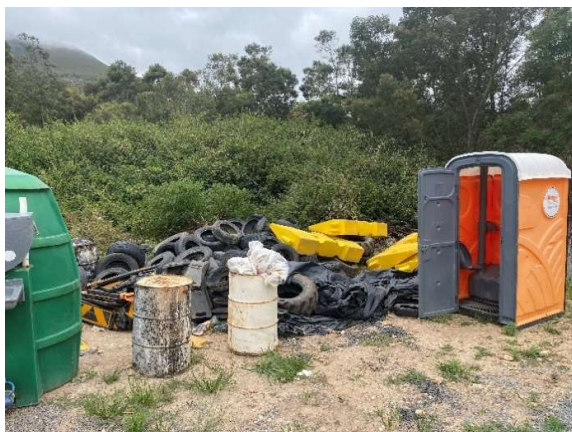
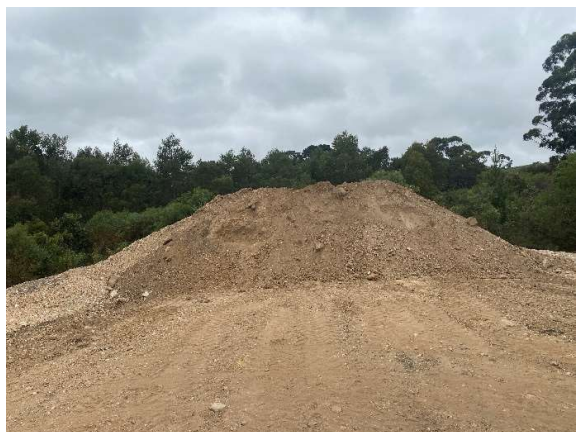
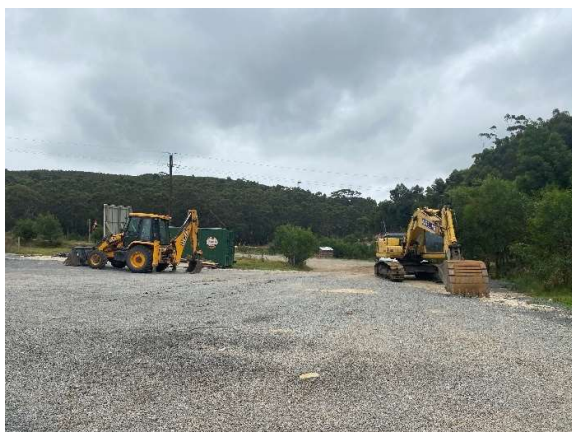
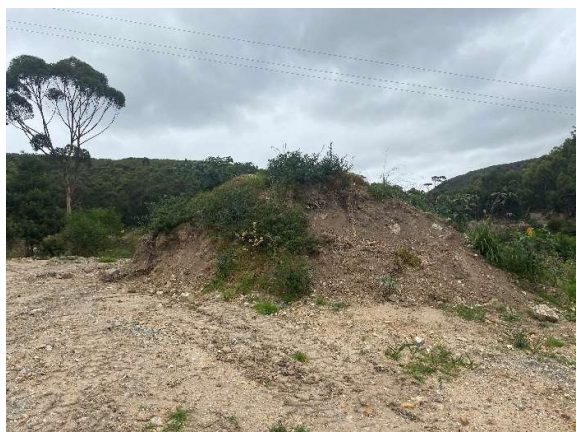
### **Stockpile and site camp Area 3 Satellite Camp**

This site was previously utilized as a stockpile and site camp area as part of the contract. The site is now again in use for this purpose as part of a concurrent contract for the emergency flood damage repairs to the Hartbees River causeway. Thus, the current status of this stockpile and site camp is no longer associated with this audit findings.

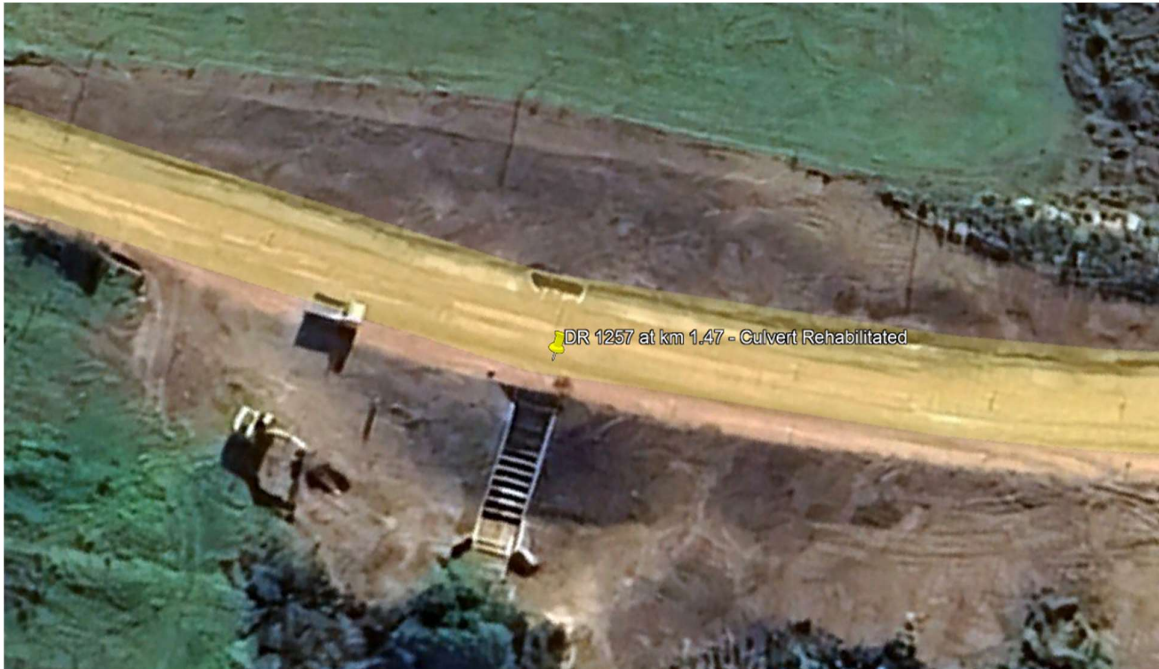
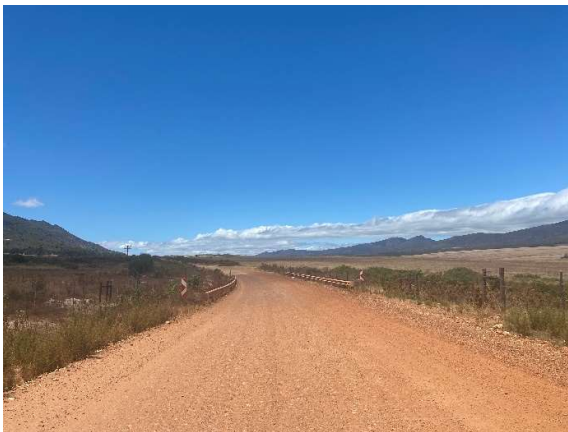
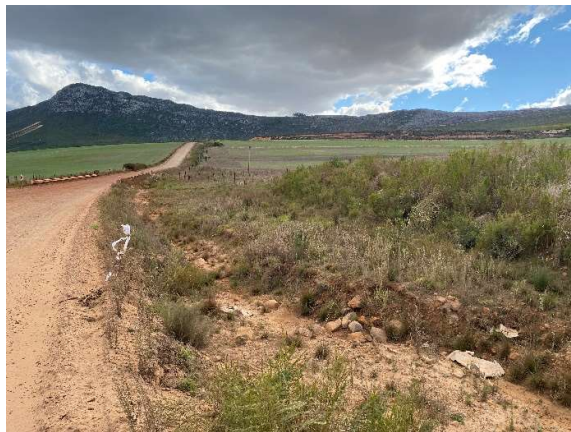
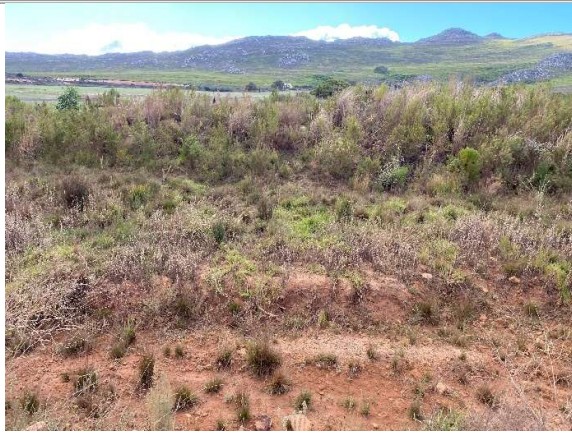
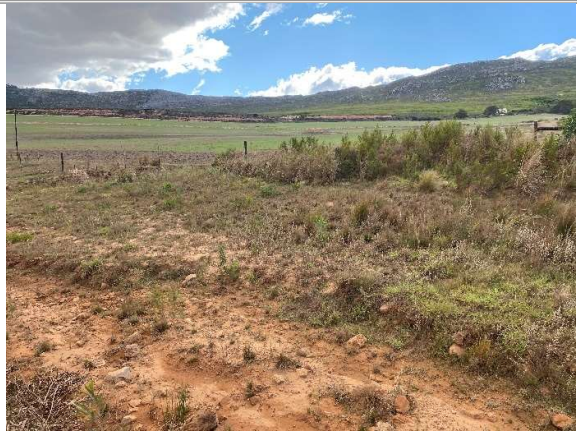
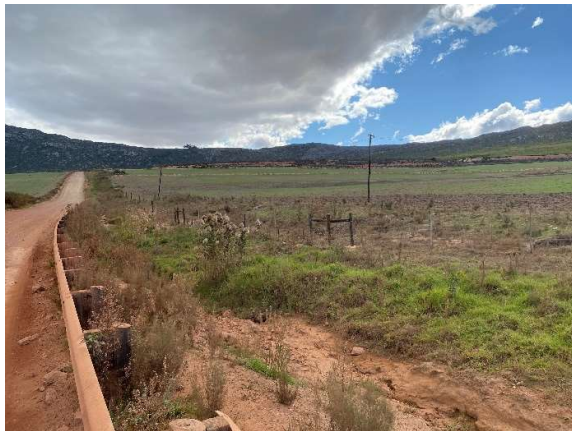
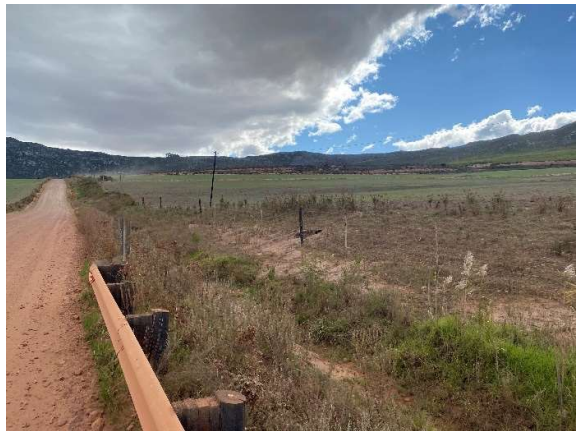
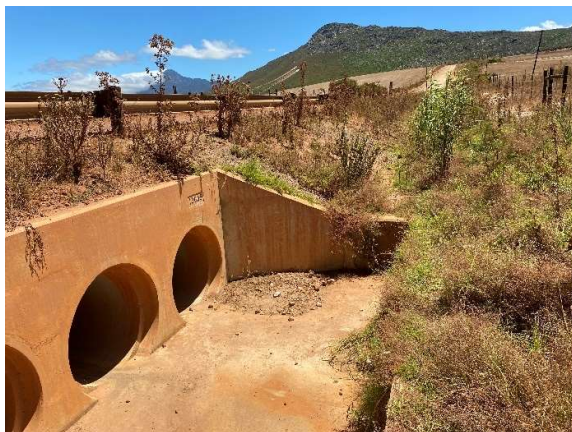
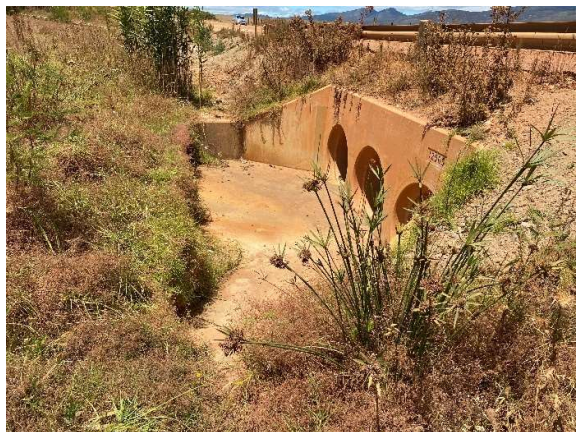
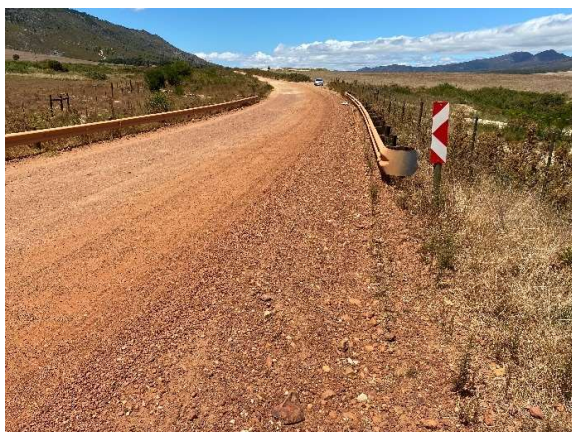
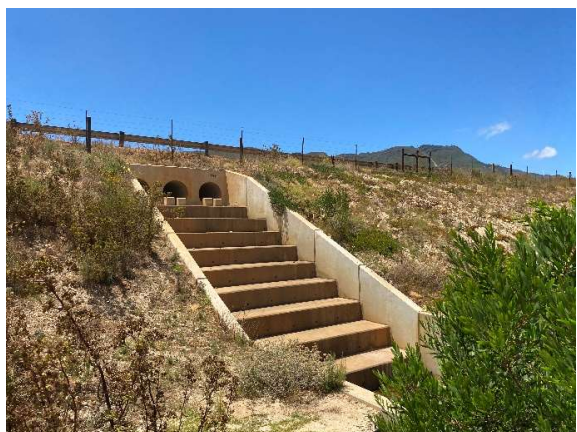
### **Culvert Upgrade and Rehabilitation at DR 1257 km 1.47**

The culvert along DR1257 has been upgraded with a temporary bypass created to accommodate traffic during the works. The three 600mm diameter pipe culverts which failed structurally have been replaced with three 1050mm diameter pipe culverts and a stepped concrete energy dissipating structure at the outlet to manage water flow and prevent erosion. Gabions were installed at the toe of the outlet structure to protect the embankment from erosion.

The culvert along the DR 1257 has been upgraded and the cleared surrounding area has been rehabilitated with indigenous natural vegetation. The three 600mm diameter pipe culverts that failed structurally have been replaced with three 1050mm diameter pipe culverts and a stepped concrete energy dissipating structure at the outlet to manage water flow and prevent erosion. Gabions were installed at the toe of the outlet structure to protect the embankment from erosion.

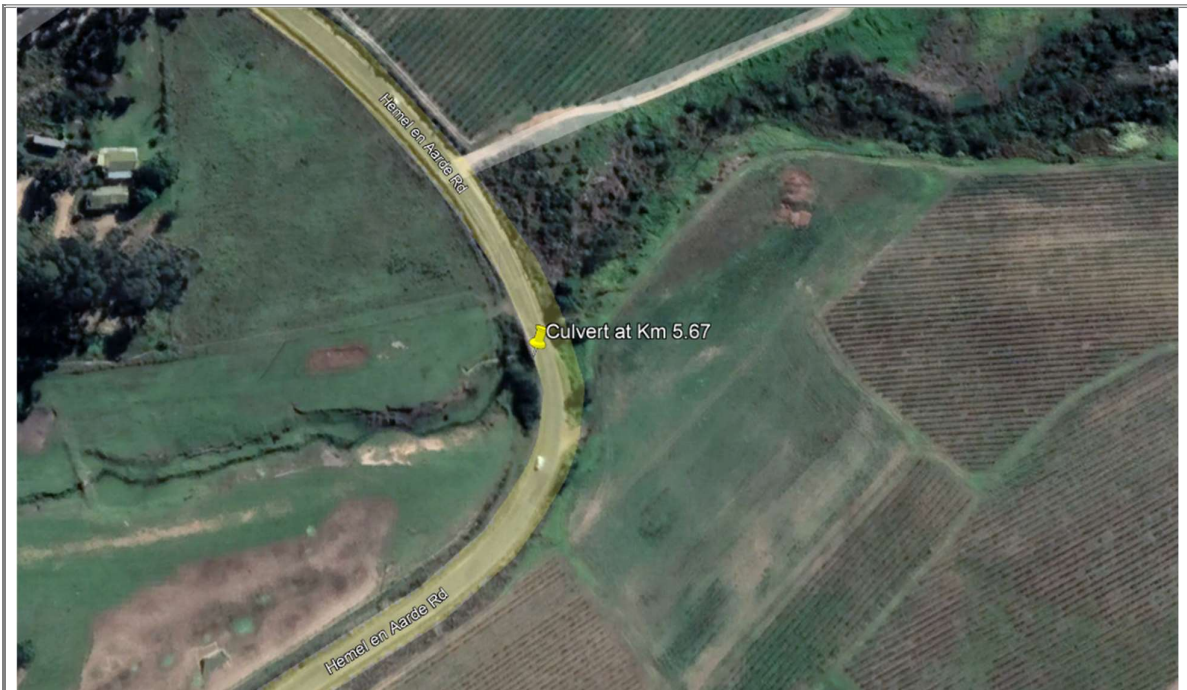
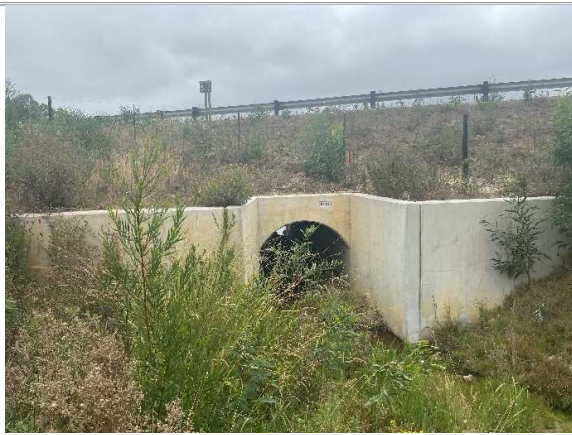
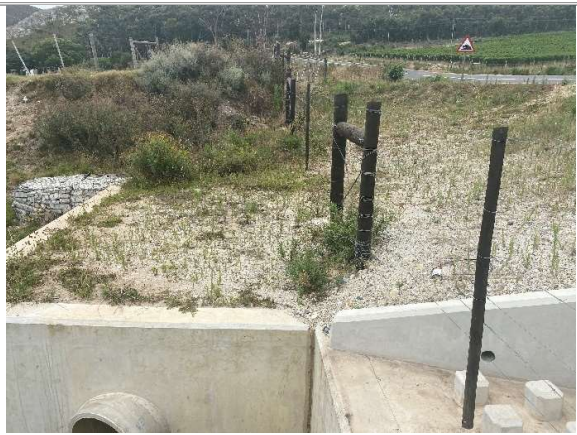
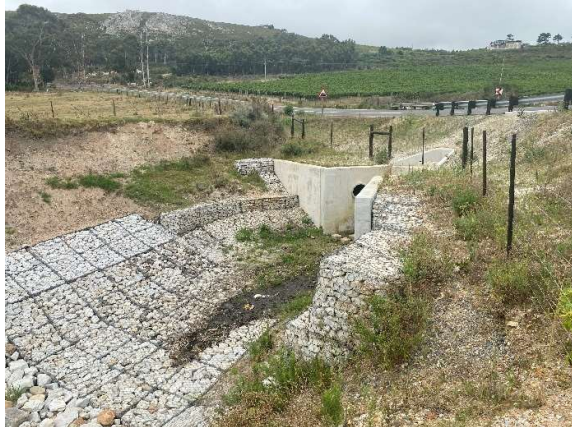
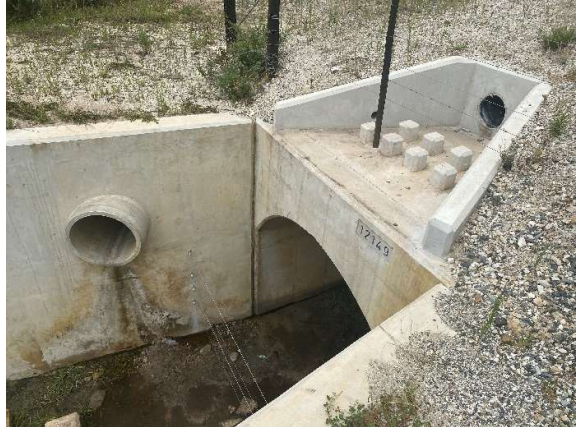
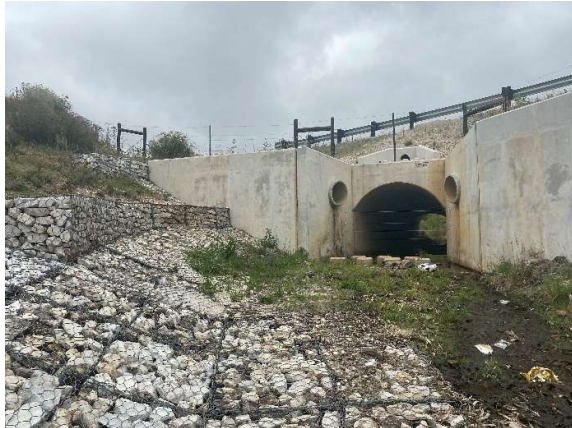
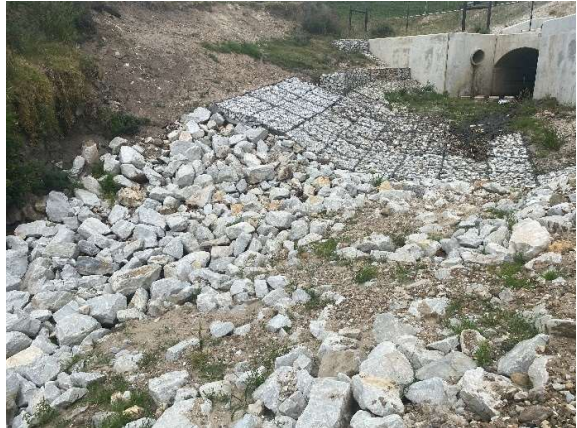
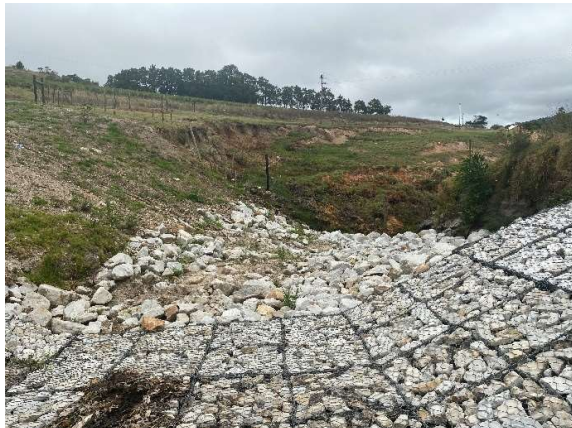
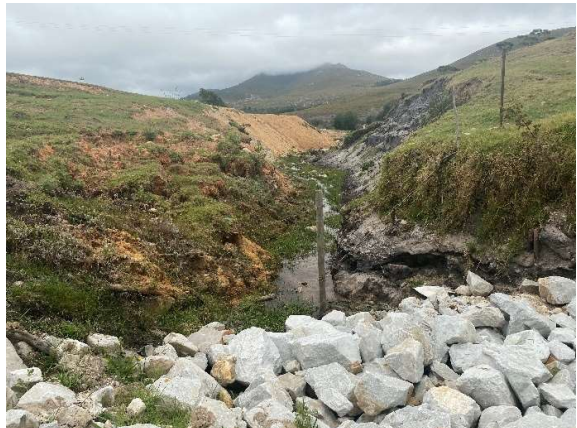
### **Culvert Upgrade at MR269 Km 5.67**

The culvert at Km 5.67 has been completed and the adjacent material stockpile has been removed and rehabilitated. The culvert has been extended, and guardrails have been installed at the culvert opening for enhanced road safety. Extensive gabion work has been completed both along the eastern and western road shoulders and at the inlets/outlets to stabilize the embankments and prevent flood-related erosion.

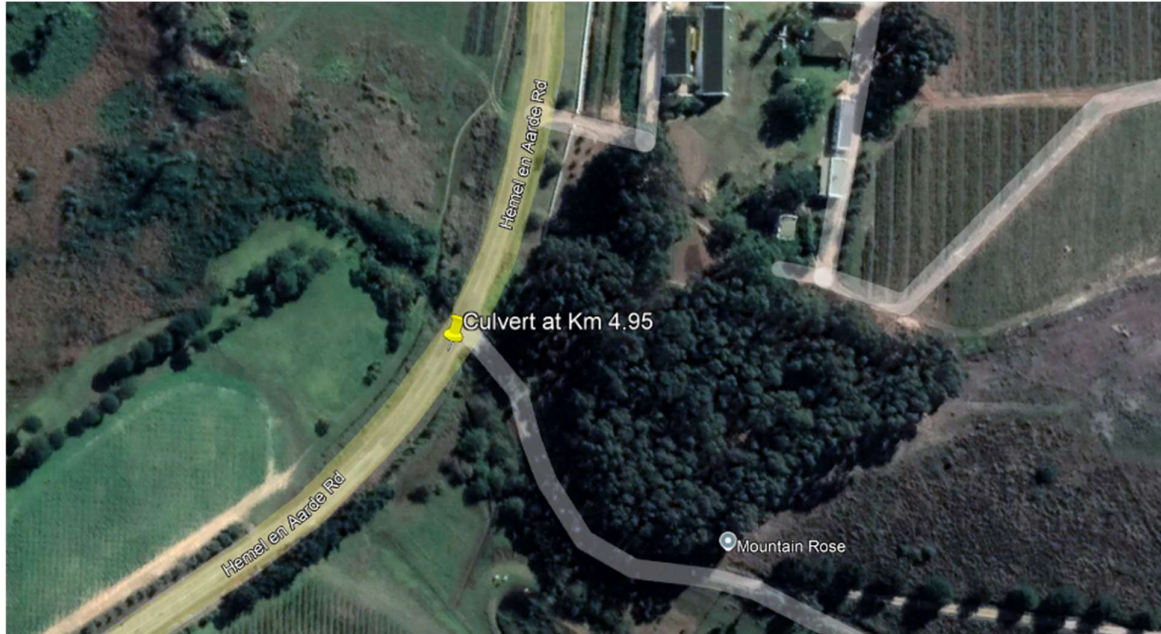
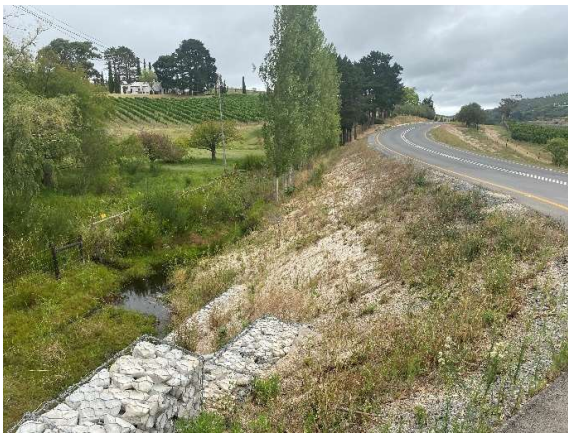
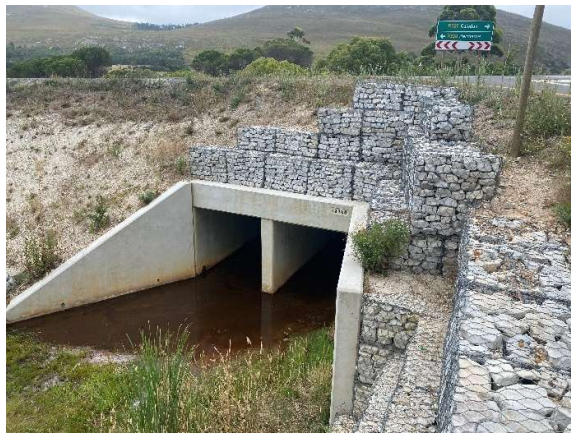
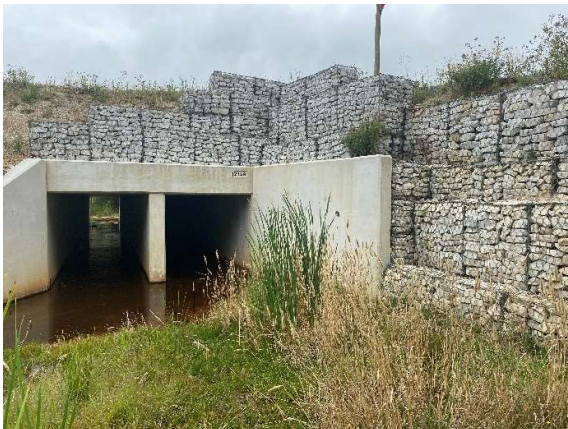
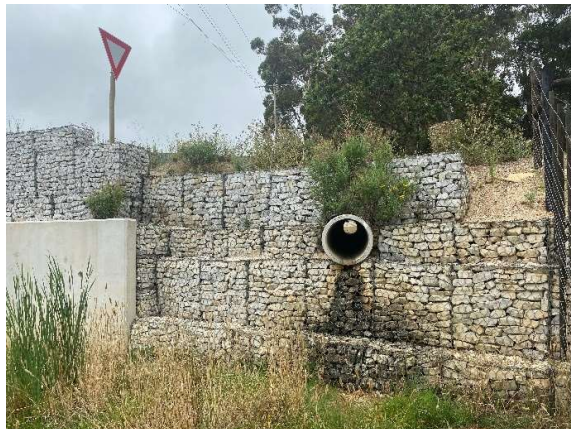
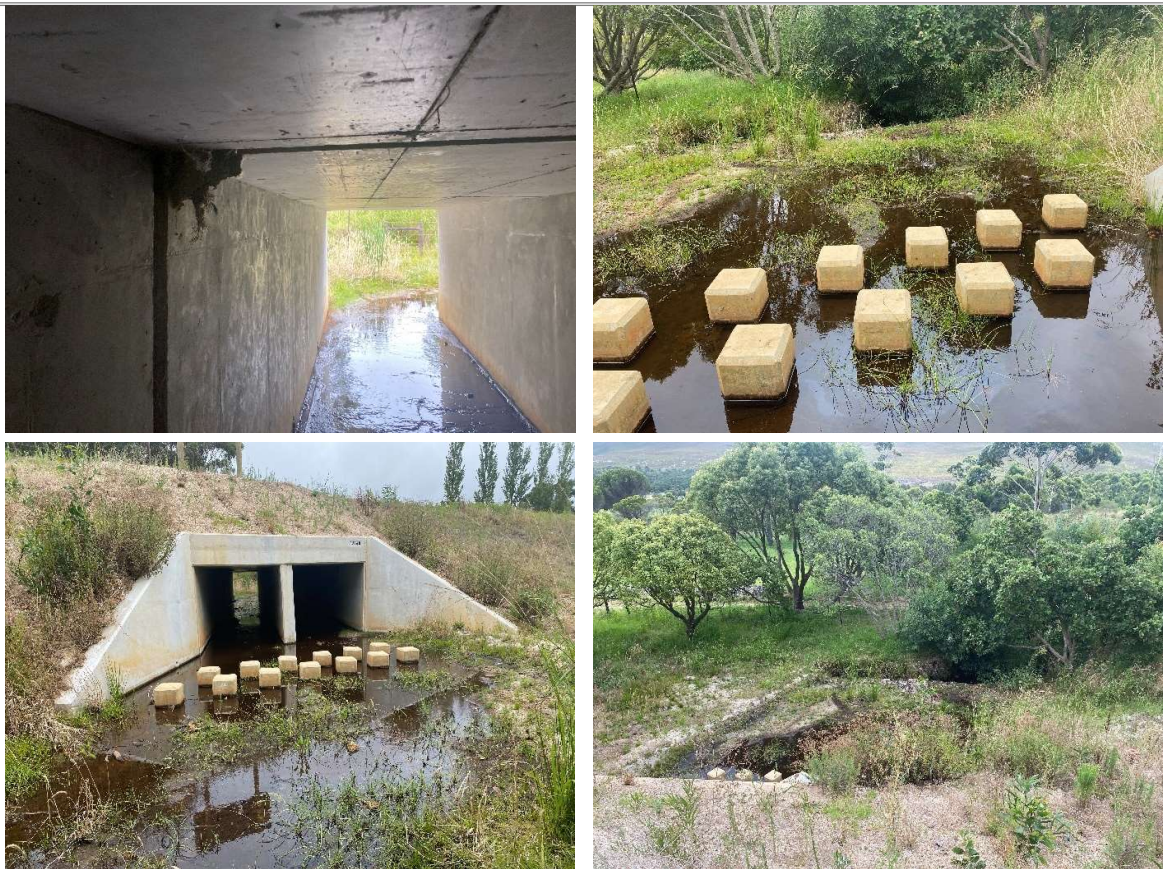
### Culvert Upgrade at MR269 Km 4.95

The culvert at Km 4.95 on the Hemel and Aarde road has been upgraded, and the areas shaped to allow for natural stormwater flows. Two 900mm diameter pipe culverts have been replaced with two new 1800mm x 1800mm box culverts with reinforced inlet and outlet structures. Gabions were installed at both ends to safeguard against flood erosion and embankment degradation.

The culvert at Km 4.95 on the Hemel en Aarde road has been upgraded, and the areas shaped to allow for natural stormwater flows. Two 900mm diameter pipe culverts have been replaced with two new 1800mm x 1800mm box culverts with reinforced inlet and outlet structures. Gabions were installed at both ends to safeguard against flood erosion and embankment degradation.

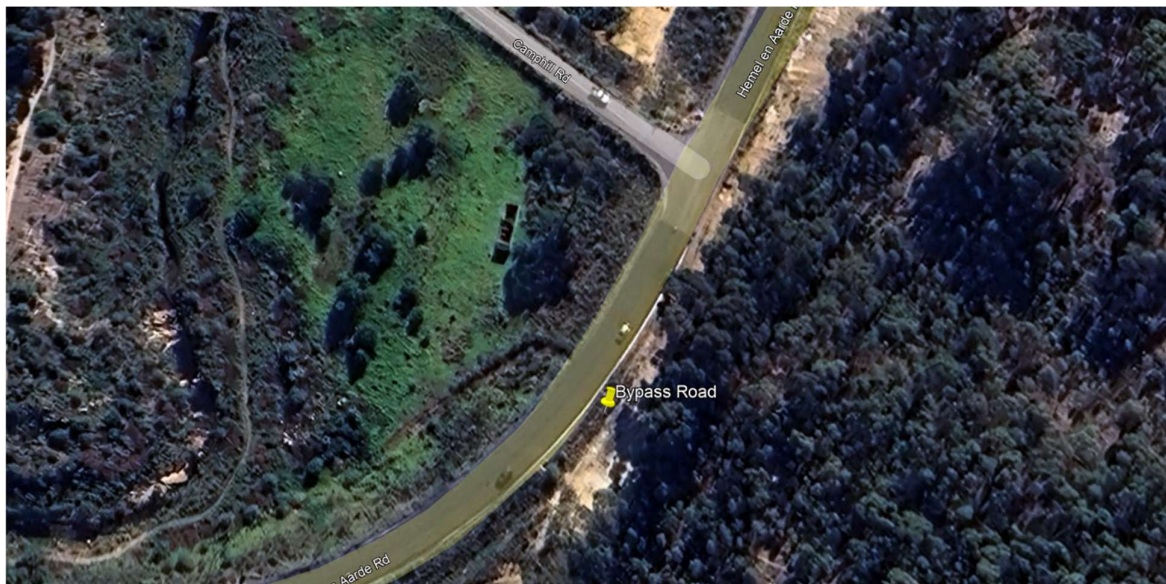
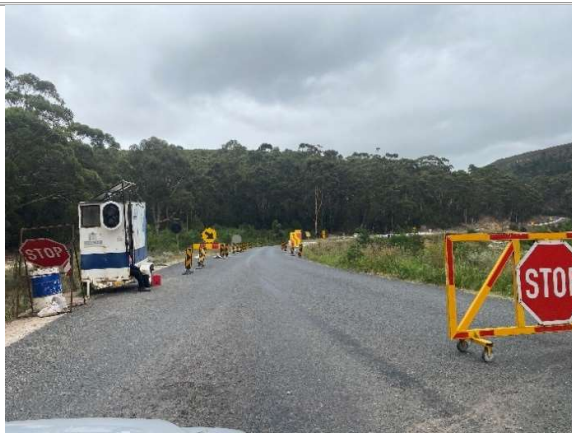
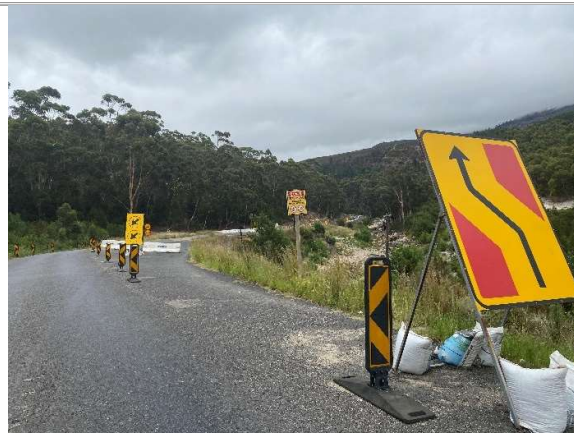
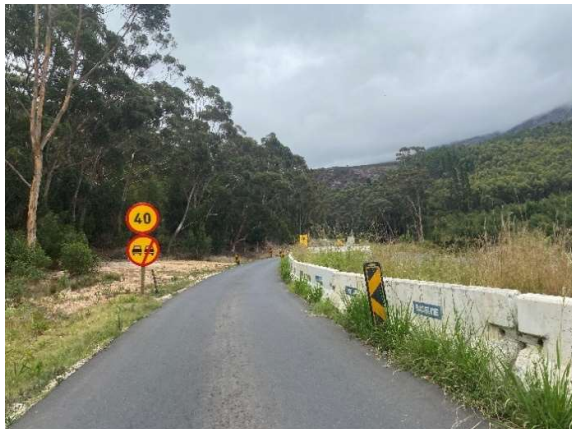
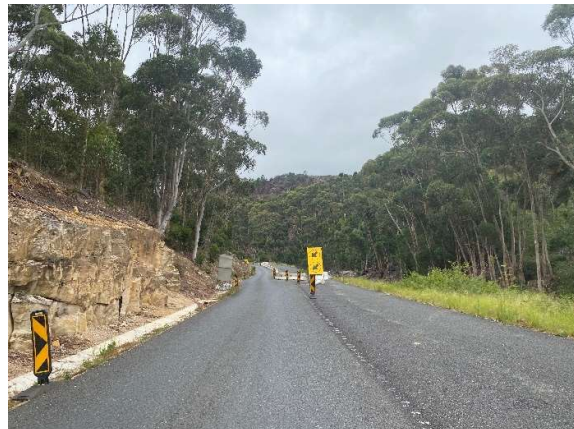
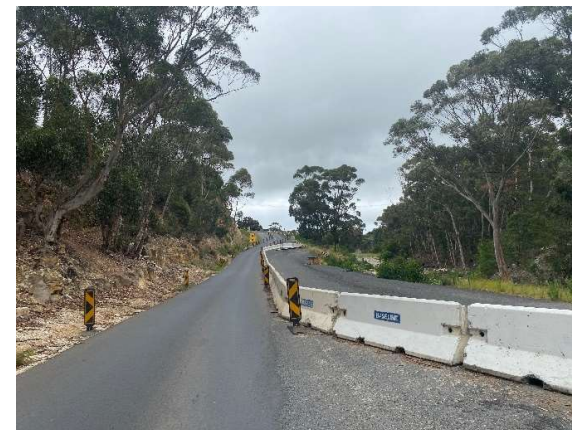
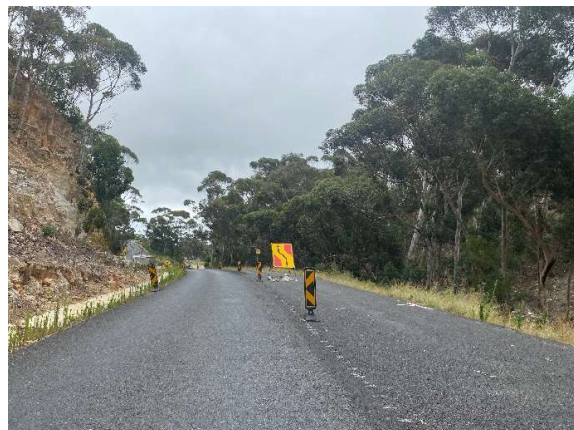
### **Bypass Road**

Due to flood damage from the Hartbees river along the shoulder of the road, a temporary bypass measure has been put in place and only the southern lane of the MR269 is operational at this stage until the flood damage has been reconstructed as part of a concurrent separate contract.

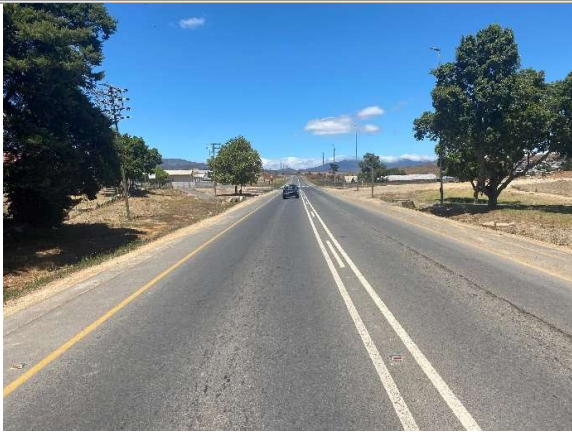
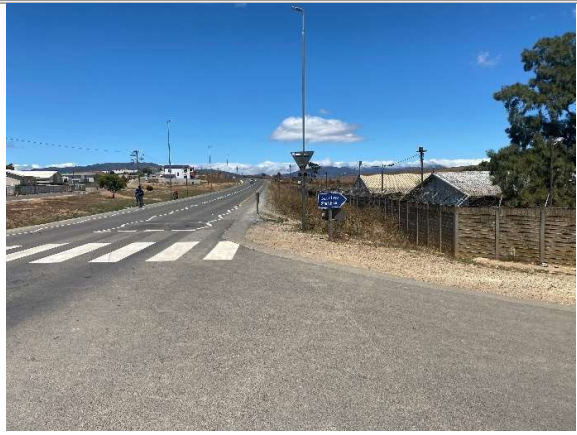
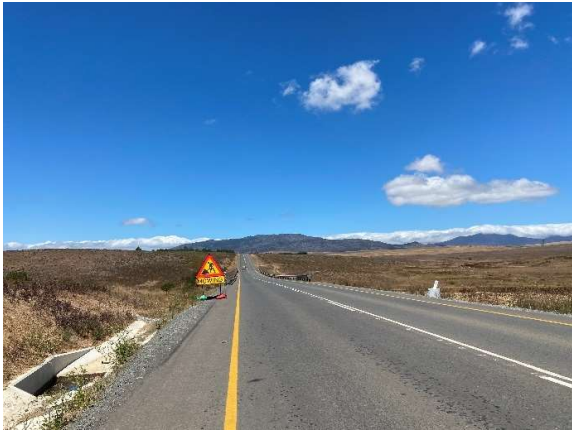
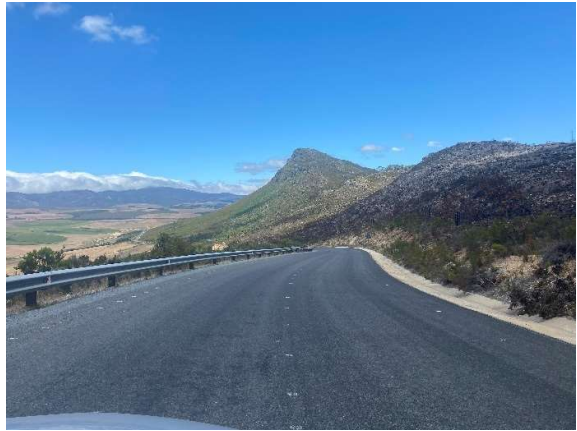
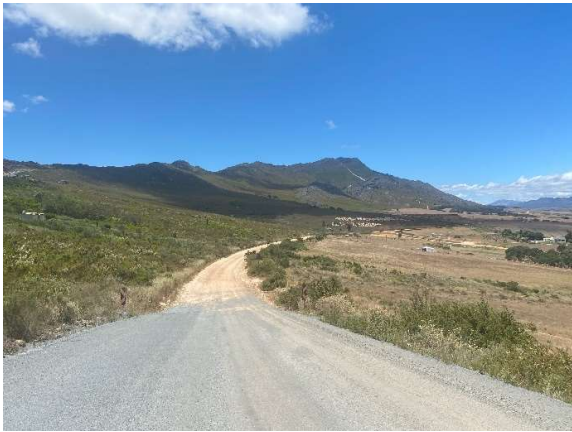
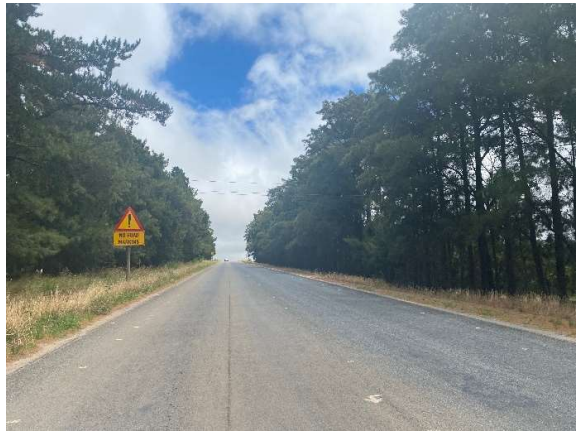
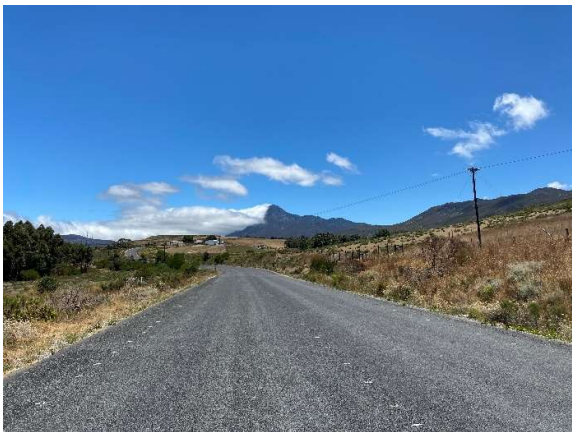
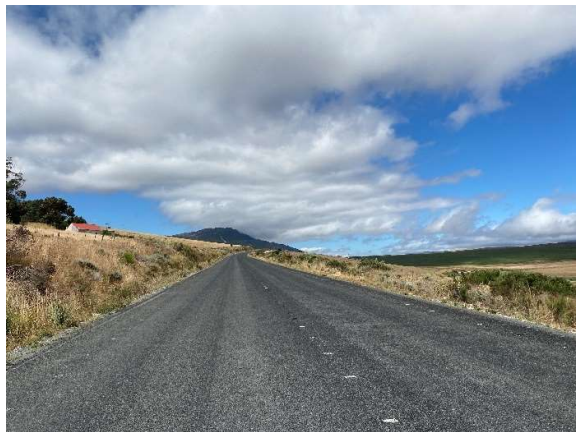
### Roadway Conditions

The road surface upgrades have all been completed at the time of audit. The only road section to be completed include the section of the road where the bypass road have been utilized and forms part of a separate contract. At some sections of the road the new road markings are yet to be painted.

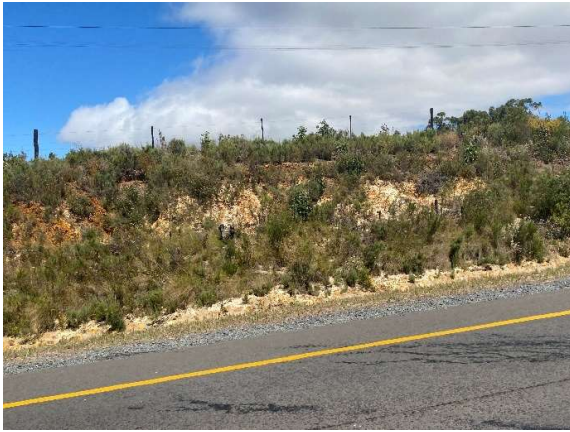
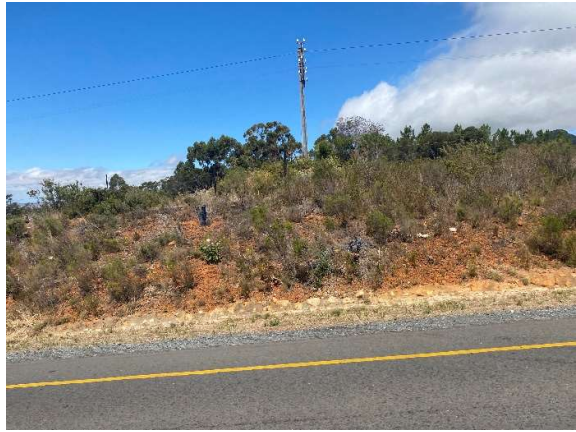
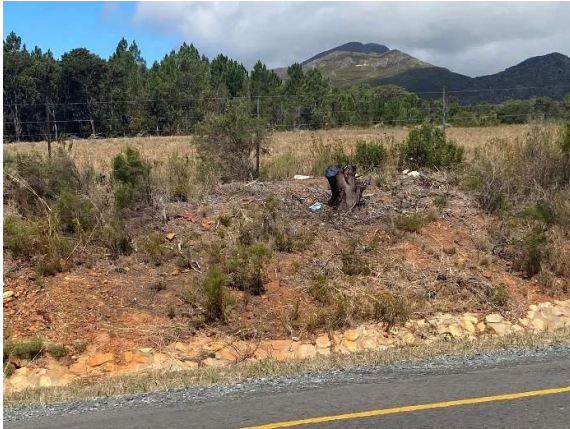
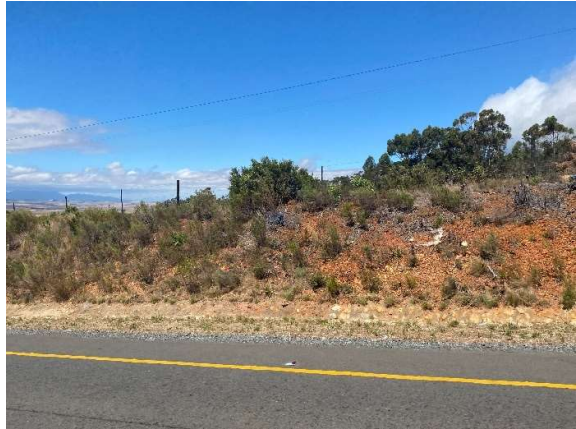
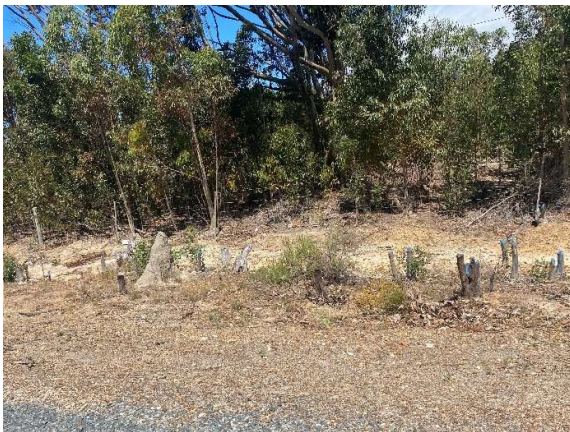
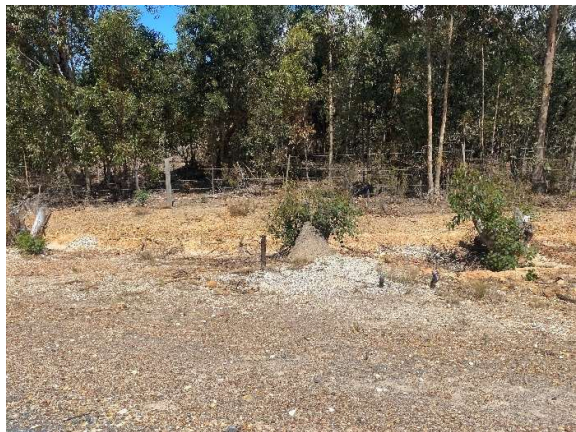
### **Invasive Tree removal**

It was noted during the audit that along several stretches of the road reserve that alien tree clearing has been undertaken. Trees have been felled, and the stumps were treated to prevent regrowth (blue).

It was noted during the audit that along several stretches of the road reserve that alien tree clearing has been undertaken. Trees have been felled and the stumps were treated to prevent regrowth (blue).
