## APPENDIX A – SITE PHOTOGRAPHS

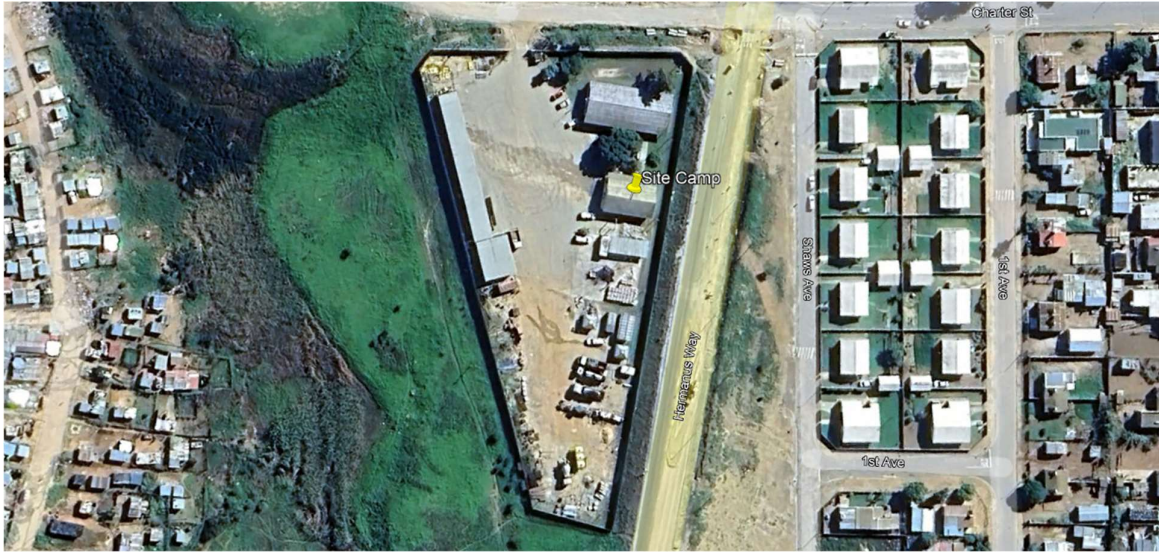
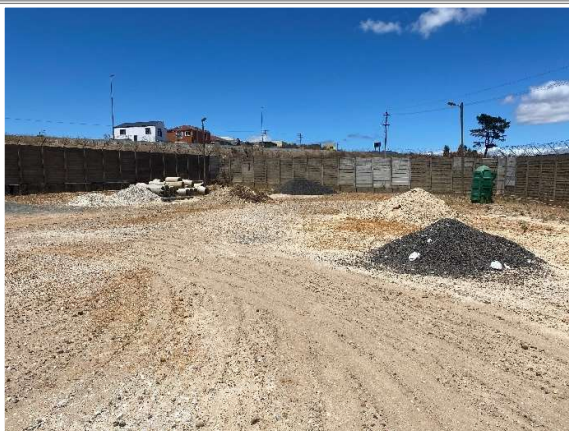
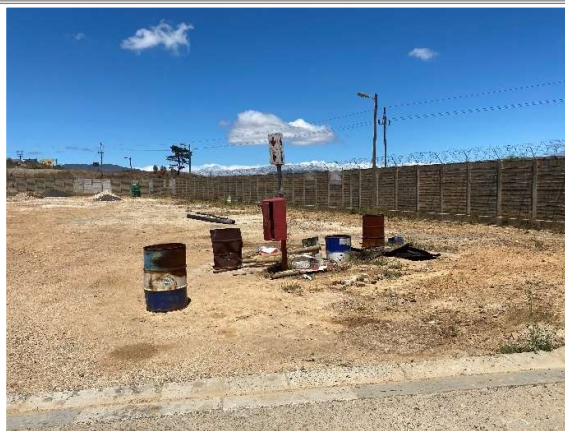
### Site Camp

The Site Camp is located off Hermanus Way at the northern end of the contract in Caledon. The site camp comprises an existing PGWC facility which includes storage areas and offices with all the required infrastructure permanently in place.

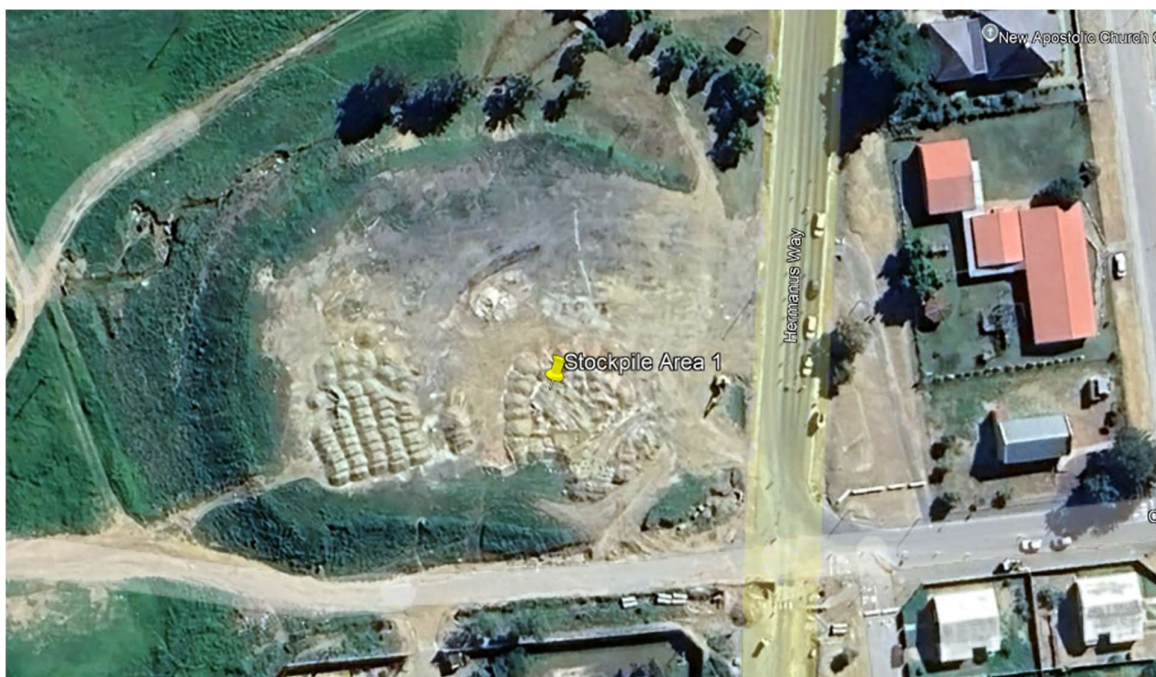
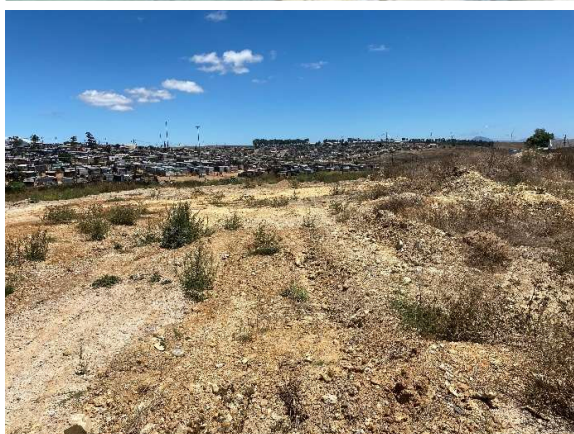
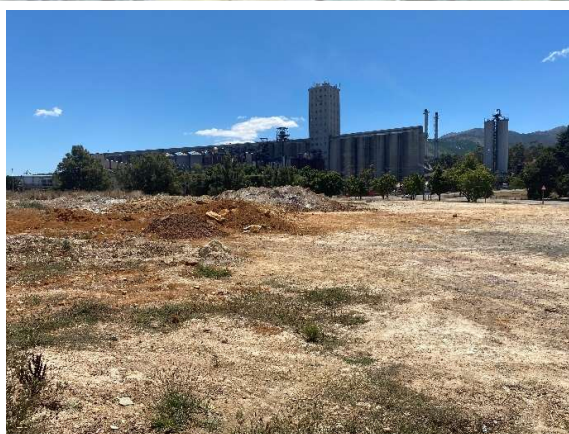
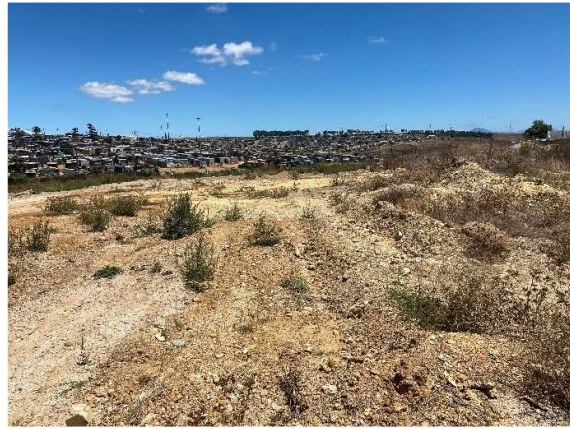
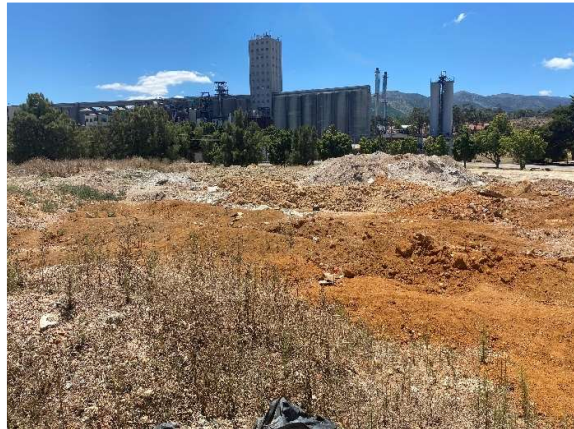
### Stockpile Area 1 on Hermanus Way

Stockpile area 1 is located immediately north of the site camp area off Hermanus Way. It is noted that this area has historically been utilized for material stockpiling of this nature.

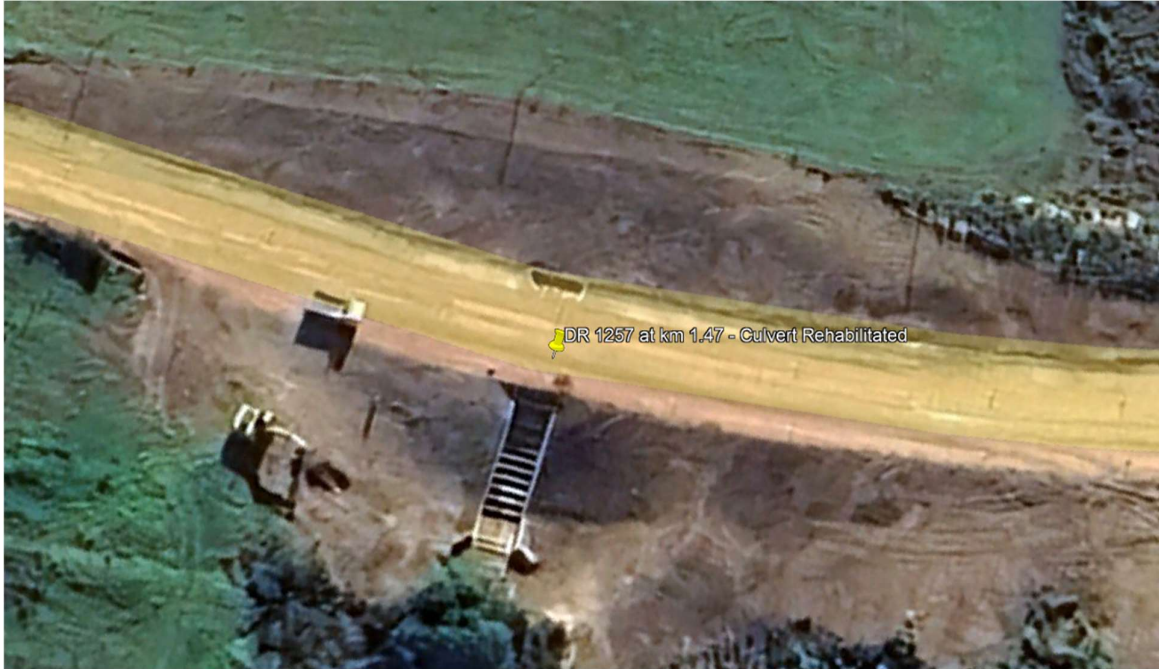
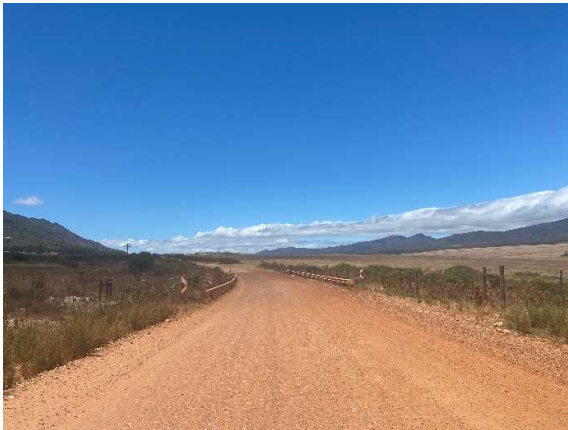
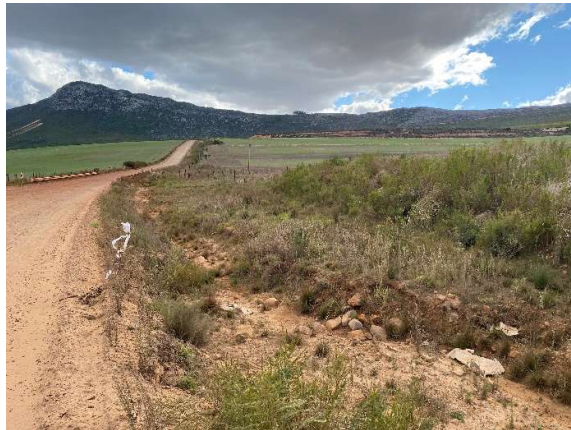
### **Culvert Upgrade and Rehabilitation at DR 1257 km 1.47**

The culvert along the DR 1257 has been upgraded and the cleared surrounding area has been rehabilitated with indigenous natural vegetation. The three 600mm diameter pipe culverts that failed structurally have been replaced with three 1050mm diameter pipe culverts and a stepped concrete energy dissipating structure at the outlet to manage water flow and prevent erosion. Gabions were installed at the toe of the outlet structure to protect the embankment from erosion.

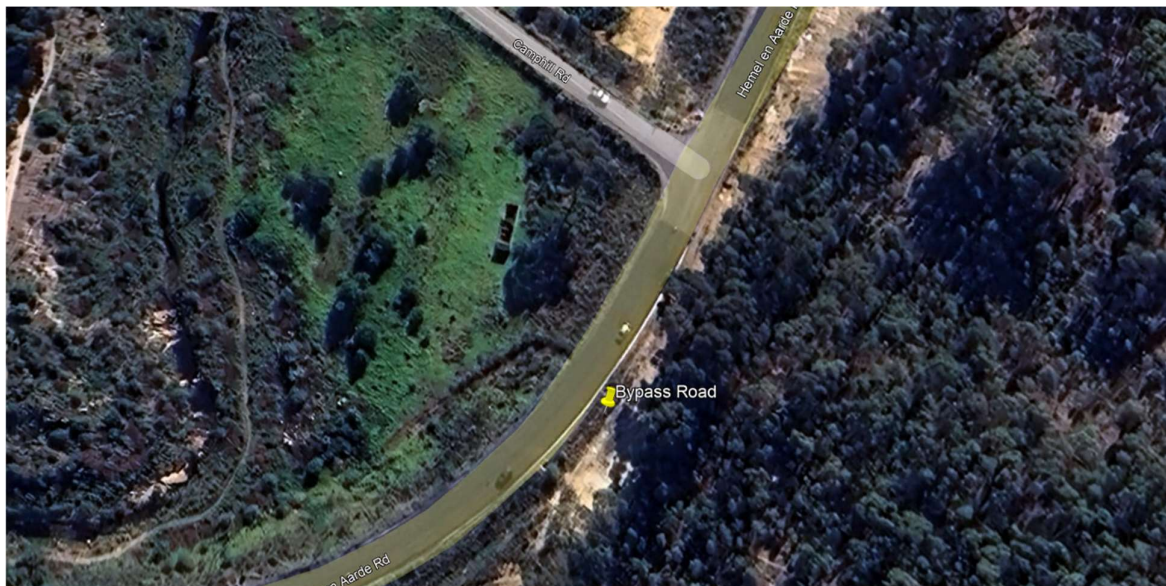
### Bypass Road

Due to flood damage from the Hartbees river along the shoulder of the road, a temporary bypass measure has been put in place and only the southern lane of the MR269 is operational at this stage until the flood damage has been reconstructed as part of a concurrent separate contract.
