## ANNEXURE A – SITE PHOTOGRAPHS

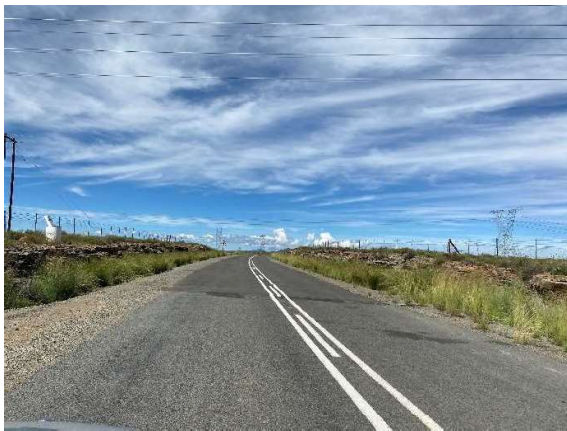
Northern end of the contract on the provincial border showing the upgraded road surface.

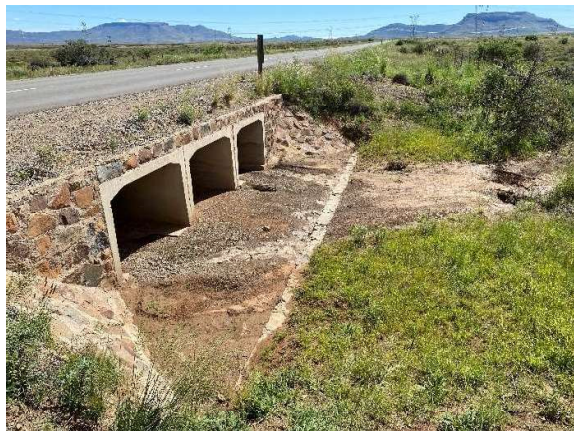
Culverts upgraded with new concrete structures, erosion control, and clearing of vegetation along TR 16/8.

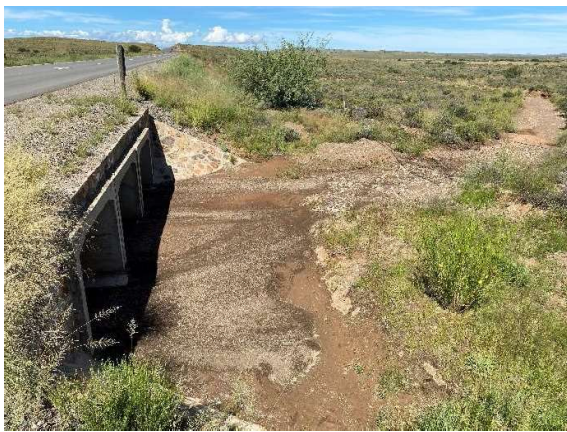
Culverts upgraded with new concrete structures, erosion control, and clearing of vegetation along TR 16/8.

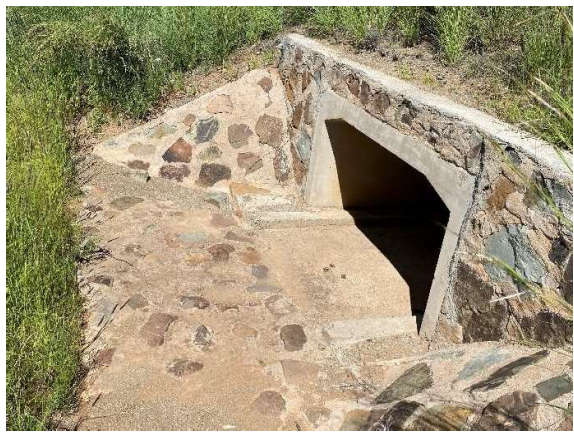
Culverts upgraded with new concrete stone pitch structures, , and clearing of vegetation along TR 16/8.

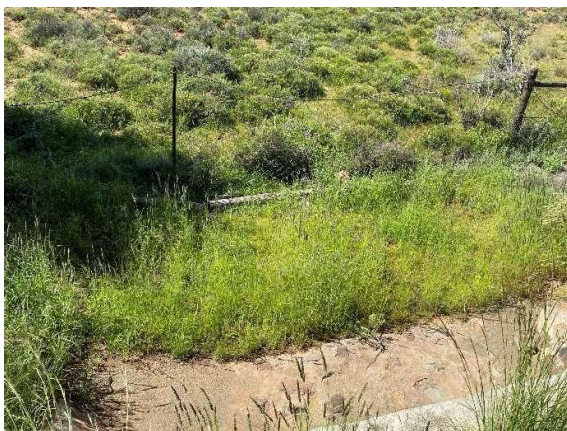
Culverts upgraded with new concrete stone pitch structures, and clearing of vegetation along TR 16/8.

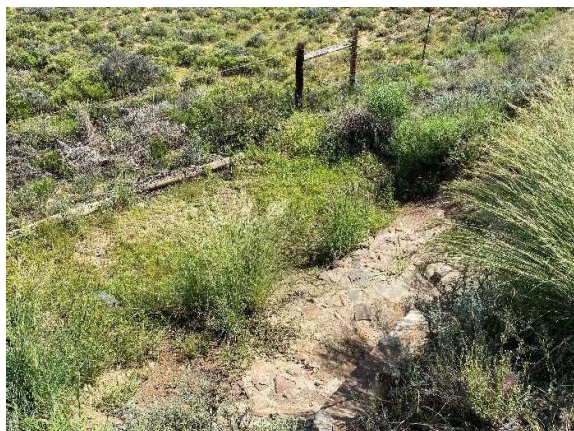
Culverts upgraded with new concrete stone pitch structures, and clearing of vegetation along TR 16/8.

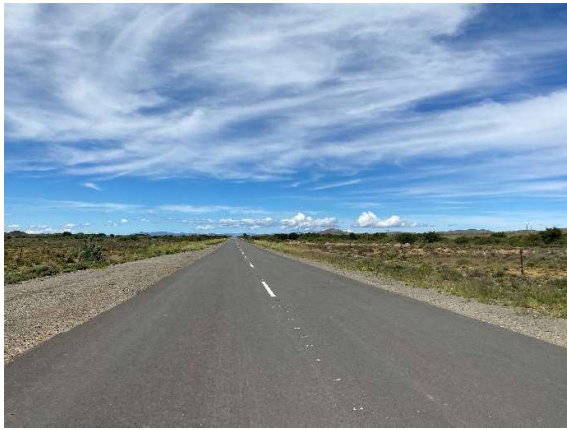
Condition of the completed road surface and road reserve along the TR 16/8.

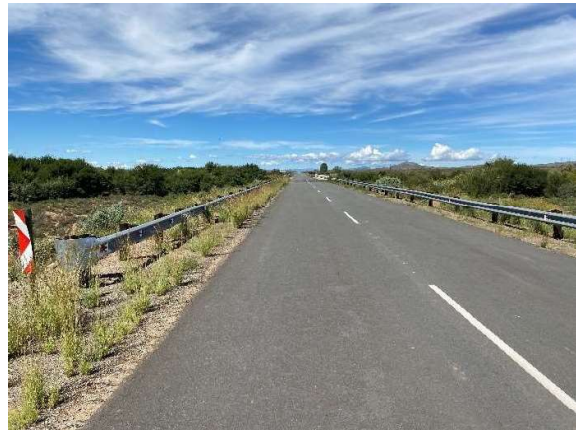
Condition of the completed road surface and road reserve along the TR 16/8 along with the guardrailings.

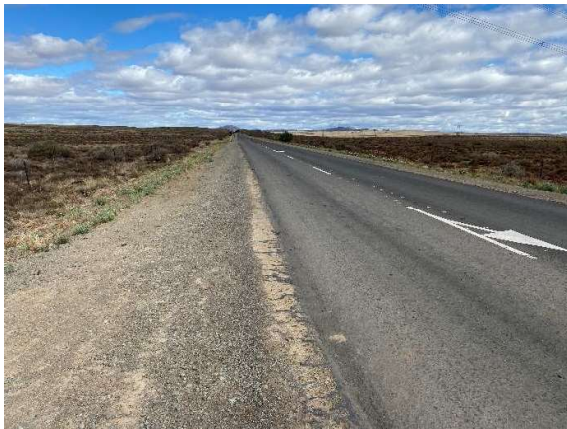
Condition of the completed road surface and road reserve along the TR 16/8.

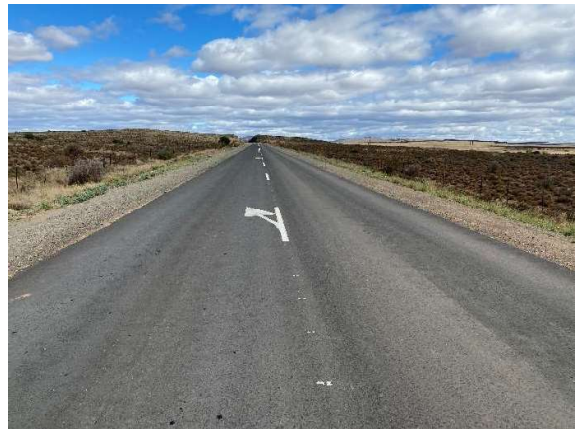
Condition of the completed road surface and road reserve along the TR 16/8.

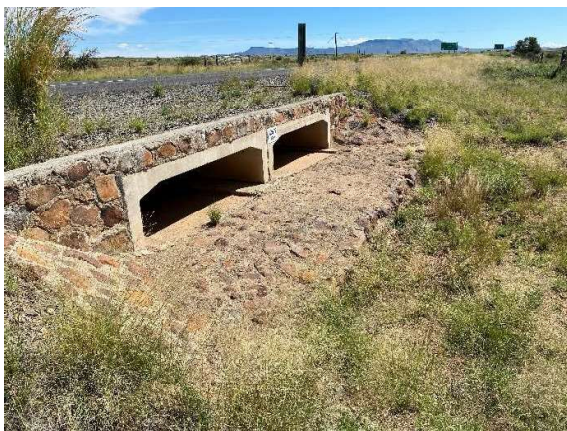
Upgraded culvert on TR 16/8 with repaired concrete and stone-pitching, daylighting and vegetation clearance.

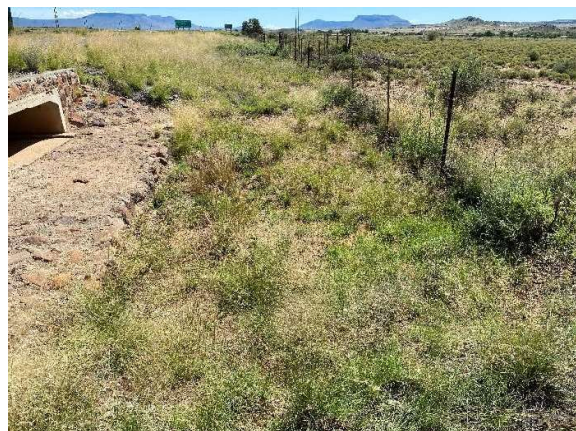
Condition of vegetation surrounding the upgraded culverts.

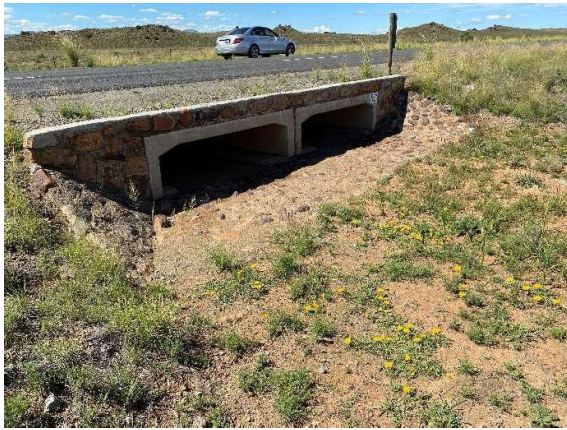
Culvert upgrading includes repaired concrete structures, stone-pitching, erosion control, and vegetation clearing.

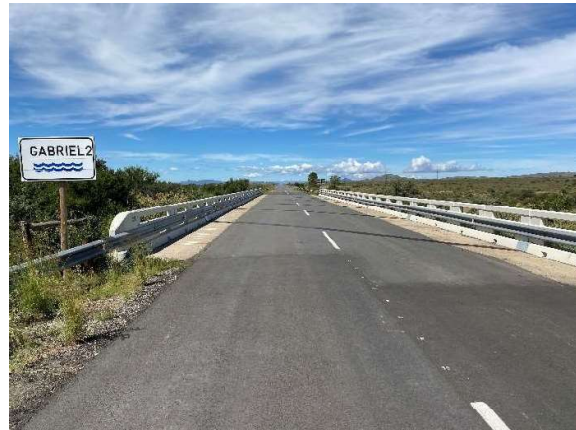
Newly installed guardrails at B4611 on TR16/8 at Km 46.11 (Gabriel Stream).

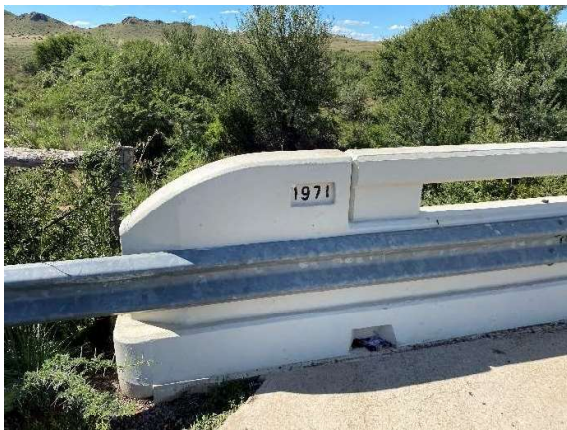
Newly installed guardrails at B4611: TR16/8 at Km 46.11 (Gabriel Stream).

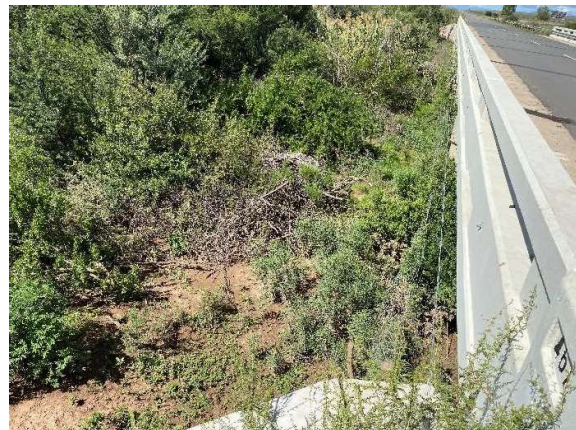
Bridge deck resealed, joints installed, with concrete and pier repairs. Condition of riverbed with spills removed.

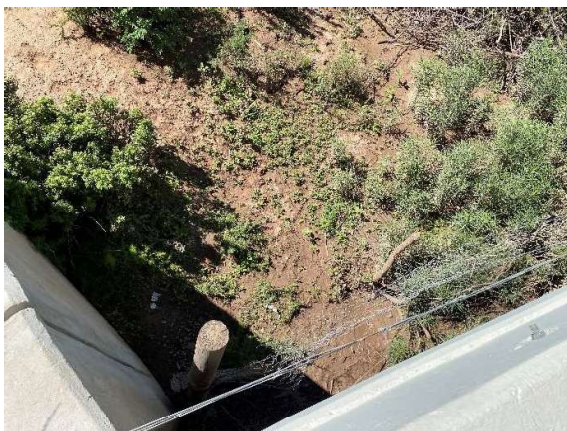
Condition of Gabriel Riverbed with newly installed wire fencing for debris.

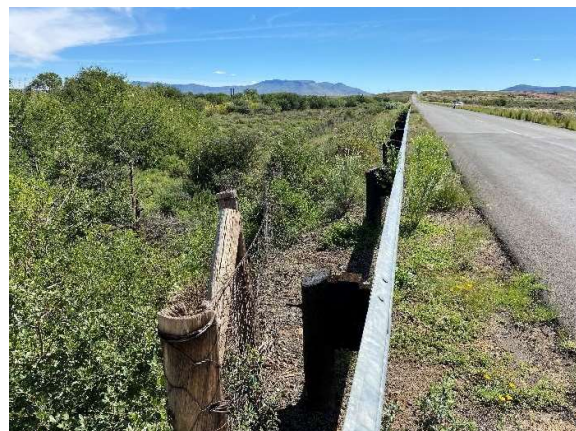
Condition of Gabriel River with newly installed wire fencing for debris.

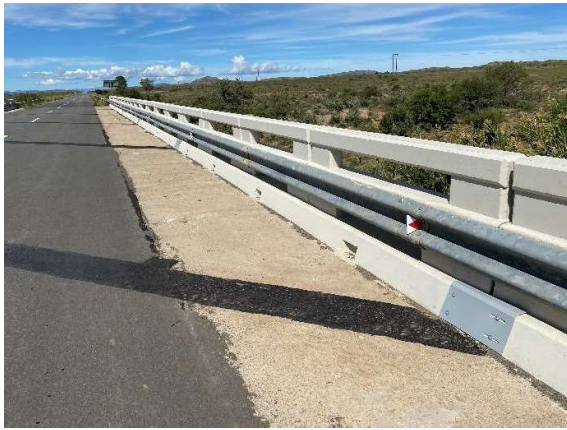
Bridge deck resealed, joints installed, with concrete and pier repairs.

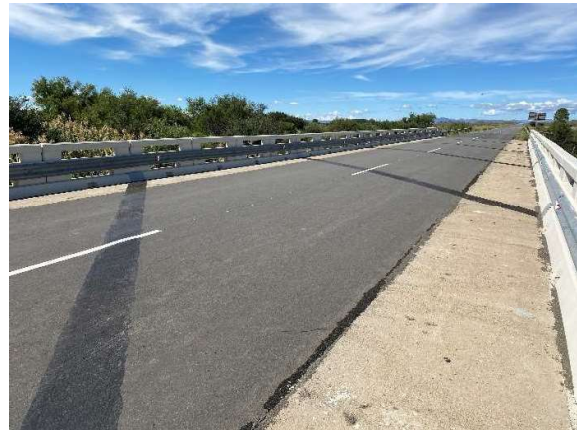
Bridge deck resealed, joints installed, with concrete and pier repairs.

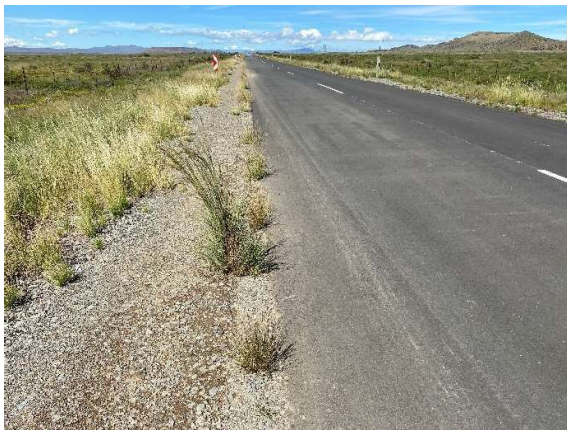
Condition of the road reserve on TR 16/9.

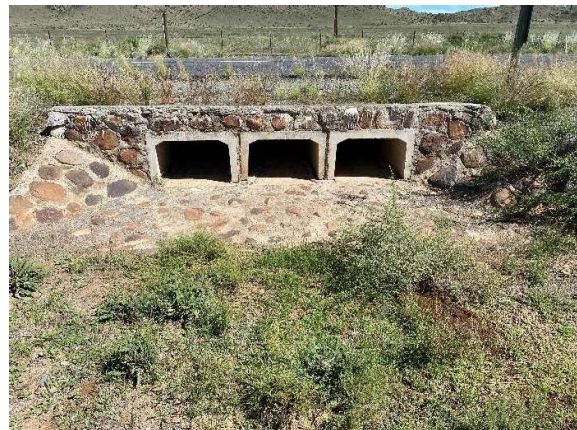
Culvert upgrading includes repaired concrete structures, stone-pitching, erosion control, and vegetation clearing.

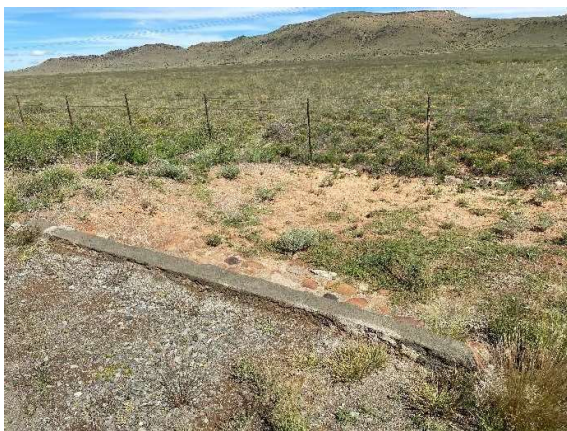
Culvert upgrading includes repaired concrete structures, stone-pitching, erosion control, and vegetation clearing.

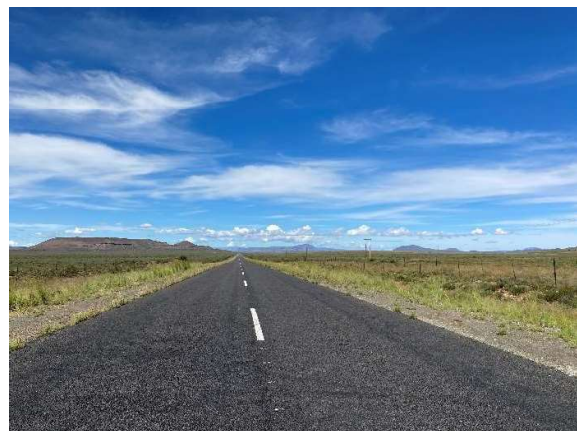
Condition of the road surface on TR 16/9.

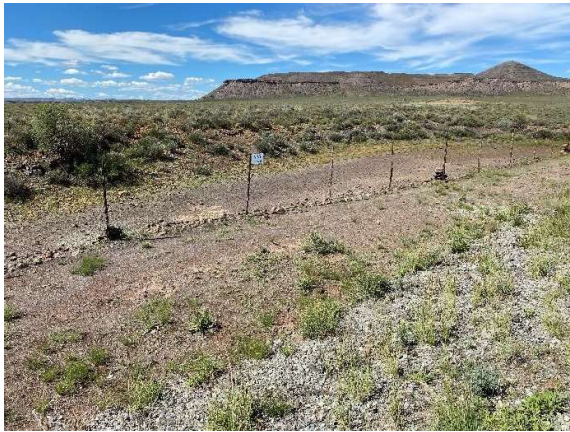
Condition of the road reserve along the TR 16/9 as seen towards the northwest.

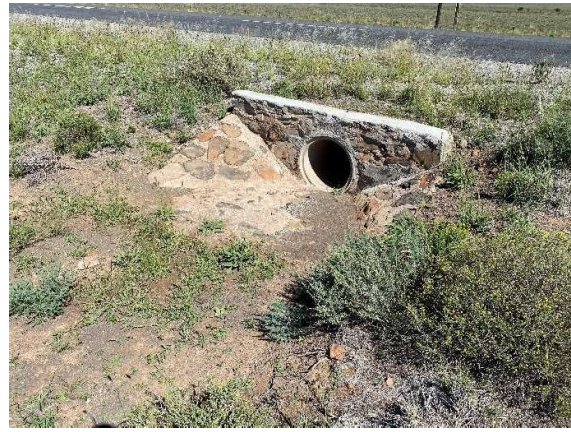
Culvert upgrading includes repaired concrete structures, stone-pitching, erosion control, and vegetation clearing.

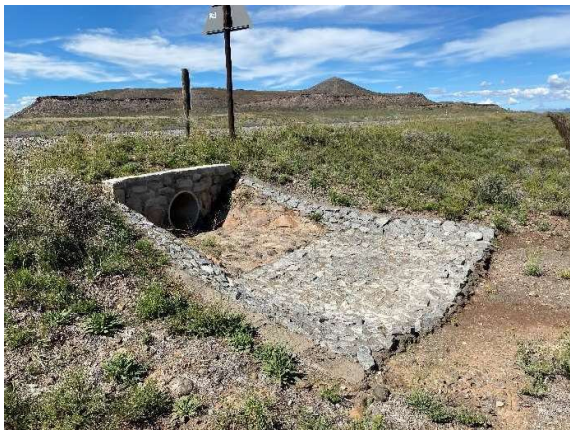
Culvert upgrading includes repaired concrete structures, stone-pitching, erosion control, and vegetation clearing.

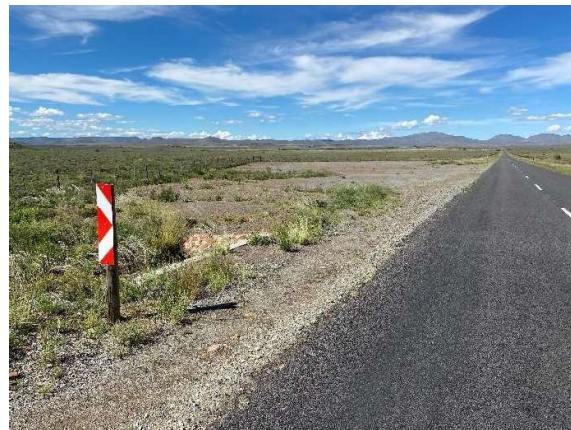
Condition of the road surface and road reserve along the TR 16/9 as seen towards the southeast.

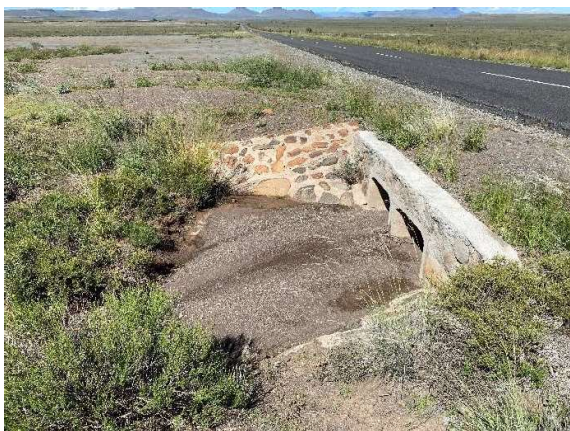
Culvert upgrading includes repaired concrete structures, stone-pitching, erosion control, and vegetation clearing.

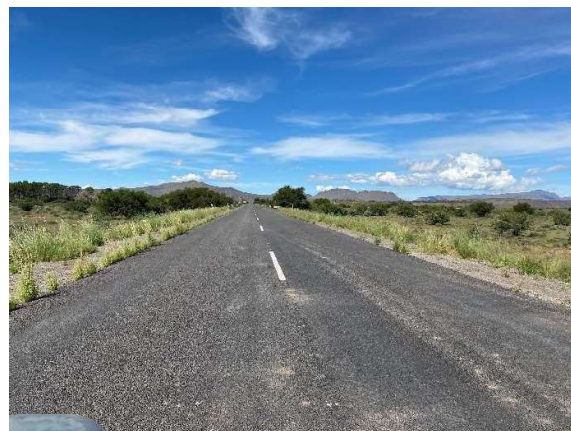
Condition of the road surface and the road reserve along the TR 16/9 as seen towards the southeast.

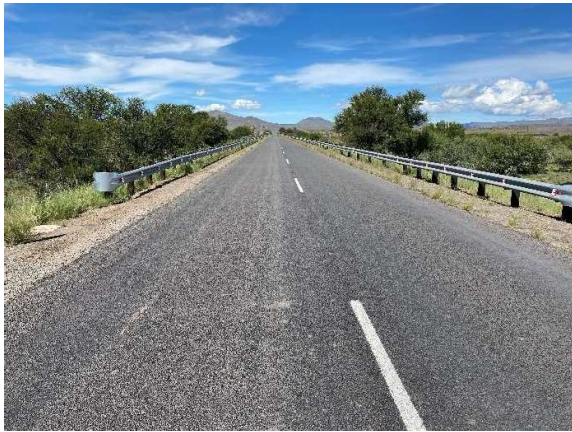
Condition of the new road surface and newly installed guardrails at Km17.36 along the TR 16/9.

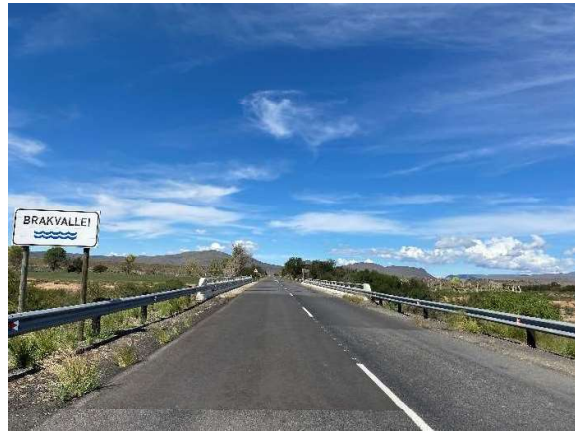
Condition of the new road surface and newly installed guardrails at Brakvallei River Bridge at Km 17.45.

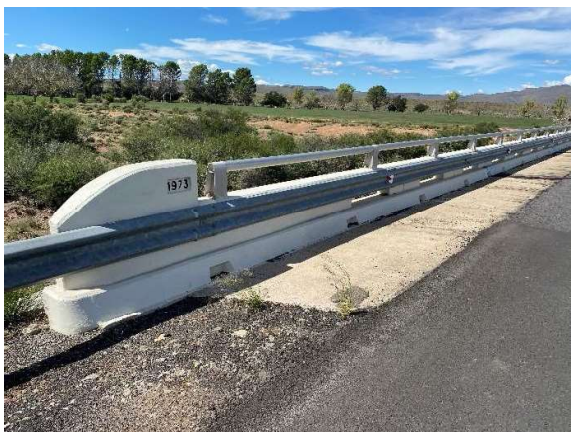
Condition of the new road surface and newly installed guardrails at Brakvallei River Bridge at Km 17.45.

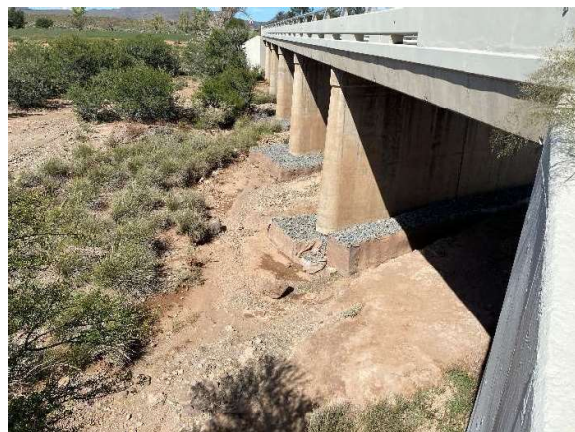
Concrete repairs and erosion protection works (gabion reinforcements) at piers and embankments.

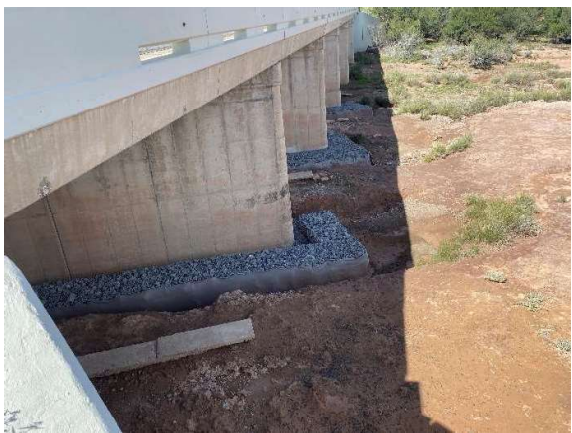
Concrete repairs and erosion protection works (gabion reinforcements) at piers and embankments.

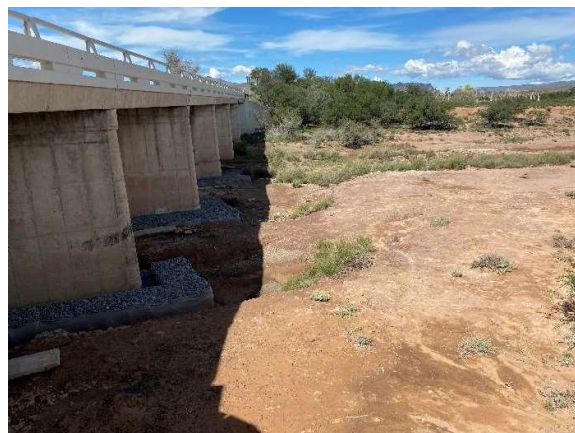
Concrete repairs and erosion protection works (gabion reinforcements) at piers and embankments.

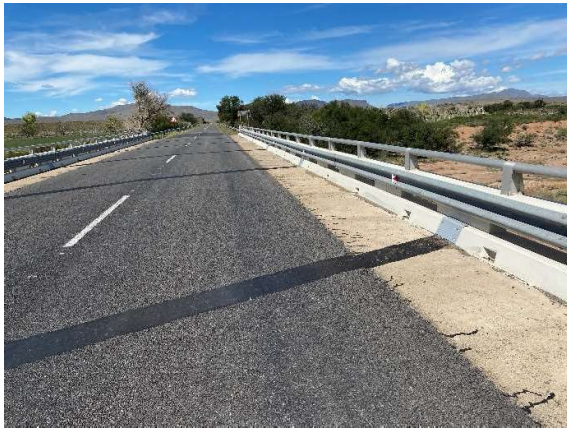
Condition of the completed Brakvallei River brige road surface as seen towards the northwest.

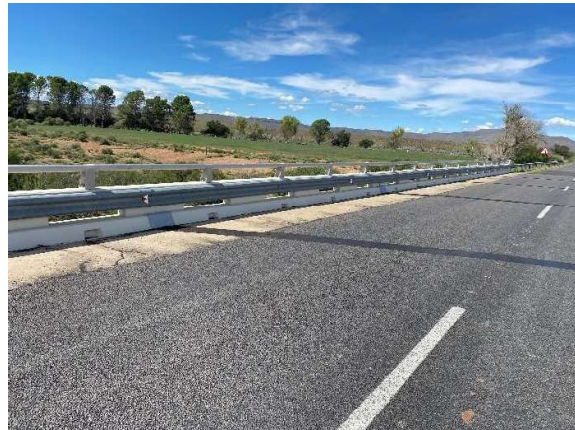
Condition of the completed Brakvallei River brige road surface as seen towards the northwest.

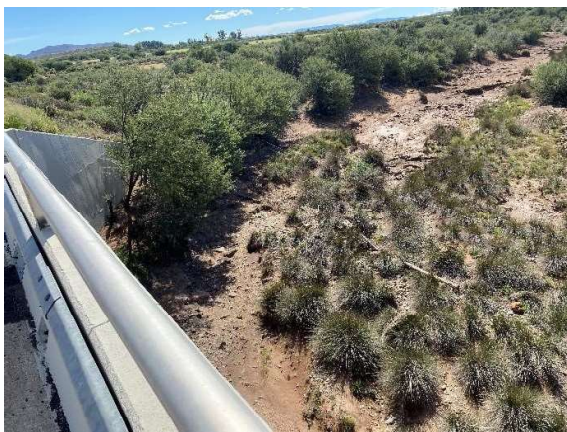
Upstream condition of the Brakvallei River bridge.

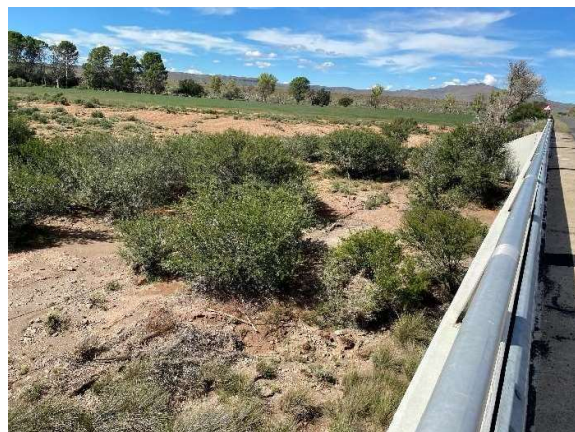
Downstream condition of the Brakvallei River bridge..

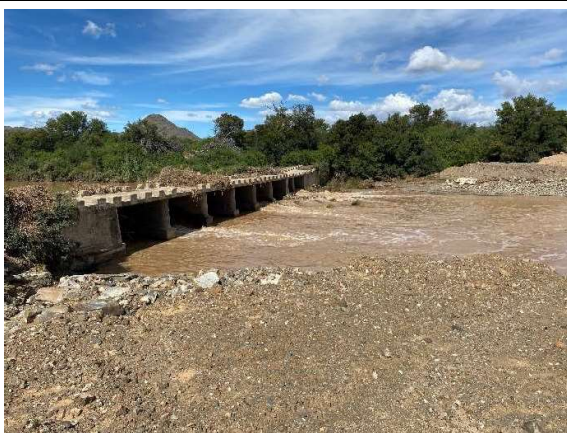
Current condition upstream of the old Buffalo River and the rehabilitated temporary bypass at Km 26.94.

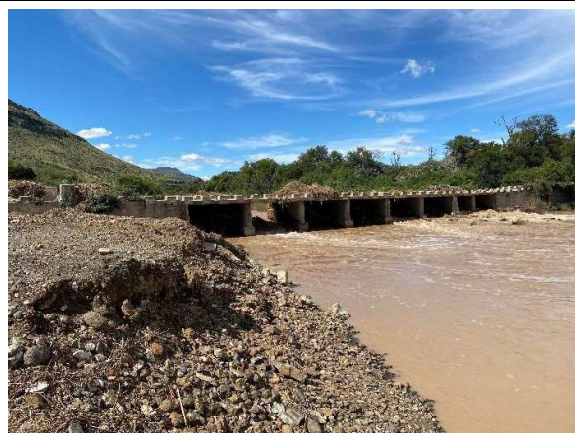
The old bridge upstream of the Buffalo River bridge as seen from the northern river bank towards the northeast.

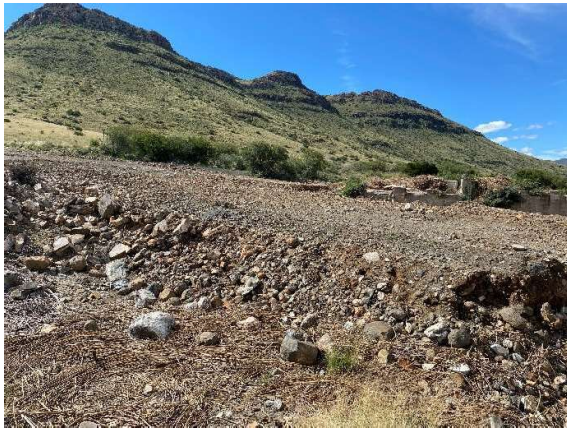
Upstream of the Buffalo River bridge where the temporary bypass road was in place.

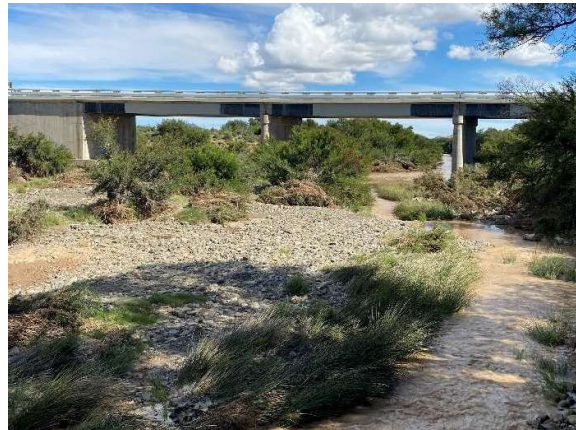
Upstream of the Buffalo River bridge as seen from the northern river bank to the southwest.

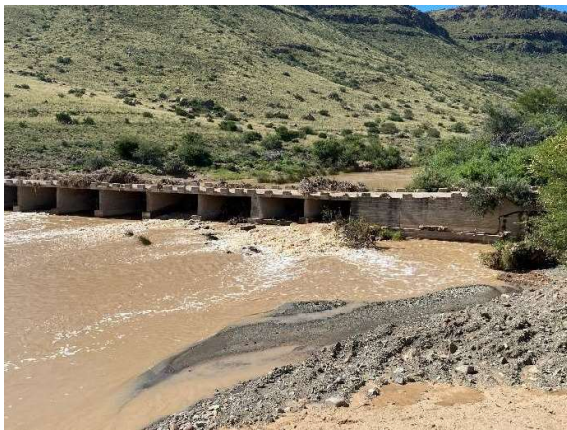
The rehabilitated temporary bypass upstream of the Buffalo River as seen from the southern bank

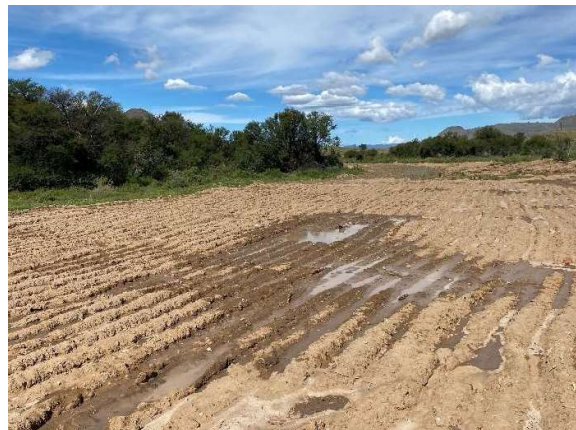
The rehabilitated temporary bypass along the southern bank of the Buffalo River as seen towards the southeast.

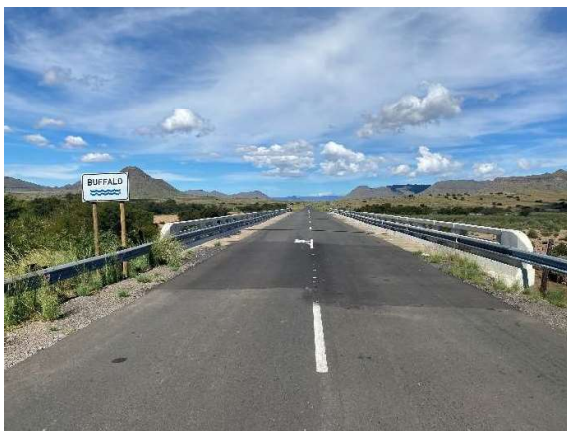
Condition of the Buffalo Bridge.

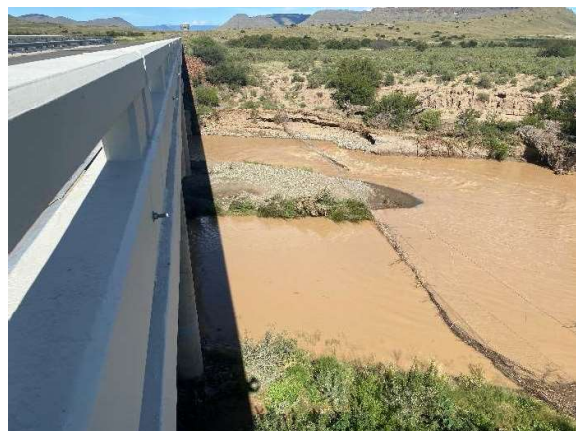
Condition downstream of the Buffalo Bridge.

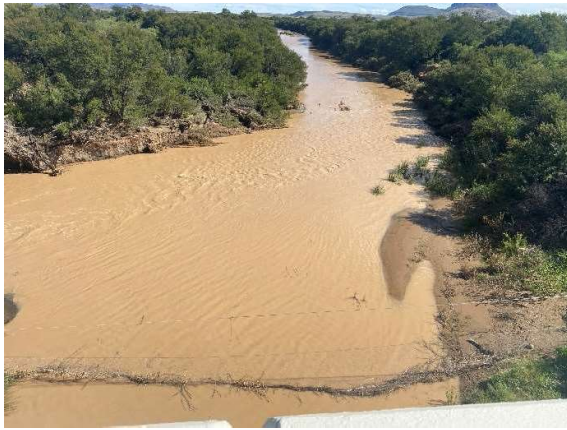
From the Buffalo River bridge seen downstream towards the southwest.

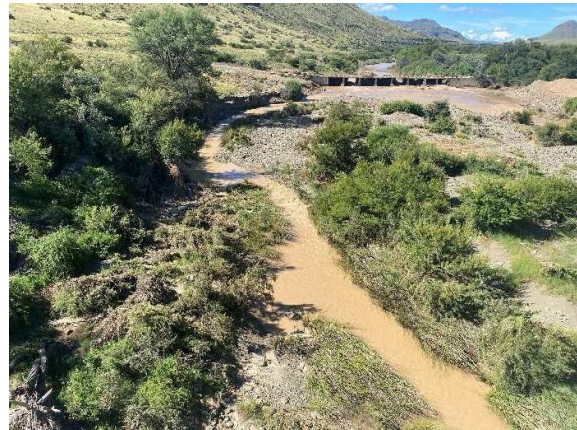
From the Buffalo River bridge seen upstream towards the northeast.

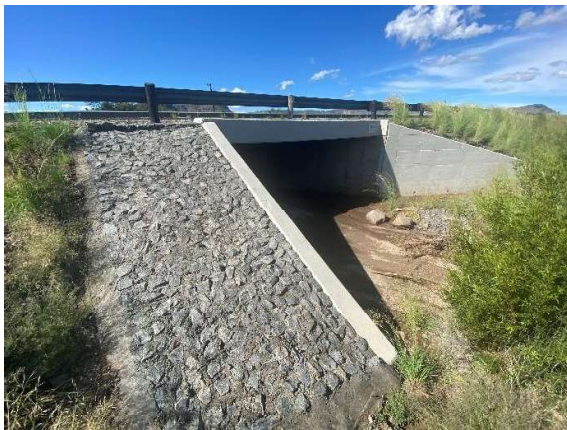
Culverts upgraded with new concrete structures, erosion control, and clearing of vegetation.

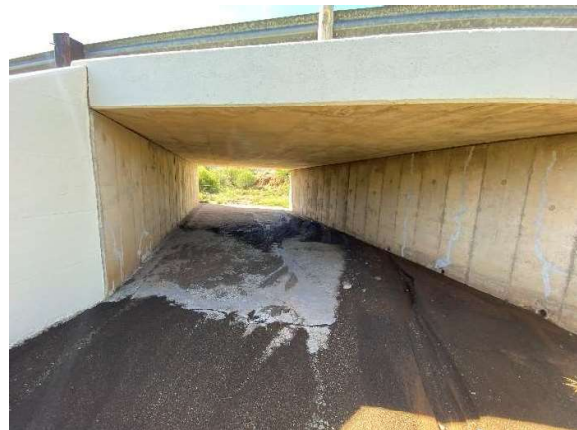
Culverts upgraded with new concrete structures, erosion control, and clearing of vegetation.

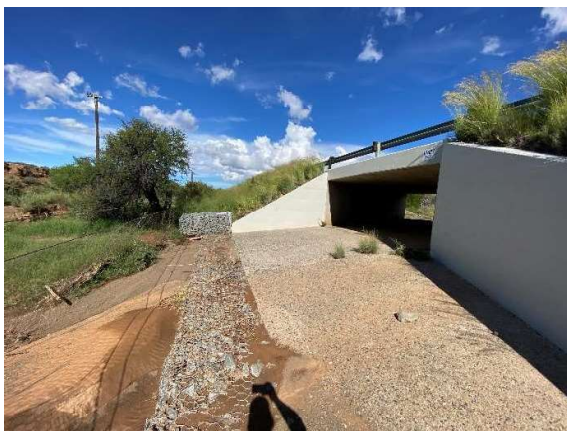
Culverts upgraded with new concrete structures, erosion control, and clearing of vegetation.

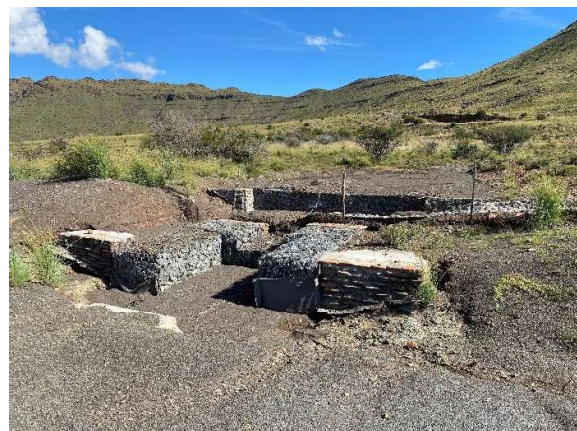
Newly installed gabion baskets for sediment within the road reserve at approximately Km 34.6 on TR 16/9.

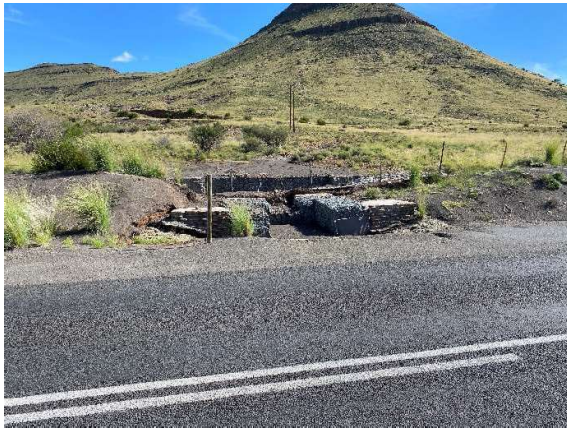
Newly installed gabion baskets for sediment within the road reserve at approximately Km 34.6 on TR 16/9.

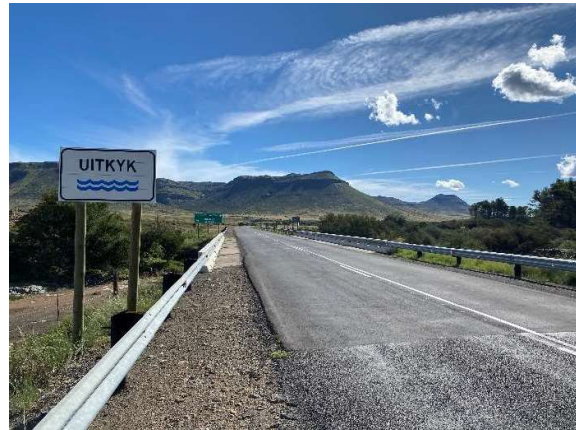
Condition of the Uitkyk Bridge.

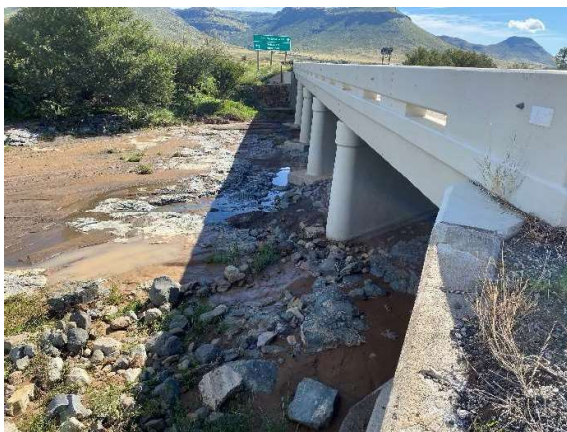
Newly upgraded culvert at the Uitkyk stream on TR 16/9.

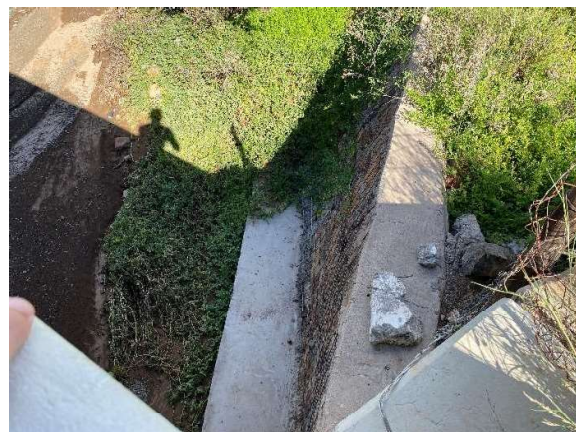
Culverts upgraded with new concrete structures, erosion control, and clearing of vegetation.
