## APPENDIX A – SITE PHOTOGRAPHS

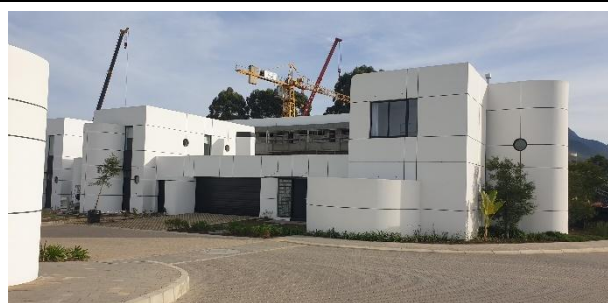
Condition of the first few constructed units off Hyacinth Lane.

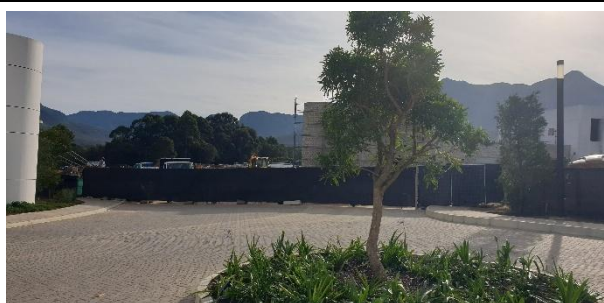
Construction area is screened at the entrance of the site along Soapberry Close and Nature Boulevard.

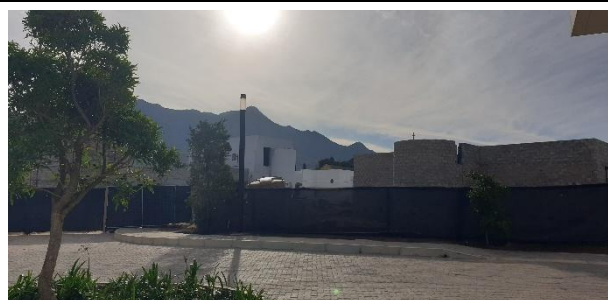
Construction area is screened at the entrance of the site along Soapberry Close and Nature Boulevard.

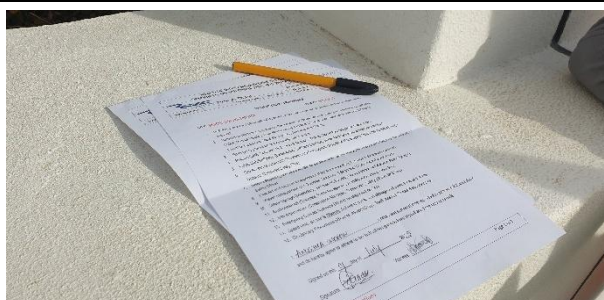
Site induction covers safety, environmental rules, and work protocols.

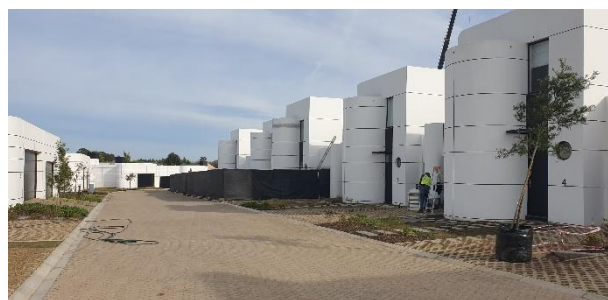
Condition of the first few constructed units off Hyacinth Lane.

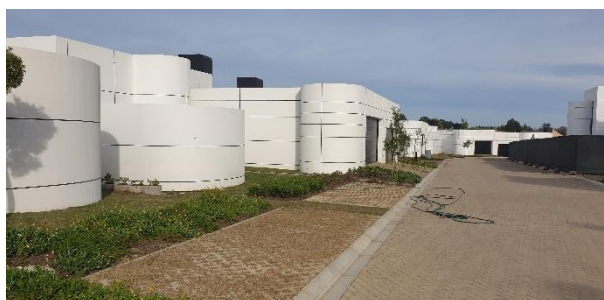
Permeable paving "grass block", SUDS intervention.

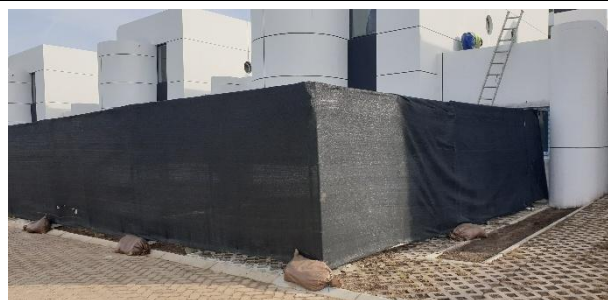
Screened construction area off Hyacinth Lane.

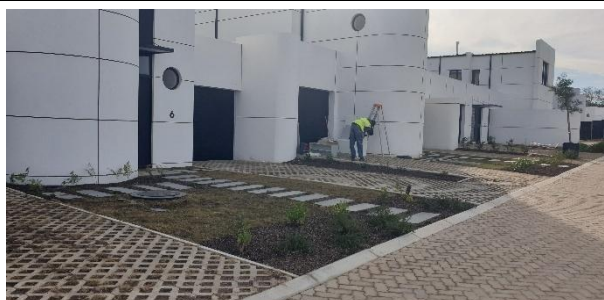
Permeable paving "grass block", SUDS intervention.

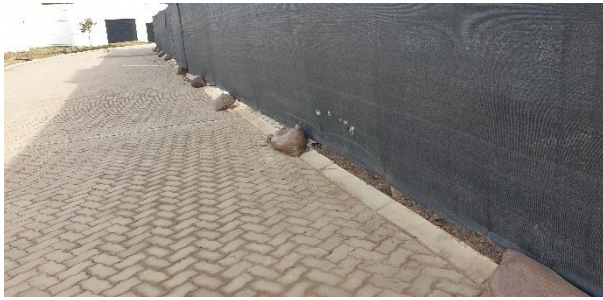
Screening held in place with sandbags.

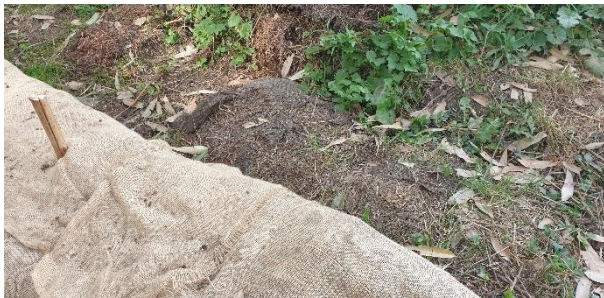
Decomposed hay bale still in place.

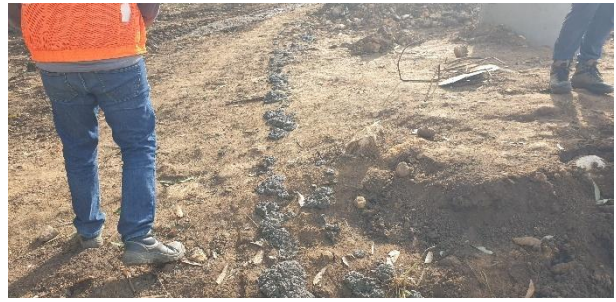
Cement spills adjacent to the rehabilitation area and stormwater outlet.

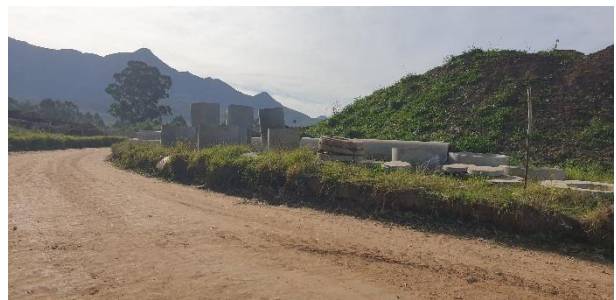
Sewage material along Nature Boulevard.

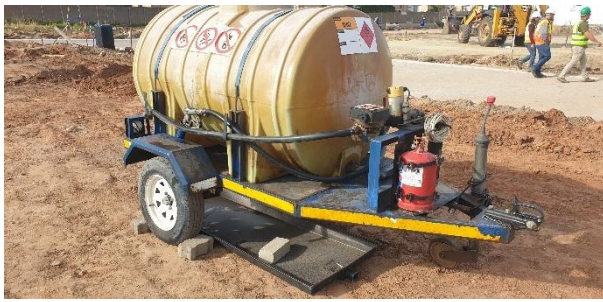
Drip tray in place below the fuel bowser.
