## ANNEXURE A – SITE PHOTOGRAPHS

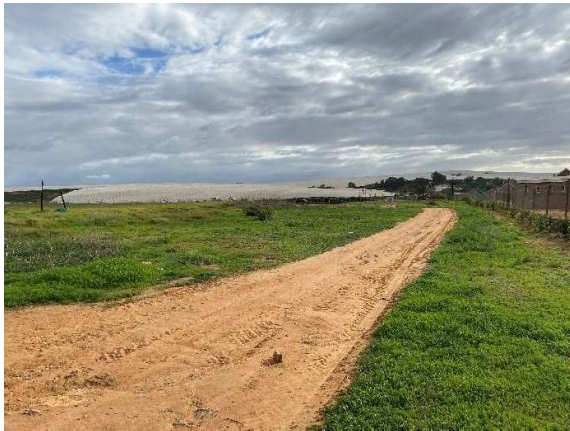
The access road leading from the northeast towards the site with the shrubs towards the right of picture.

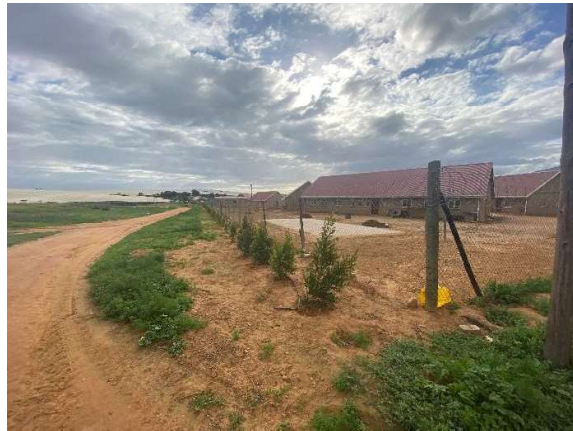
Syzygium shrubs as hedging and screening with drip irrigation installed along the northern boundary.

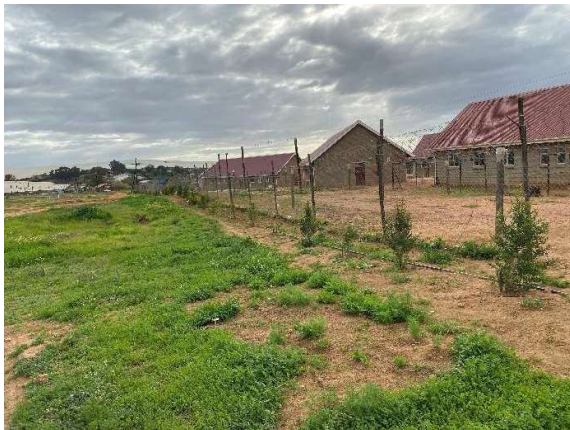
Syzygium shrubs as hedging and screening with drip irrigation installed along the northern boundary.

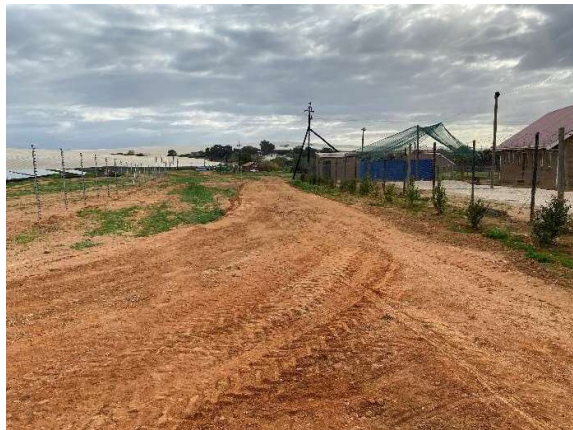
Syzygium shrubs as hedging and screening with drip irrigation installed along the northern boundary.

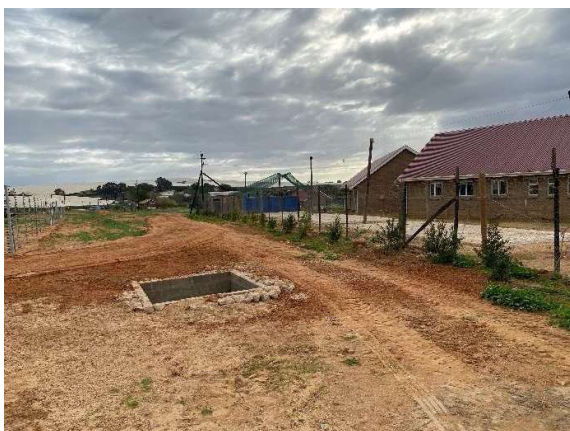
Stormwater catchpit along the northern boundary of the site between the footprint and the houses.

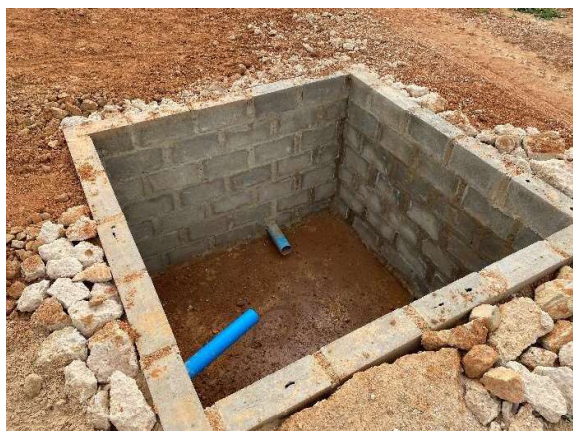
Stormwater catchpit along the northern boundary of the site between the footprint and the houses.

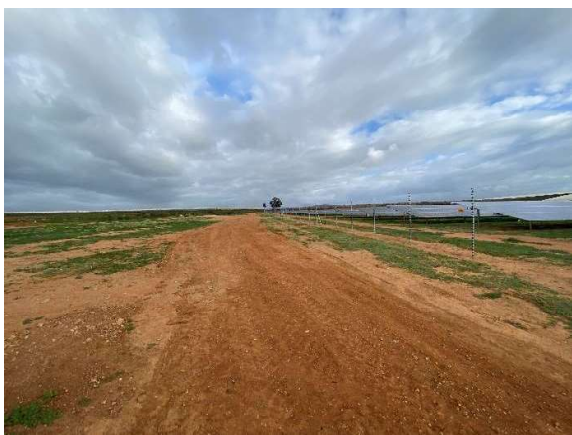
The access road leading around the site boundary along the east of the site seen towards the south.

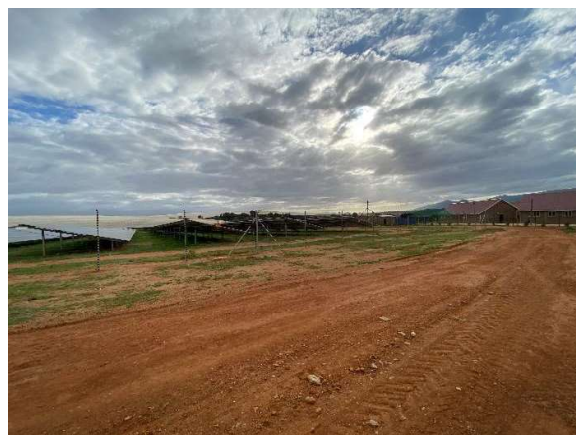
Along the eastern boundary of the site seen towards the northwest across the site.

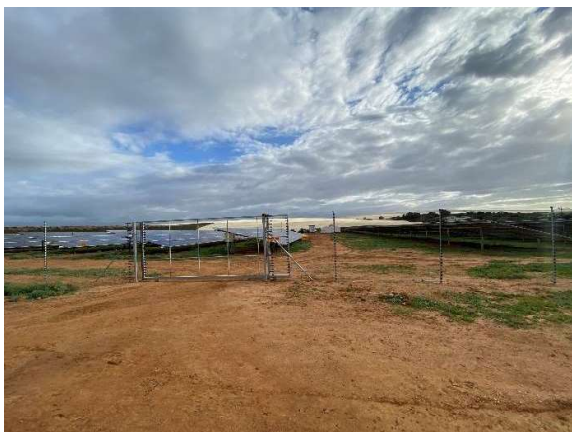
Eastern boundary of the development footprint at the entrance gate to the site.

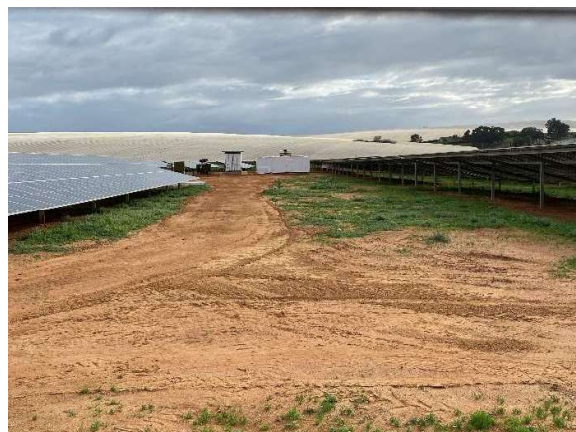
From the entrance gate to the site seen towards the west and the control station.

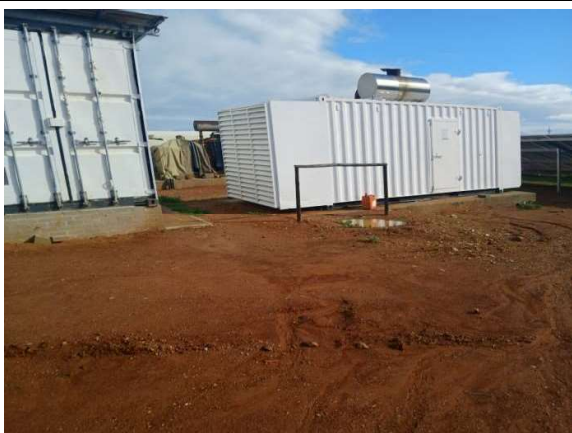
Completed electrical control stations.

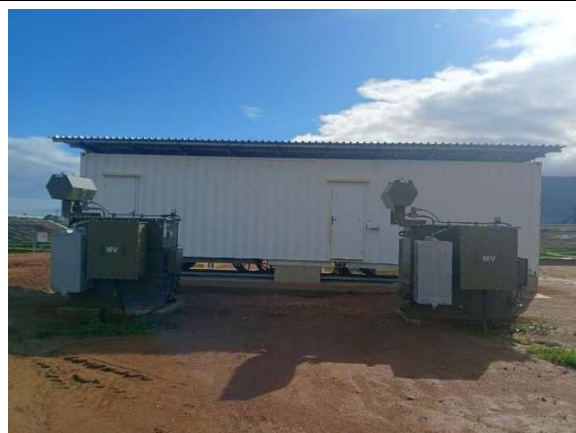
Completed electrical control stations.

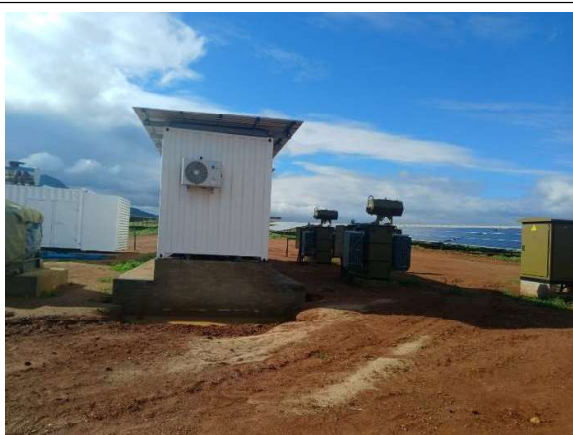
Completed electrical control stations.

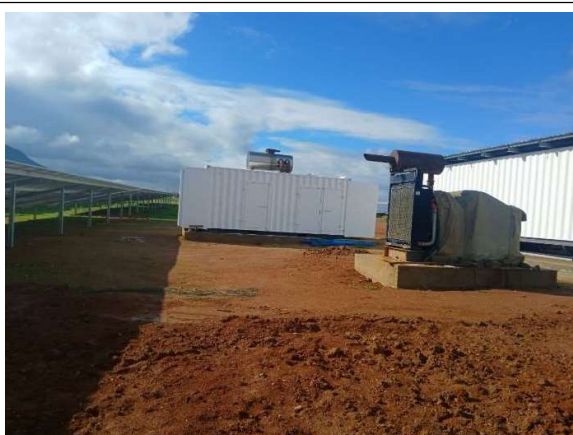
Completed electrical control stations.

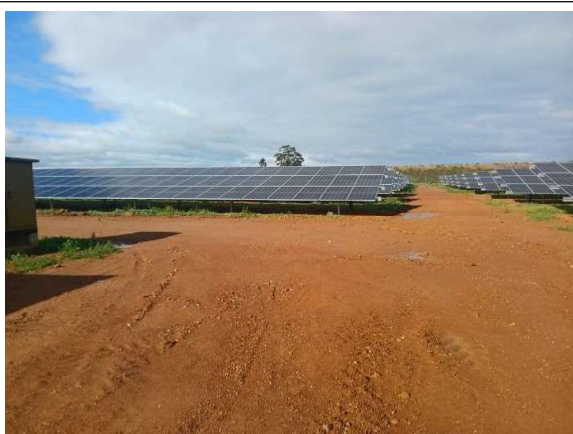
Solar panels as seen from the centre of the site towards the south.

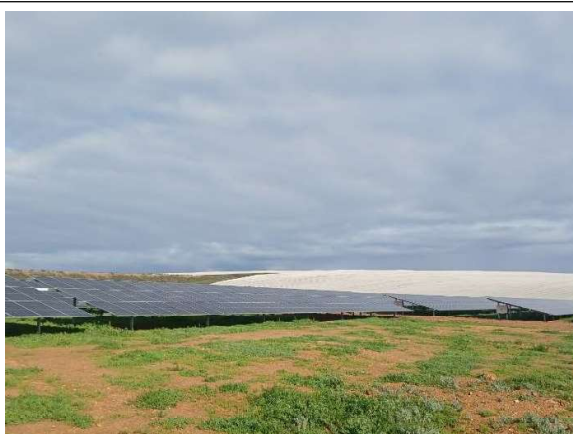
Solar panels and condition of completed works as seen from the northeastern corner towards the southwest.

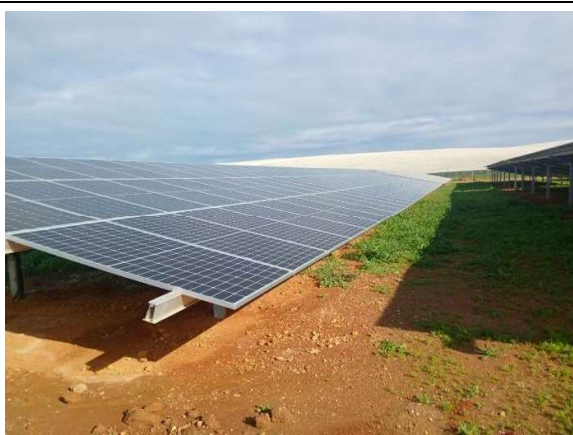
Condition of the completed panel structures as seen towards the west.

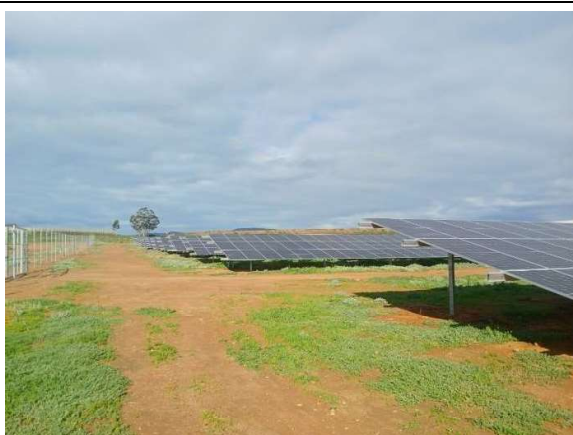
Condition of the completed panel structures along the eastern boundary as seen towards the south.

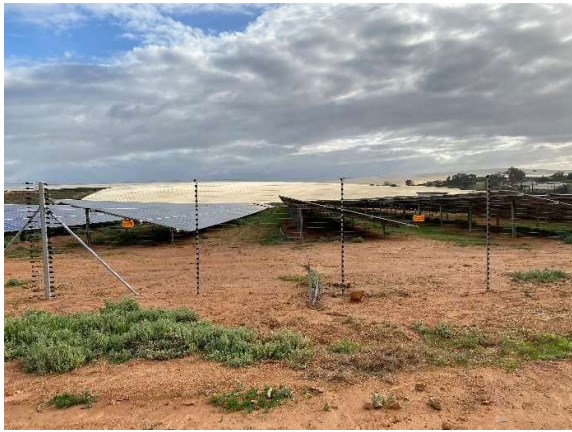
Condition of the completed panel structures as seen from the eastern boundary towards the west.

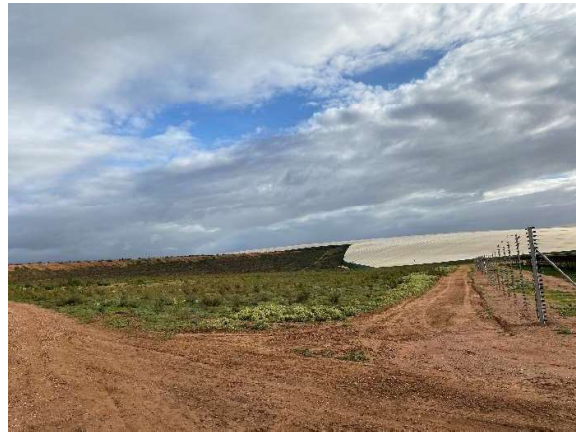
The access road along the southern boundary as seen towards the west.

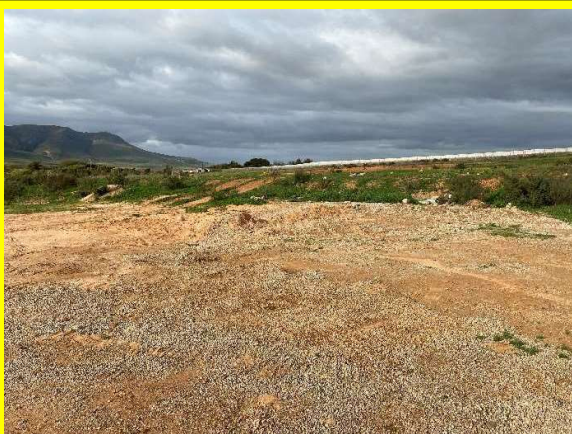
Adjacent to the site camp area, some remaining building sand and aggregate for mixing concrete is still in place.

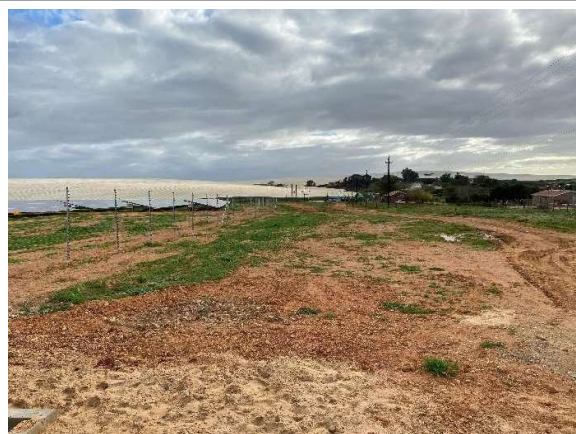
Along the northern boundary of the site as seen towards the west where stormwater measure were completed.

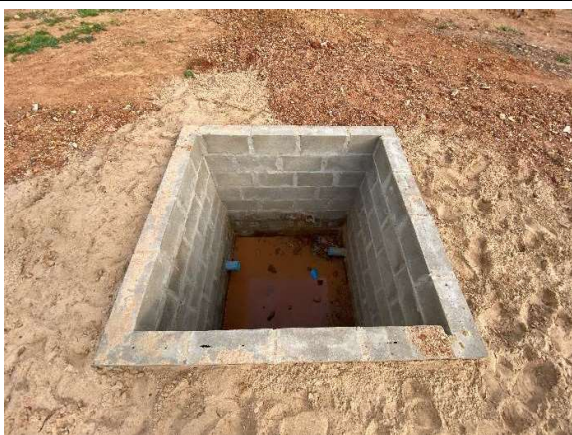
Condition of a completed stormwater catchpit along the northern boundary of the site.

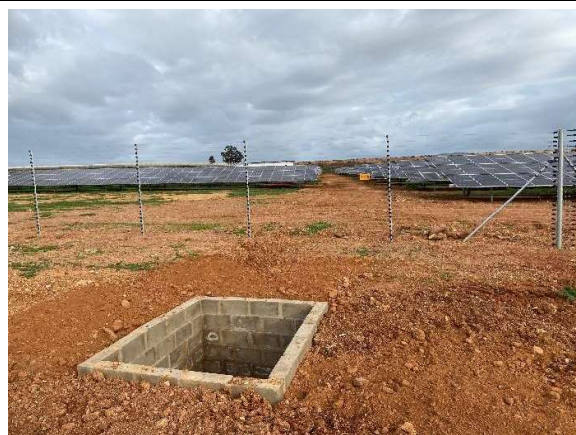
Completed stormwater catchpit along the northern boundary of the site as seen towards the south.

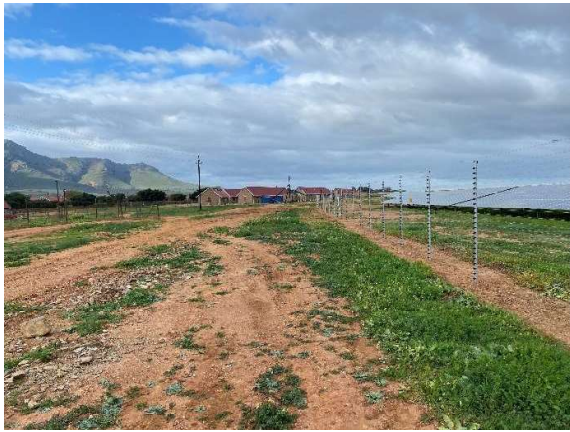
Along the northwestern boundary of the site as seen towards the east.

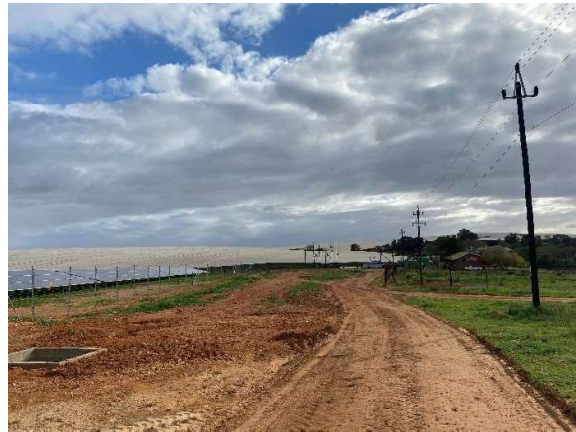
Along the northwestern boundary of the site as seen towards the west.

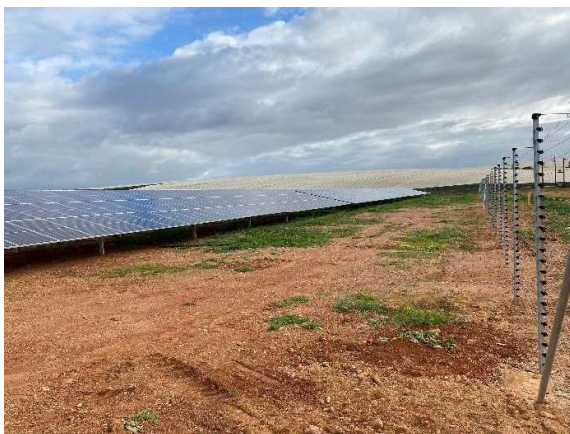
Along the inside of the northern fence as seen towards the west.

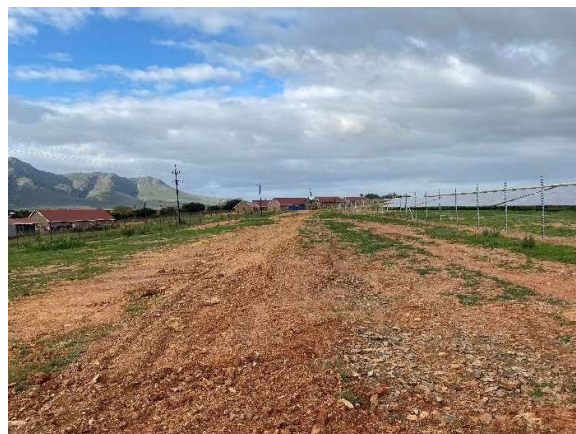
From the northwestern boundary of the site footprint as seen towards the east.

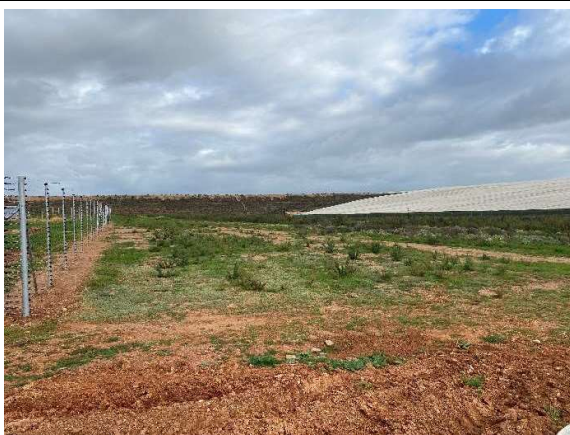
From the northwestern boundary of the site footprint as seen towards the south.

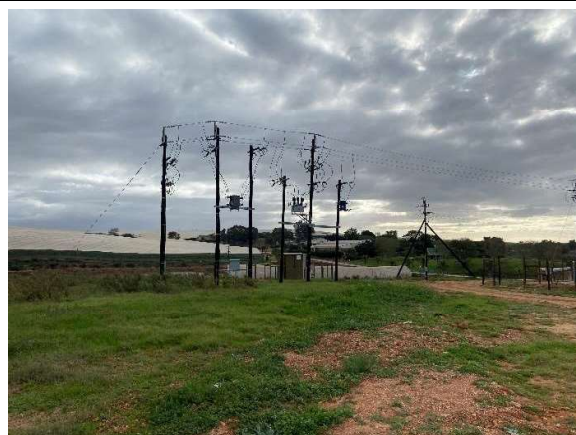
The ring main unit located immediately northwest of the site.

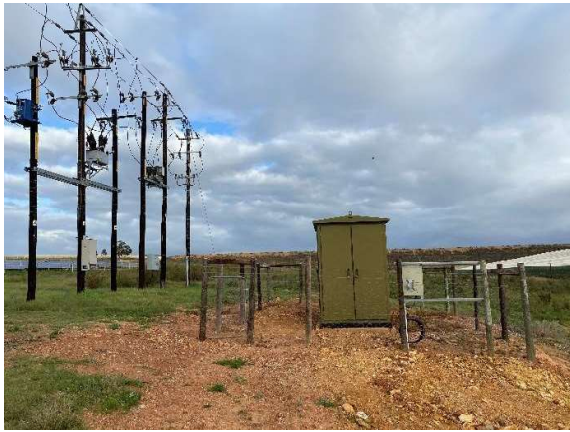
The ring main unit located immediately northwest of the site.

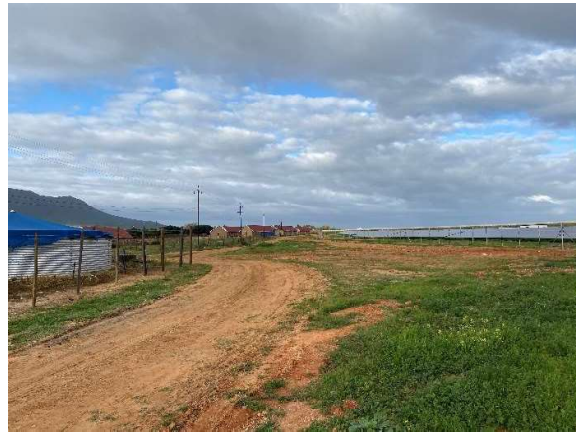
From the ring main unit as seen towards the east along the northern boundary access road.

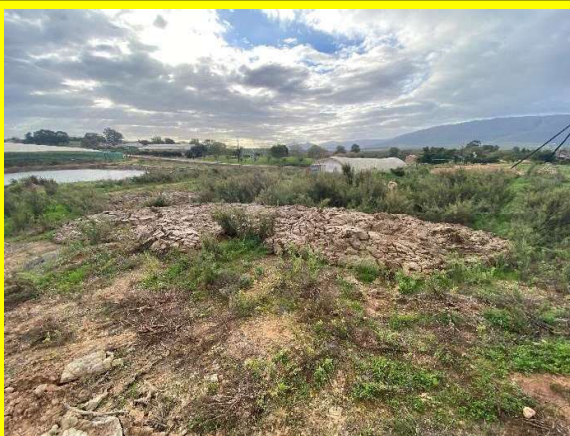
The dam sludge which was placed along the gravel road towards the west of the site.

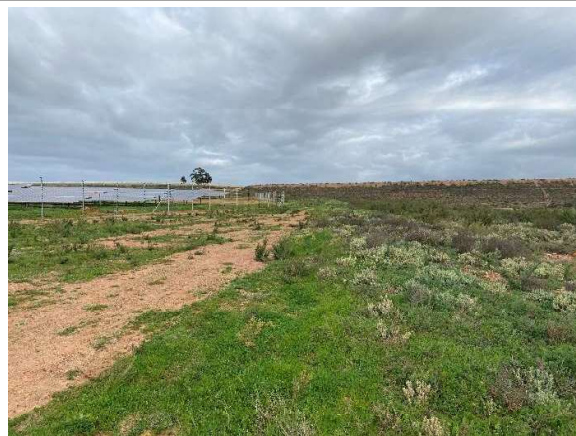
Along the western boundary of the site within the staked buffer area as seen towards the south.

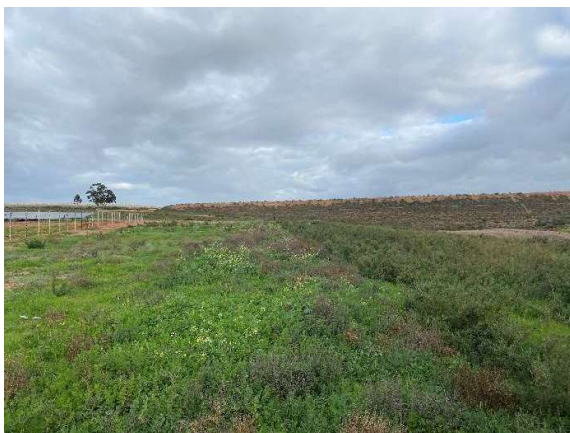
Along the western boundary of the site within the staked buffer area as seen towards the south.

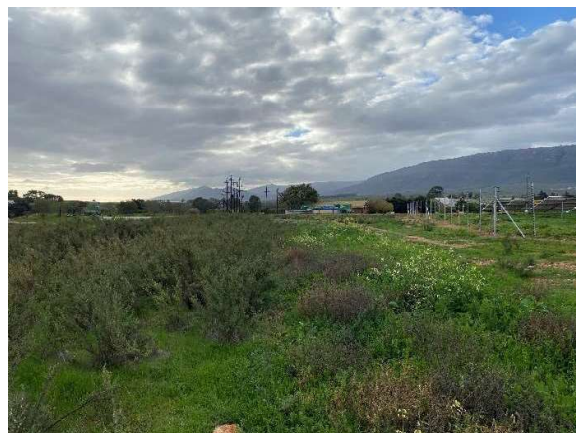
Along the western boundary of the site within the staked buffer area as seen towards the north.

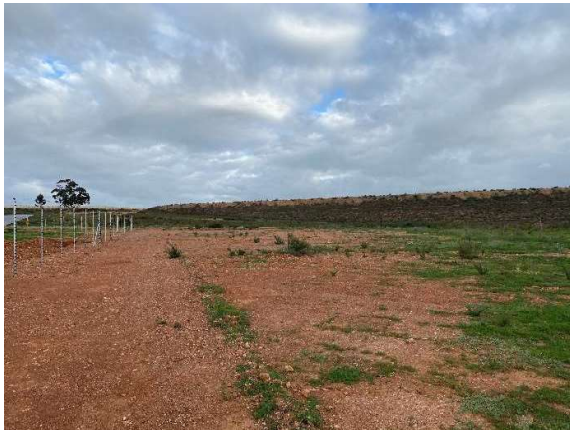
Along the western boundary of the site within the staked buffer area as seen towards the south.

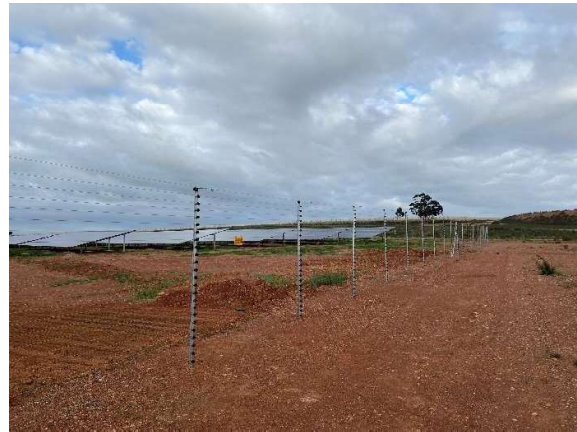
Along the western boundary of the site where the water pipeline connects to the internal water pipeline.

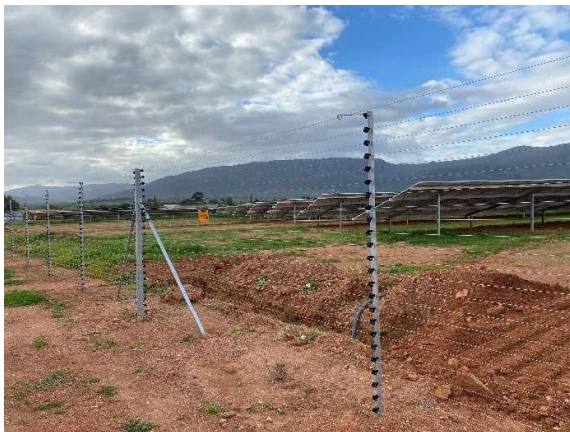
Along the western boundary of the site where the water pipeline connects to the internal water pipeline.

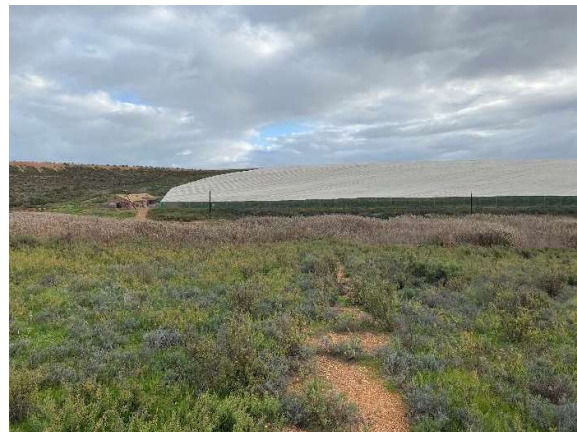
The location of the water pipeline within the no-go area has been overgrown again with indigenous veld.

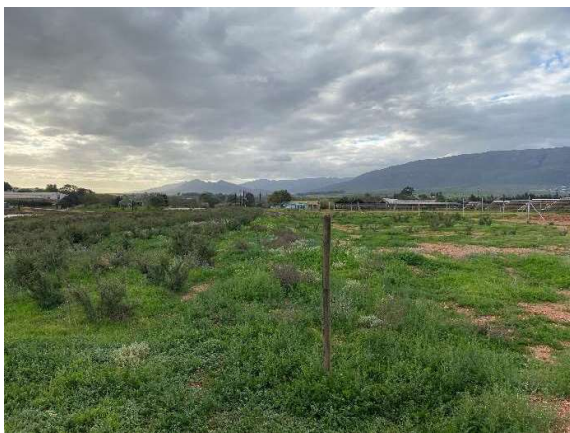
The buffer area no-go stakes still in place along the west of the site as seen towards the north.

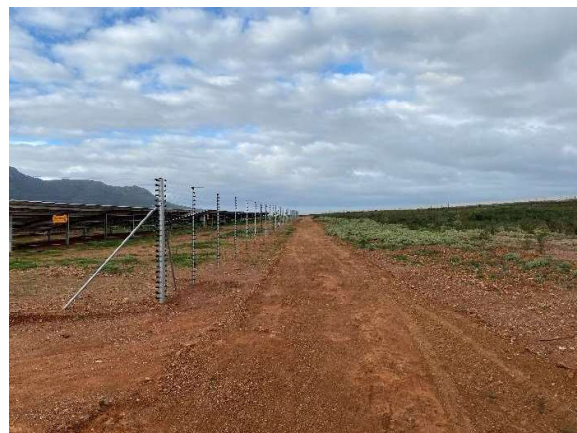
The access road along the southern boundary of the site as seen towards the east.
