**ENVIRONMENTAL MONITORING REPORT NO. 46**  
**FOR**  
**HARTLAND ON**  
**PORTION 11 OF FARM VAALE VALLEY 219, MOSSEL BAY**

**MOS25/1027/74**

**June 2025**

## ENVIRONMENTAL MONITORING REPORT NO. 46 – JUNE 2025

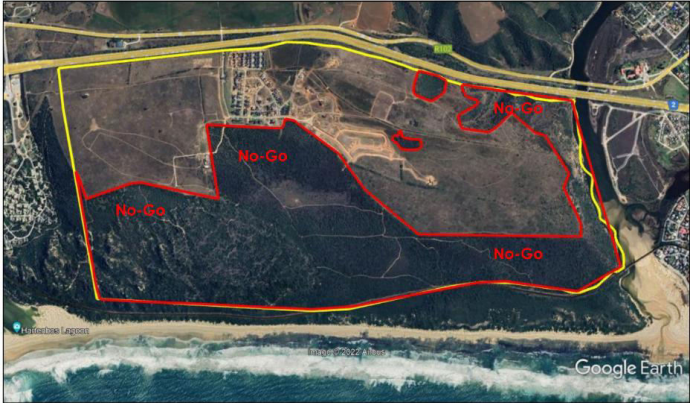
| | | <p>environmental issues noted during this reporting period.</p> <p>Figure 7: Construction No-Go area</p> | |

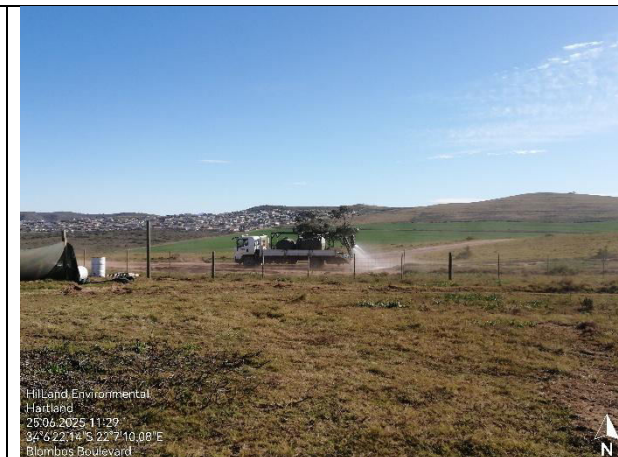
Water truck

| Topsoil stripping and dust impact management | | |
|---|---|---|
| <p>10.3.7 – Topsoil must be neatly removed and stored away without contamination. It is also to be used for rehabilitation once construction is complete.</p> <p>The location of stockpiles must take into account the prevailing wind direction and should be situated so as to have the least possible dust impact to surrounding residents, road-users and other land-users.</p> <p>The speed limit should be set at 20-40km/h.</p> <p>Dust must be suppressed on access roads and the construction site during dry periods by the regular application of water or a biodegradable soil stabilisation agent. Water used for this purpose must be used in quantities that will not result in the generation of excessive run off.</p> | <p>Compliant &amp; ongoing</p> | <p>Topsoil is placed next to open trenches (windrow) for use during rehabilitation in the same sequence.</p> <p>Bulk topsoil stockpile sites for Retirement village and Fynbos Heuwels were approved by the ECO – internal open space of the retirement village (this will be moved in the next month).</p> <p>Phase H2 – rehabilitation of the road verges – topsoil and grass seed mix to be implemented.</p> <p>Subsoil will be stockpiled according to the earthworks master plan and covered with topsoil – ongoing alien clearing on the swale required.</p> <p>Dust suppression is ongoing and observed during site inspections.</p> |

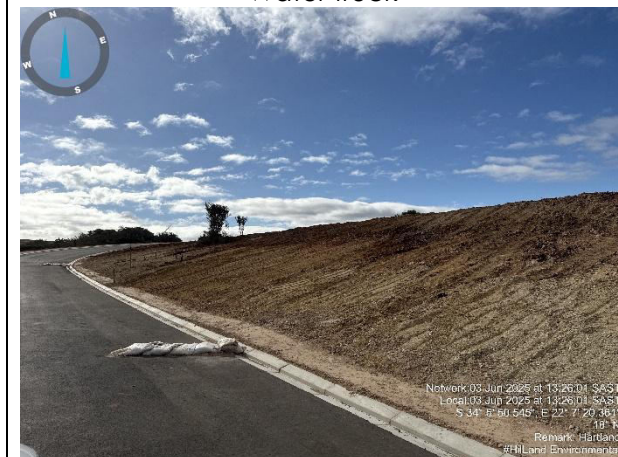
Phase H2 slopes

| Soil erosion mitigation | | | |
|---|---|---|---|
| Areas which have been covered with topsoil from the stockpiles, and which may be subject to erosion should be stabilized. | Ongoing | Rehabilitation follows the construction phase. Road verges are to be covered with topsoil and the steeper sections will require erosion protection (silt fences or sandbags). <b>This is necessary for Phase H2.</b> | |

- Shaping of the road verges were done – rehabilitation (topsoil) to be completed.

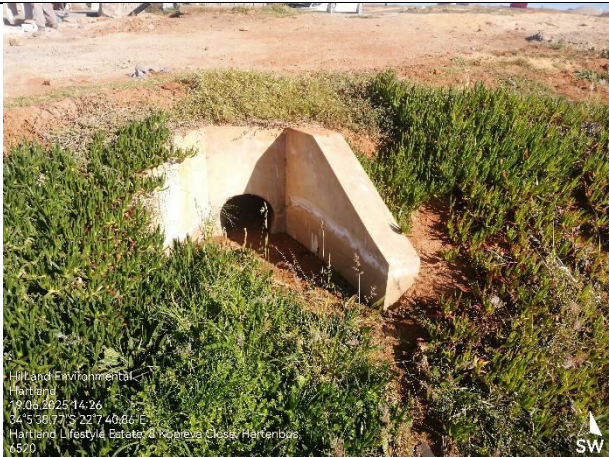
| Soil erosion mitigation | | | |
|---|---|---|---|
| 10.3.1-<br>Erosion control measures including silt fences, low soil berms and/or shutter boards must be put in place around the stockpiles to limit sediment runoff from stockpiles. | Ongoing | <p>Currently there are no soil erosion issues.</p> <p>Silt fences to be installed to capture silt runoff once the stormwater outlets have been construction (Phase H2).</p> | <p>Phase 4 – silt buildup has been removed. Vegetation in place and no signs of soil erosion.</p> |

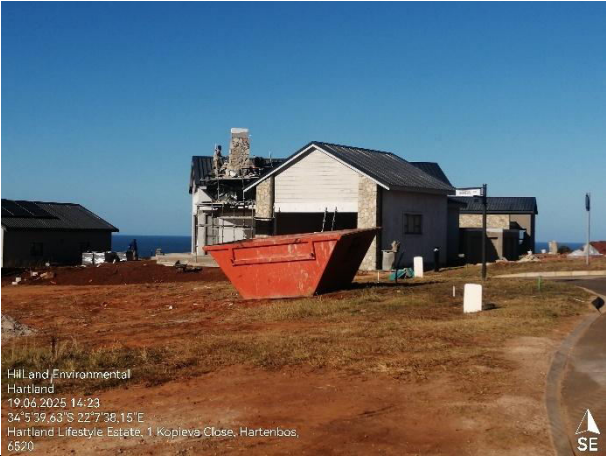
| | | | <p><b>Ongoing</b> - Wind-blown litter remains an ongoing construction related problem. Therefore, the contractor has a dedicated litter picking team conducting weekly litter picking.</p> <p>Either the bins must be cleaned out more frequently or the workers must be briefed on waste and litter weekly.</p> <p>The HOA has also appointed a dedicated litter picker.</p> <div data-bbox="1232 489 1836 946"><p>Hilland Environmental<br/>Hartland<br/>19.08.2025 14:23<br/>34°59'63"S 22°7'38,15"E<br/>Hartland Lifestyle Estate, 1 Kopleys Close, Hartenbos,<br/>6520</p><p>SE</p></div> |

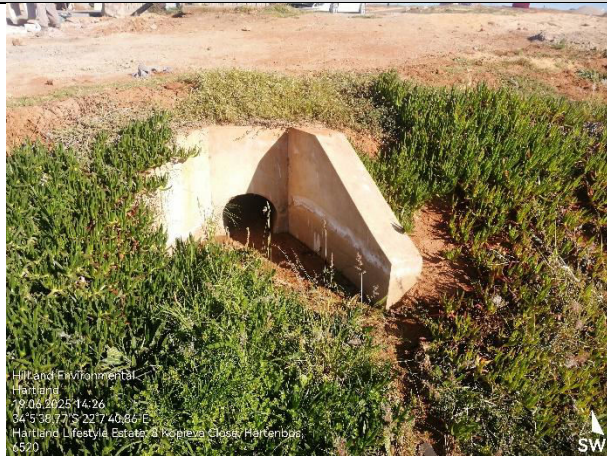
| OEMPr requirements | Level of compliance | Comments / Findings | Photos (if applicable) |
|---|---|---|---|
| Waste traps must be cleared of any obstructions monthly or when heavy rainfall has occurred. | Ongoing | Litter and silt wash are being removed from stormwater outlets and must be monitored by the HOA and management – ongoing activity that the HOA is assisting and managing. | <p>Hill and Environmental<br/>Hartland<br/>12.08.2025 14:26<br/>34°5'36.77"S 22°17'40.66"E<br/>Hartland Lifestyle Estate 3.10.2025 Close Hartland<br/>6520</p> <p>SW</p> <p>Stormwater outlet was recently cleaned out</p> |

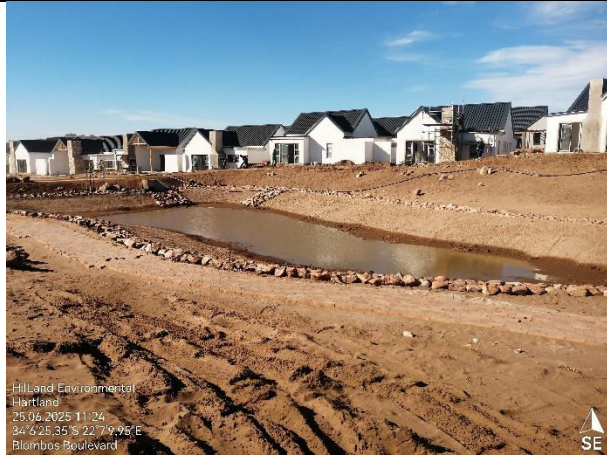
| | | | <p>Stormwater retention ponds in the retirement village.</p> |

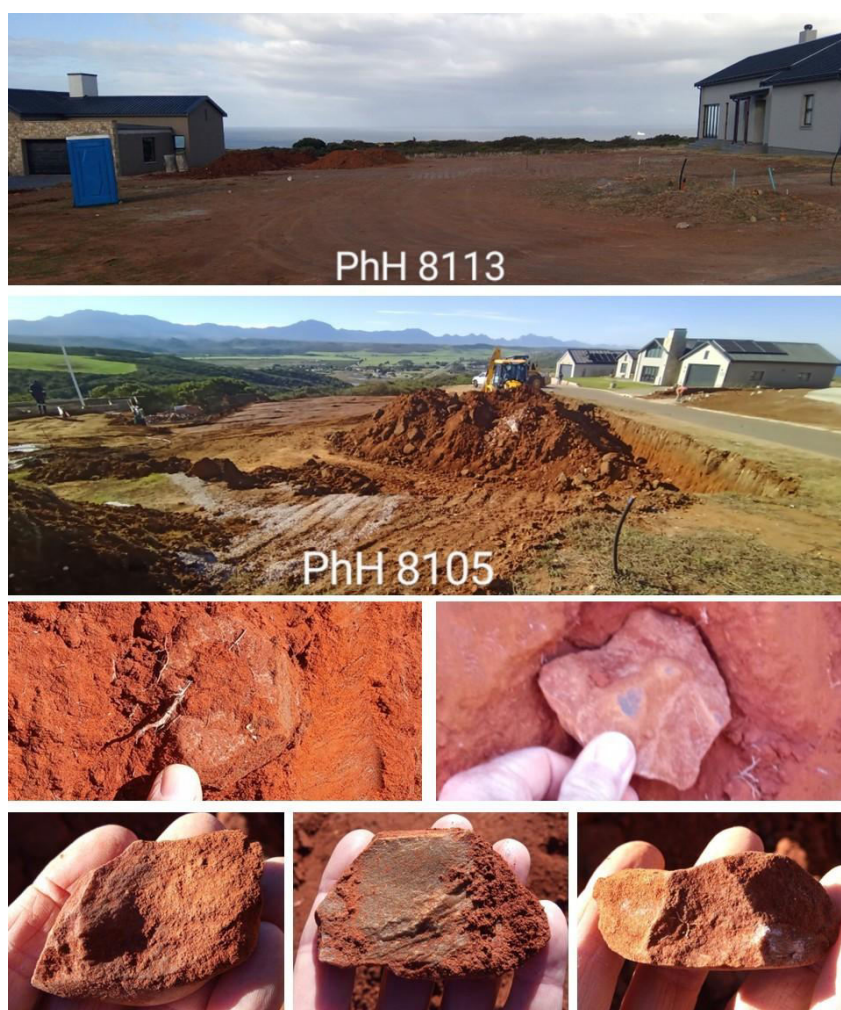
Figure 1. Hartland – Phase H – works in progress and Stone Age pieces recorded at 8105.

House platforms in Phase H included the completion of Erf 8113 while excavations are nearly complete at 8105 (Figure 1). Several Stone Age pieces of likely Middle Stone Age origin were recorded in exposed profiles as well as stockpiles. Artefacts are in quartzite and include flakes, cores, flaked cobbles and chunks. Due to their low densities, the absence of anthropogenic strata, and the absence of associated cultural and organic remains, these find are rated Not Conservation Worthy and require no further action in terms of the NHRA.

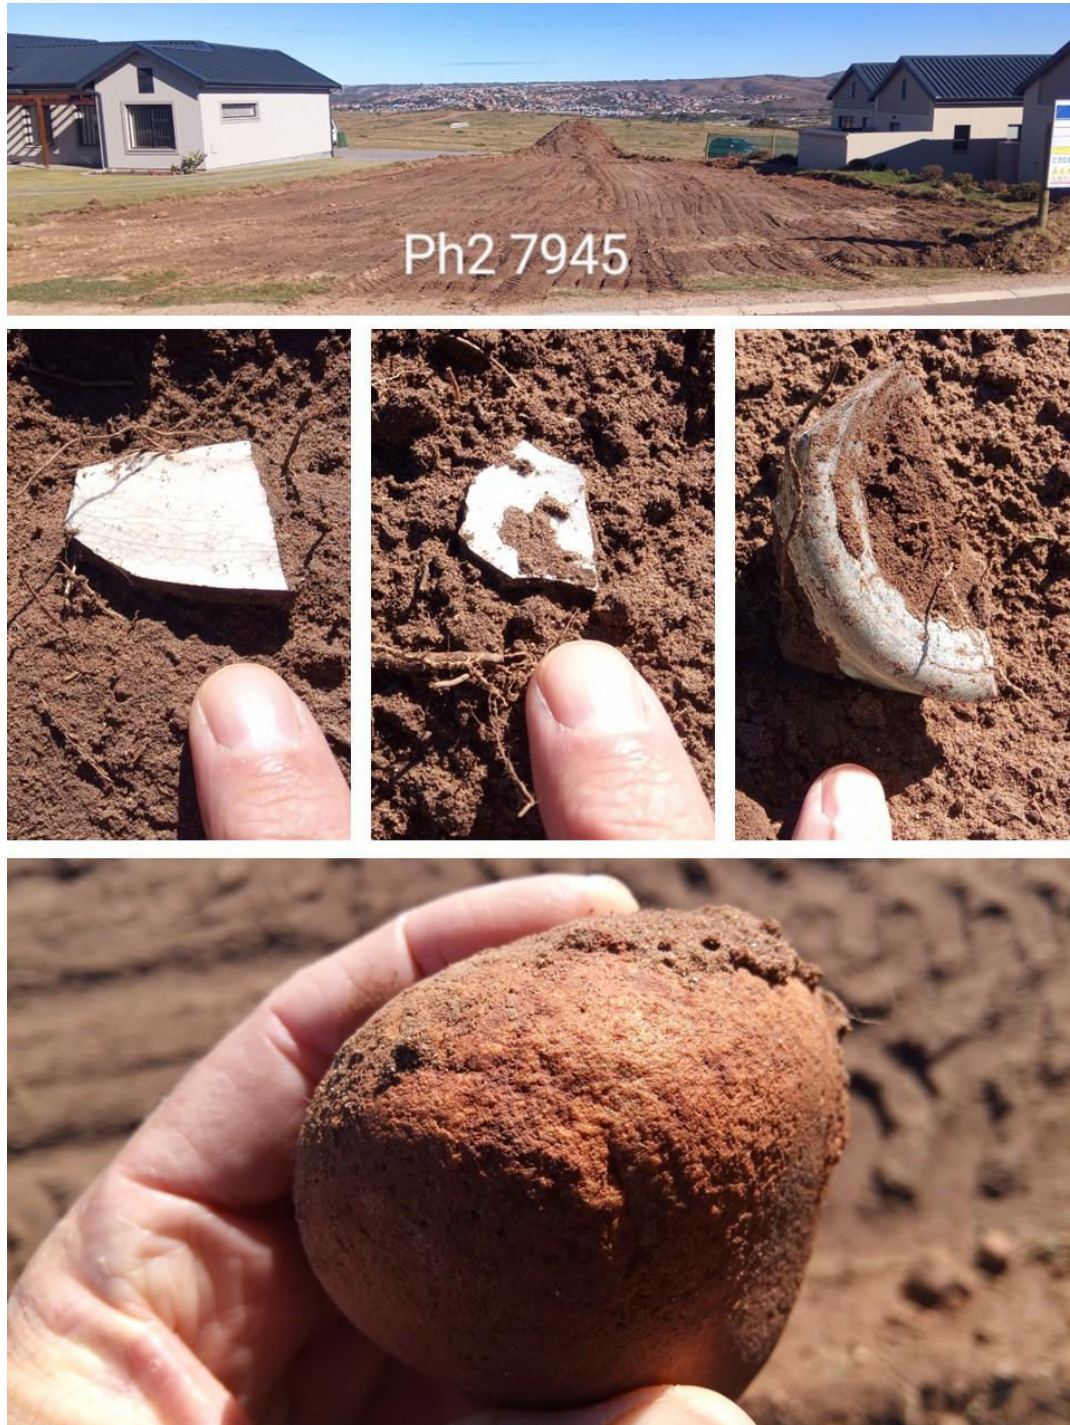
Figure 2. Hartland – Phase 2 – works in progress and modern / colonial period debris and a Stone Age hammerstone recorded at 7945.

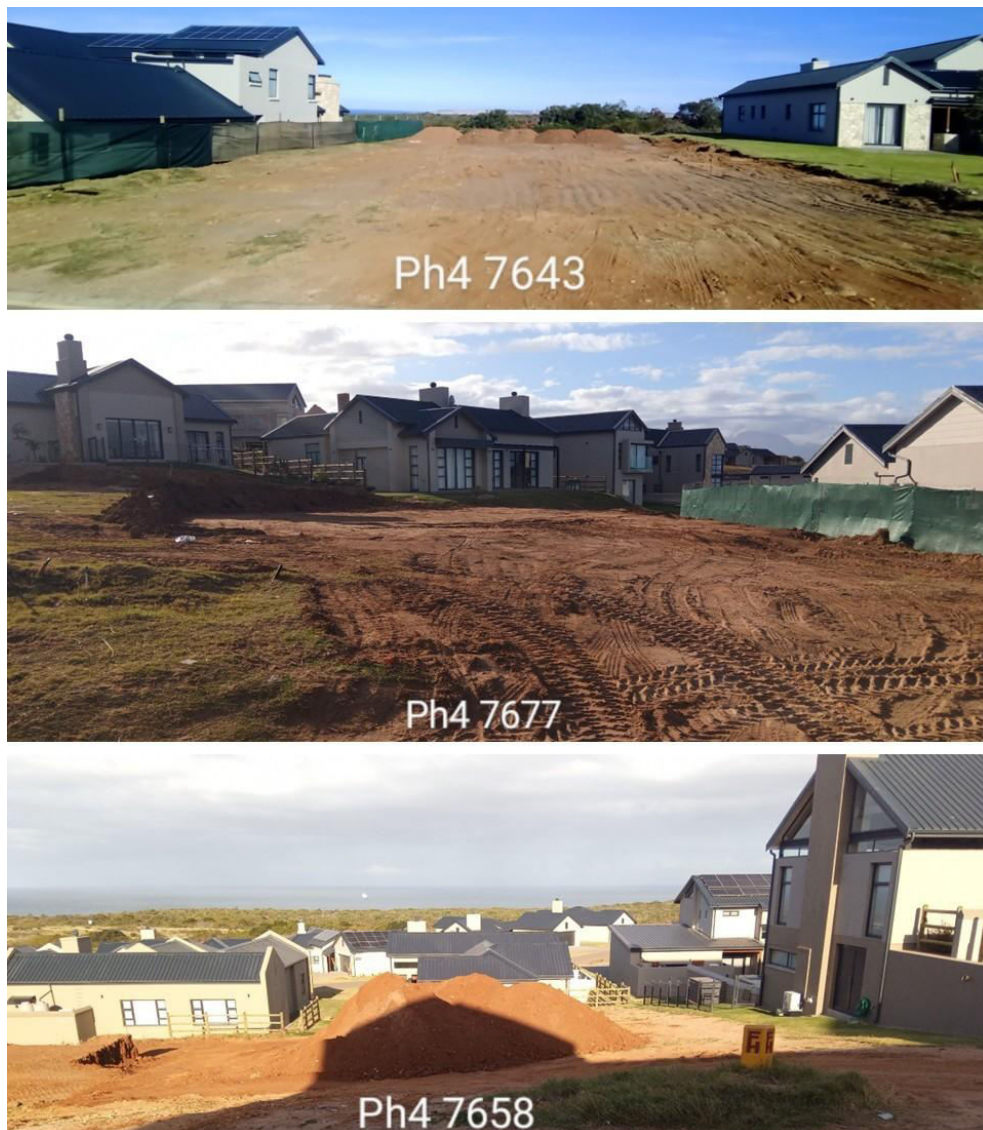
Figure 3. Hartland – Phase 4 – works in progress.

House platforms at Erven 7643, 7677, 7658 (Figure 3) and 7657 require no further excavation and some will be completed with fill and compaction. Erven 7622 yielded a few Stone Age pieces and is nearly complete (Figure 4). Artefacts are in quartzite and included flaked cobbles and a hammerstone of indeterminate age. Due to their low densities and the absence of associated

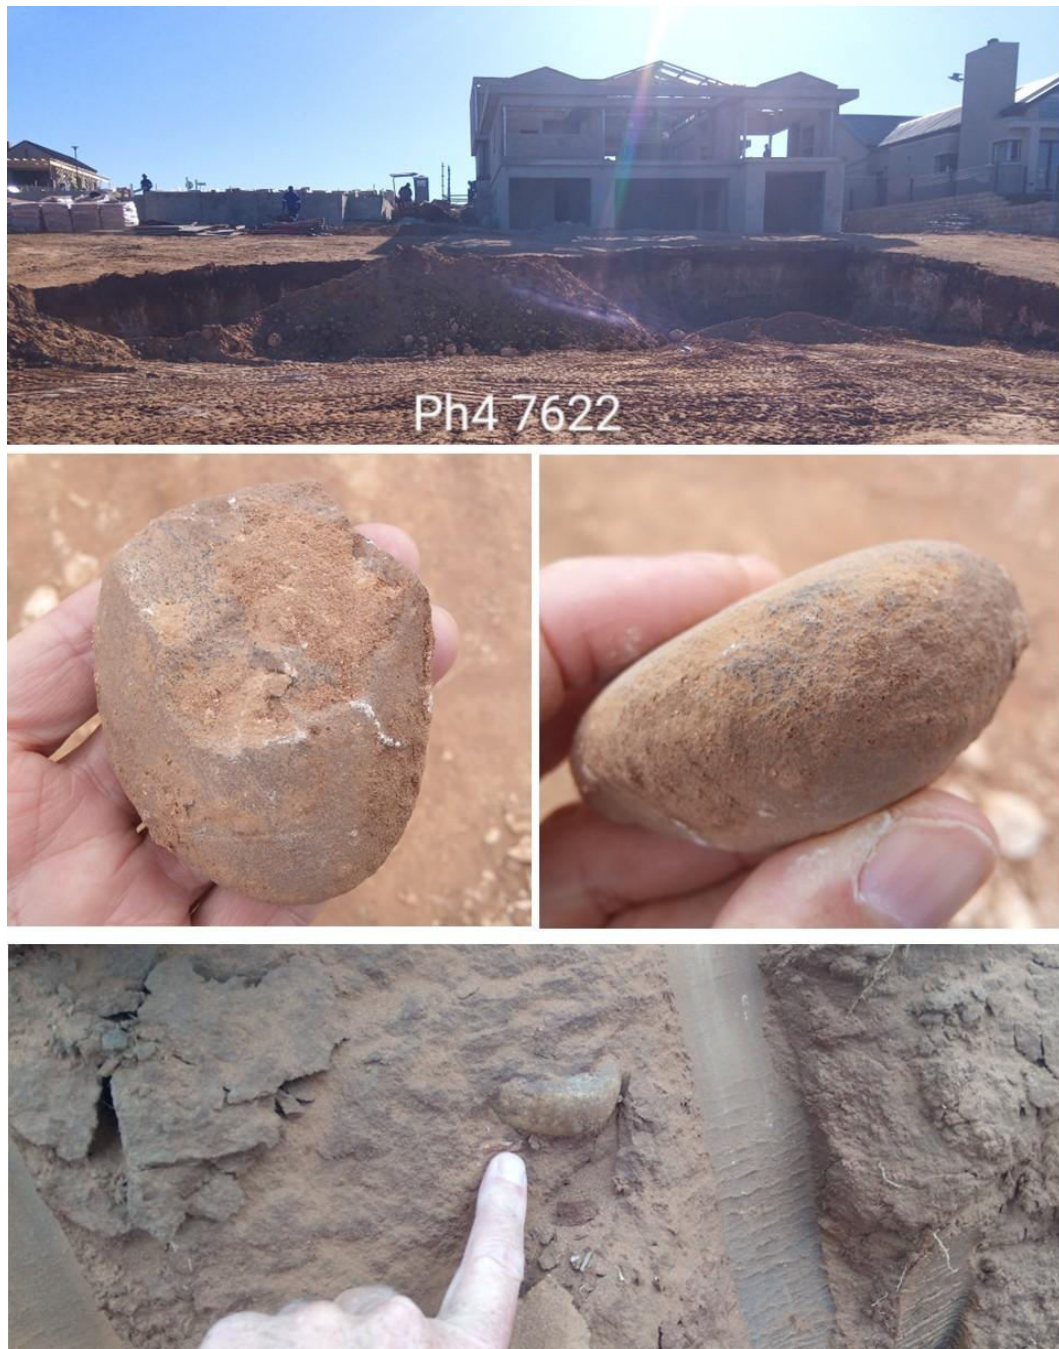
organic and other cultural remains, these finds are Not Conservation Worthy and require no further work with respect to the NHRA.

Figure 4. Hartland – Phase 4 – works nearly complete at 7622. Stone Age flaked cobbles and hammerstone.

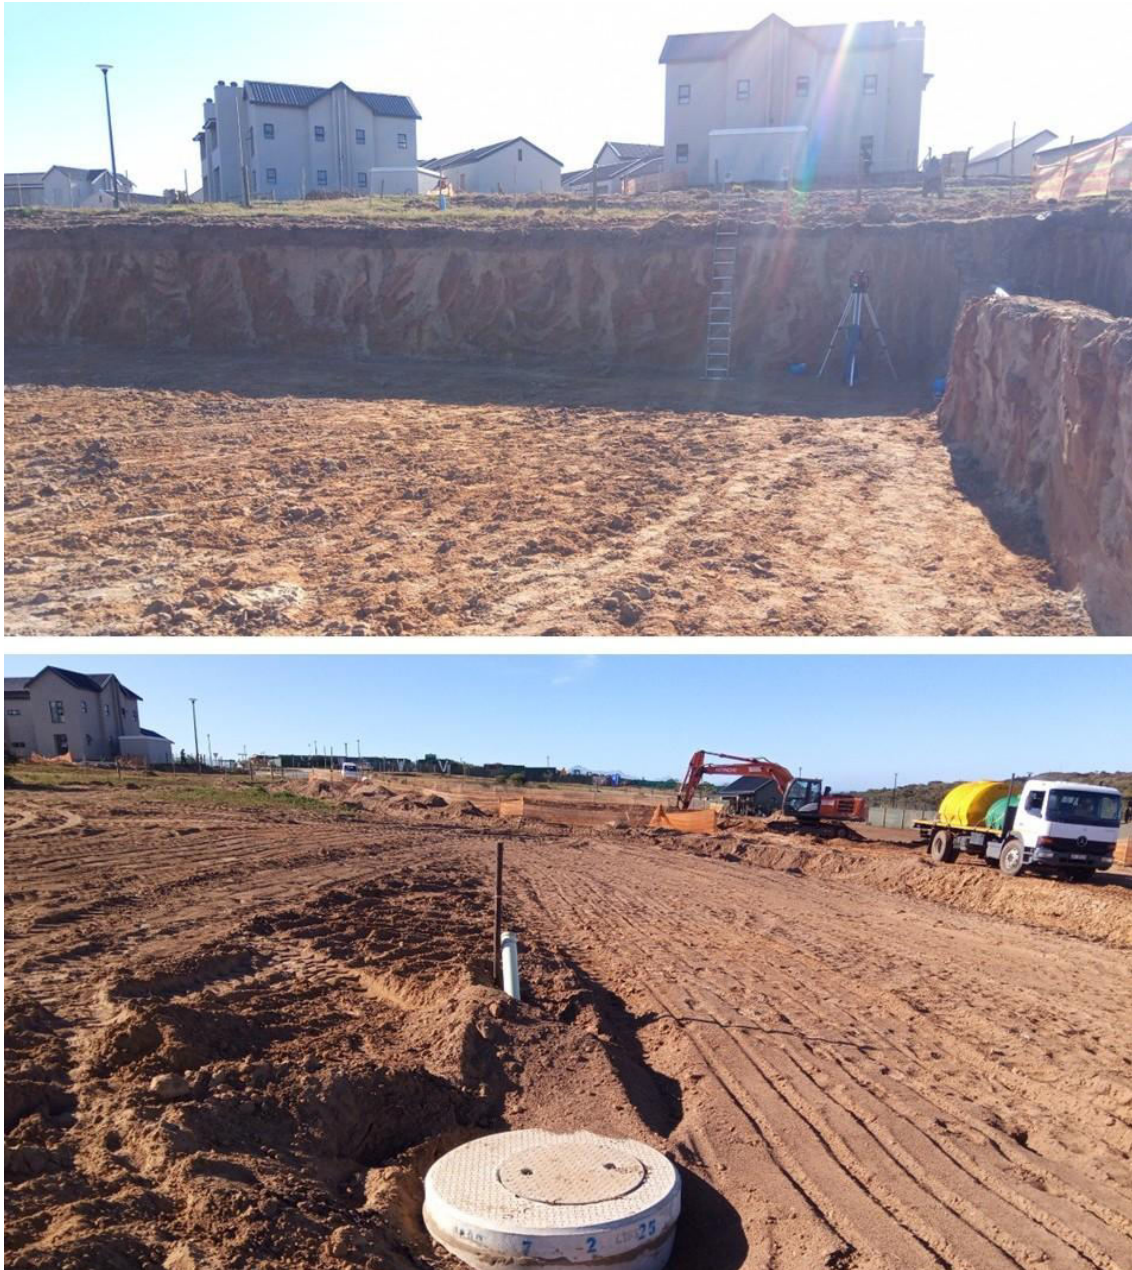
Earthworks involved trenching and a large block excavation (Figure 5). No heritage resources were identified.

Figure 5. Hartland Retirement Village – works in progress.

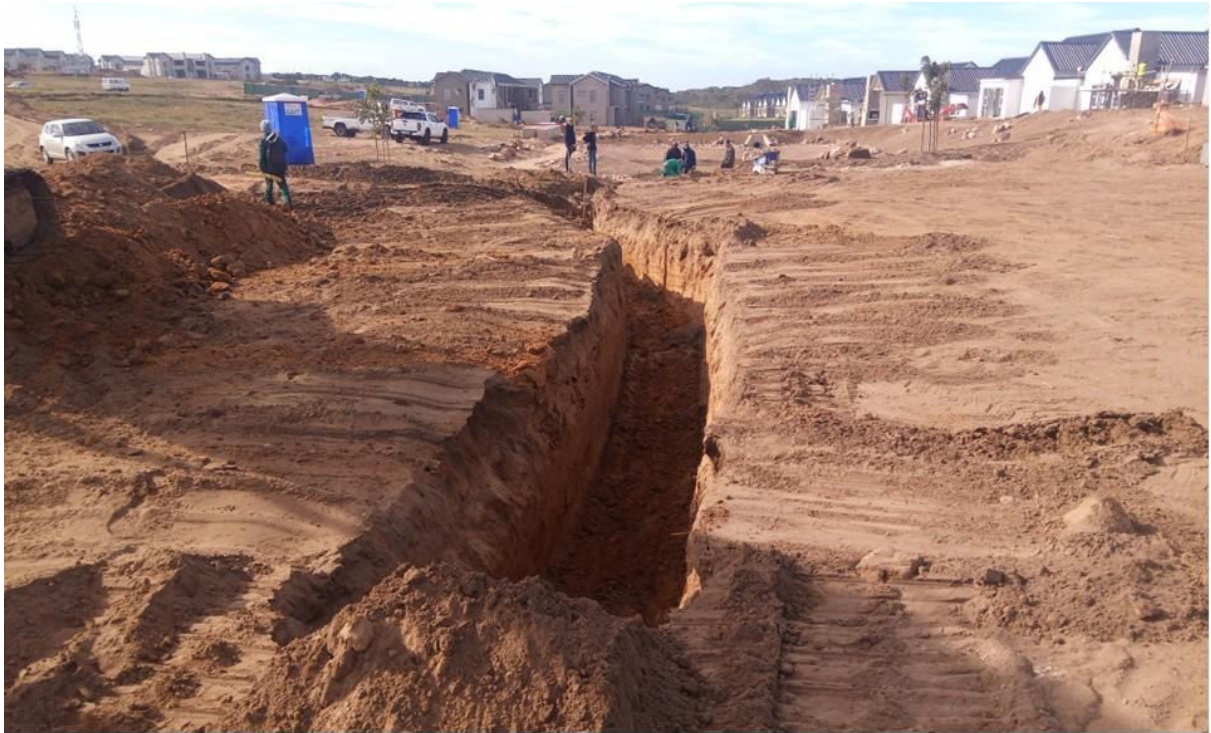
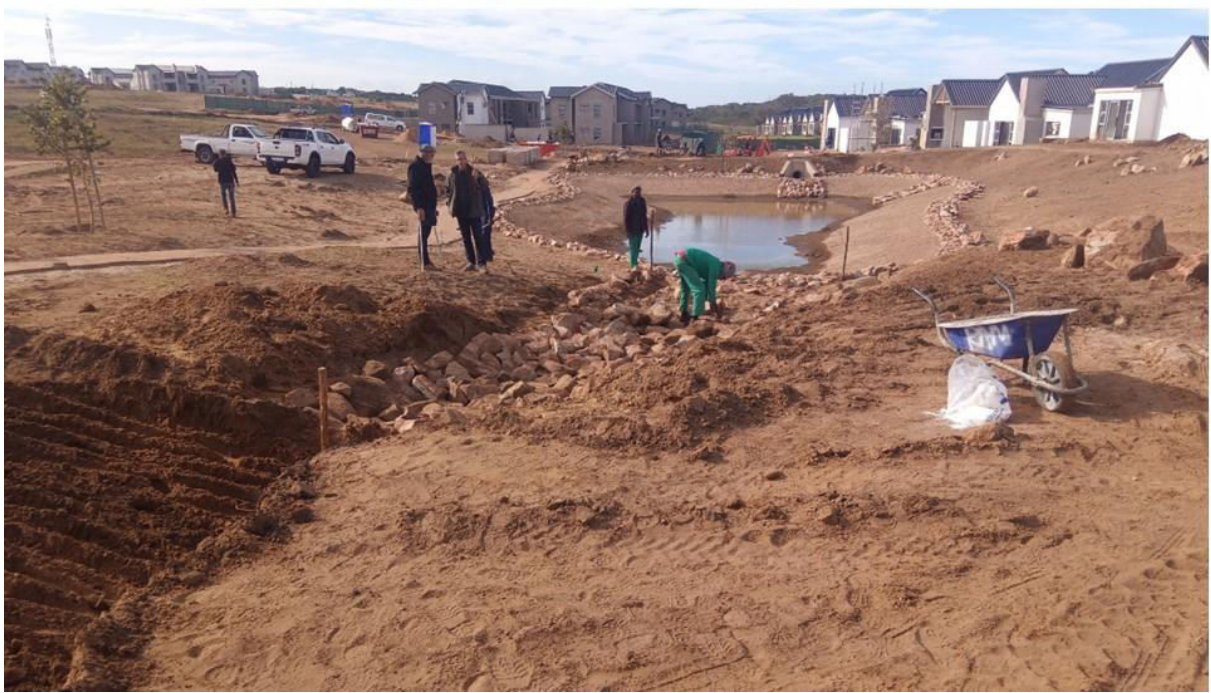
Earthworks involved the excavation of a trench leading to and from a storm water “pond” (Figure 6). No heritage resources were identified.

Figure 6. Hartland Retirement Village Phase 2 – works in progress.

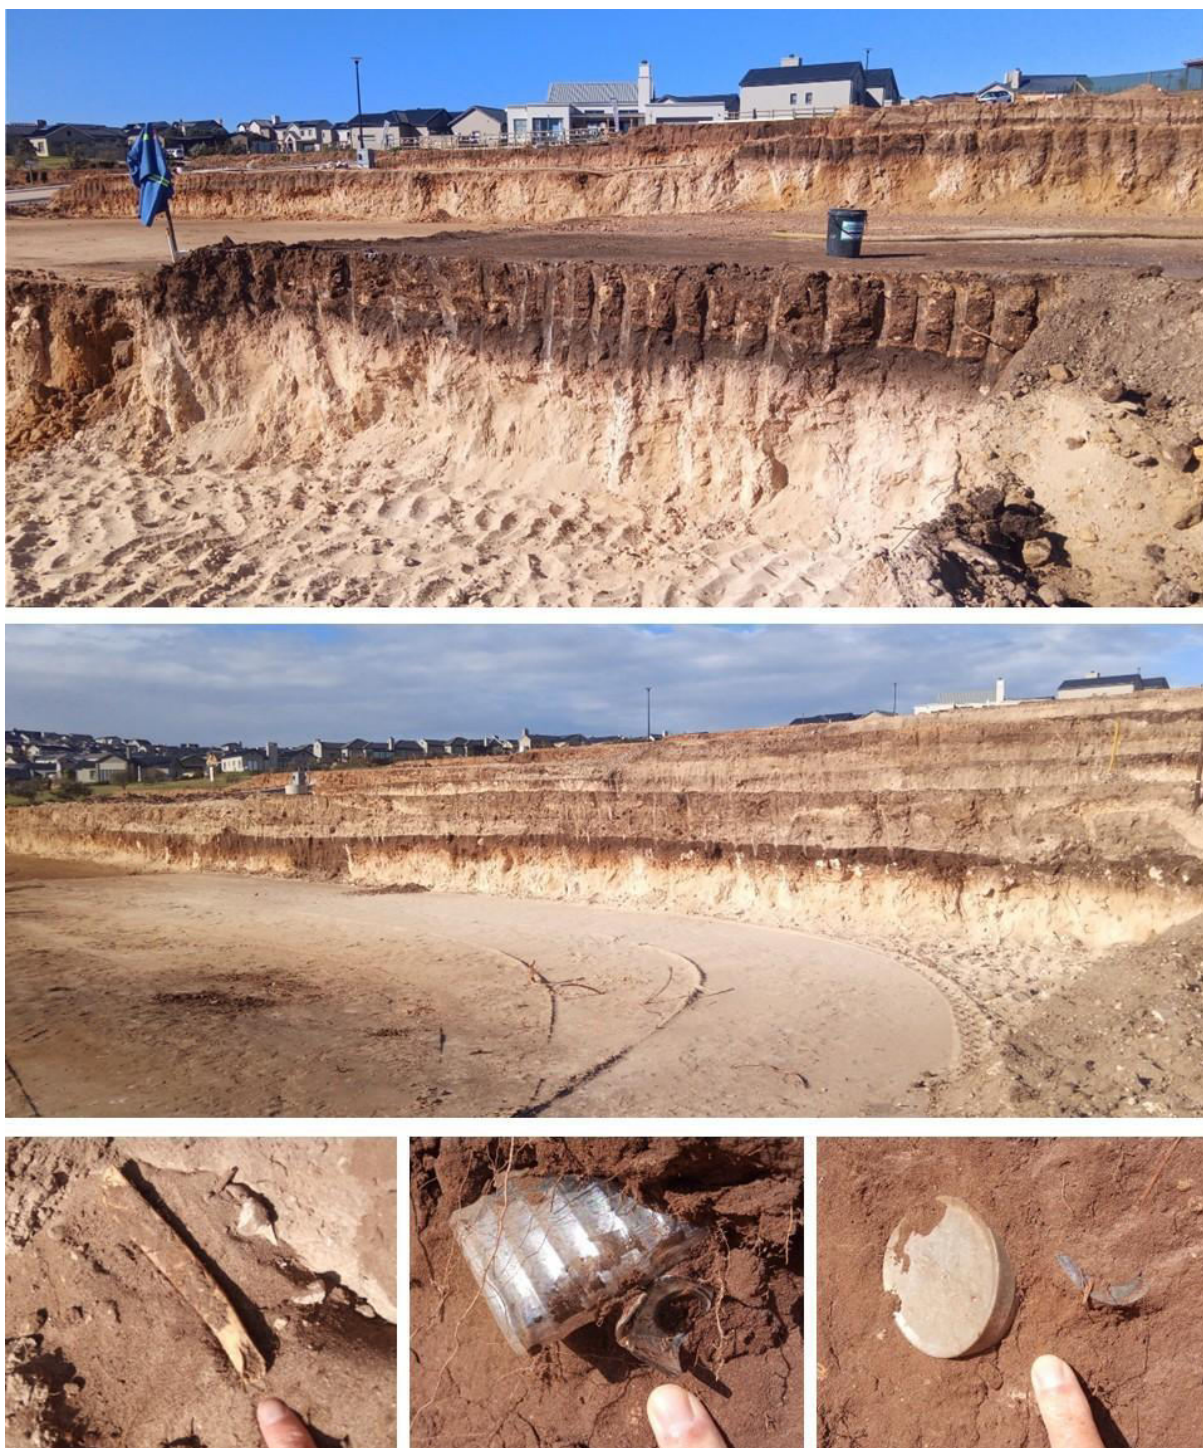
Works included the third and fourth columns of terraces for house foundations and road box cuts (Figures 7 & 8). Several pieces of debris of modern / colonial period age were recorded in an exposed profile and in excavated sediments. These included fragments of glass, ceramic, metal, animal bones as well as a heavily rusted pickaxe (Figure 7). Due to their low densities and disturbed context, these materials are rated as Not Conservation Worthy and require no further work in terms of the NHRA.

Figure 7. Hartland - Phase A Klein Karoo – works in progress and a few examples of modern / colonial period pieces.

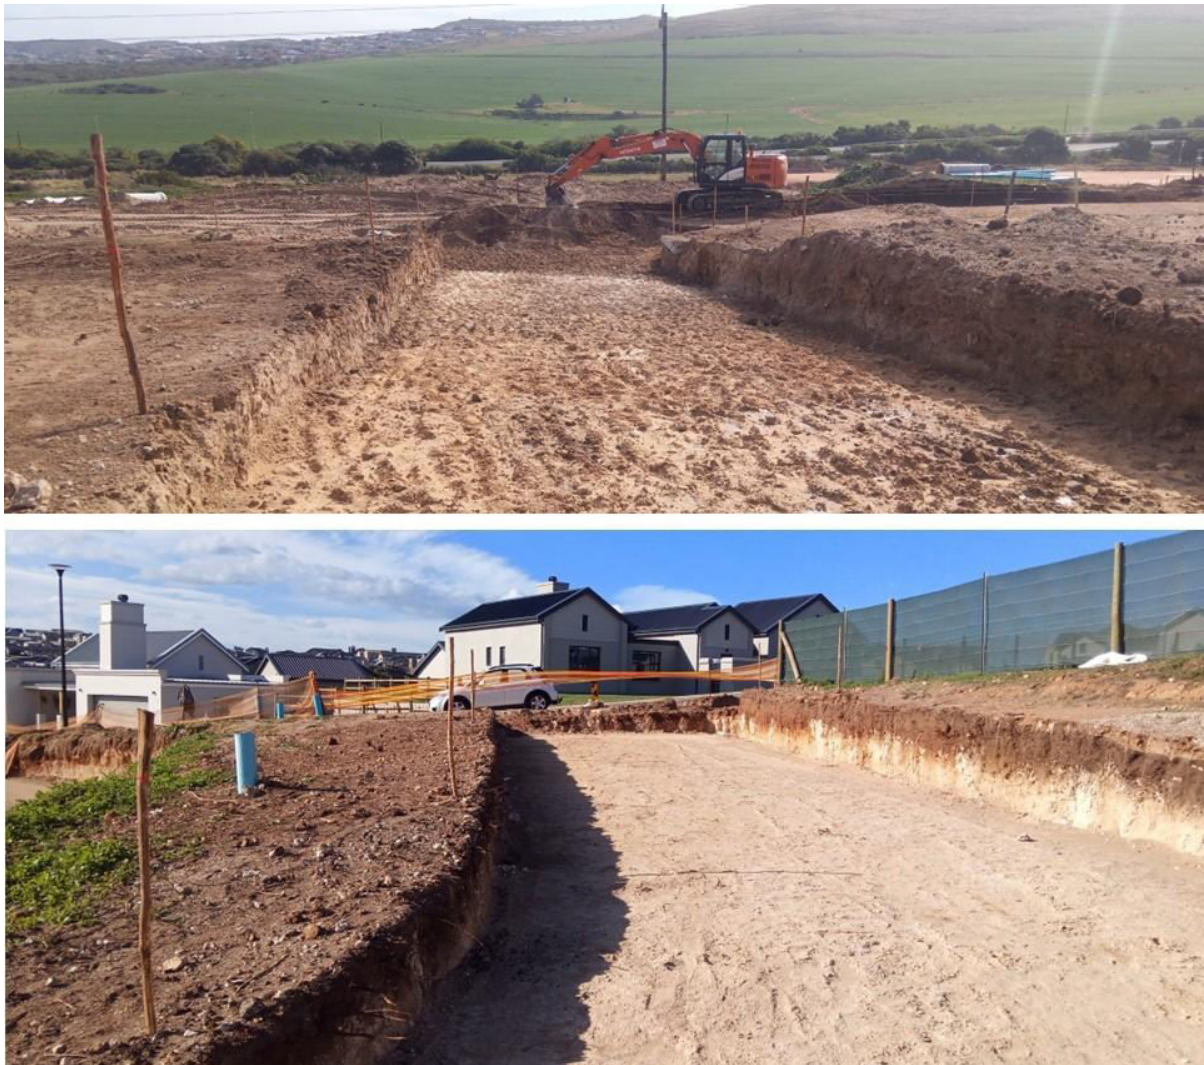
Figure 8. Hartland - Phase A Klein Karoo – road box cuts.

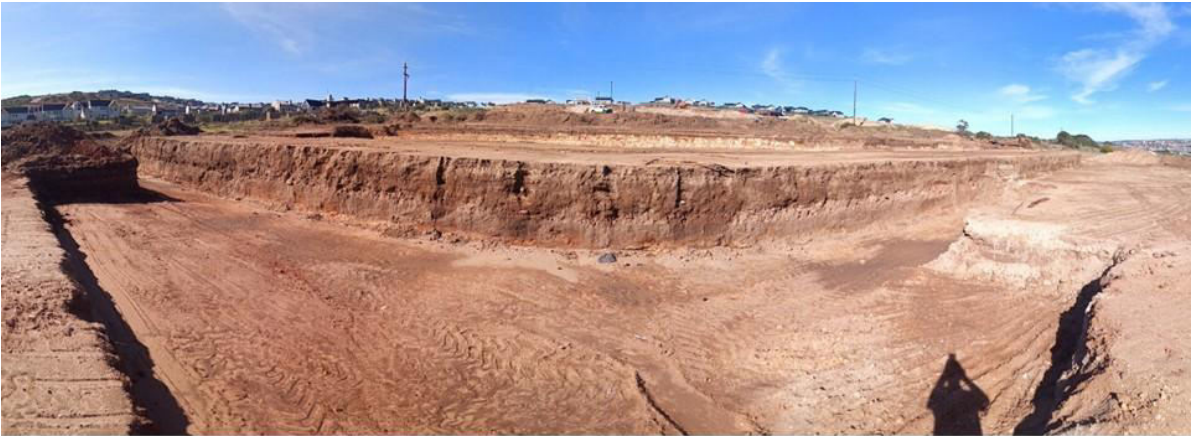
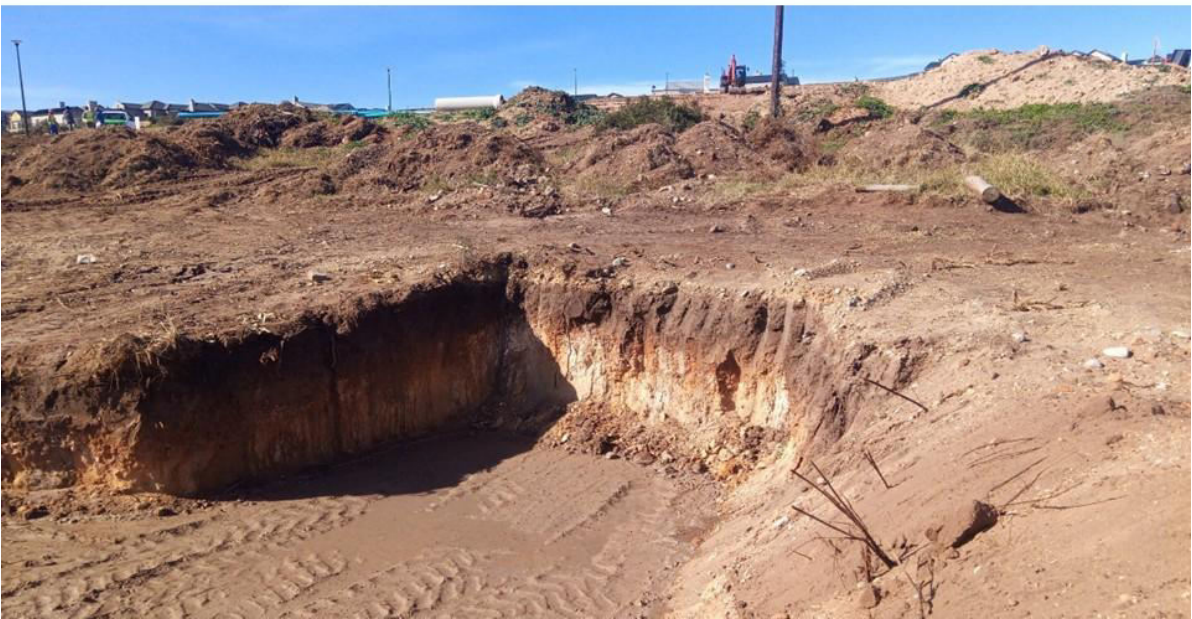
Works involved structural / foundation excavations (Figure 9). A few fragments of glass and ceramics of modern / colonial origin are scattered across this area and were not necessarily unearthed during excavations. No significant heritage resources were identified.

Figure 9. Hartland – School Site – works in progress.
