# ENVIRONMENTAL MONITORING REPORT

# HARTENBOS LANDGOED PHASE 2 DEVELOPMENT ON A PORTION OF THE REMAINDER OF THE FARM VAALEVALLEY 219, MOSSEL BAY

**DATE:** 9<sup>th</sup> December 2019

**REPORT NR:** EMR/HBLG/MSB/03/19

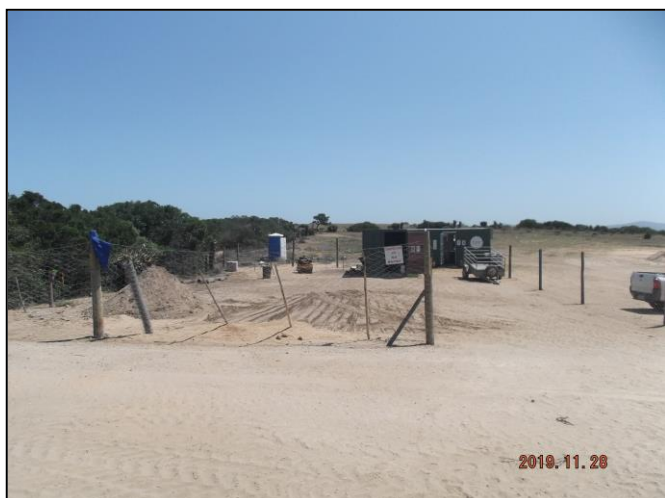
**Image 1: The site camp has been fenced off along its perimeter**

| Section<br>5 | | COMPLIANCE WITH EA and EMPr | |
|---|---|---|---|
| Demarcation and No-Go Areas | Partial | The site camp has been fenced off along its perimeter. | Adequate signage needs to be in place, designating the site office/camp as a restricted area to non – construction people, please refer to page 15 of the approved EMPr. |

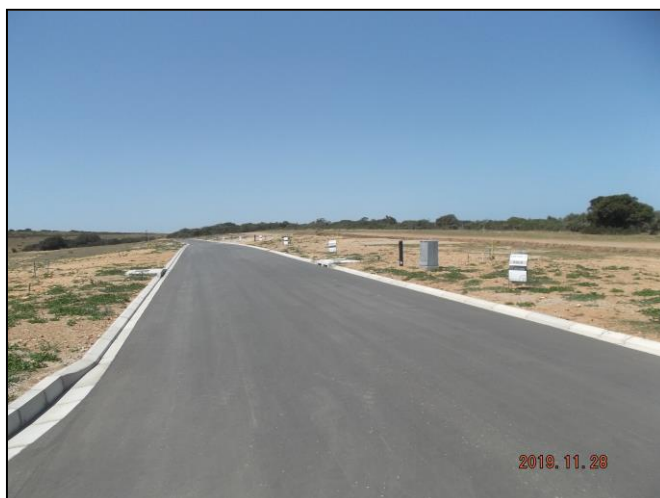
**Image 2: Roads and kerbing have been constructed within the development site**

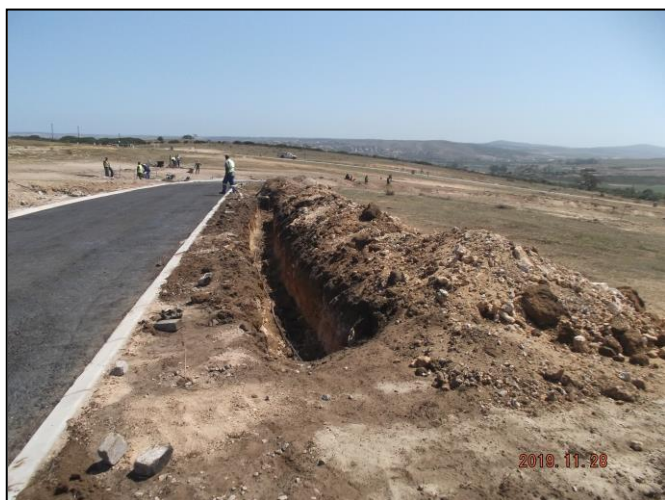
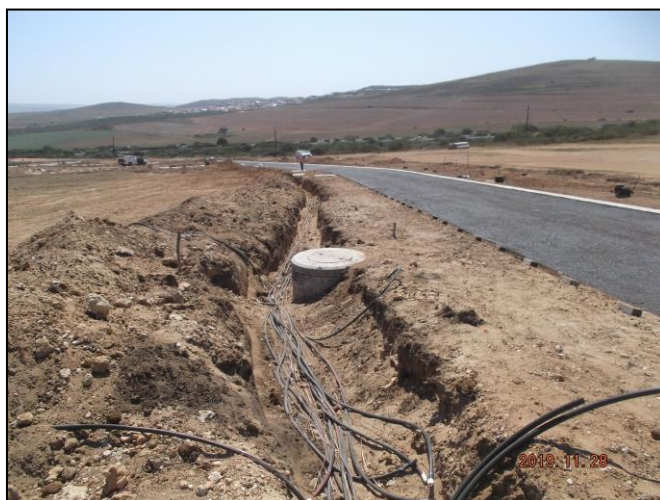
**Images 3 & 4: Installation of electricity cables within the trenches**

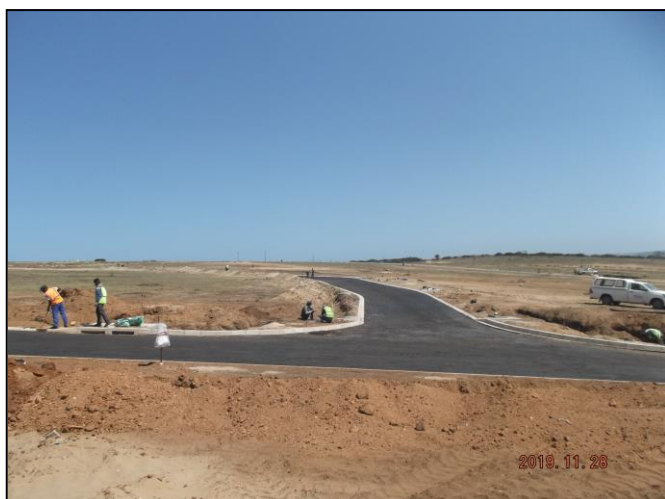
**Images 5: Installed road network within the development site**

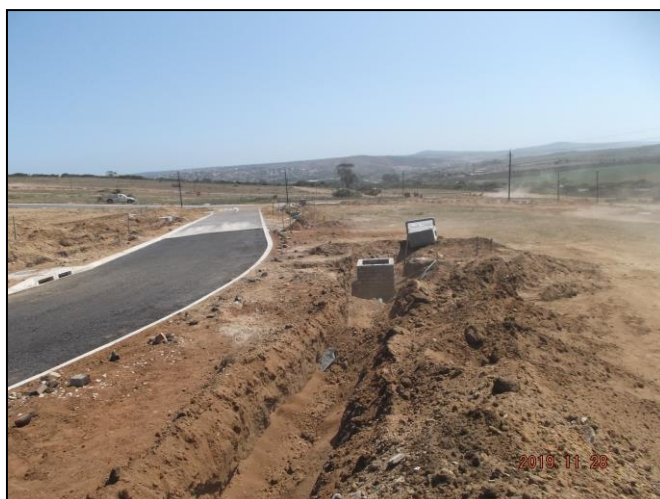
**Image 6: Construction of valve chambers along the pipeline route within the development site**

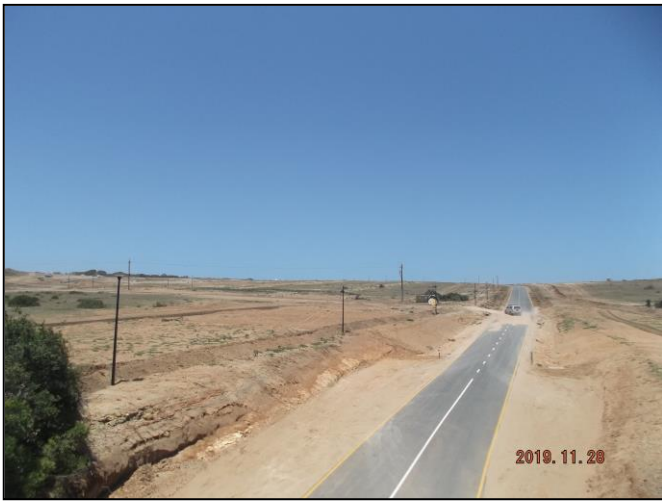
**Image 7: Development site**

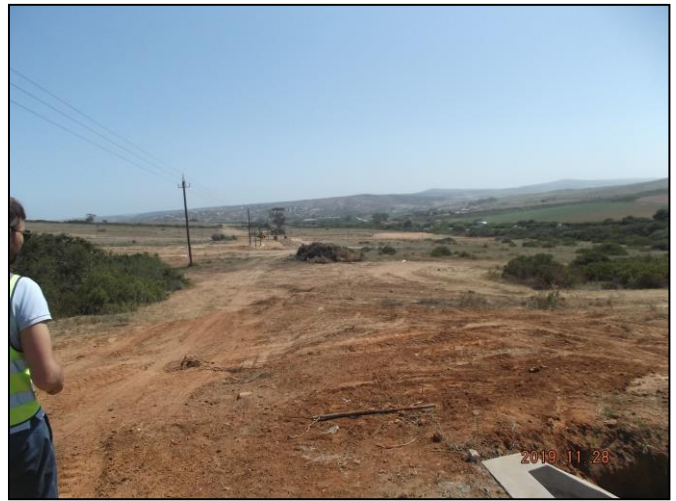
**Image 8: Development site in a western direction**

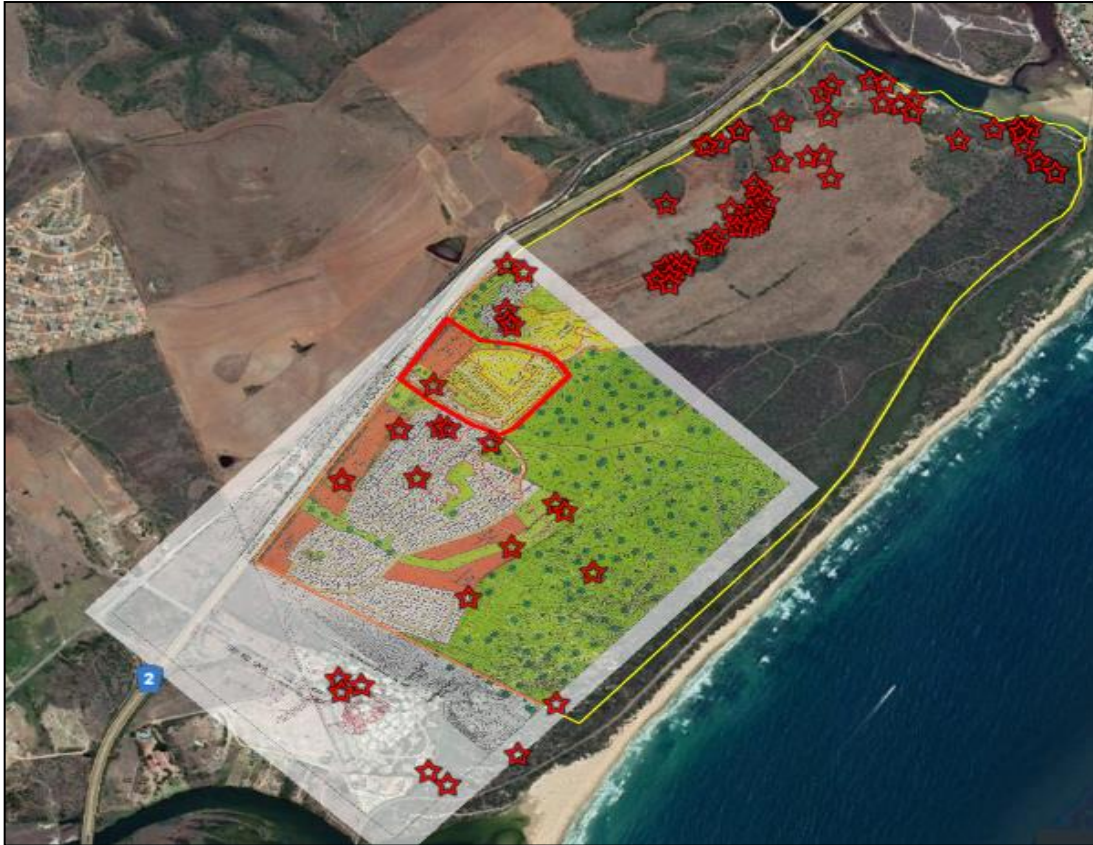
No permits have been obtained from Heritage Western Cape as stipulated in the Impact Assessment Report conducted by MAPCRM cc. Refer to Figure 3 for the archaeological of the Heritage Report compiled for the assessment of this development which have been overlain on a Google Earth Image of the site in addition to the most recent Site Development Plan.

Figure 3: Site map indicating areas of heritage interest

| Section<br>5 | COMPLIANCE WITH EA and EMPr | | |
|---|---|---|---|
| Discovery and Protection of Heritage resources | No | No permits were obtained from Heritage Western Cape as stipulated in the Impact Report by MAPCARM cc dated 28 September 2005. | No archaeological remains were to be found according to our knowledge. Permits can still be obtained from Heritage Western Cape |

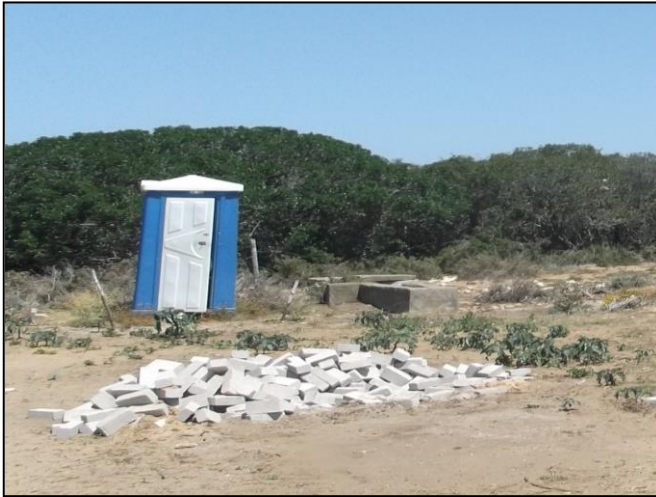
| Section<br>5 | | COMPLIANCE WITH EA and EMPr | |
|---|---|---|---|
| Ablution facilities | Partial | A chemical toilet was provided for the labourers on site (Image 9). | As stated in the approved EMPr, one chemical toilet must be provided for every fifteen |

**Image 9: The chemical toilet must be placed on a level surface**

| Section<br><b>5</b> | | <b>COMPLIANCE WITH EA and EMPr</b> | |
|---|---|---|---|
| | | | labourers on site therefore two chemical toilets must be provided on site to accommodate the 35 labourers |

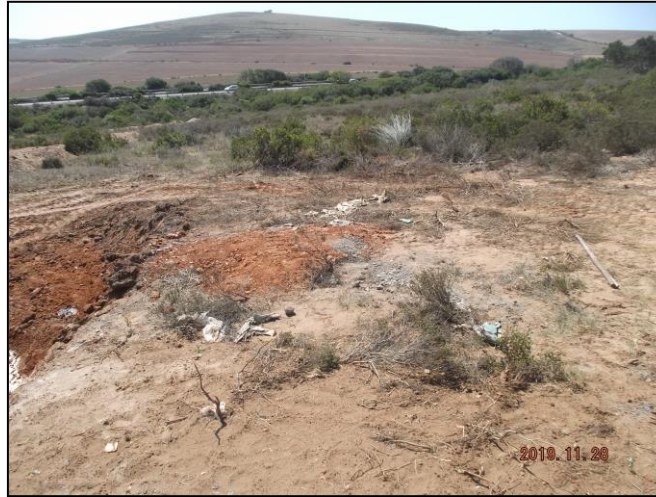
| Section<br><b>5</b> | | <b>COMPLIANCE WITH EA and EMPr</b> | |
|---|---|---|---|
| Housekeeping | Partial | Building rubble and removed branches were noted within the development site (Image 10). The general housekeeping of the site was in a good condition. | The building rubble must be removed within the development site and disposed of at an appropriate registered facility. In addition, the housekeeping must be maintained for the duration of the construction period. |

**Image 10: The building rubble must be removed from site and disposed of at an appropriate registered facility**

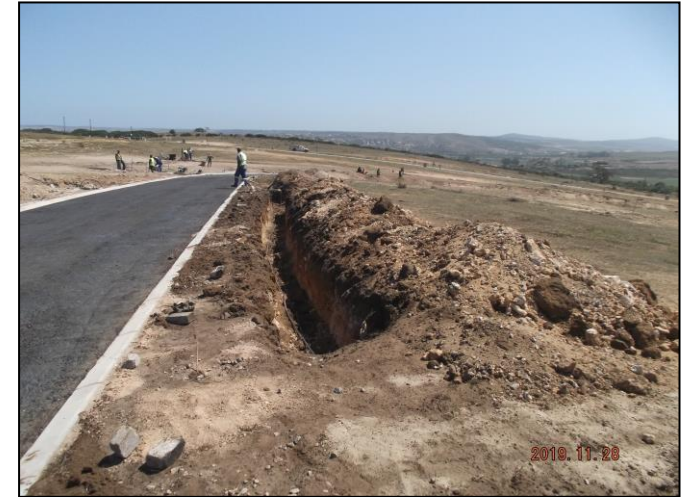
| Section<br><b>5</b> | | <b>COMPLIANCE WITH EA and EMPr</b> | |
|---|---|---|---|
| Topsoil and subsoil management Stockpiles and lay-down areas | No | The topsoil and subsoil were not stored separately on site (Image 11). In addition, the stockpiles on site were not demarcated however no erosion were noted to the stockpiles. | Topsoil and subsoil which has been removed must be stored separately and left in that position for the duration until rehabilitation ventures. Please refer to page 22 of the approved EMPr. |

**Image 11: The topsoil and subsoil must be stored separately for the duration of the project**

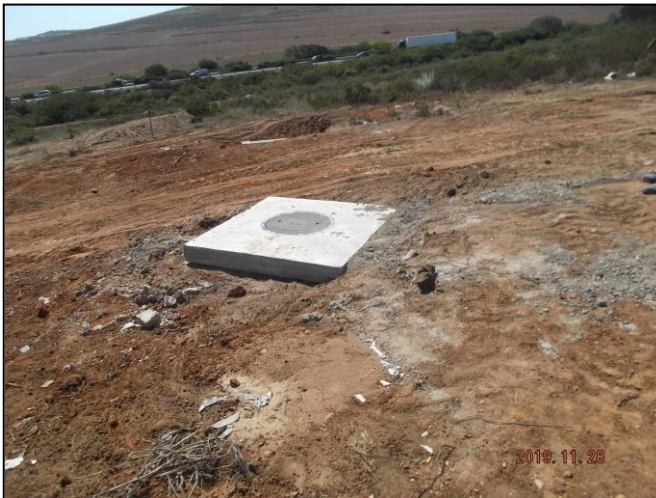
| Section<br><b>5</b> | | <b>COMPLIANCE WITH EA and EMPr</b> | |
|---|---|---|---|
| Concrete Management | Partial | Concrete was noted on the bare ground within the development site (Image 12). | The concrete must be removed from the ground and disposed of at an appropriate registered facility. The concrete management must be maintained for the duration of the project. |

**Image 12: The concrete powder and pieces must be removed from the ground and disposed of at an appropriate registered facility**

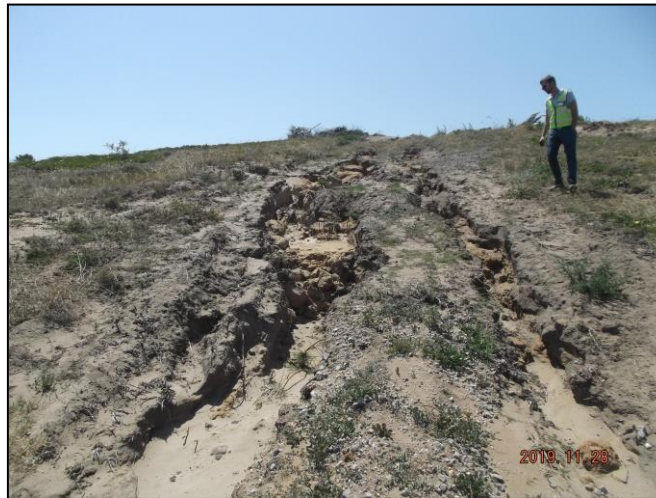
| Section<br><b>5</b> | | <b>COMPLIANCE WITH EA and EMPr</b> | |
|---|---|---|---|
| Erosion Control and Stormwater Management | No | Erosion was noted within the development site, as seen from Image 13. | The erosion gullies must be rehabilitated and further erosion on site must be mitigated. |

**Image 13: The erosion gullies on site must be rehabilitated and further erosion must be mitigated**

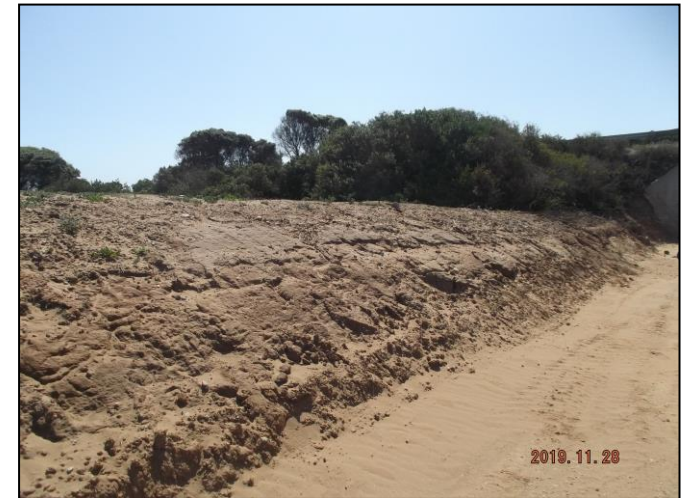
**Image 14: The embankment on site must be revegetated with indigenous vegetation**

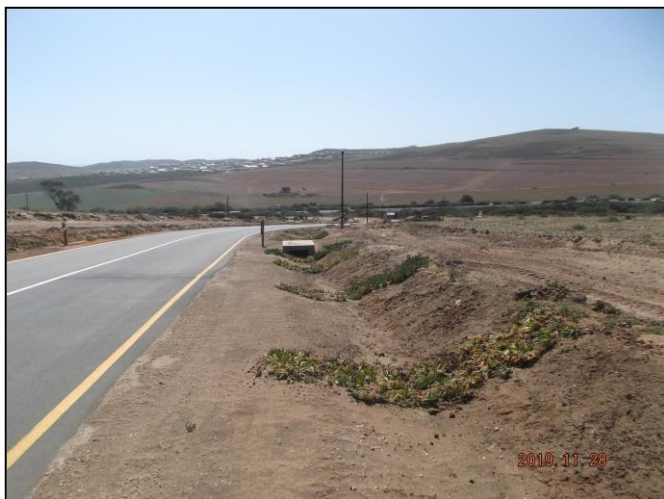
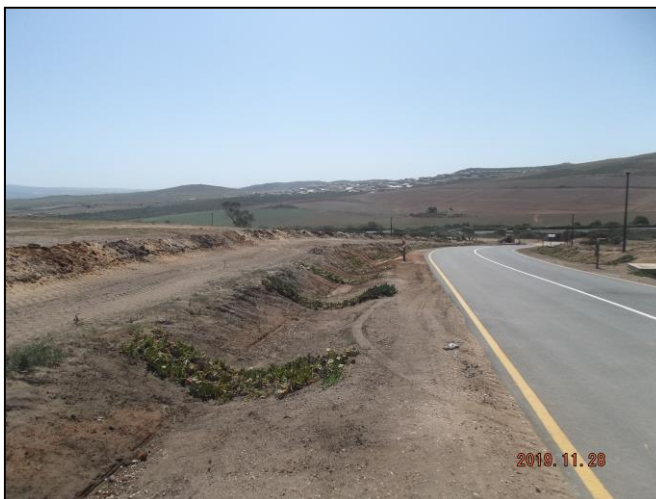
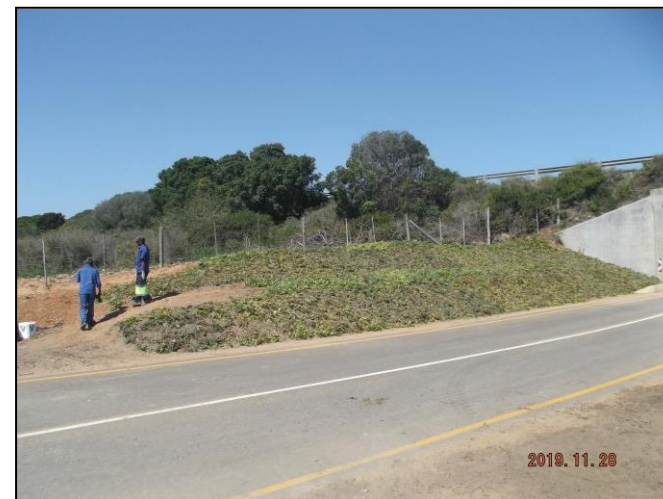
| Section<br><b>5</b> | | <b>COMPLIANCE WITH EA and EMPr</b> | |
|---|---|---|---|
| Rehabilitation | Yes | During our site inspection it was noted that the contractor was undertaking rehabilitation activities on site, as seen from Images 15 to 17. | Final rehabilitation and landscaping must be undertaken once construction activities have concluded on site. Completed areas must be |

**Images 15 to 17: Disturbed areas were revegetated with indigenous vegetation**

| Section<br>5 | COMPLIANCE WITH EA and EMPr | | |
|---|---|---|---|
| | | | rehabilitated as soon as practically possible by implementing the rehabilitation mitigation measures as specified within the approved EMPr. |
