## APPENDIX A – SITE PHOTOGRAPHS

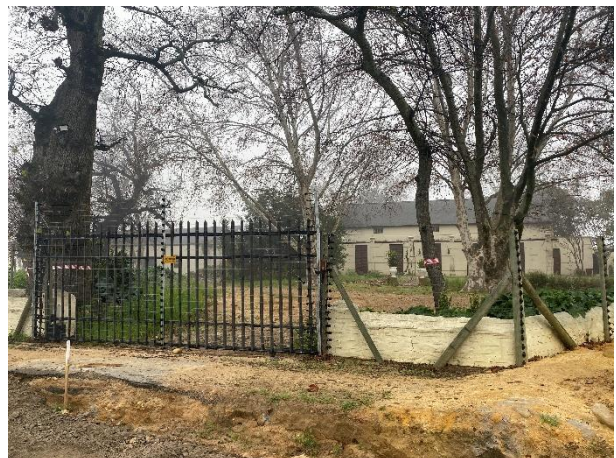
Workers' homesteads to be demolished and crushed; Firwoods Homestead to be retained.

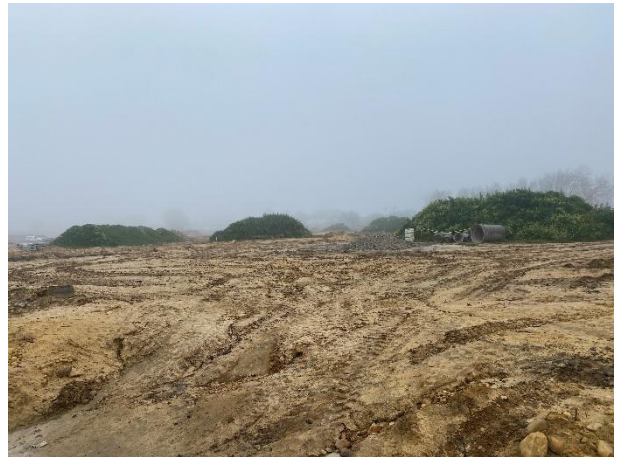
Stormwater pipeline material adjacent to the road being chipped and sprayed west of the Firwoods Homestead.

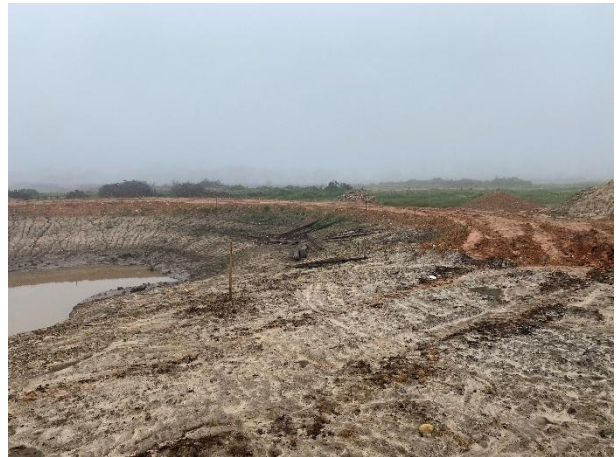
1.1m stormwater pipeline material adjacent to the large stormwater pond to be installed.

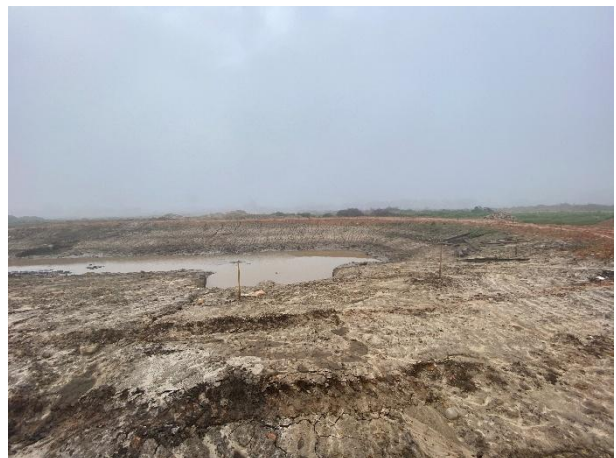
Condition of the large stormwater pond located east of the existing Firwoods Homestead.

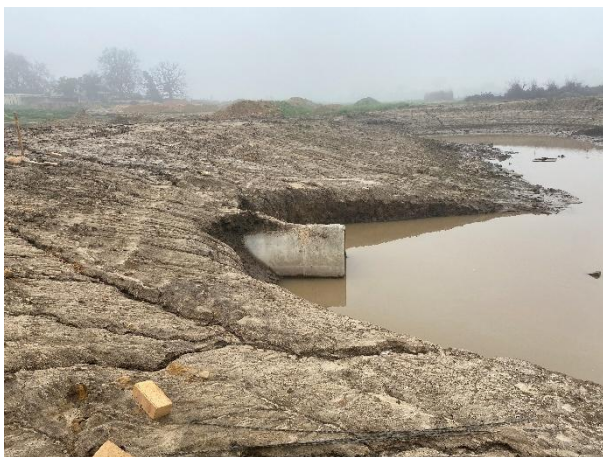
Condition of the large stormwater pond located east of the existing Firwoods Homestead.

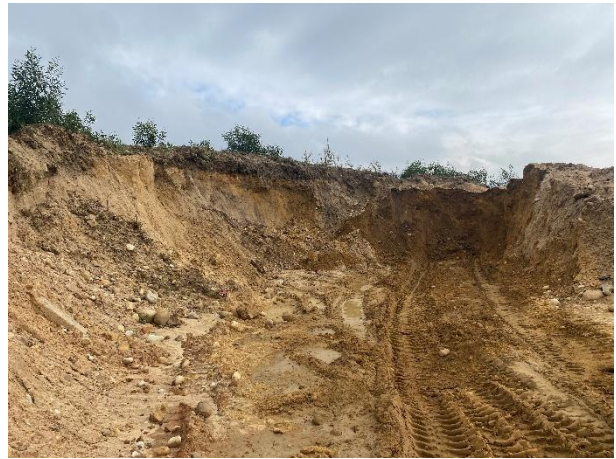
Dumped base material after the construction of the mall west of the development site, creating a quarry.

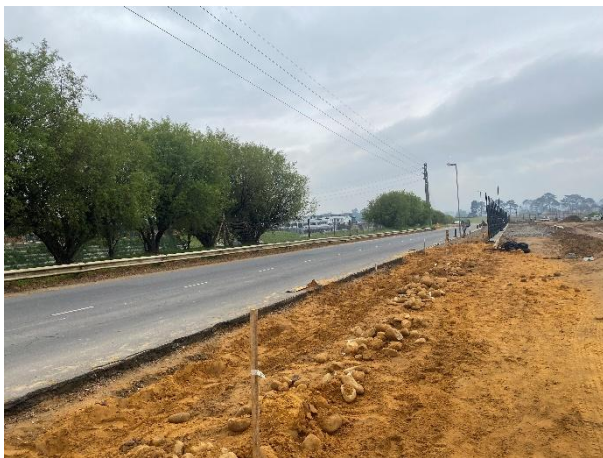
Condition of New Eskdale Street towards the southwest where the ClearVu boundary fence is being installed.

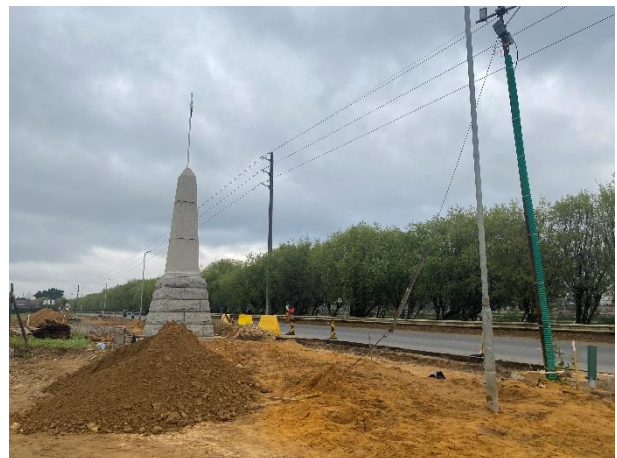
Condition of New Eskdale Street towards the southwest, where the ClearVu boundary fence is being installed.

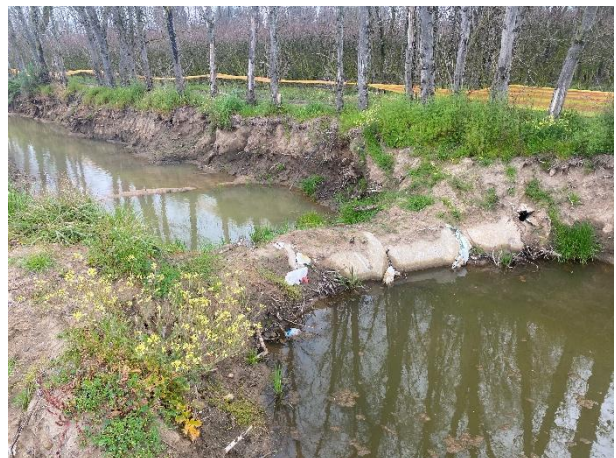
Collapsed stormwater channel with a new, formalised channel under construction.

Collapsed culvert to be upgraded.

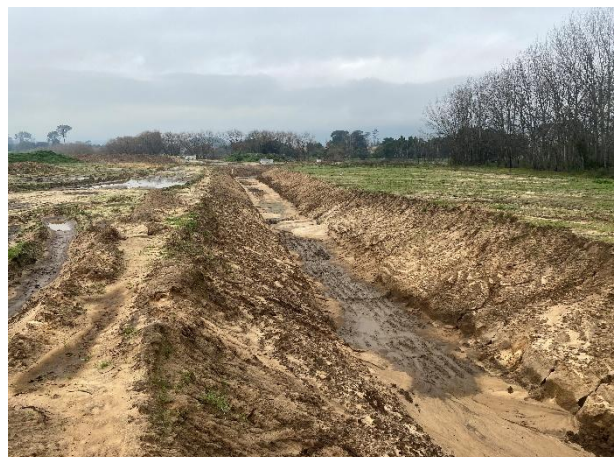
Recent rain filled the excavated stormwater channel; sandbags were placed to control flow.

Stormwater channel being upgraded towards the southwest.

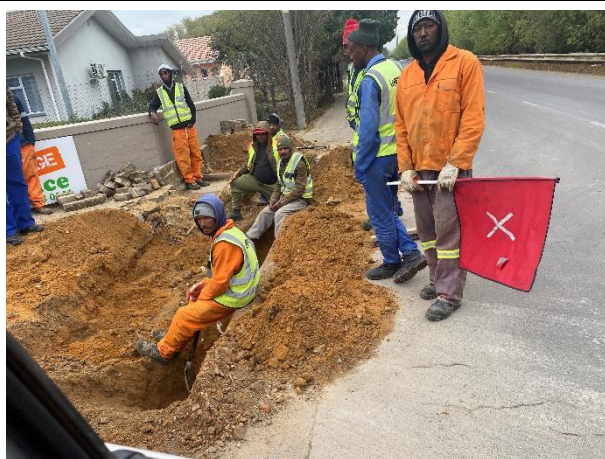
Stormwater channel being upgraded towards the southwest.
