## APPENDIX A – SITE PHOTOGRAPHS

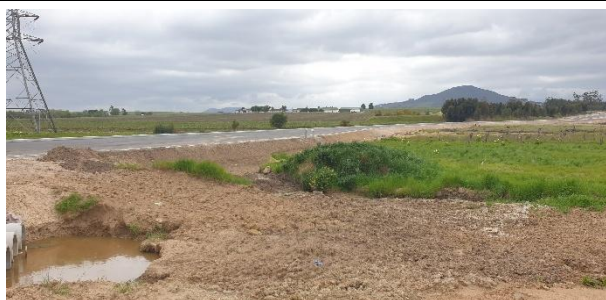
Drainage channel adjacent to the R44 to Stellenbosch.

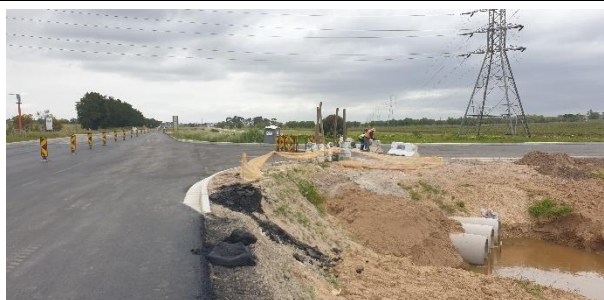
Condition of the main access road towards the north.

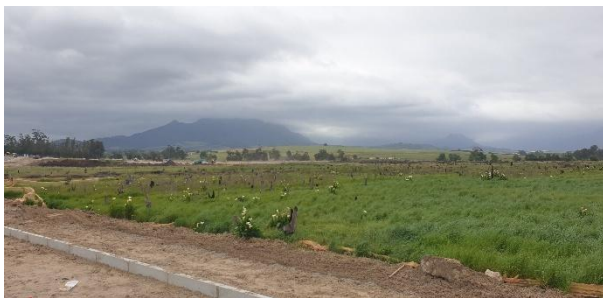
Condition of the wetland area adjacent to the R44 to Stellenbosch towards the south.

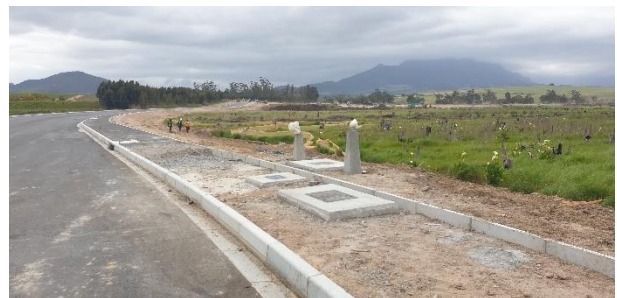
Condition of the wetland area adjacent to the R44 to Stellenbosch towards the southeast.

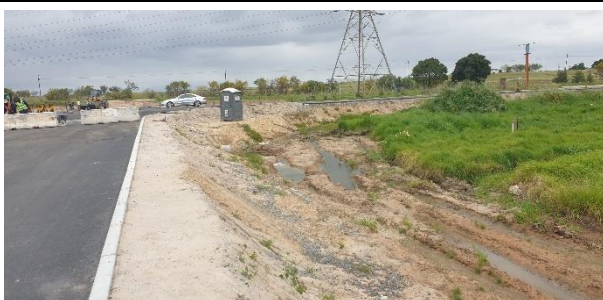
Pedestrian walkways under construction alongside the main access road.

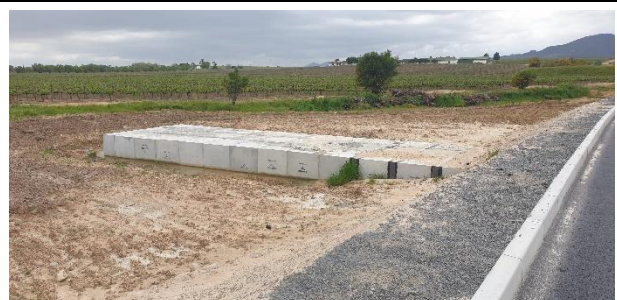
Condition of the drainage area adjacent to the main access road.

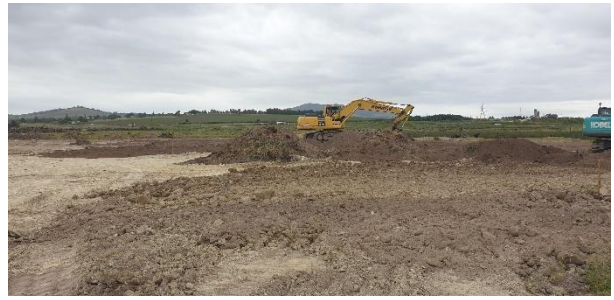
Location of the traditional headstone grave site. Topsoil and composting are being spread across the site.

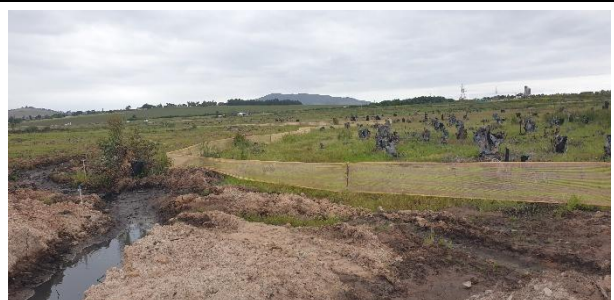
Drainage channels being shaped across the site.

Rehabilitation/Wetland area fully demarcated. Contractor is reminded to install sediment traps where necessary.

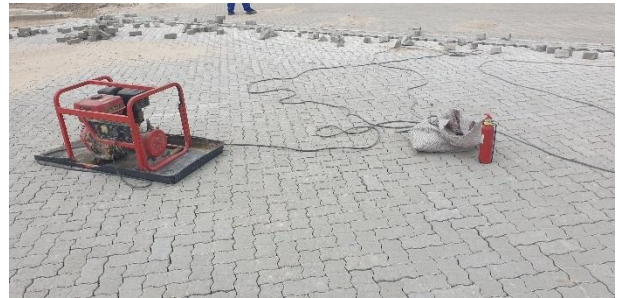
Generator placed within a drip tray, a fire extinguisher is present on-site.
