## APPENDIX A – SITE PHOTOGRAPHS

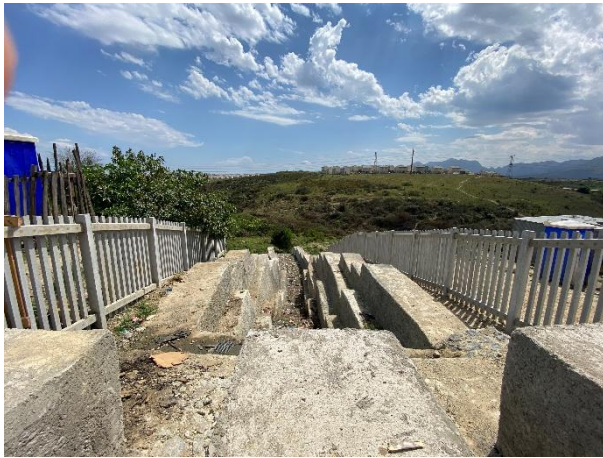
Site 28(1).1

Completed upgraded/replaced SW outlet structure.

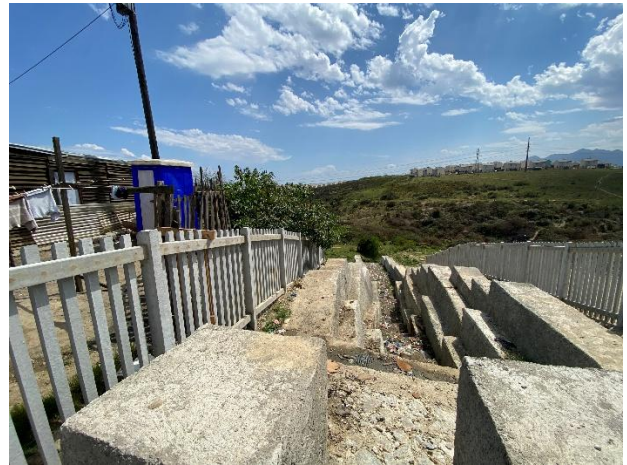
Chemical toilet available adjacent to the works area.

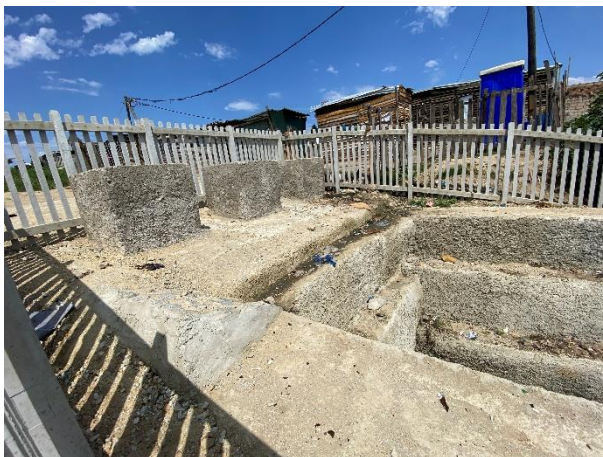
Completed upgraded/replaced SW outlet structure.

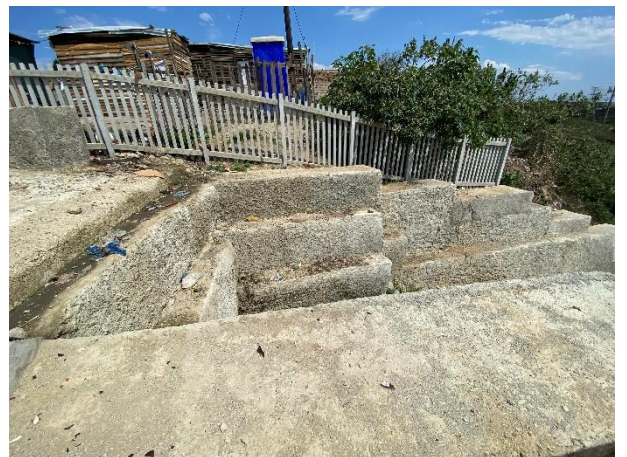
Completed reconstruction of stormwater outlet structure headwall.

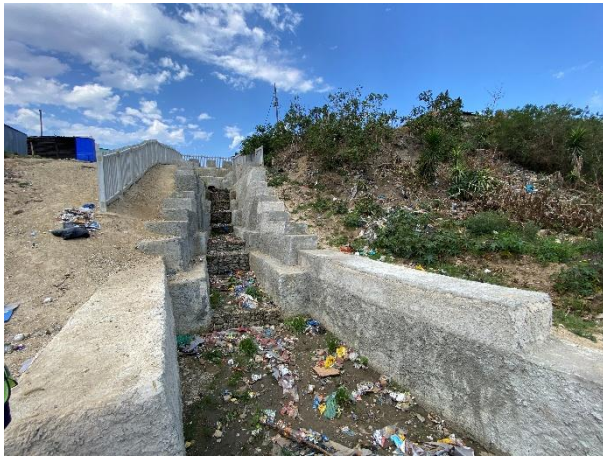
New gabion/mattress flood attenuation works completed. Local residents responsible for dumping.

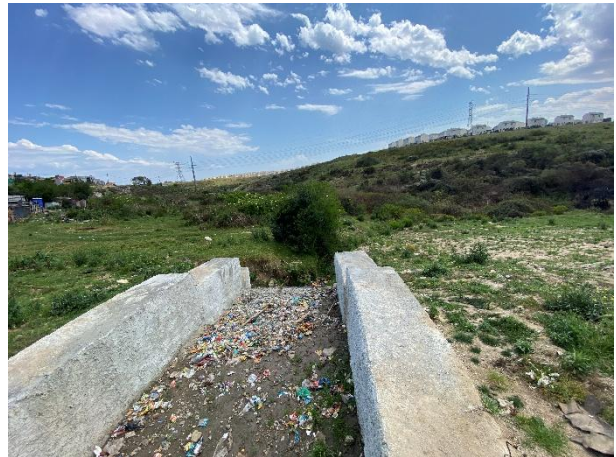
New gabion/mattress flood attenuation works completed. Local residents responsible for dumping.

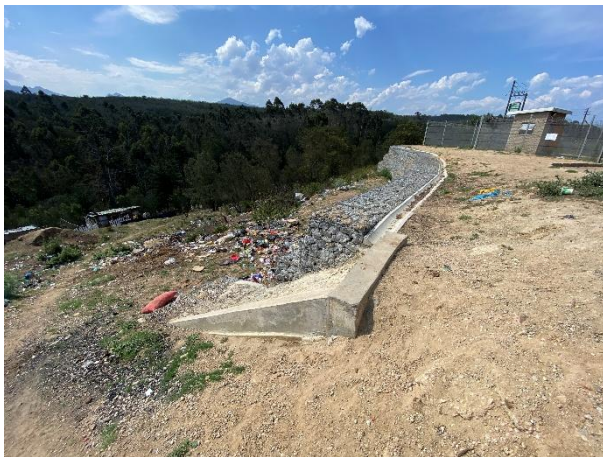
Completed reconstruction of gabion retaining wall. Local residents responsible for dumping.

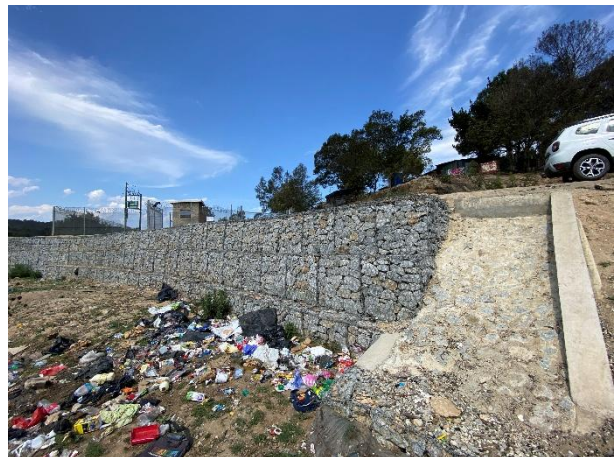
Completed reconstruction of gabion retaining wall. Local residents responsible for dumping.

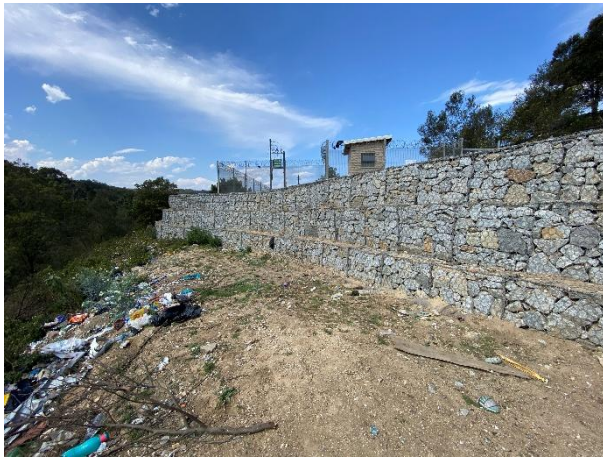
Completed reconstruction of gabion retaining wall. Local residents responsible for dumping.

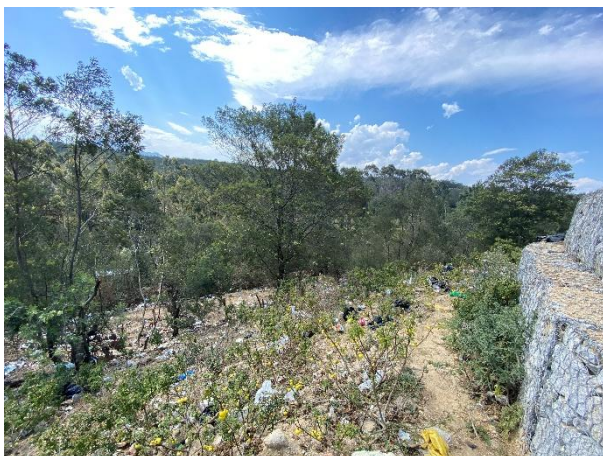
Completed reconstruction of gabion retaining wall. Local residents responsible for dumping.

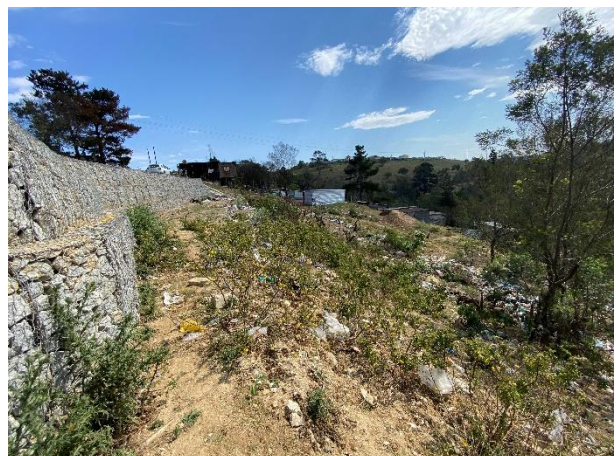
Completed reconstruction of gabion retaining wall. Local residents responsible for dumping.

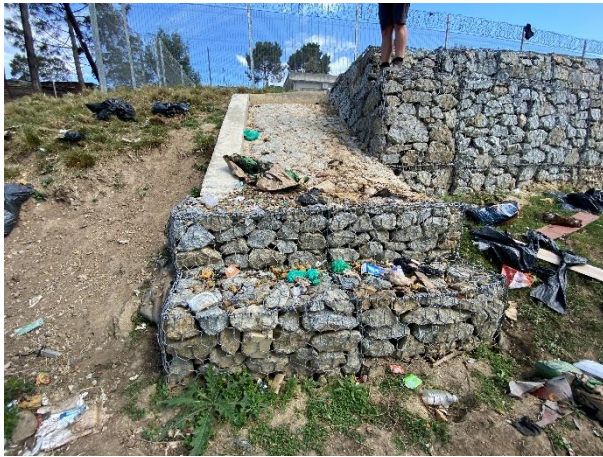
Shaping and tie in at the ends of the gabion structure completed. Local residents responsible for dumping.

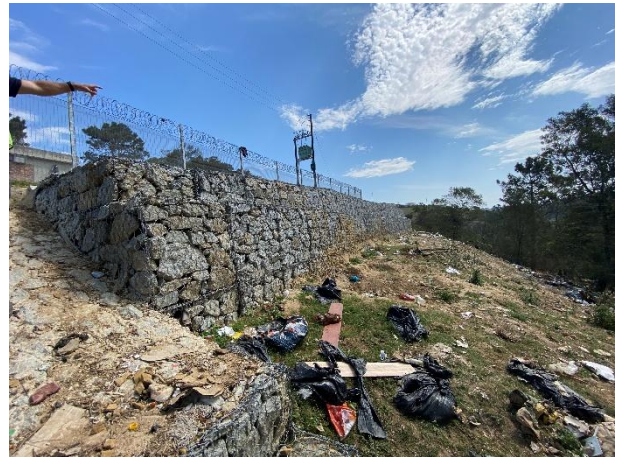
Completed reconstruction of gabion retaining wall. Local residents responsible for dumping.

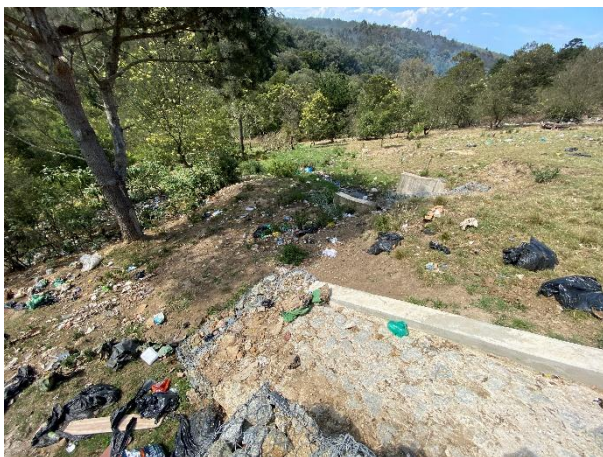
Shaping and tie in at the ends of the gabion structure completed. Local residents responsible for dumping.

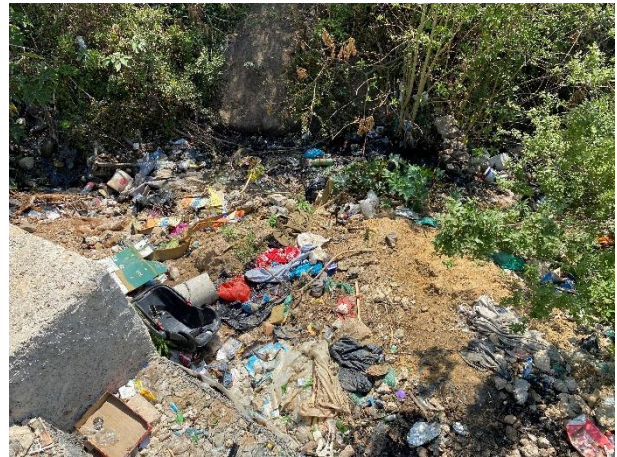
Local residents responsible for dumping.

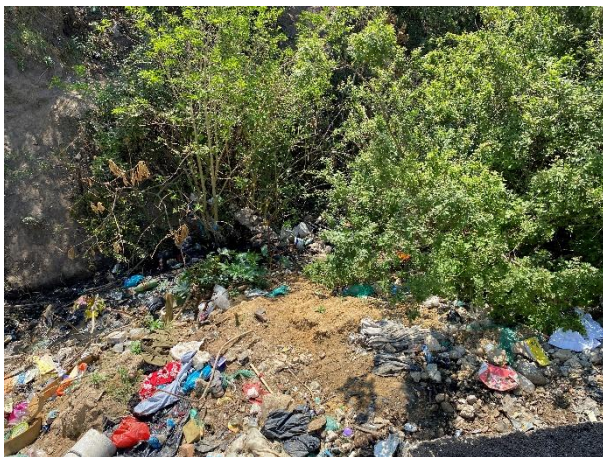
Local residents responsible for dumping.

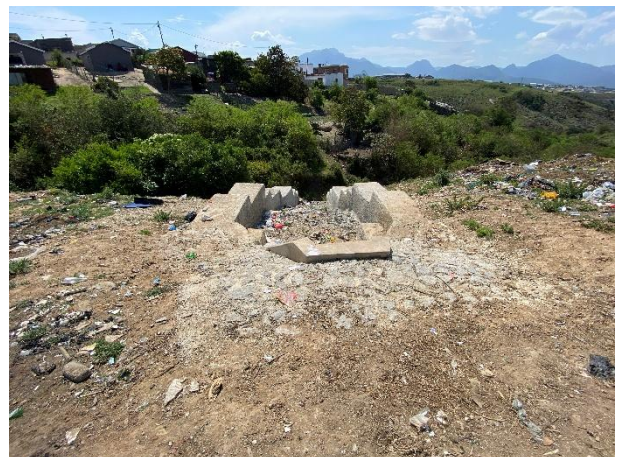
New gabion/mattress flood attenuation works outlet completed. Erosion damage fix and rehabilitated.

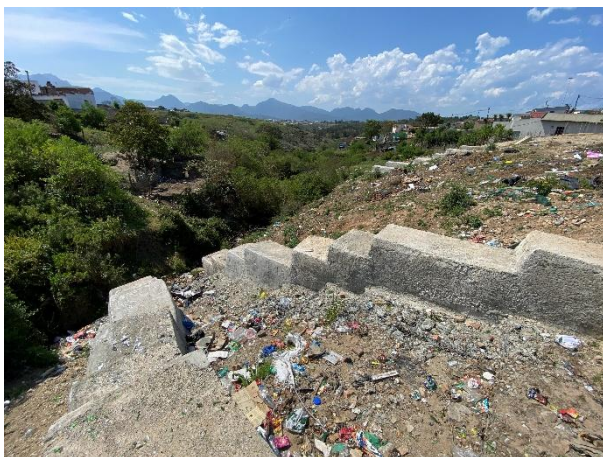
New gabion/mattress flood attenuation works outlet completed. Local residents responsible for dumping.

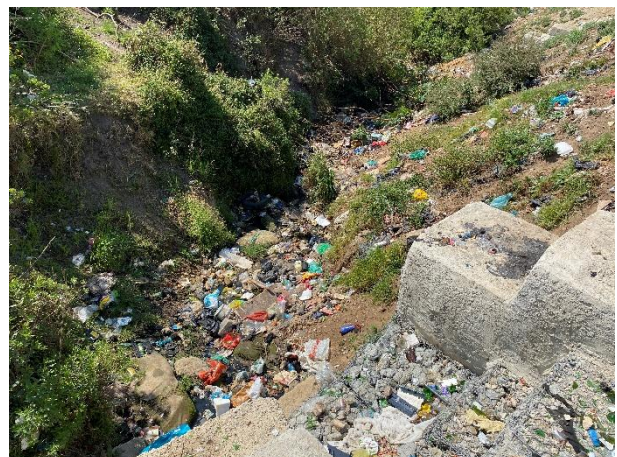
Local residents responsible for dumping.

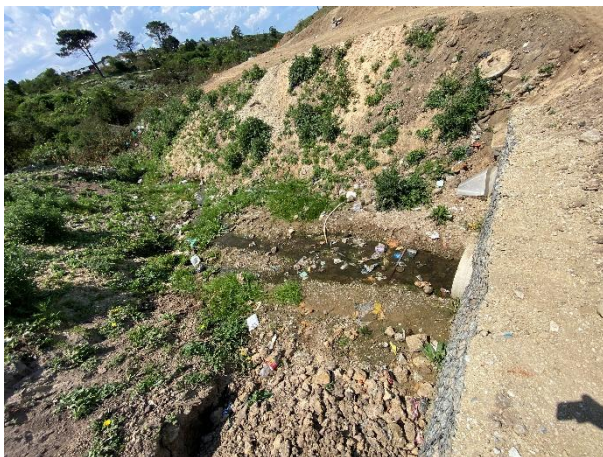
Upgraded stormwater outlet infrastructure. Erosion damage to be fixed and rehabilitated.

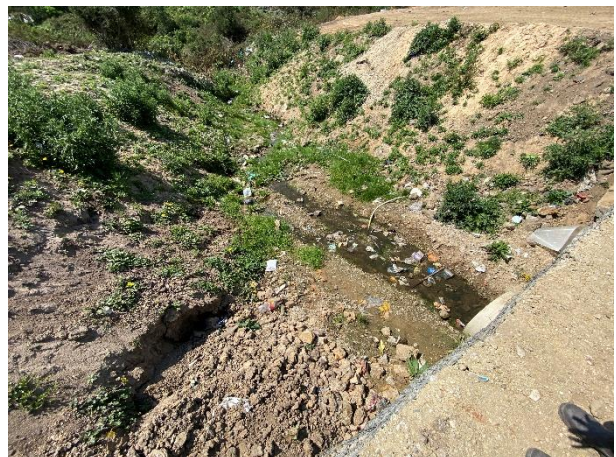
Upgraded stormwater outlet infrastructure. Erosion damage to be fixed and rehabilitated.
