### ENVIRONMENTAL MONITORING REPORT No. 1 FOR

*Maintenance to and Management of the stormwater infrastructure for  
Project 28(1) – Flood damage repair in George Municipal area*

**GEO24/1252/15**

**June 2024 to July 2024**

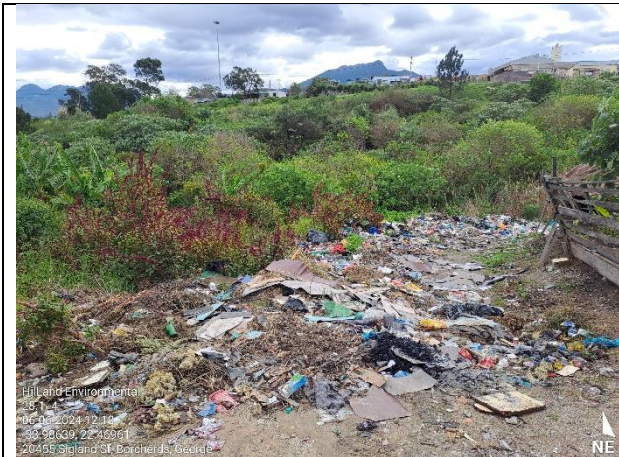
**28(1).4**

Site condition before commencement

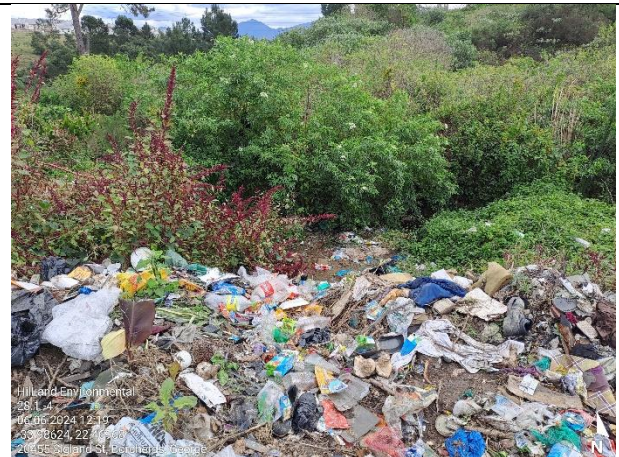
Site condition before commencement

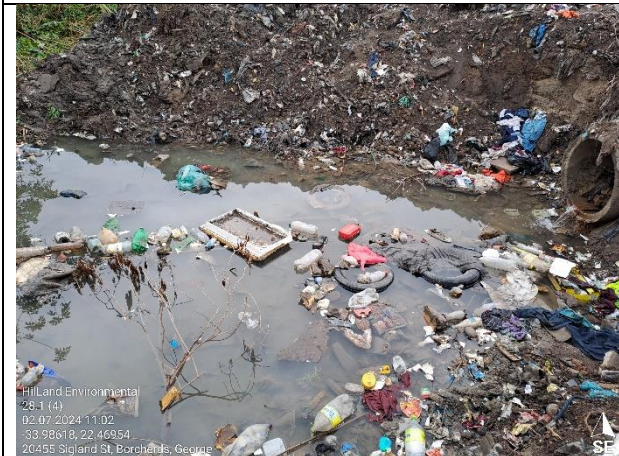
Exposing the existing stormwater pipe

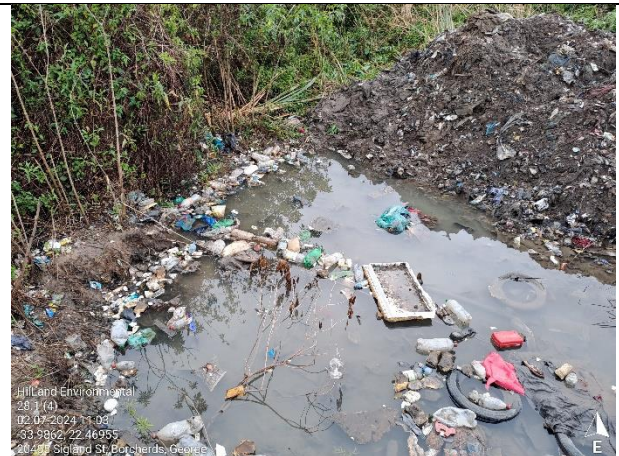
Working zone

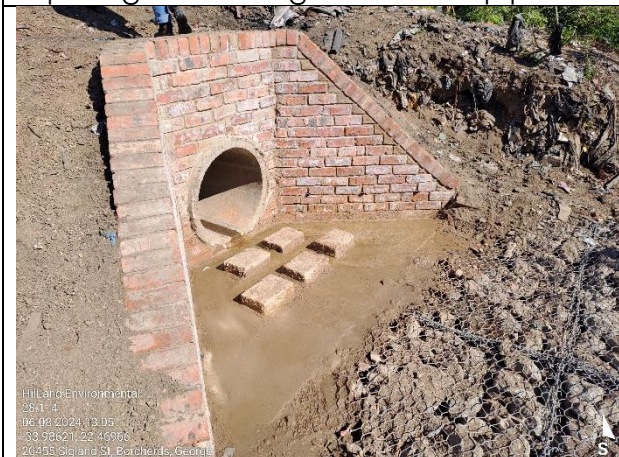
New headwall and gabion/reno protection complete

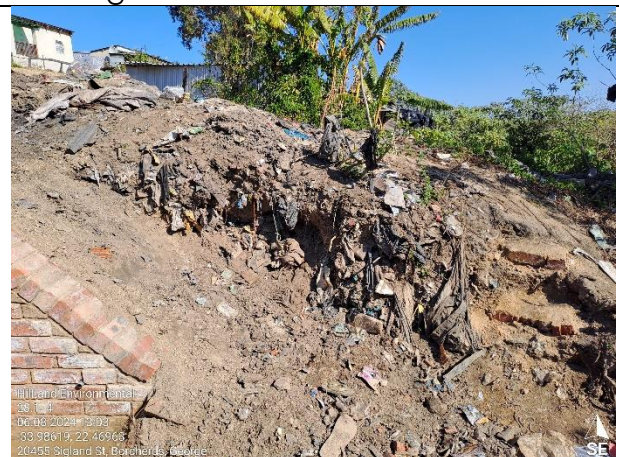
Final shaping to be done

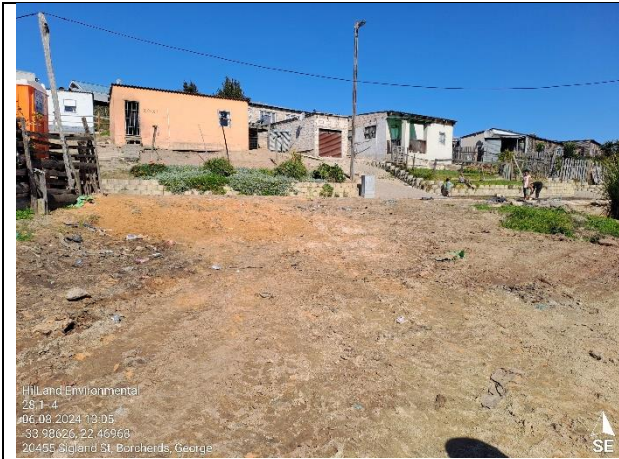
Temporary construction access – no environmental issues

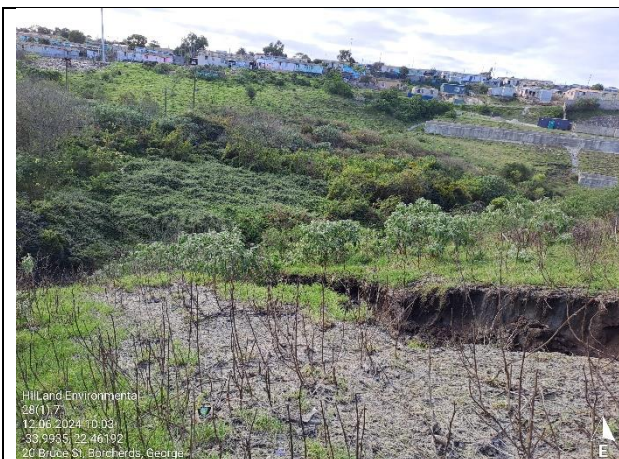
**28(1).7**

Site condition before commencement

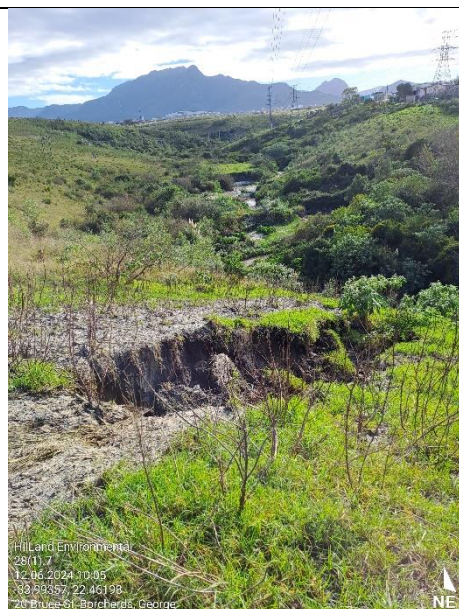
Site condition before commencement

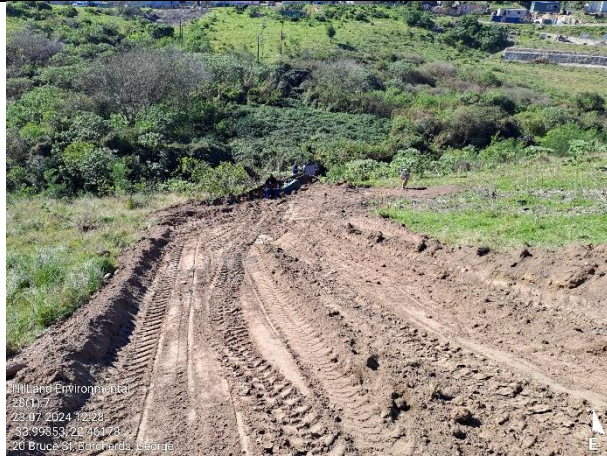
Temporary construction access

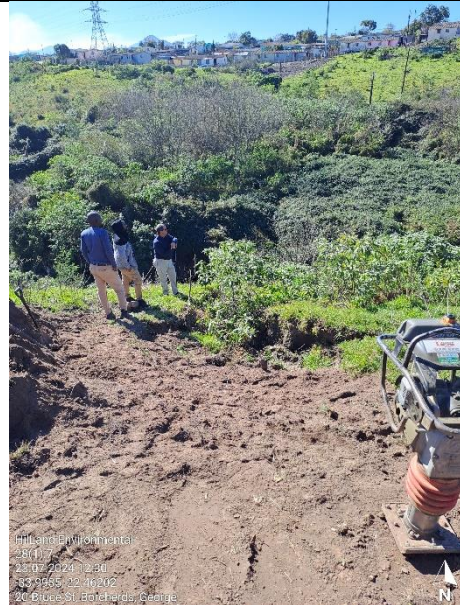
Backfilling and compacting within the demarcated (pegged) footprint

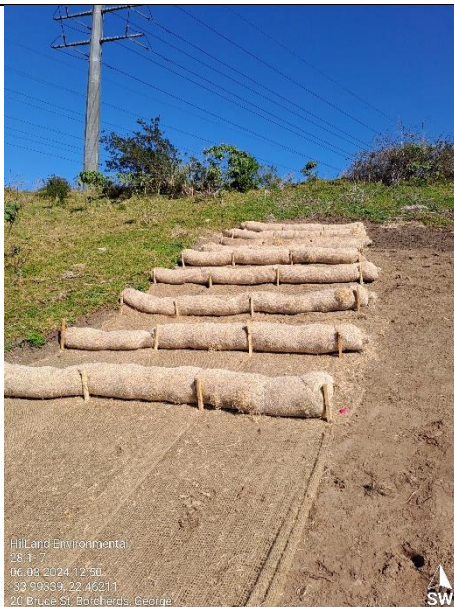
Rehabilitation complete – erosion protection installed

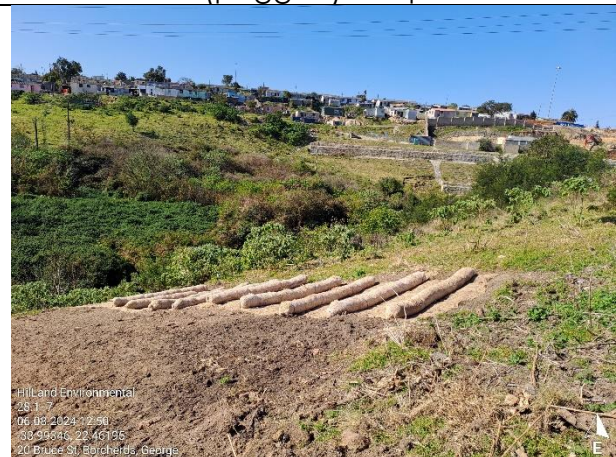
Rehabilitation complete – erosion protection installed

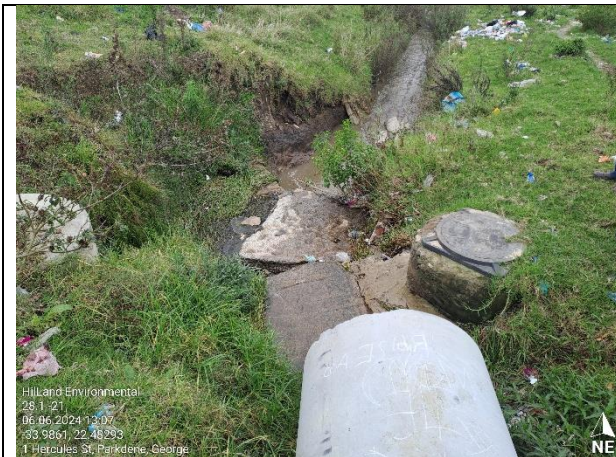
Site condition before commencement

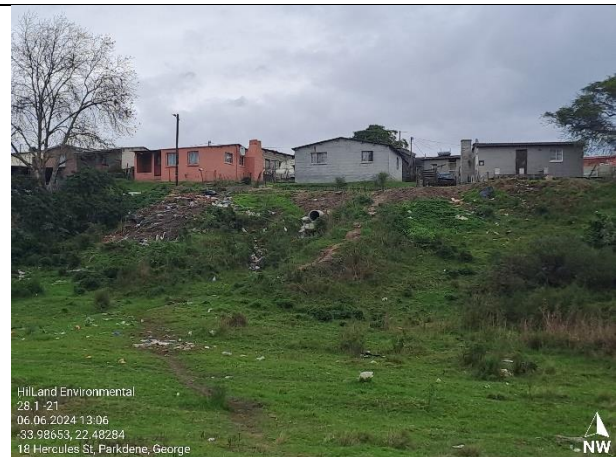
Site condition before commencement

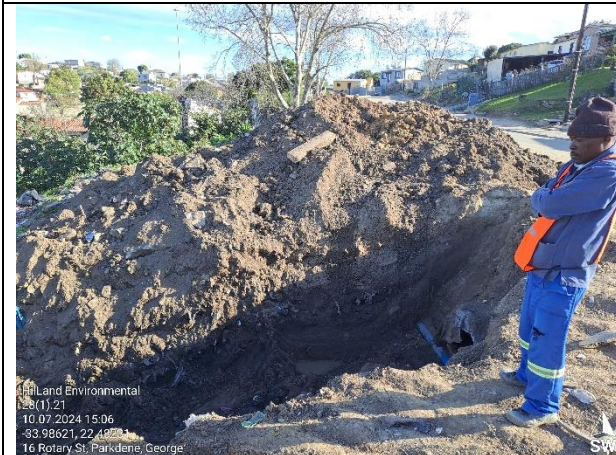
Exposing existing stormwater infrastructure and excavation within the pegged working zone.

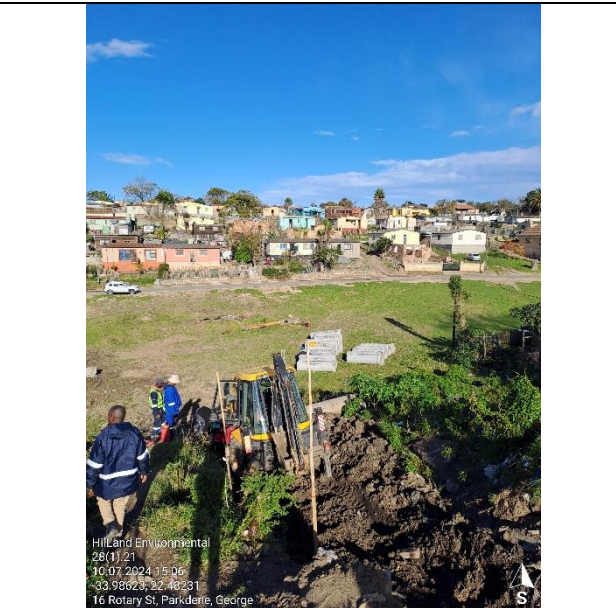
Excavation of the stormwater pipe trench

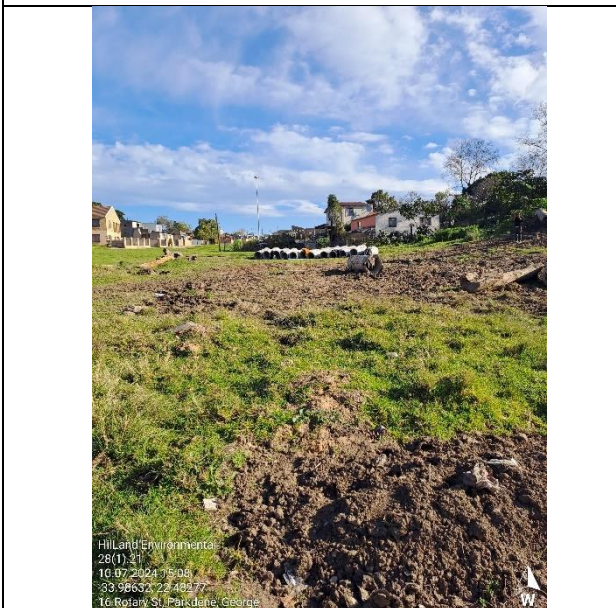
Construction material stockpile

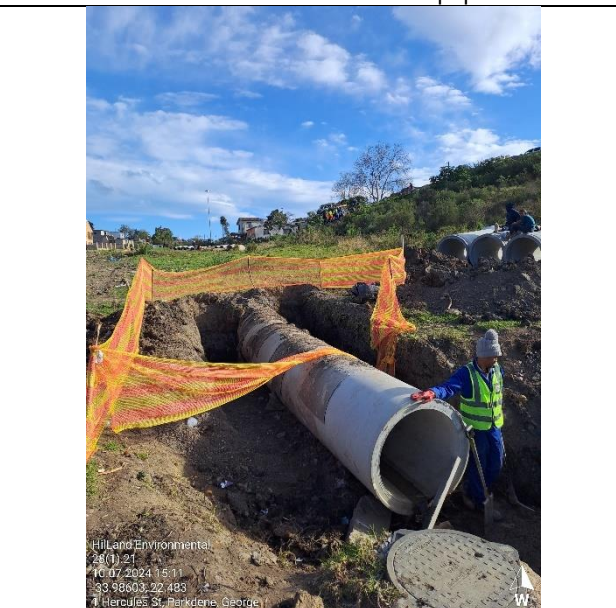
Exposing existing stormwater infrastructure

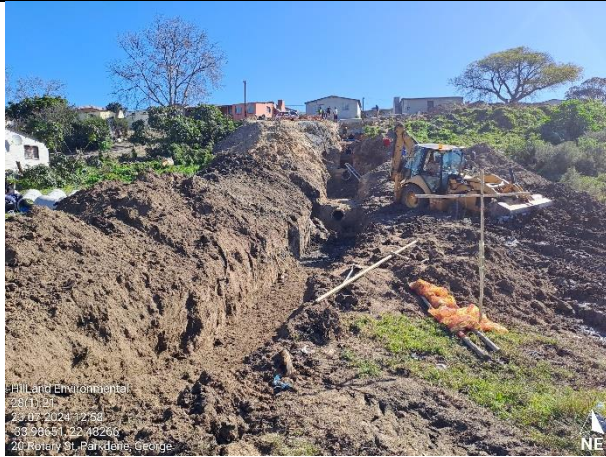
Construction progress

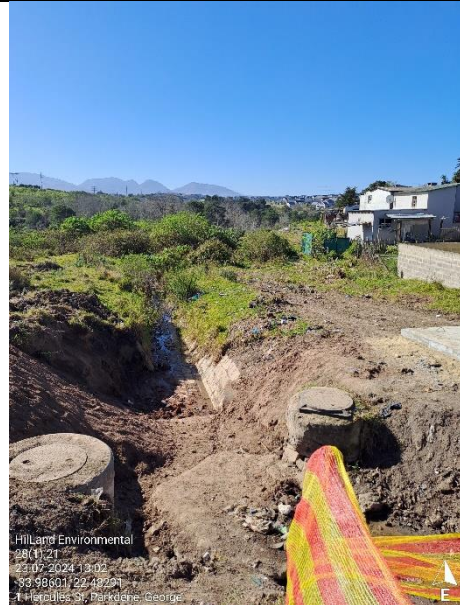
Construction progress – note the demarcation is in place which gets vandalized and/or stolen when the contractor leaves the site

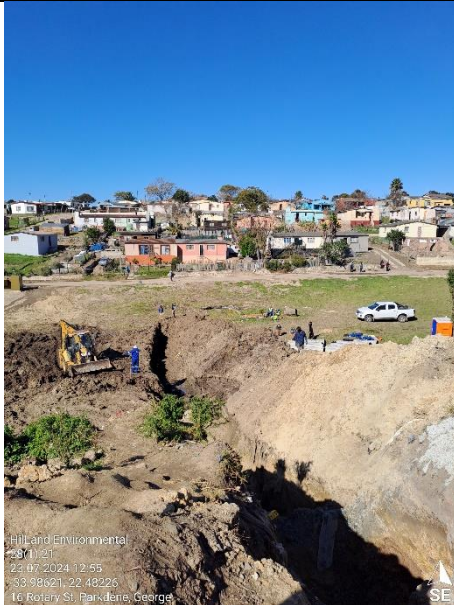
Construction progress

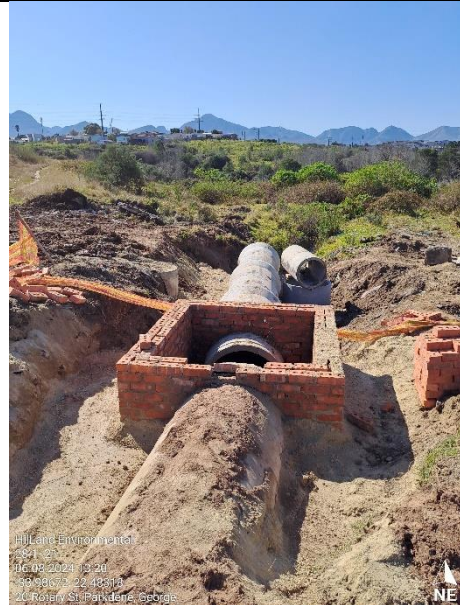
Construction progress – new manhole

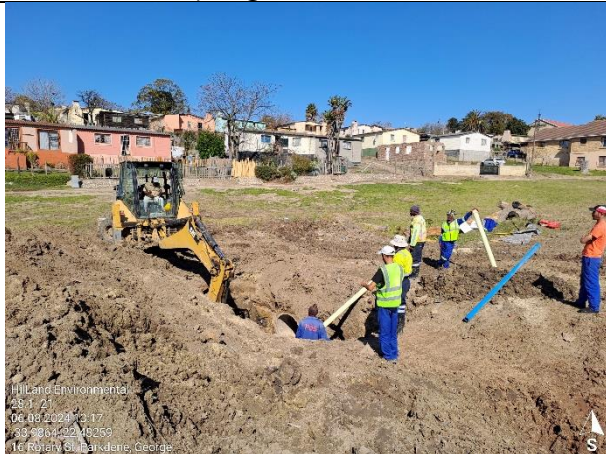
Construction progress – tie in with existing stormwater line

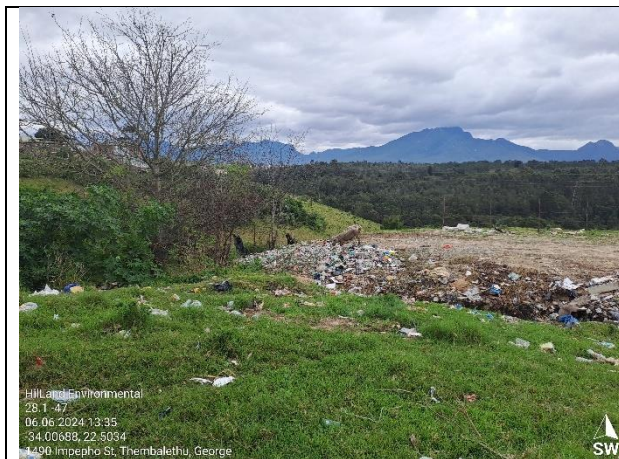
Site condition before commencement

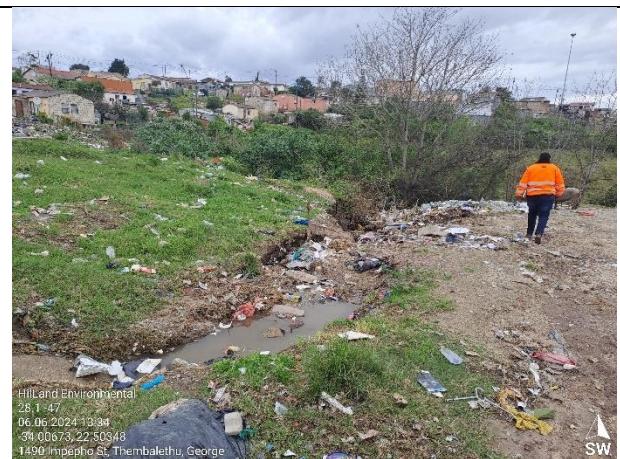
Site condition before commencement

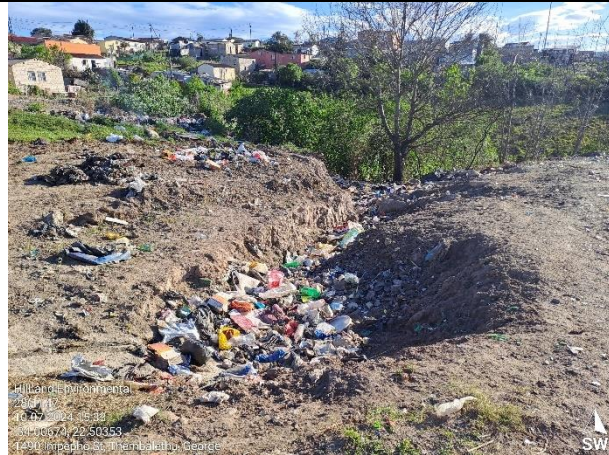
Construction footprint pegged out

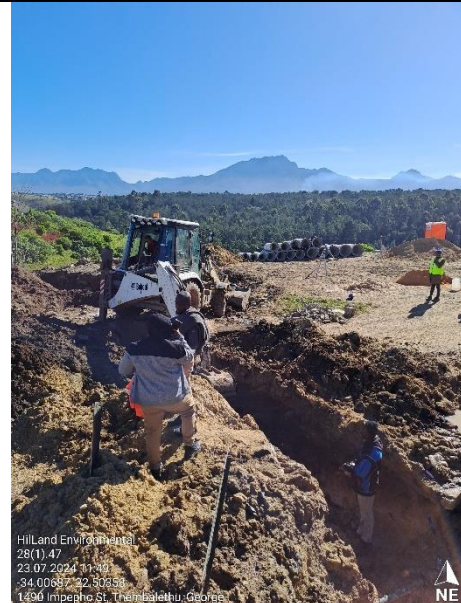
Construction progress

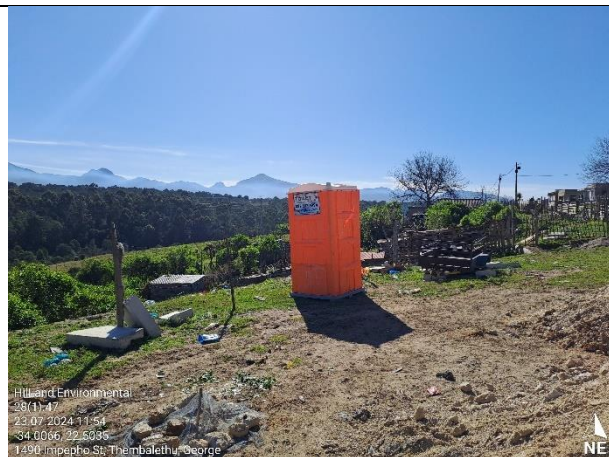
Portable toilet facilities are available at each site

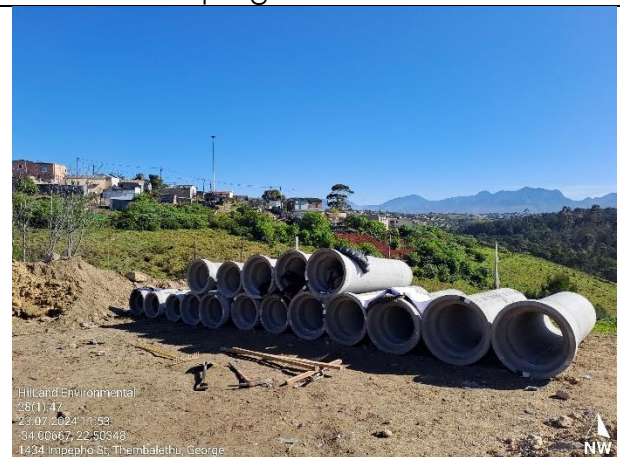
Construction material stockpile on existing disturbed area (historic dump area)

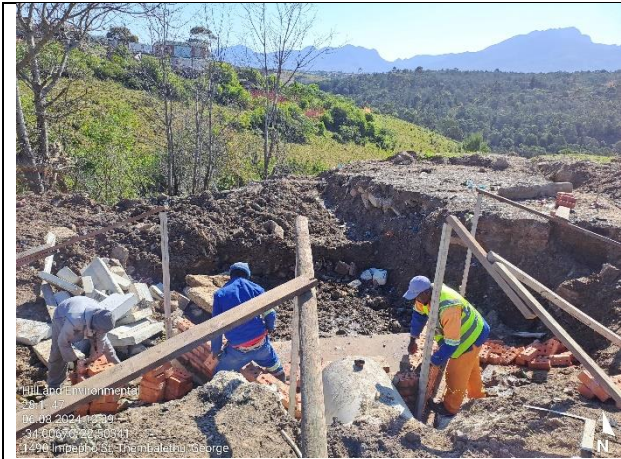
Construction progress – headwall construction

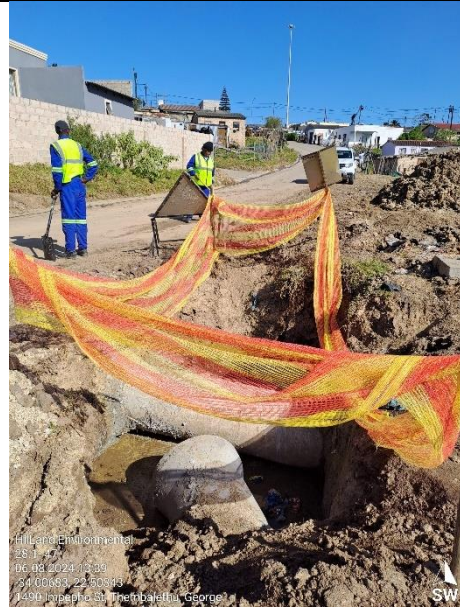
Construction progress – note the demarcation is in place at the time of the inspection

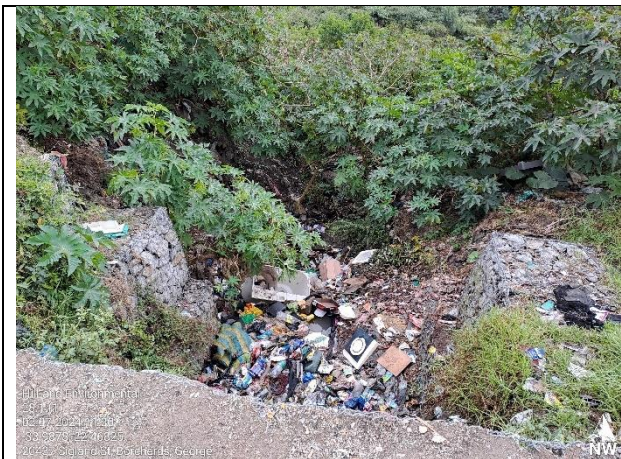
## 28(1).1

Site condition before commencement

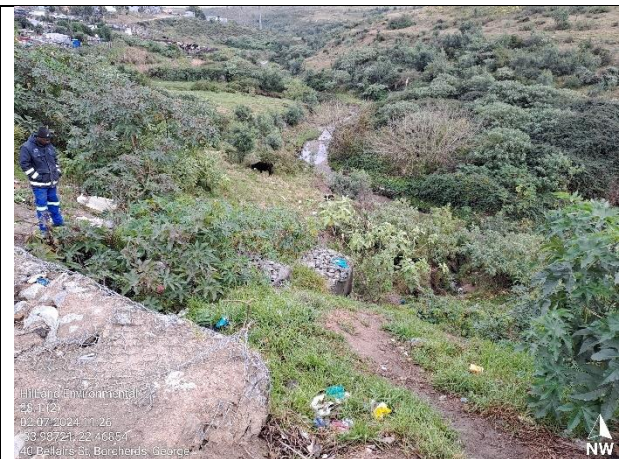
Site condition before commencement

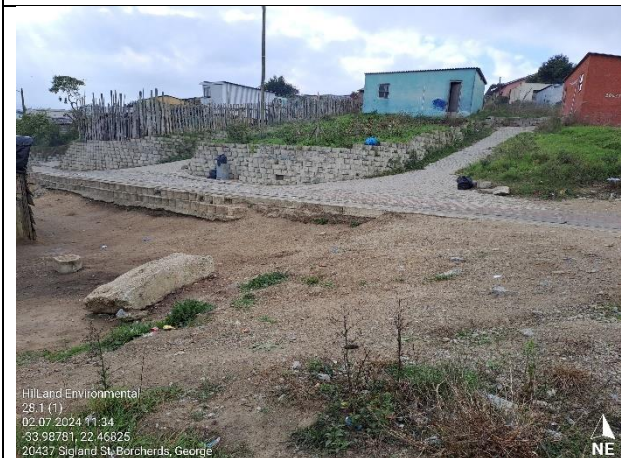
Proposed access to the site

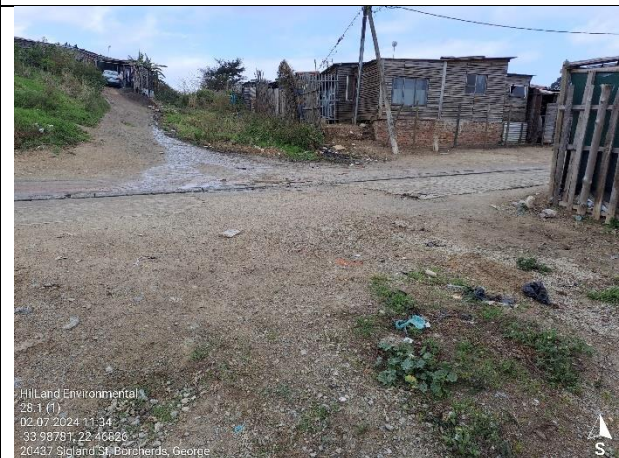
Proposed access to the site

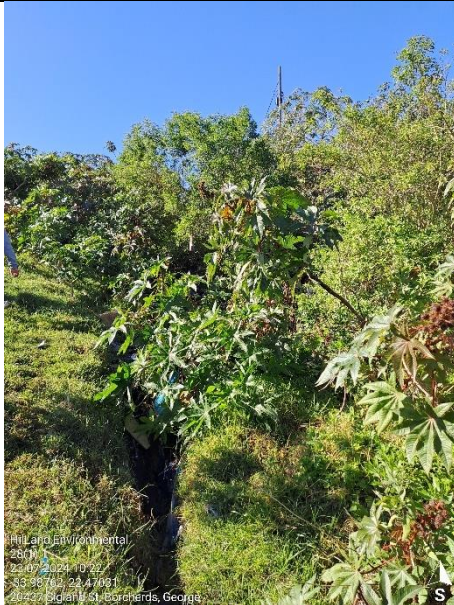
Construction footprint pegged out

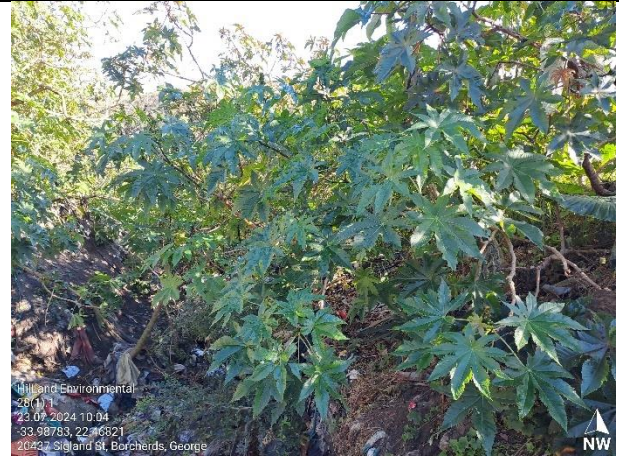
Construction footprint pegged out

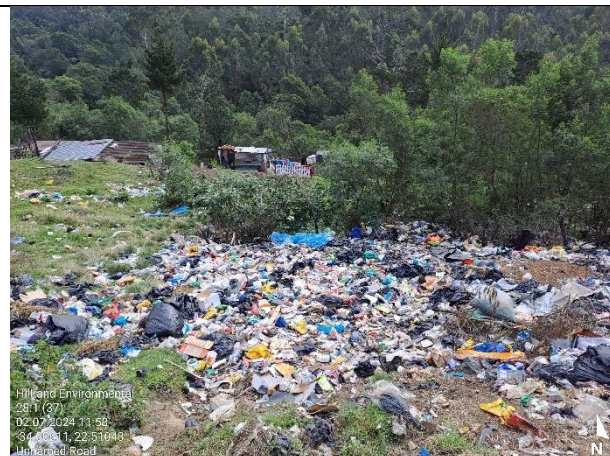
28(1).37

Site condition before commencement

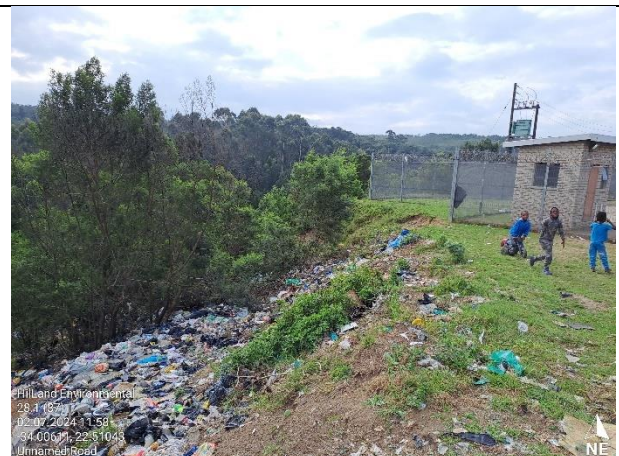
Site condition before commencement

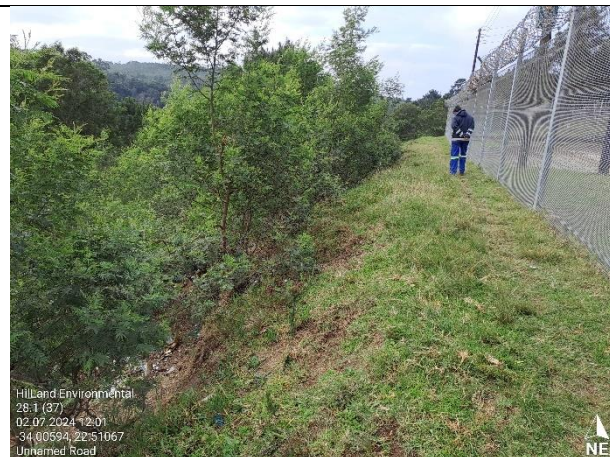
Site condition before commencement

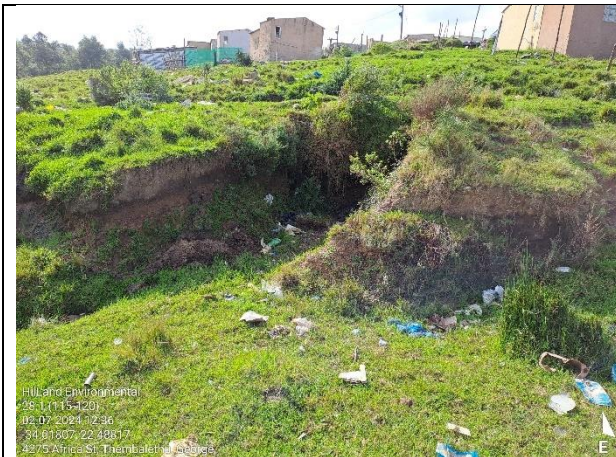
Site condition before commencement

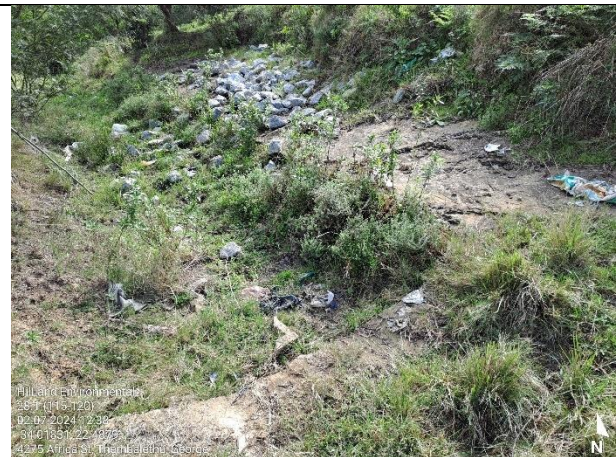
Site condition before commencement

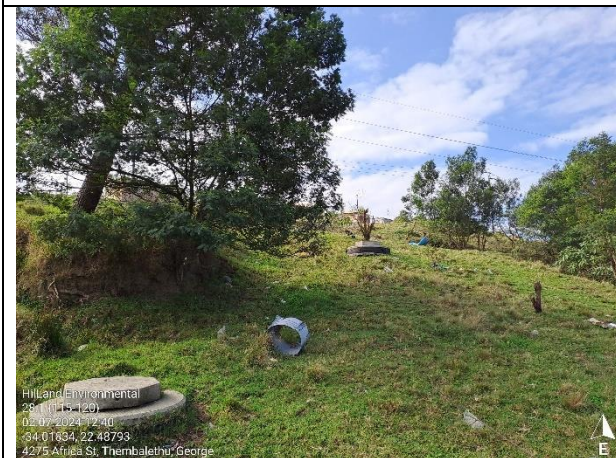
Site condition before commencement

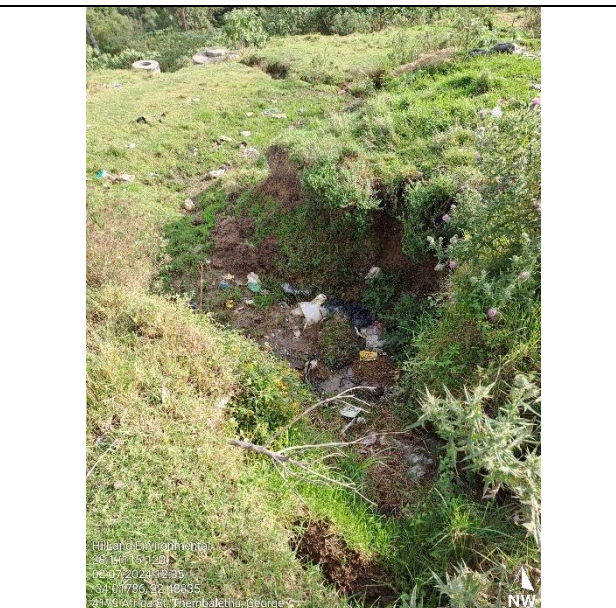
Site condition before commencement

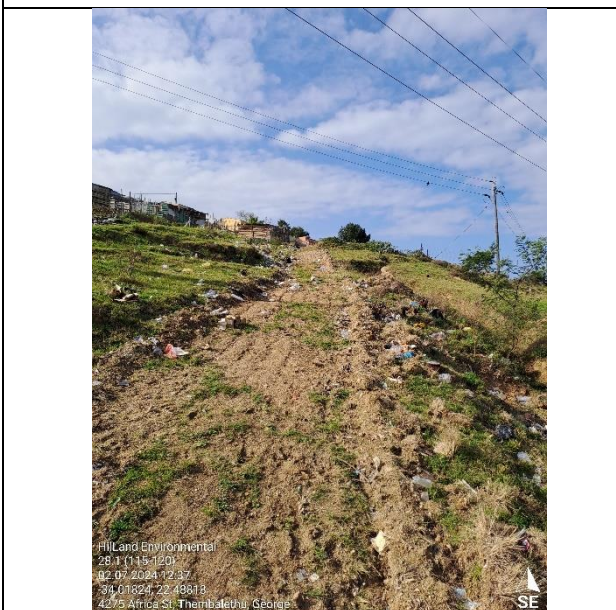
Site condition before commencement  
Proposed access to the site

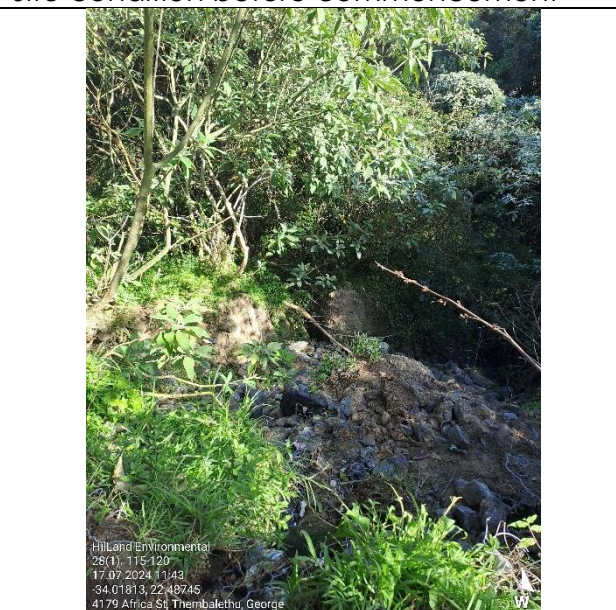
Construction footprint pegged out

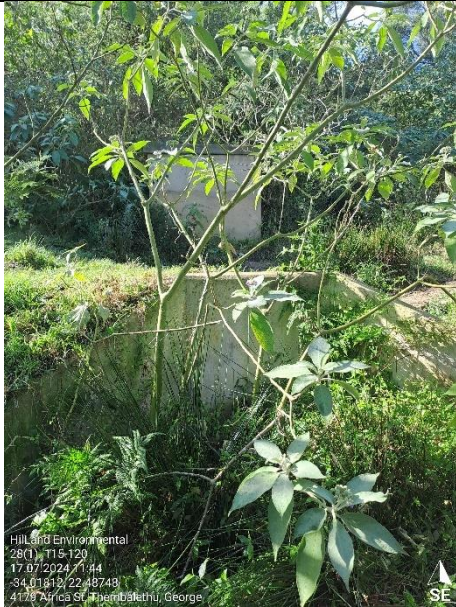
Construction footprint pegged out

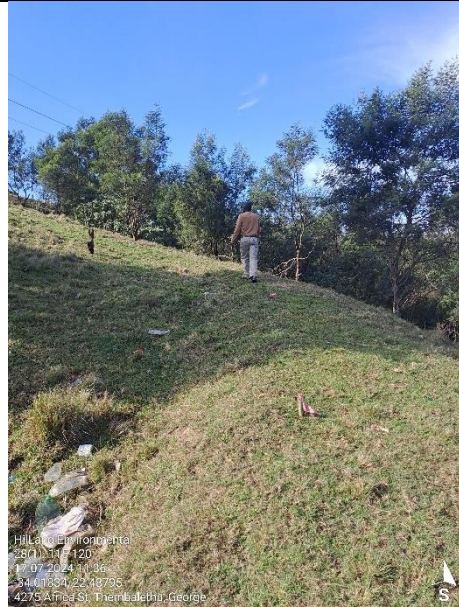
Construction footprint pegged out
