### ENVIRONMENTAL MONITORING REPORT 2

*Maintenance to and Management of the stormwater infrastructure for  
Project 28(1) – Flood damage repair in George Municipal area*

**GEO24/1252/16**

**August 2024**

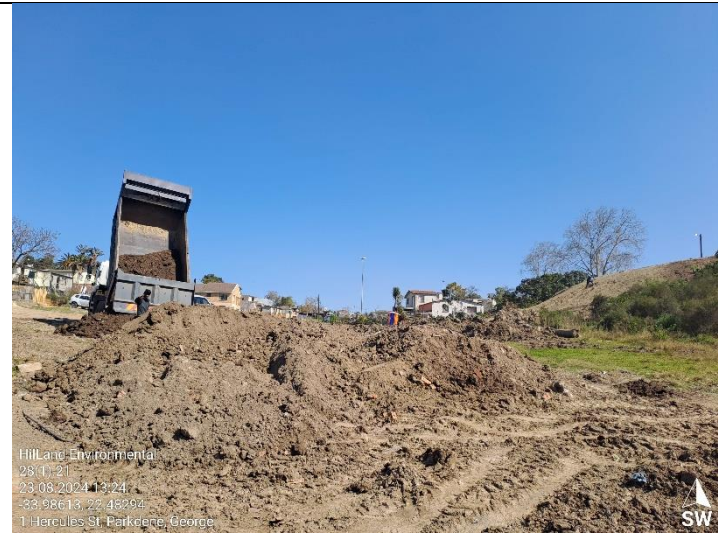
28(1).21

Topsoil for rehabilitation and shaping

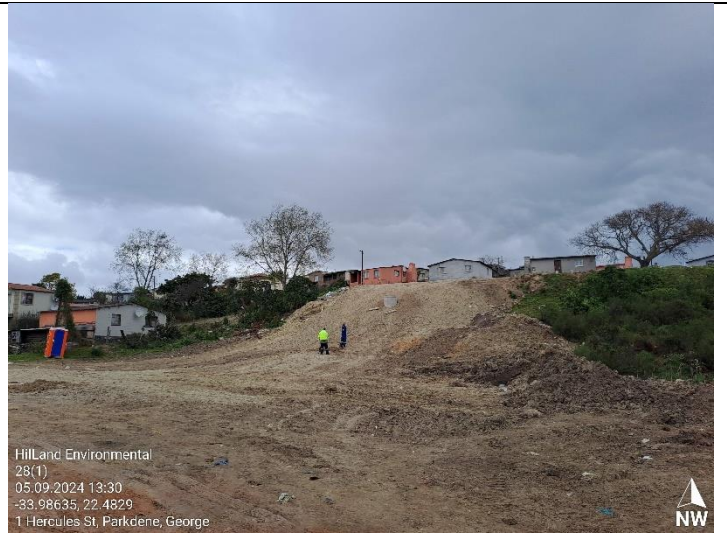
Shaping of the slope around the stormwater infrastructure is complete, and rehabilitation in progress.

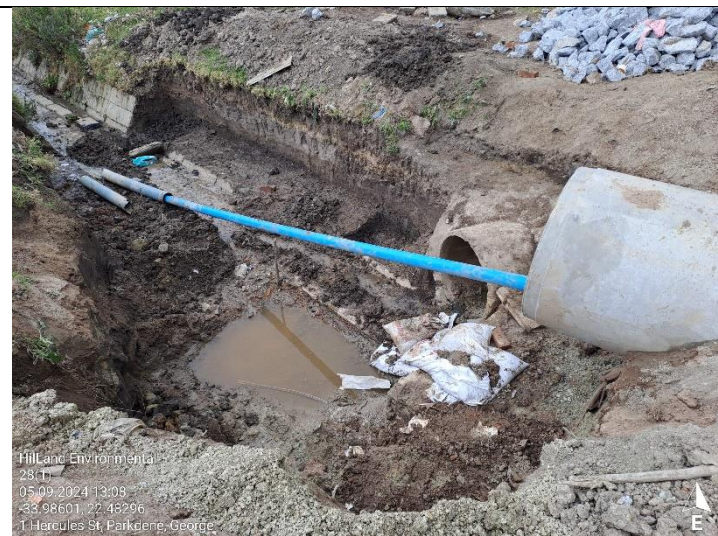
Construction of the stormwater headwall.

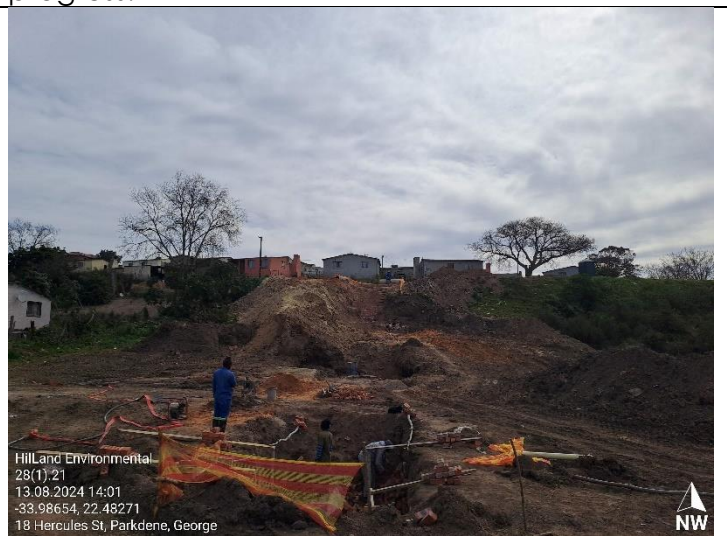
Construction progress

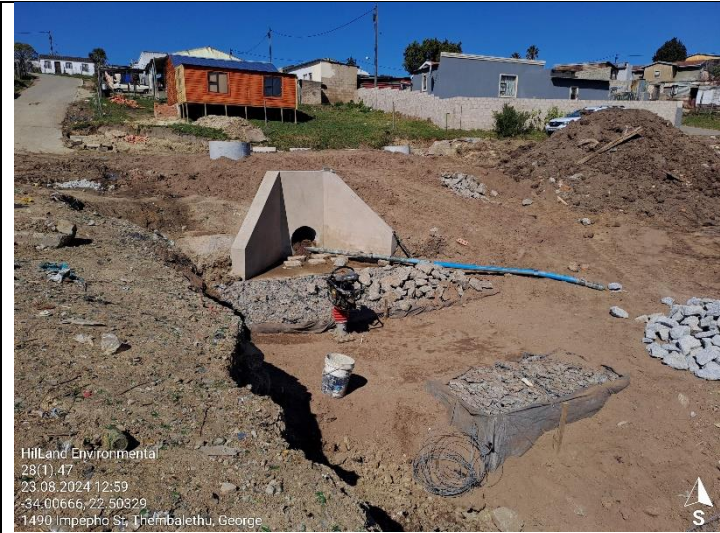
28(1).47

Construction progress

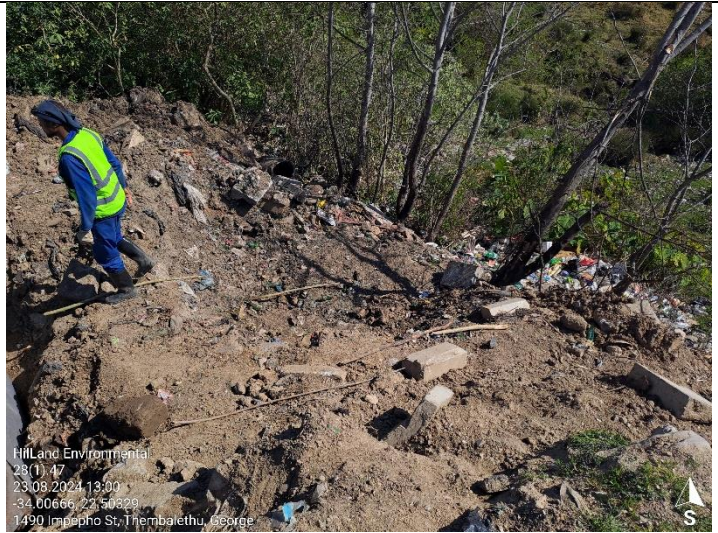
Working within the construction zone

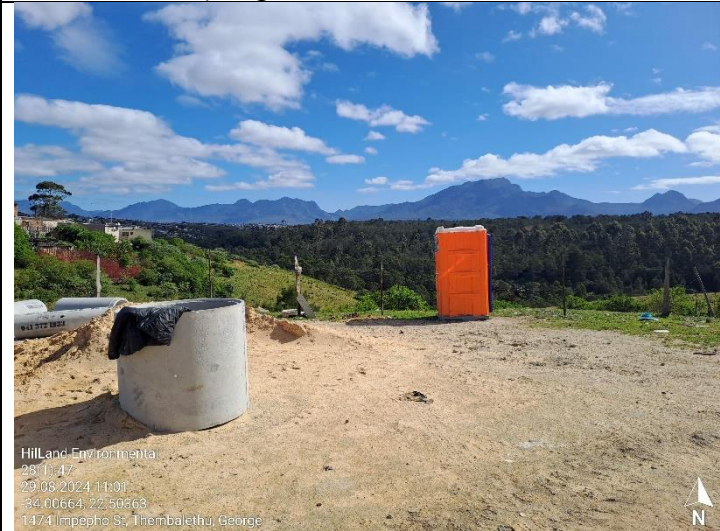
Portable toilet on site. Material stockpile area – previously transformed area.

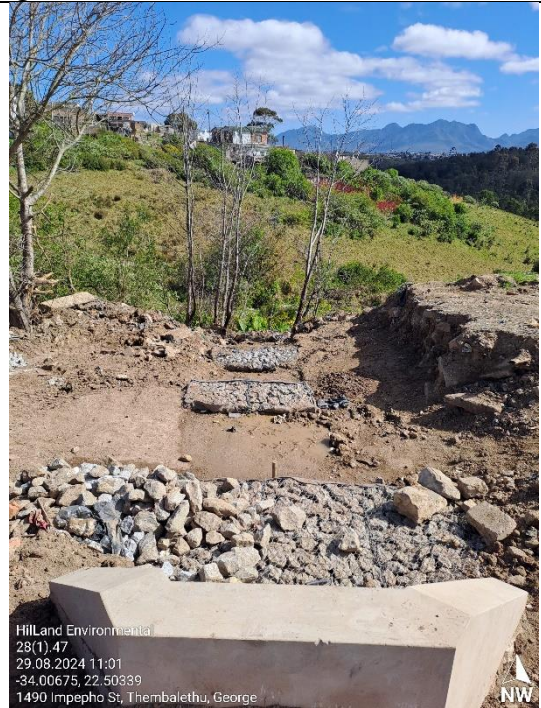
Construction progress

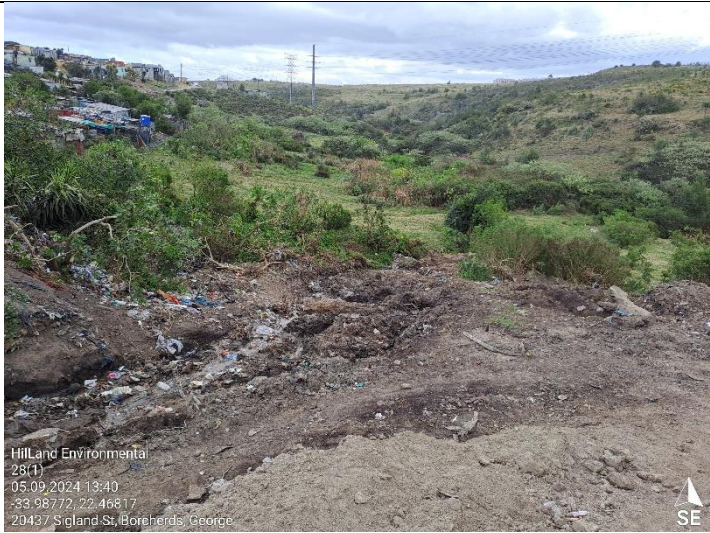
**28(1).1**

Dumped rubbish and invasive alien plants have been removed.

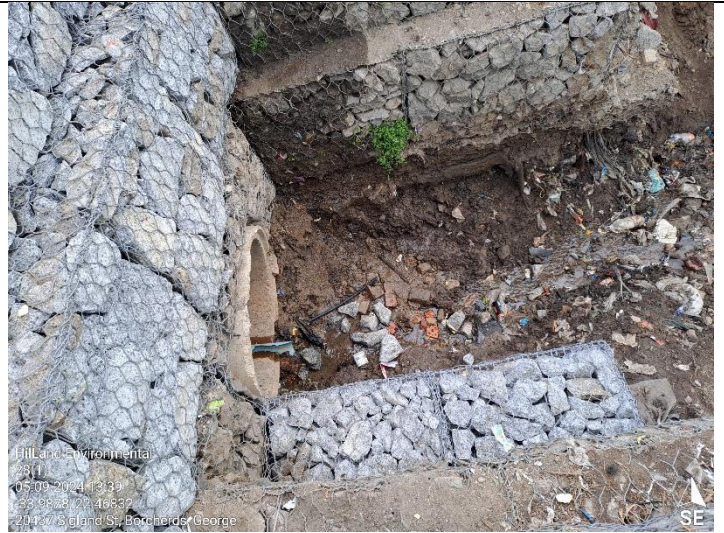
Stormwater outlet has been repaired – gabion/reno mattress protection installation to follow.

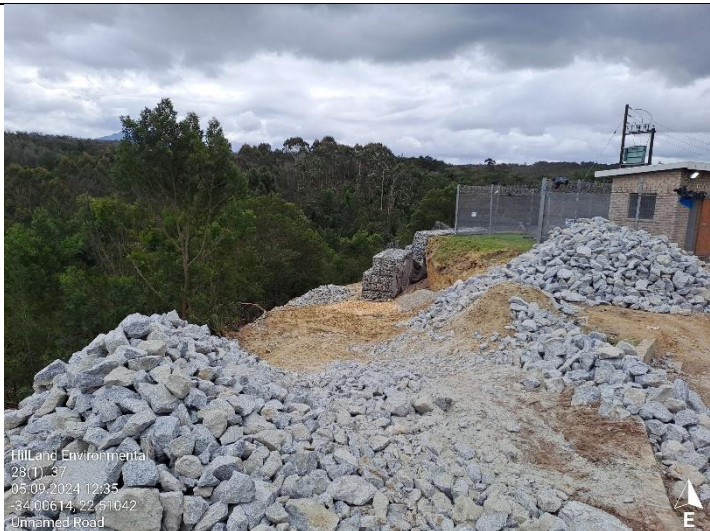
**28(1).37**

Material stockpile in the road reserve.

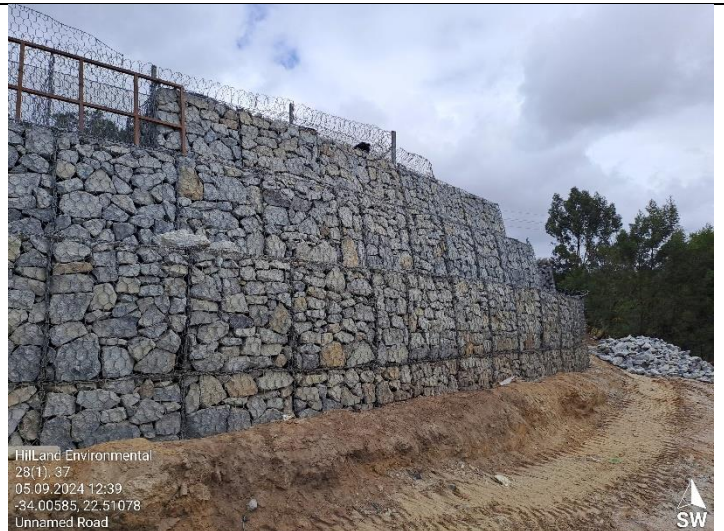
Construction progress.

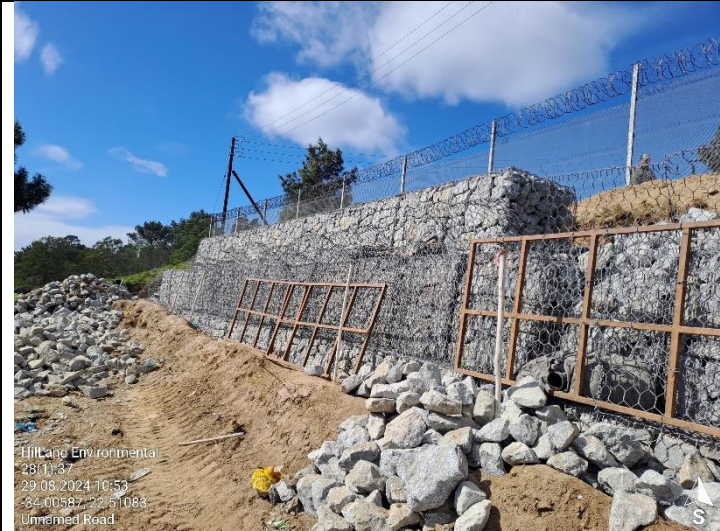
HillLand Environmental  
28(1).115-120  
29.08.2024 10:53  
-34.00587, 22.51083  
Unnamed Road

Construction progress.

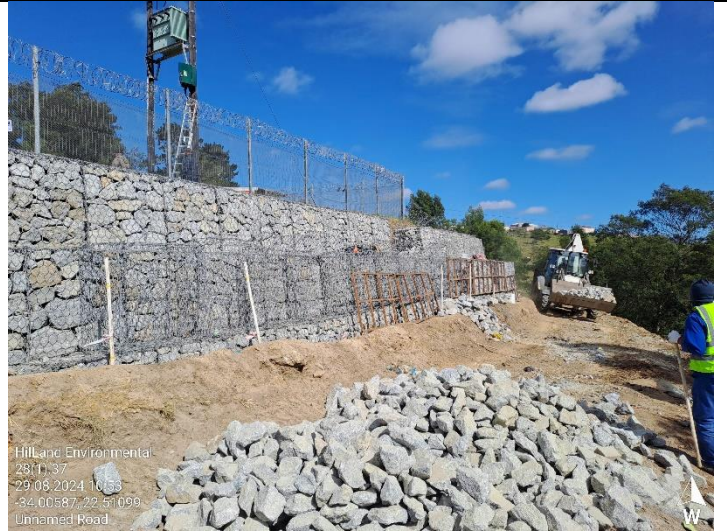
HillLand Environmental  
28(1).115-120  
29.08.2024 10:53  
-34.00587, 22.51096  
Unnamed Road

Material delivery via a small track within the working zone.

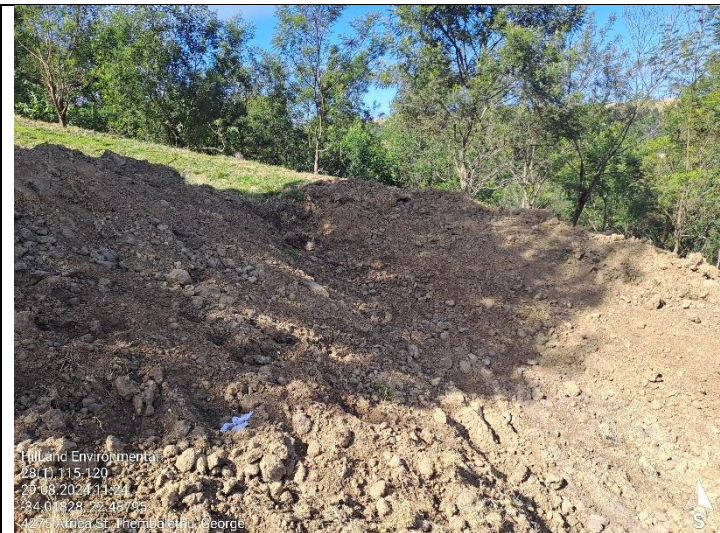
HillLand Environmental  
28(1).115-120  
29.08.2024 11:24  
-34.01808, 22.48764  
4179 Africa St, Thembalethu, George

Site preparation.

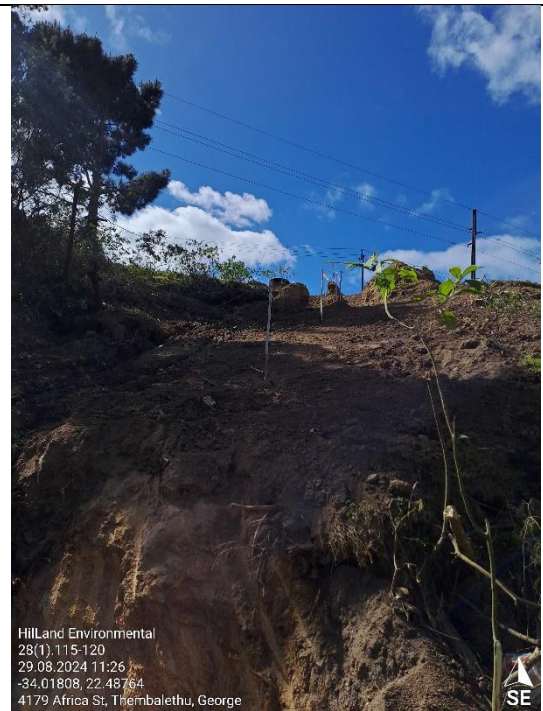
HillLand Environmental  
28(1).115-120  
29.08.2024 11:26  
-34.01808, 22.48764  
4179 Africa St, Thembalethu, George

Site preparation – silt fences will be required if the slope is left exposed for a prolonged period

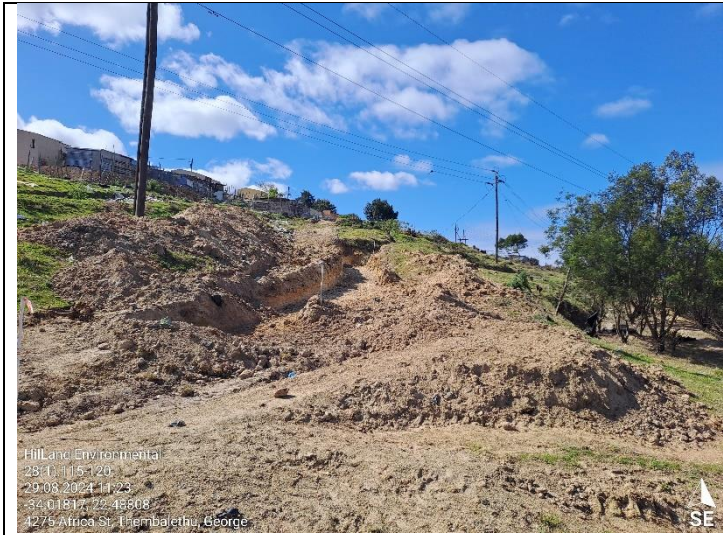
Site preparation in progress.
