## ENVIRONMENTAL MONITORING REPORT 3

*Maintenance to and Management of the stormwater infrastructure for  
Project 28(1) – Flood damage repair in George Municipal area*

**GEO24/1252/17**

**September 2024**

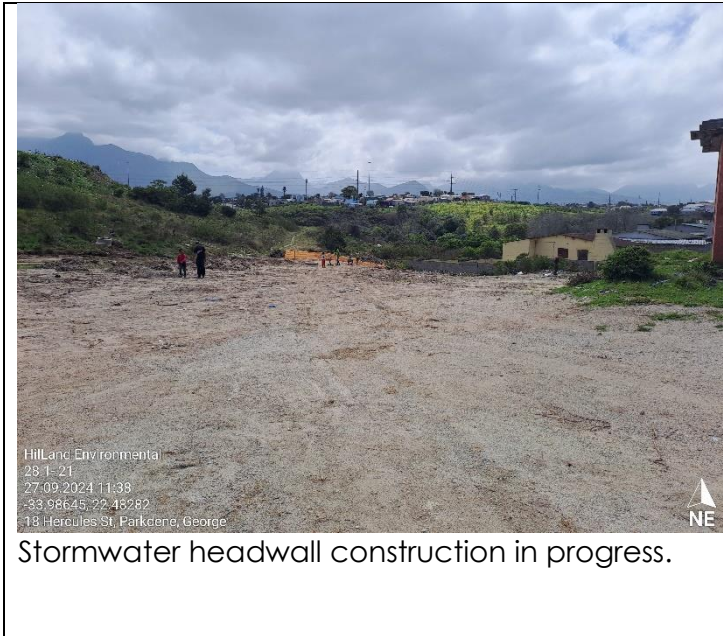
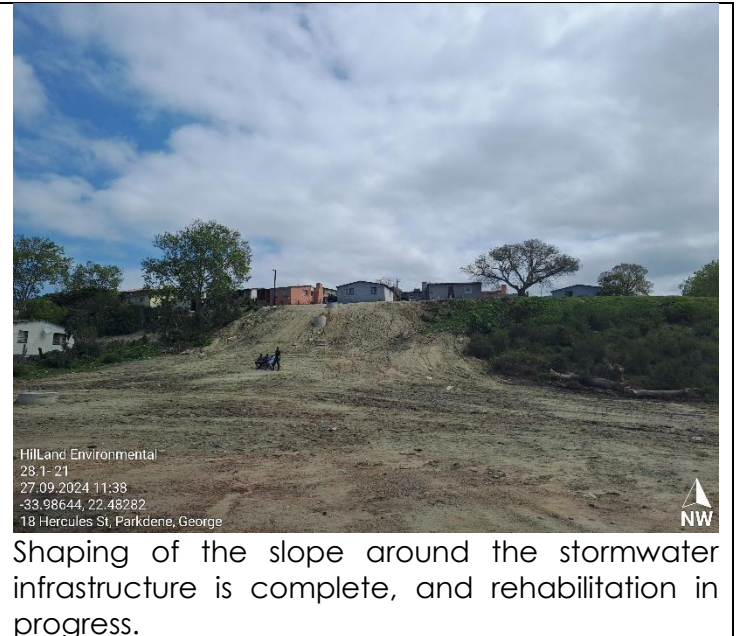
### 28(1).21

Construction is near completion, final rehabilitation to be completed.

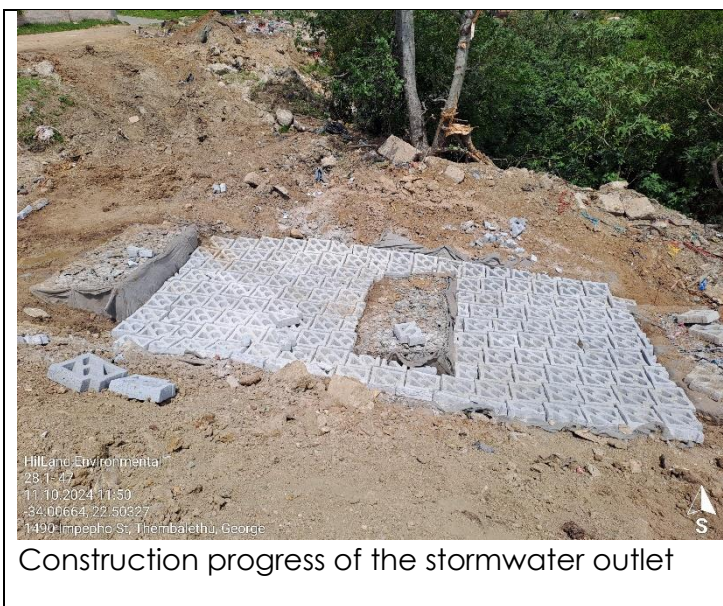
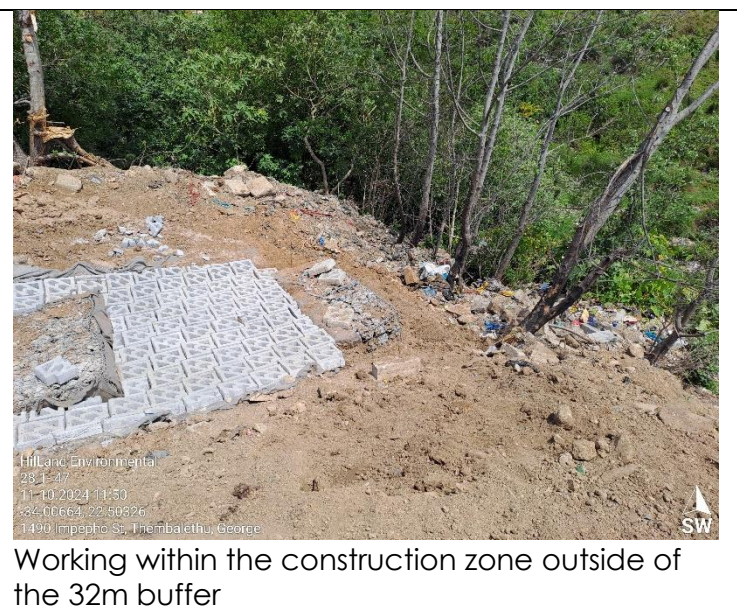
### 28(1).47

Construction material stockpile area – previously transformed area.

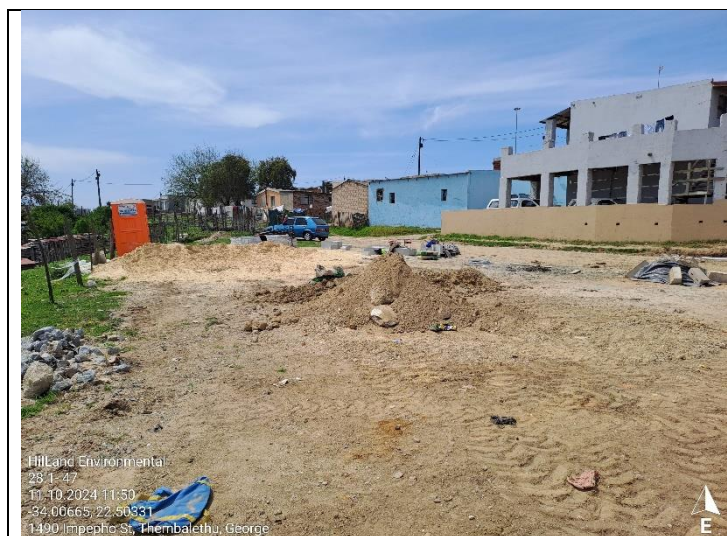
Portable toilet on site. Material stockpile area – previously transformed area.

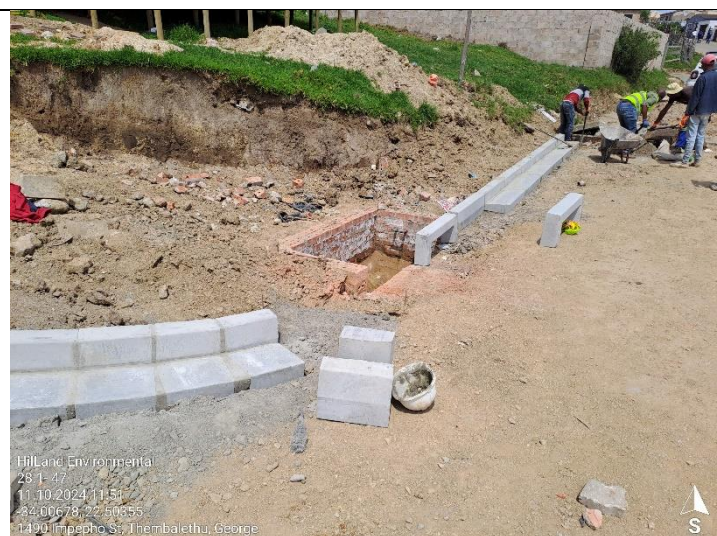
Construction progress – stormwater inlet

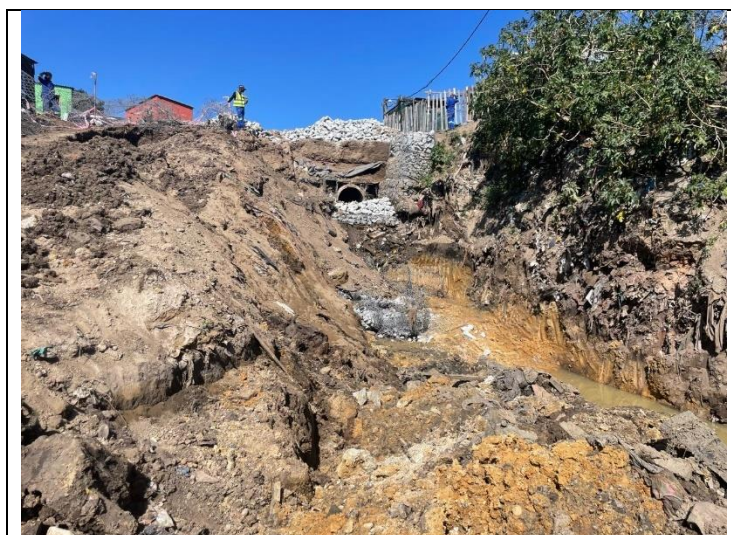
### 28(1).1

Photo by WEC – 19.09.2024 – construction progress. Access (left) as per the contractor's method statement.

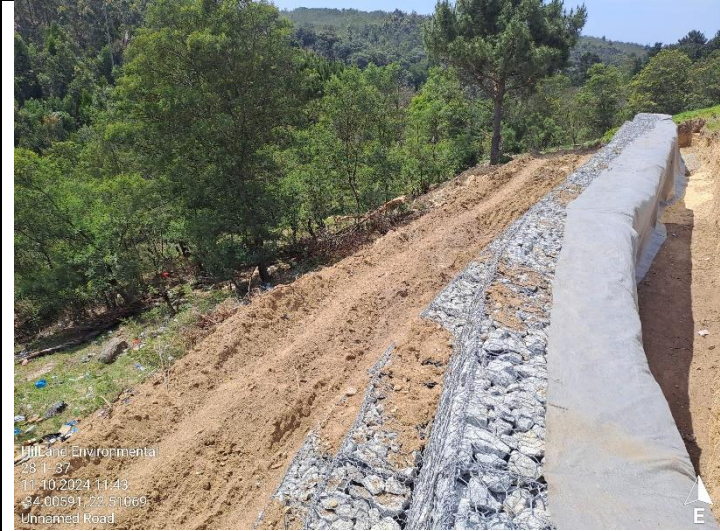
Backfilling behind the gabion structure in progress.

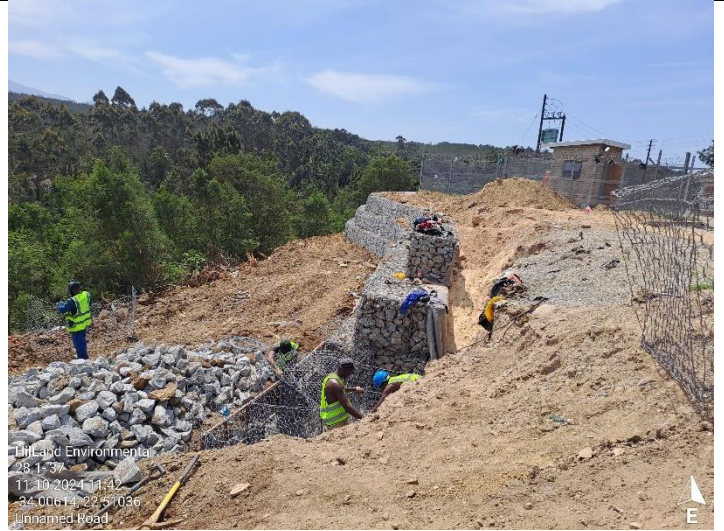
Construction progress – gabion retaining structure.

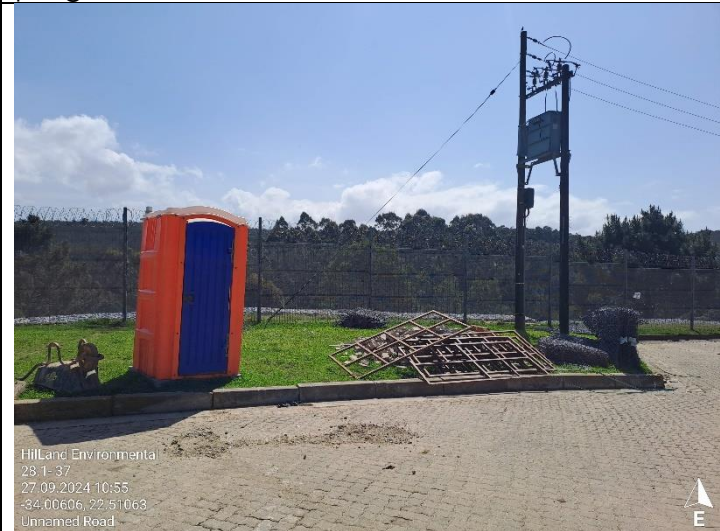
Portable ablution facility in the WWTW site.

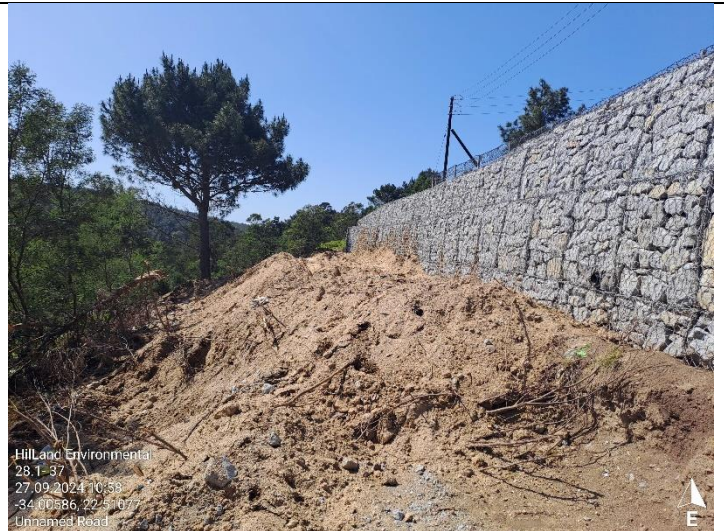
Shaping/sloping below the gabion structure in progress.

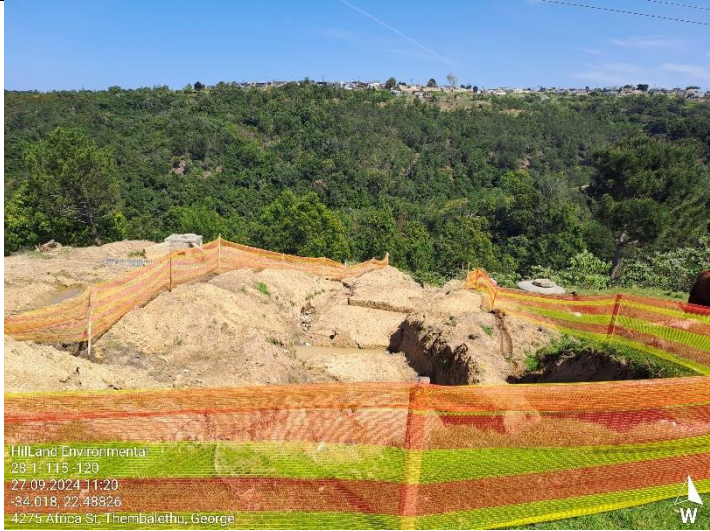
Construction progress – site demarcation in place.

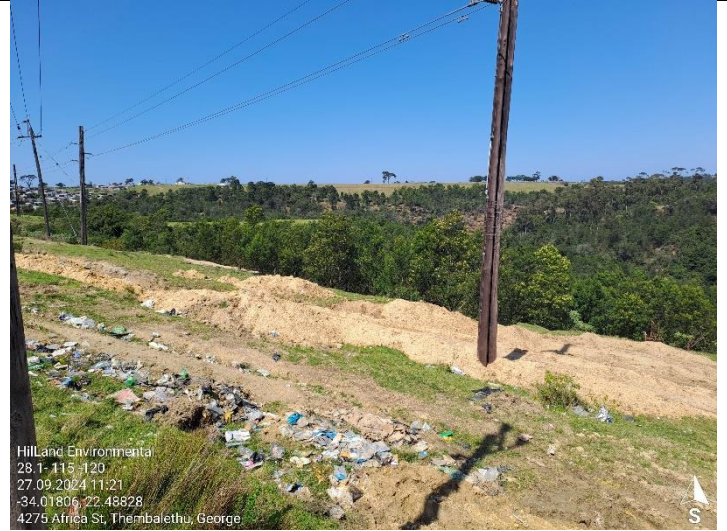
Site preparation and construction progress.

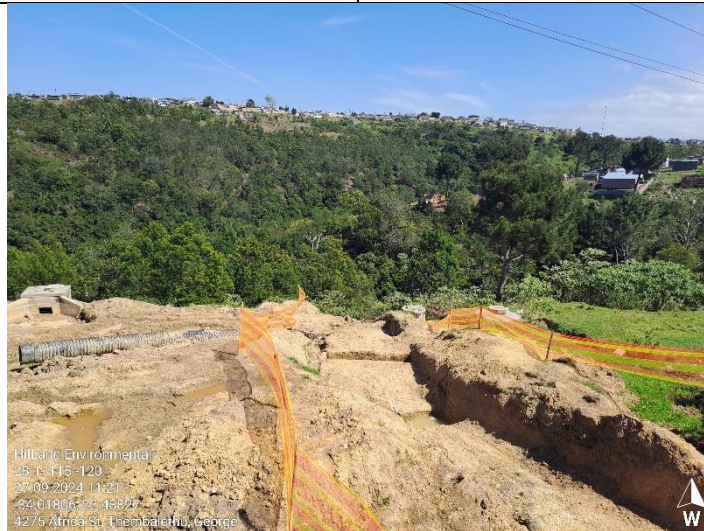
Construction progress.

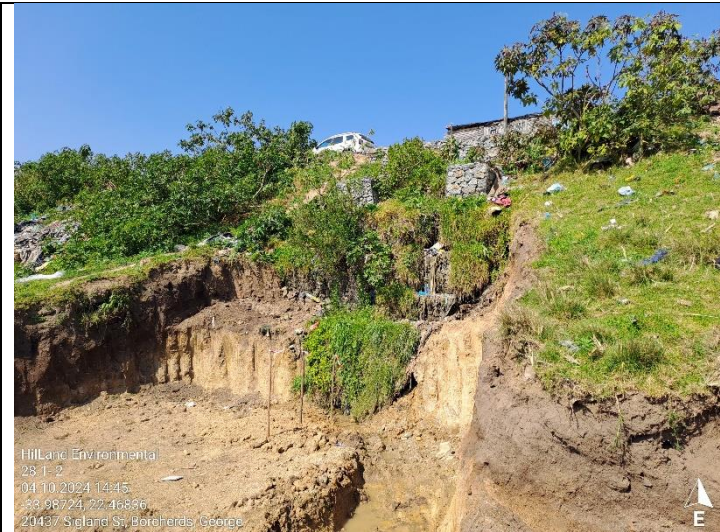
Construction progress – rubble removed, and survey pegs installed.

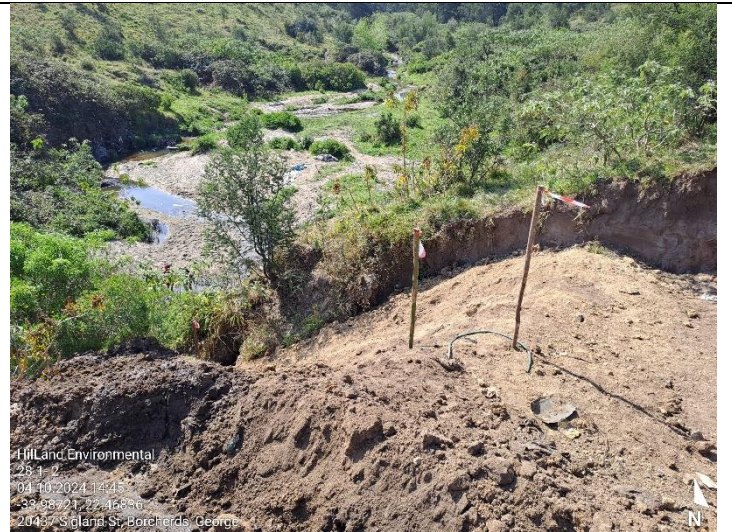
Silt fence to be installed below the gabion structure to prevent silt movement into the river.

Site preparation and excavation commenced in October 2024. Access method statement was approved by the ECO. Surveyor pegged the stormwater outlet structure. Bidum silt fence must be installed and maintained to prevent silt movement into the river.

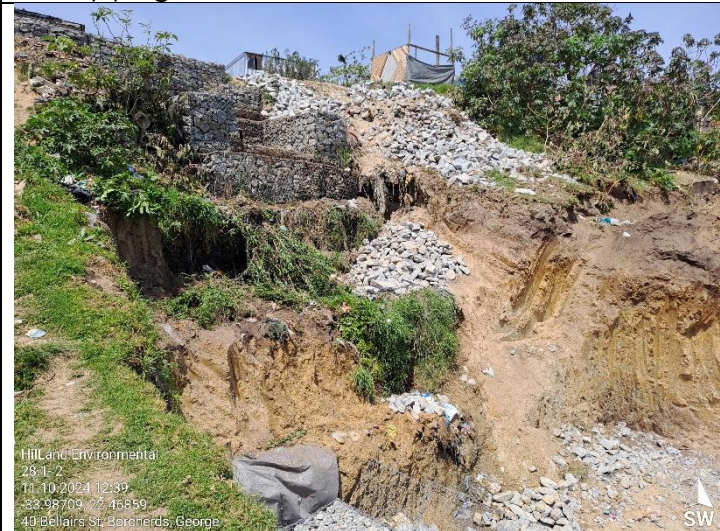
Construction material stockpile area – road reserve.

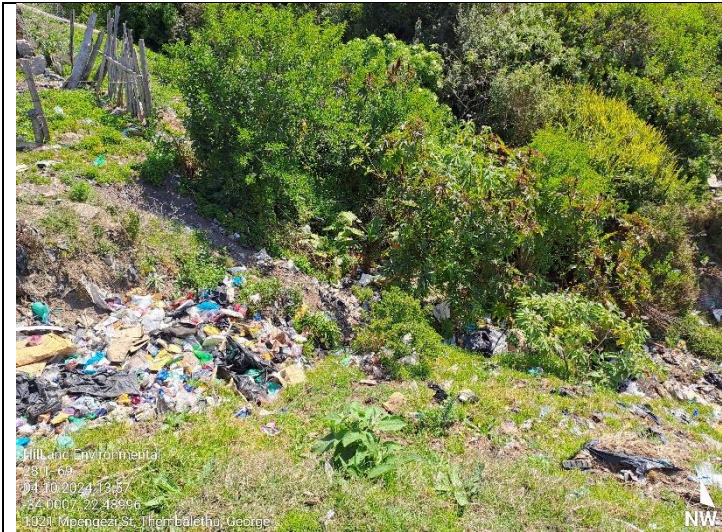
Contractor setting out the construction footprint. Dumped rubble to be removed and disposed at the municipal waste disposal site.

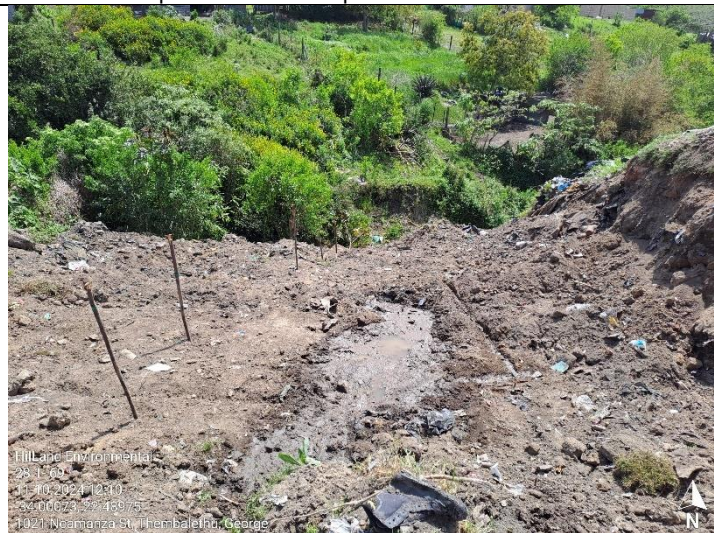
Construction footprint – silt fence to be installed below the last gabion position to prevent silt movement into the stream.

Site preparation and excavation commenced in October 2024. Dumped rubble was removed to the municipal waste disposal site. Bidum silt fence must be installed and maintained to prevent silt movement into the stream.

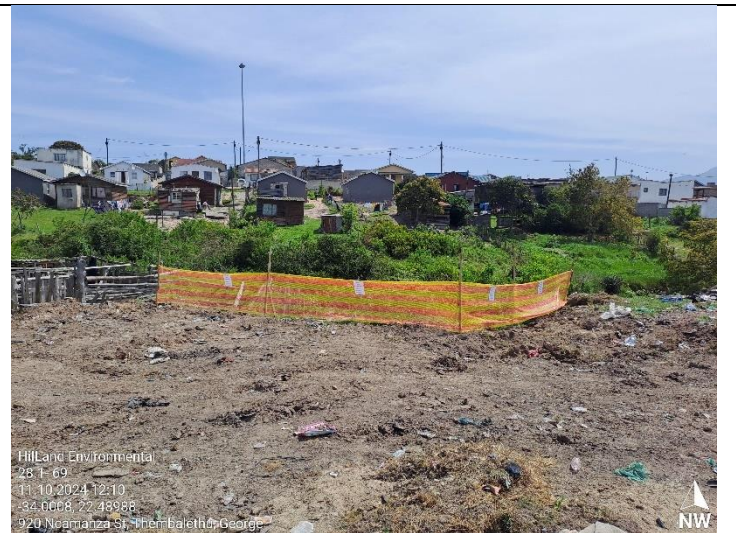
Construction zone demarcation in place.

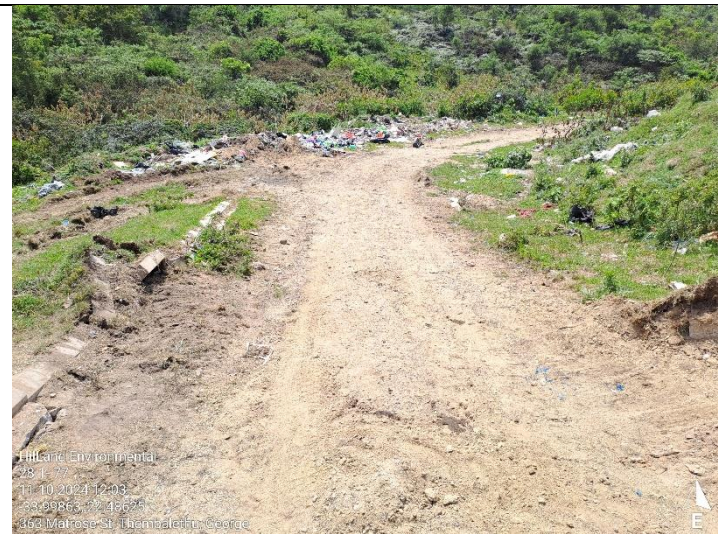
Existing access track is used.

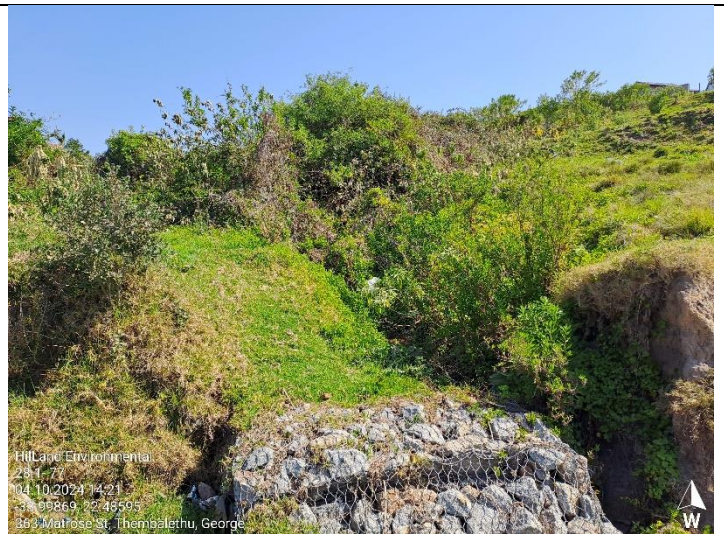
Contractor setting out the construction footprint. No plant rescue was required.

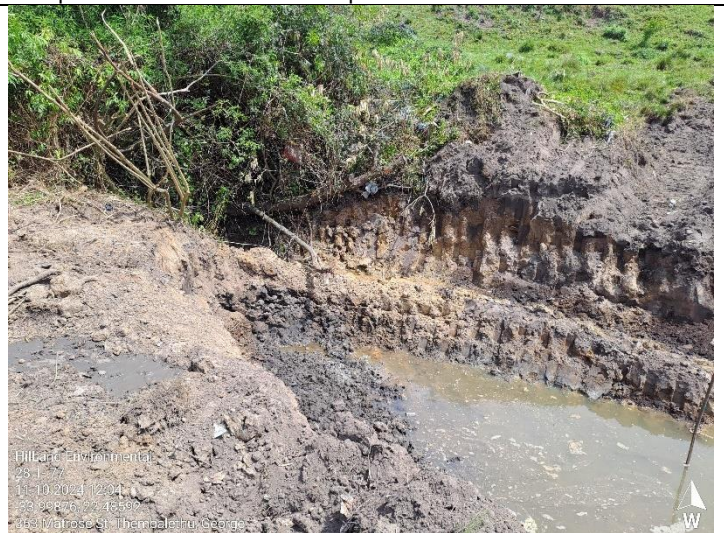
Excavation in progress. Silt fence to be installed and maintained to prevent silt movement downstream.

Site preparation and excavation commenced in October 2024. Surveyor pegged the stormwater outlet structure. Silt fence must be installed and maintained to prevent silt movement downstream.
