## ENVIRONMENTAL MONITORING REPORT 4

*Maintenance to and Management of the stormwater infrastructure for  
Project 28(1) – Flood damage repair in George Municipal area*

**GEO24/1252/18**

**October – 9 December 2024**

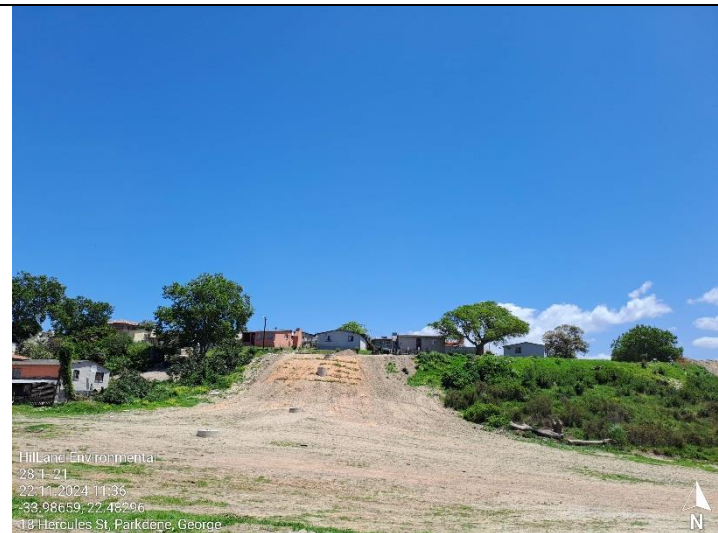
Shaping of the slope around the stormwater infrastructure and rehabilitation is complete.

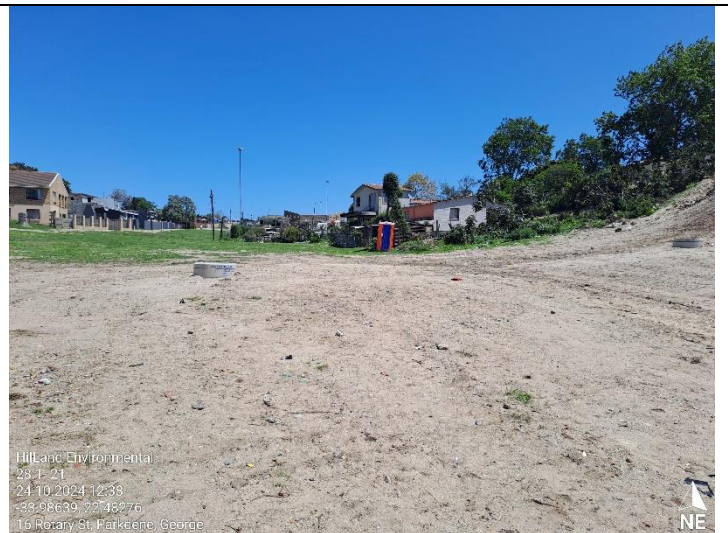
Compacted soil was loosened.

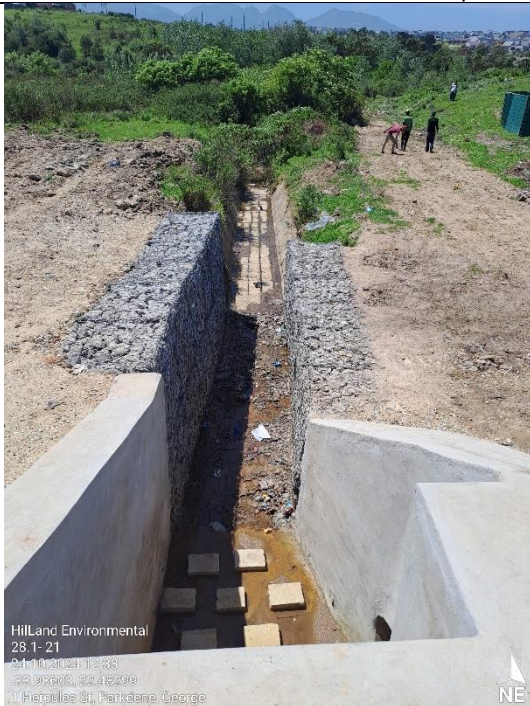
Headwall construction completed

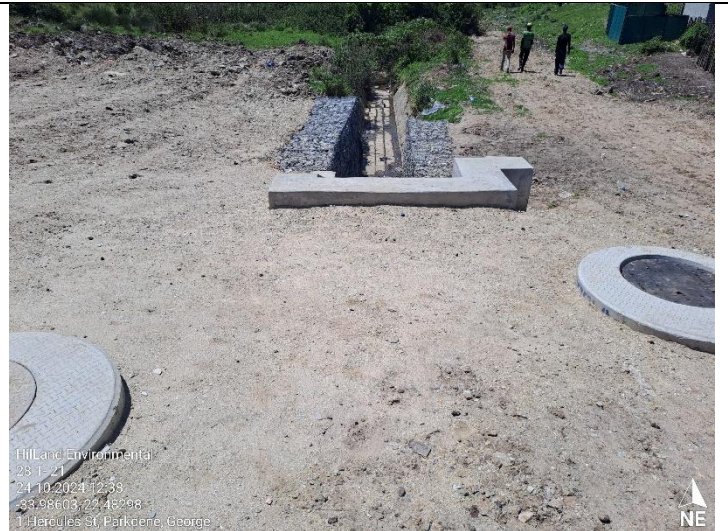
Compacted soil was loosened.

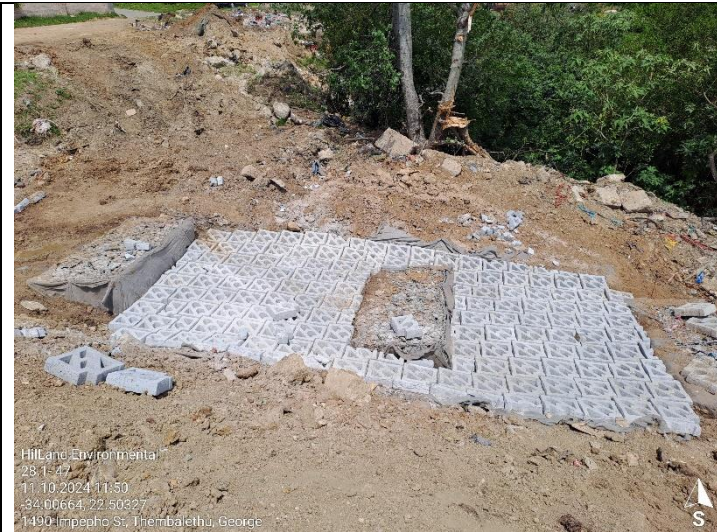
Construction progress of the stormwater outlet.

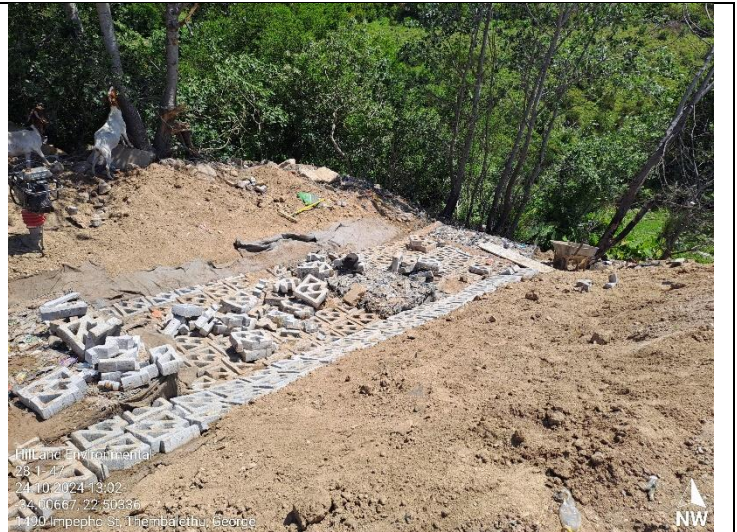
Working within the construction zone outside of the 32m buffer.

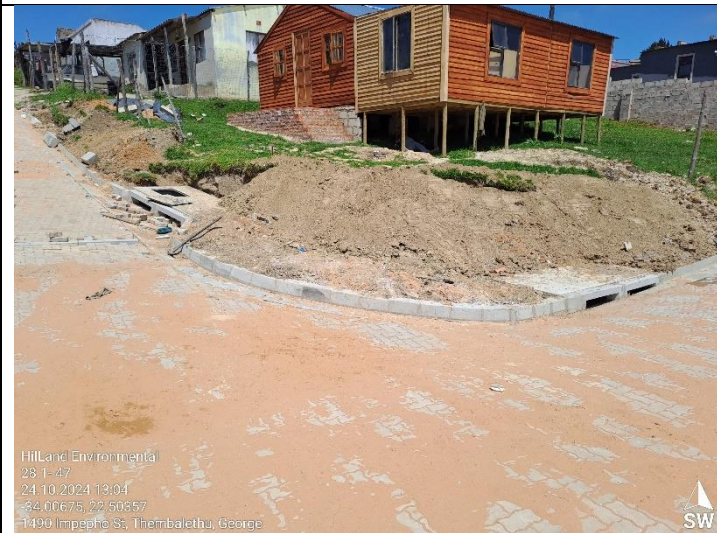
Construction progress – stormwater inlets.

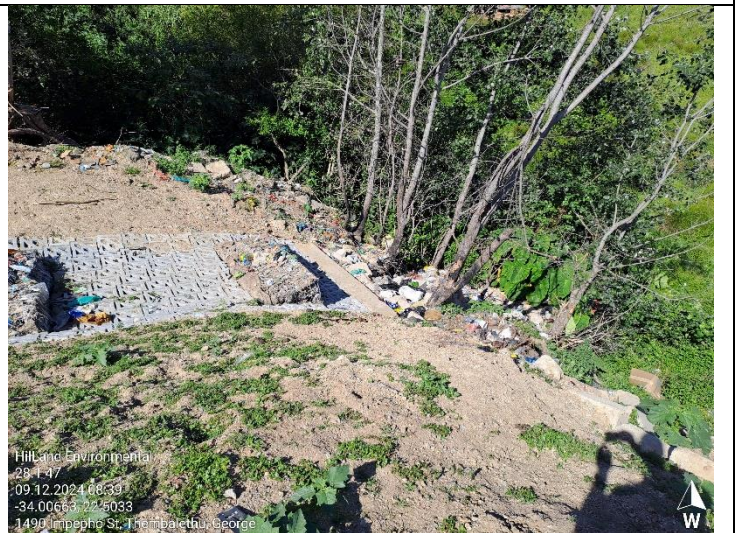
Construction completed.

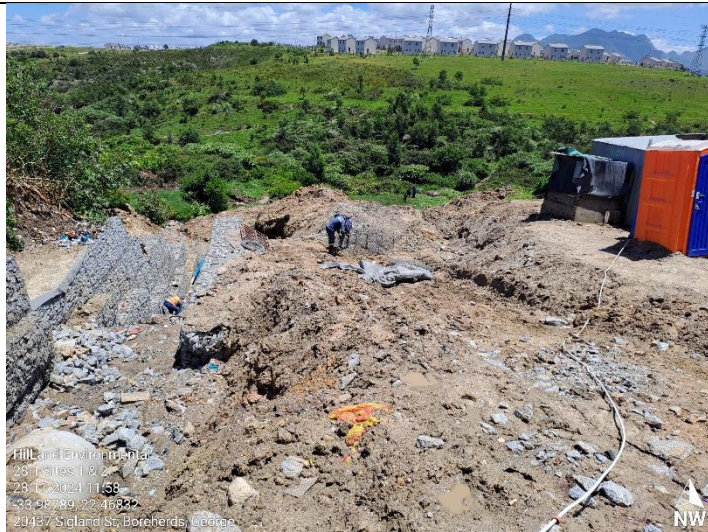
Construction progress. Gabion installation in progress.

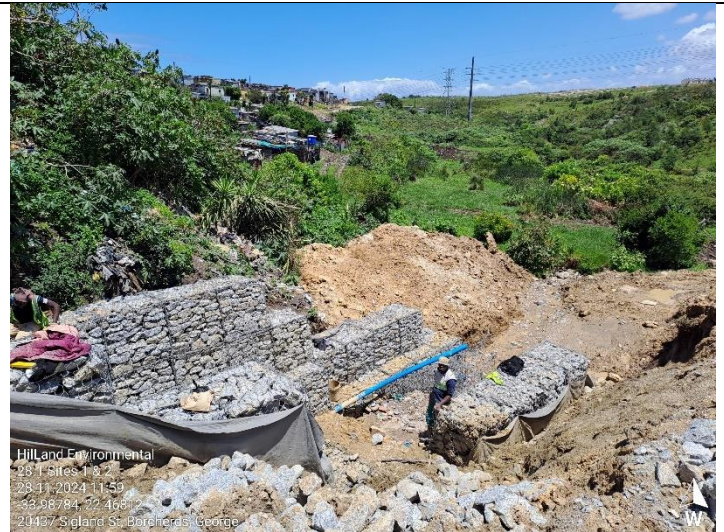
Construction progress. Excavated soil consists of historic dumped material (litter/rubble etc).

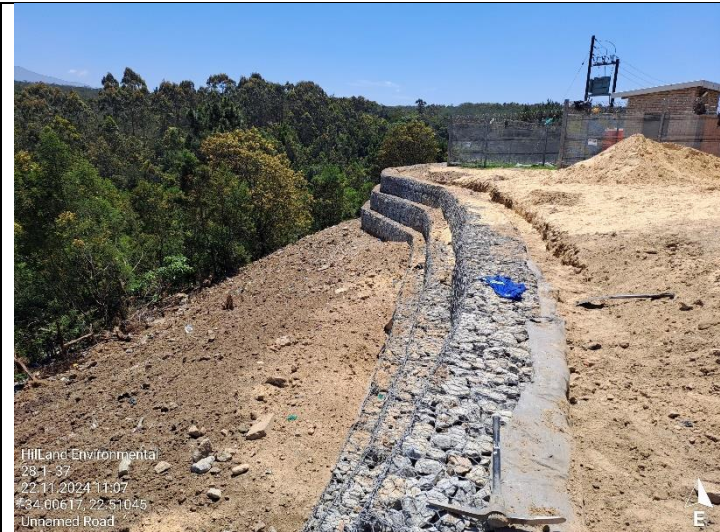
Gabion retaining wall construction completed.

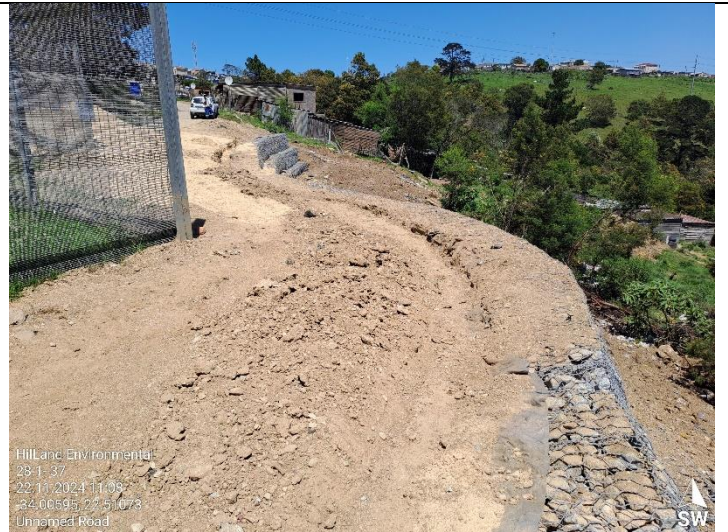
Backfilling completed.

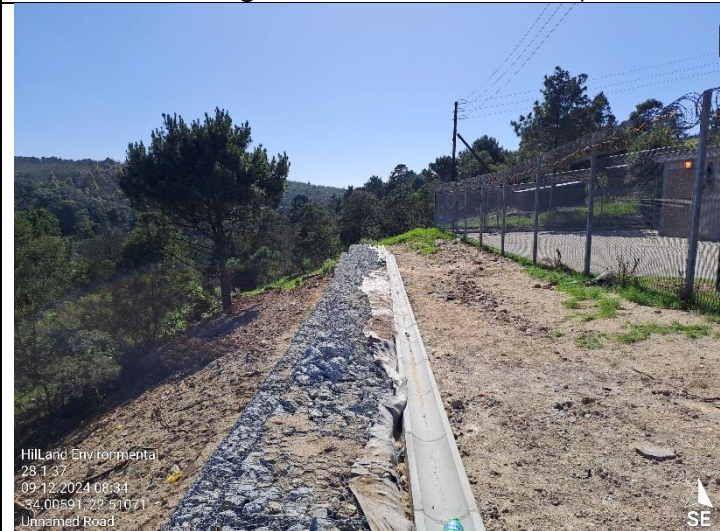
Topsoil to be replaced (behind the gabion structure).

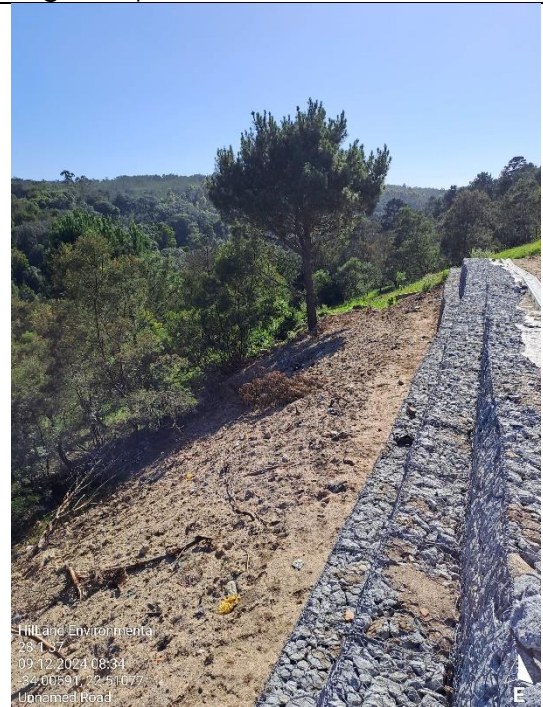
Shaping/sloping below the gabion structure completed. Rehabilitate with grass seed/sod mix.

- Construction near completion and shaping/sloping still to be done – no environmental issues note.
- the slope below the gabion structure must be rehabilitated with grass seed/sods.

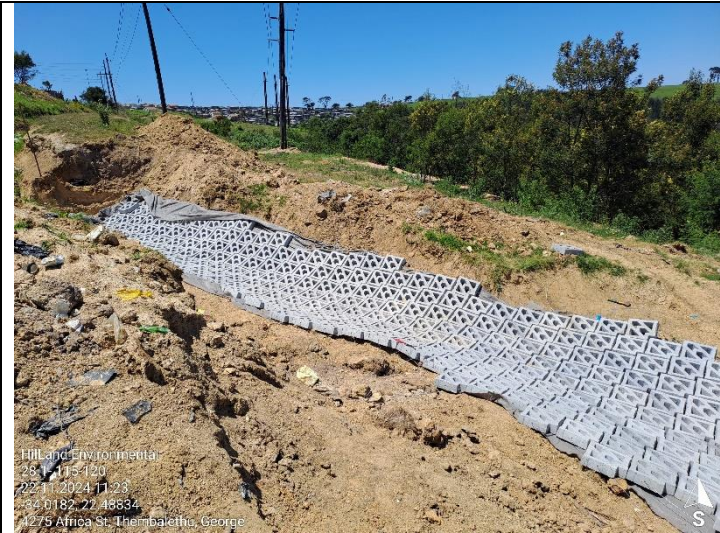
Construction progress – armorflex stormwater channel.

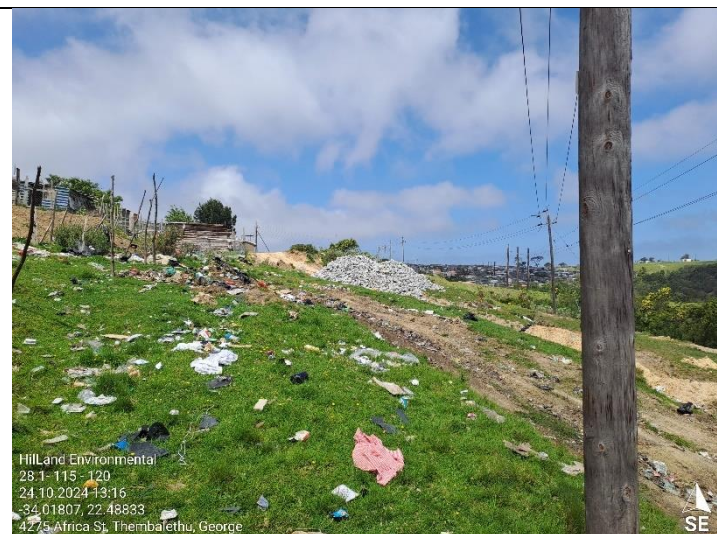
Construction material stockpile area – within development footprint zone.

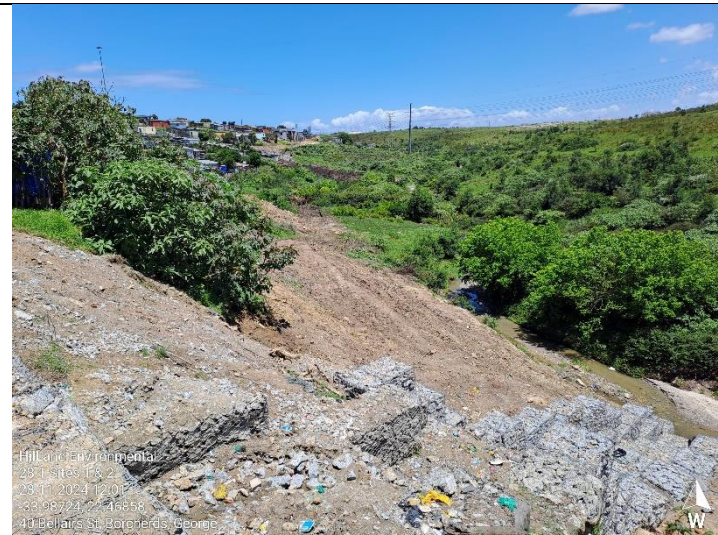
Gabion structure construction completed – final clean up to be done.

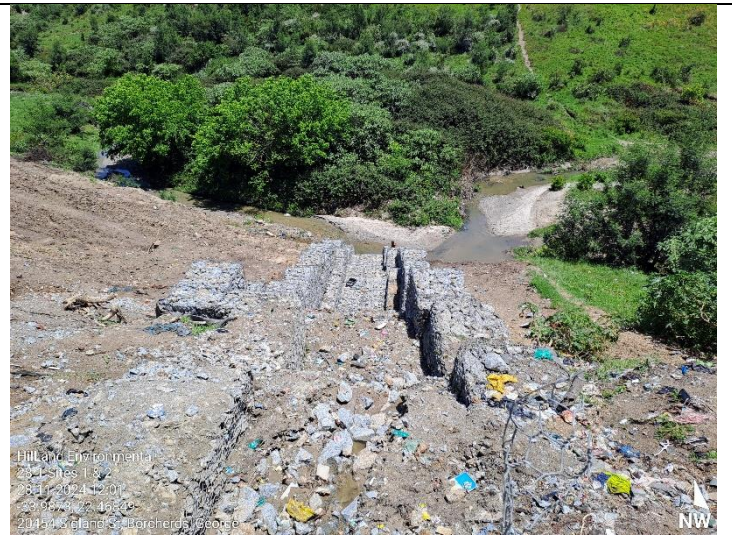
Gabion structure construction completed – final clean up to be done.

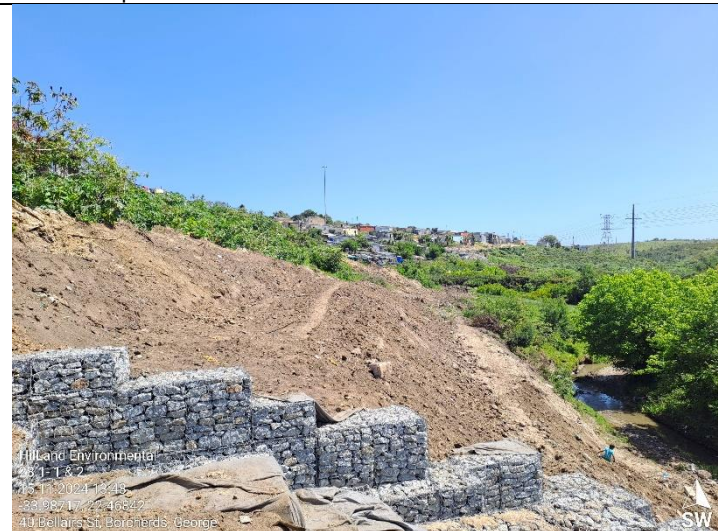
Access area to be rehabilitated with grass seed/sod mix and erosion protection (small silt fences).

- Site preparation and excavation commenced in October 2024.
- Access method statement was approved by the ECO – minor deviation due to the steep slope and stability of the slope. The slope must be rehabilitated with grass seed/sods and small silt fences.
- Gabion installation completed and backfilled behind the gabions completed.
- Bidum silt fence/sandbags must be installed and maintained to prevent silt movement **into** the river.
- Final rehabilitation in process.

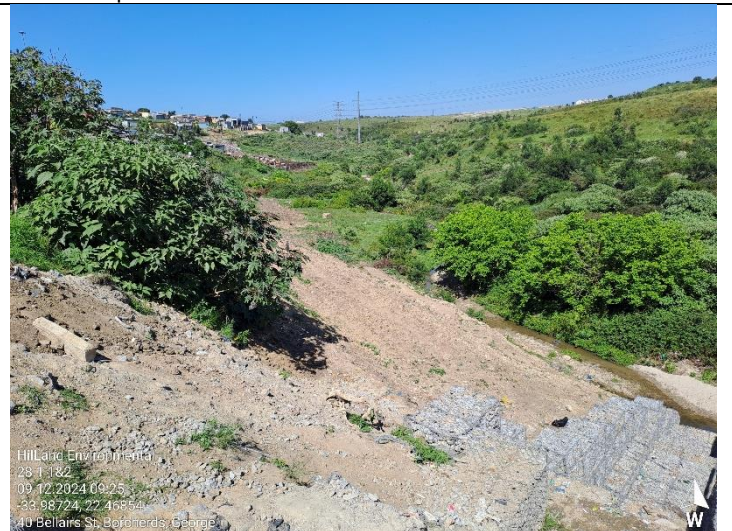
Backfilling completed – final clean-up to be done.

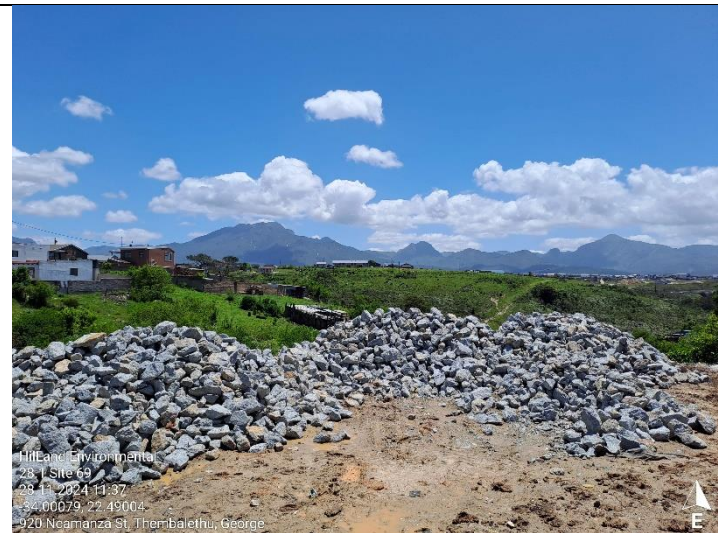
Construction material stockpile area – historic transformed area – no environmental issues.

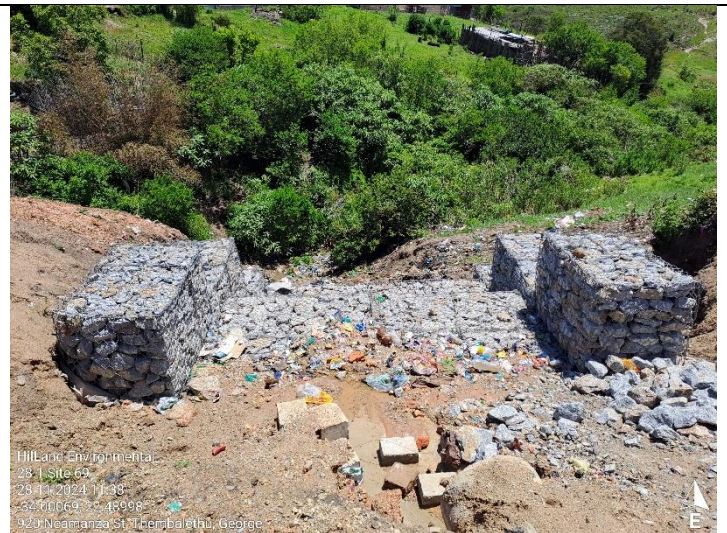
Contractor progress – note litter/rubble dumped after hours (not the contractor).

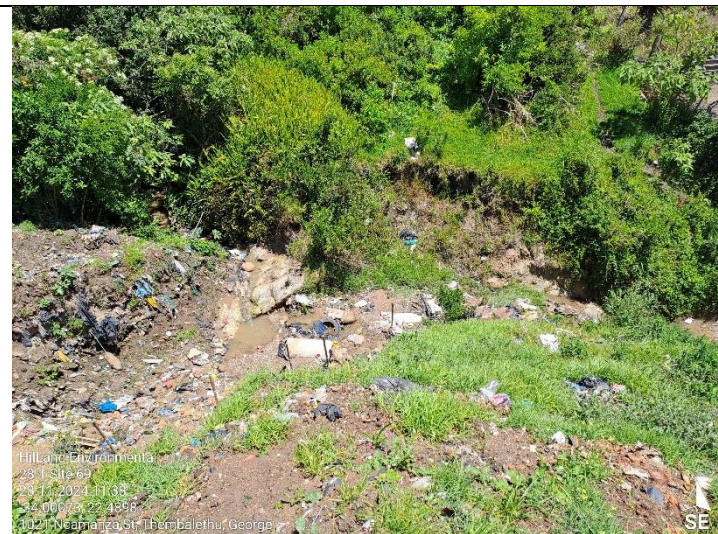
Construction footprint – silt fence to be installed below the last gabion position to prevent silt movement into the stream, however, note the degraded condition of the stream prior to commencement.

- Site preparation and excavation commenced in October 2024.
- Dumped rubble was removed to the municipal waste disposal site – ongoing during the construction phase.
- Bidum silt fence/sandbags must be installed and maintained to prevent silt movement into the stream – it must be noted that the stream is heavily degraded and filled with litter/trash. The contractor is constantly removing litter/trash from the site (working area) that is dumped after hours.
- Portable toilet is on site.

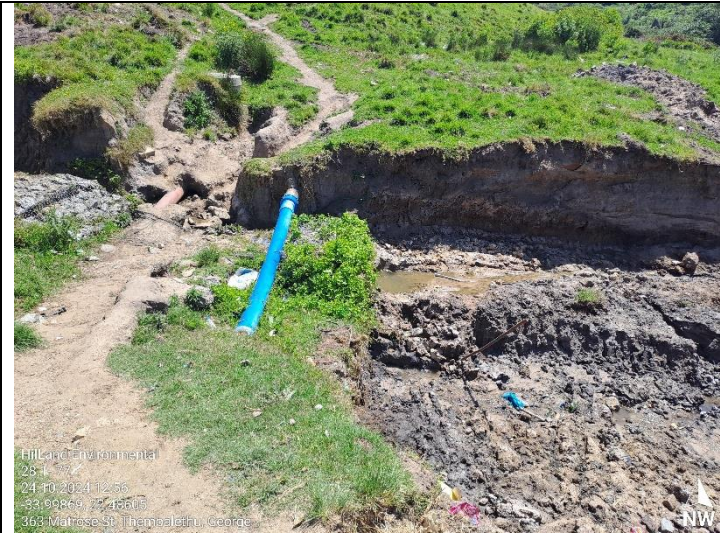
Existing services exposed and must be protected during construction phase.

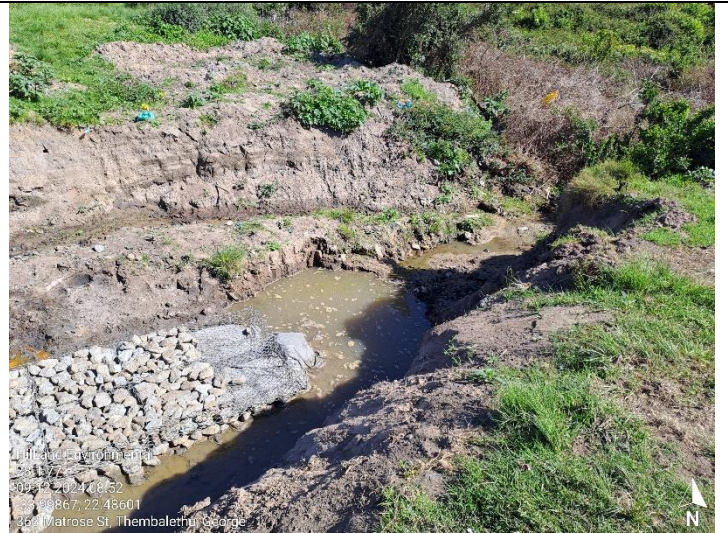
Temporary stream diversion in place during gabion construction.

- Site preparation and excavation commenced in October 2024.
- Surveyor pegged the stormwater outlet structure.
- Silt fence must be installed and maintained to prevent silt movement downstream - temporary stream diversion in place.
- Gabion installation commenced.

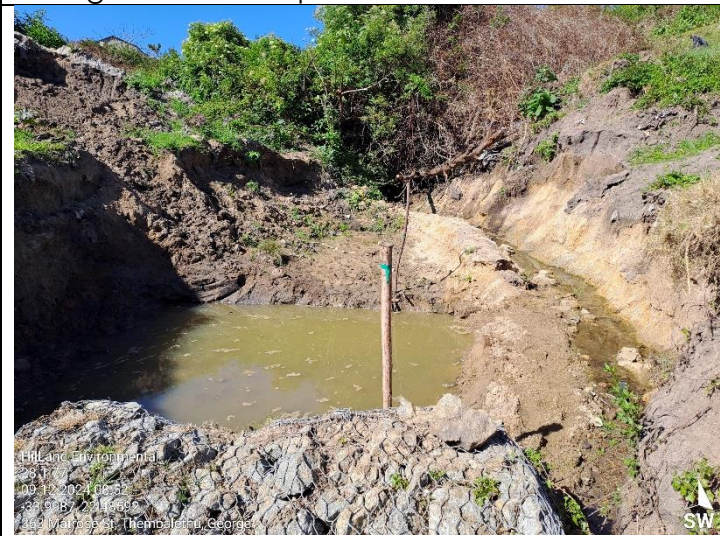
Temporary stream diversion in place.
