## ENVIRONMENTAL MONITORING REPORT 5

*Maintenance to and Management of the stormwater infrastructure for  
Project 28(1) – Flood damage repair in George Municipal area*

**GEO24/1252/19**

**January 2025**

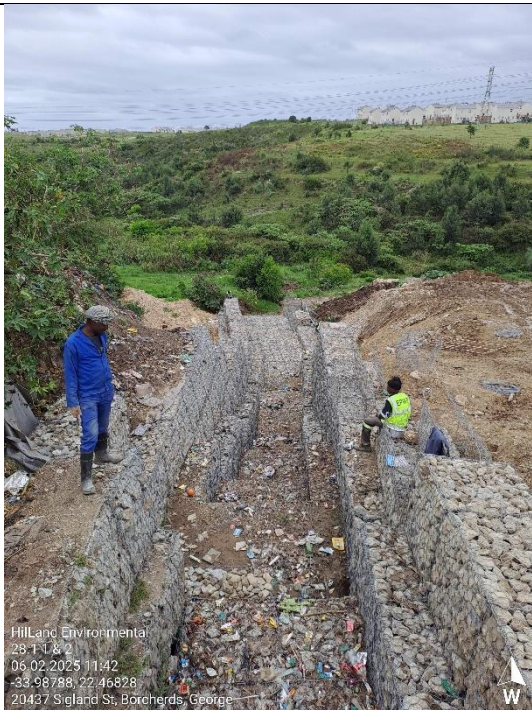
Construction progress. Gabion installation in progress. Note the continual dumping of waste/litter in the stormwater outlet structure.

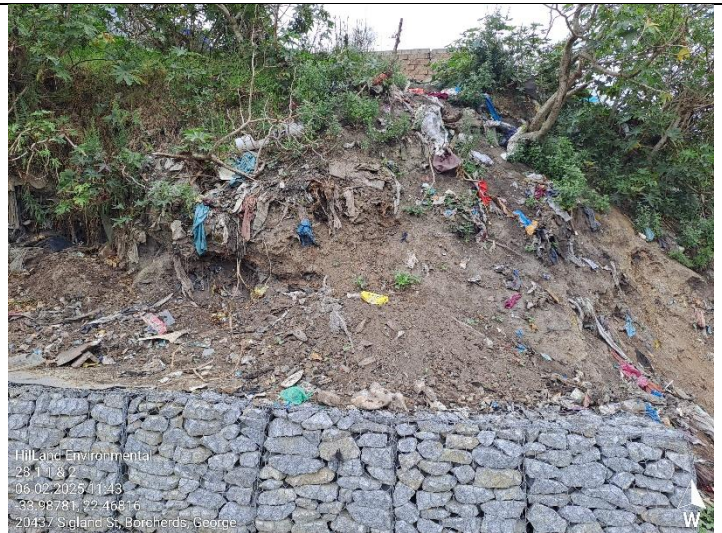
Unstable slope consisting of historical dumped waste.

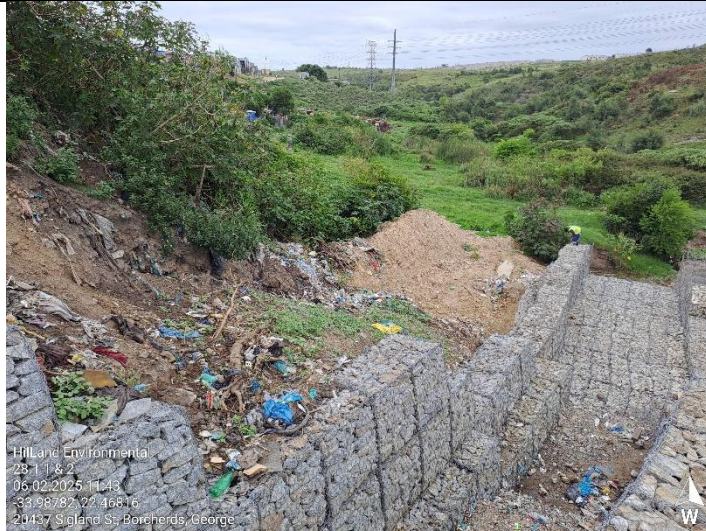
Construction progress.

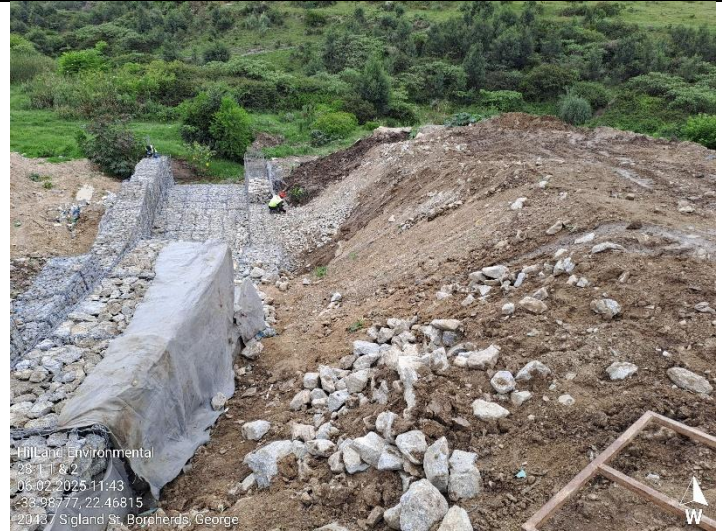
Construction progress and showing the stockpile area (RHS of the gabion structure).

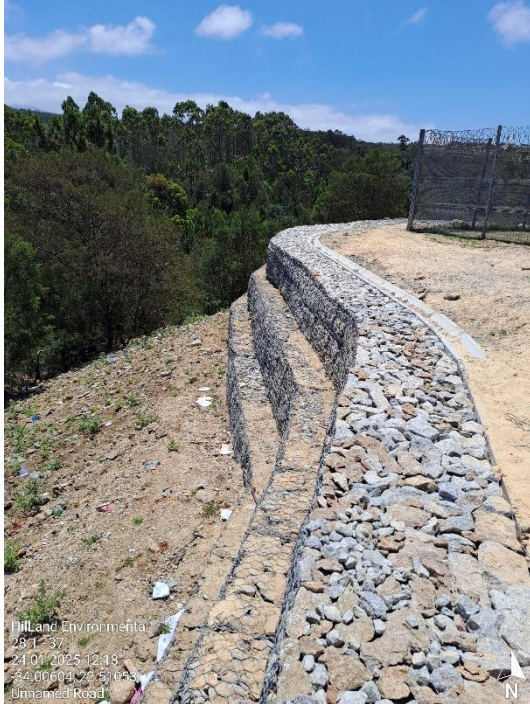
Gabion retaining wall construction completed.

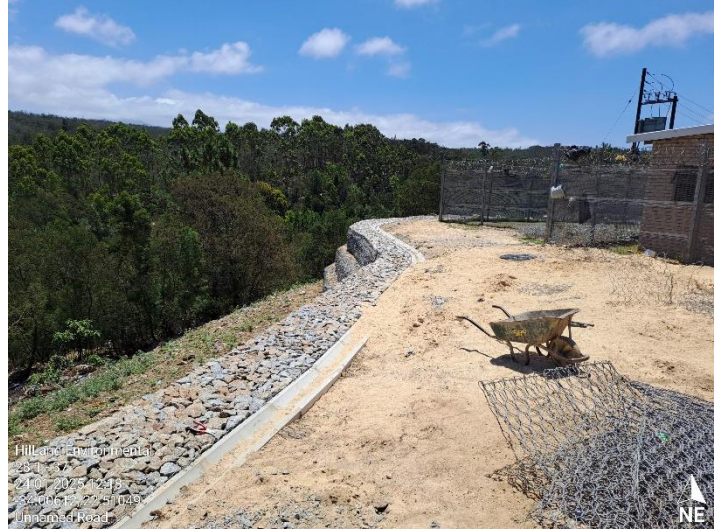
Backfilling completed.

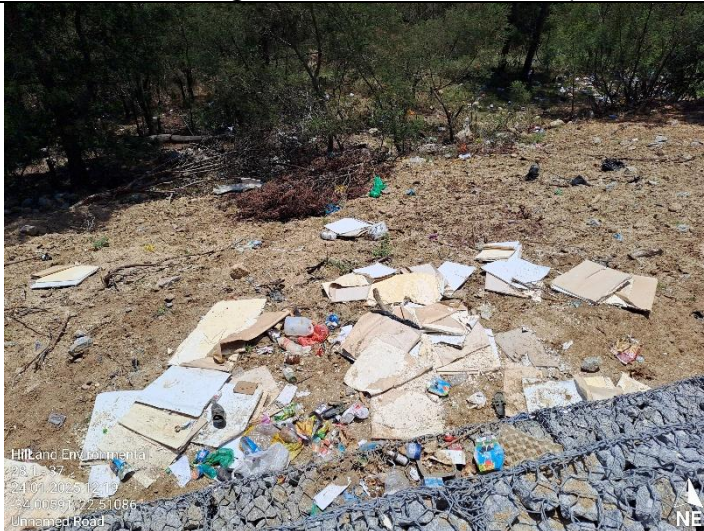
Continual dumping of waste and litter remains an ongoing issue.

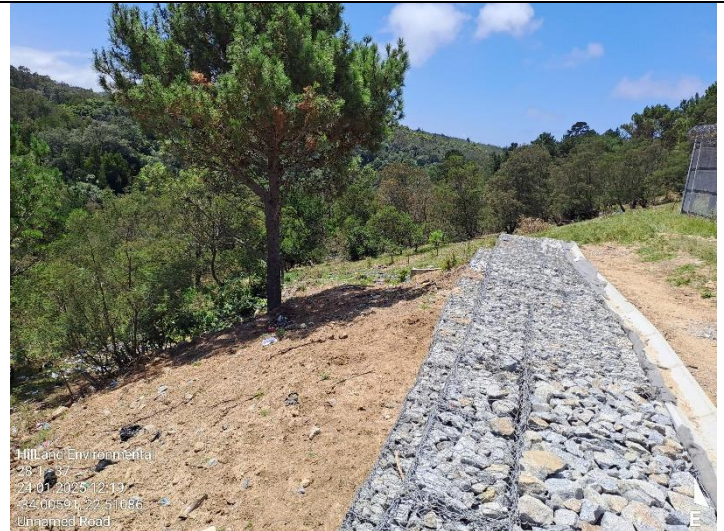
The slope below the gabion structure has been shaped to the satisfaction of the ECO.

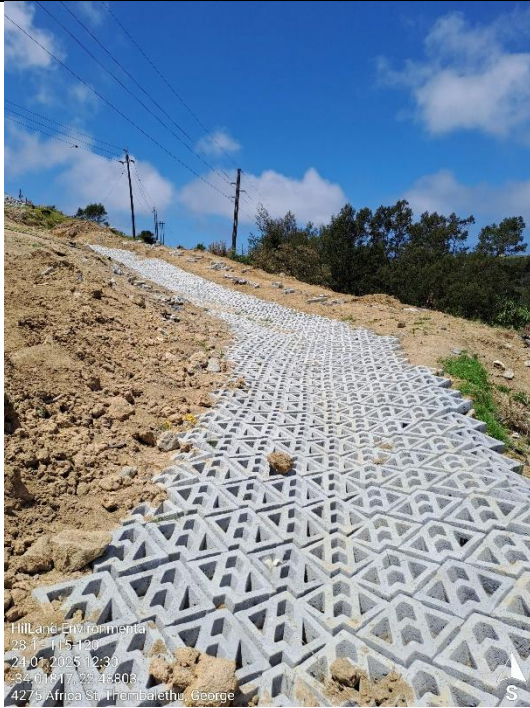
Construction progress – armorflex stormwater channel.

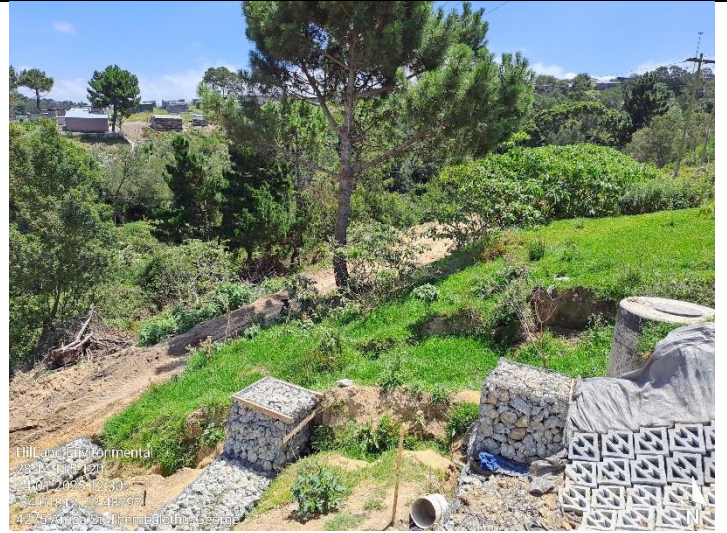
Construction progress.

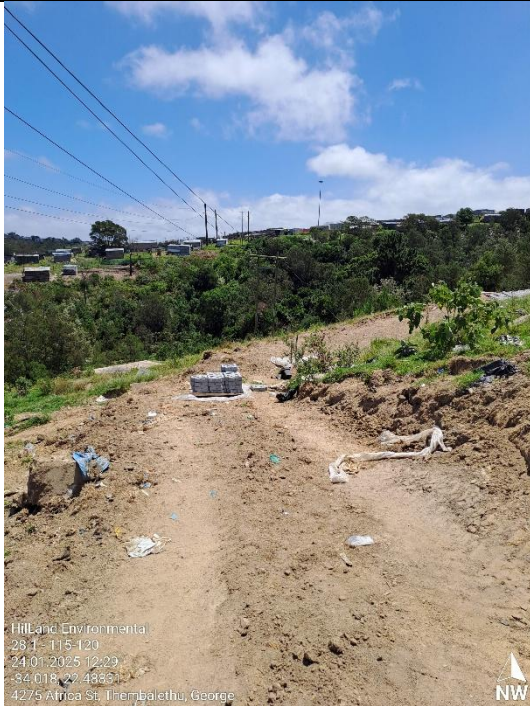
Temporary construction haul route.

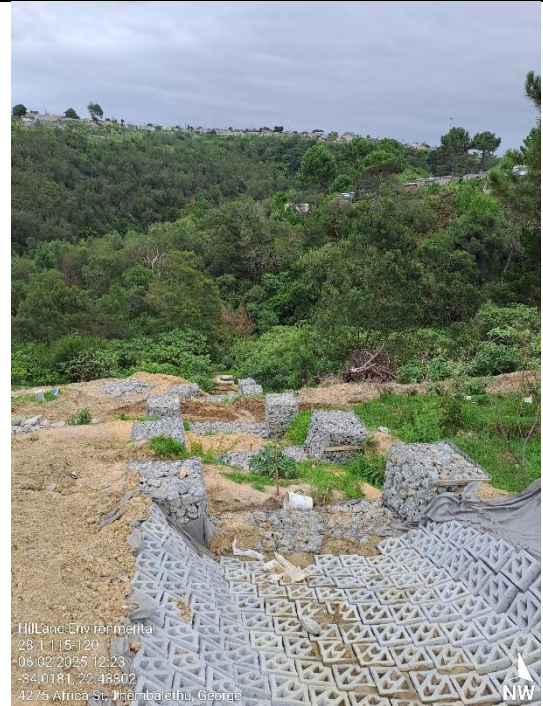
Construction site – silt is captured in the armorflex.

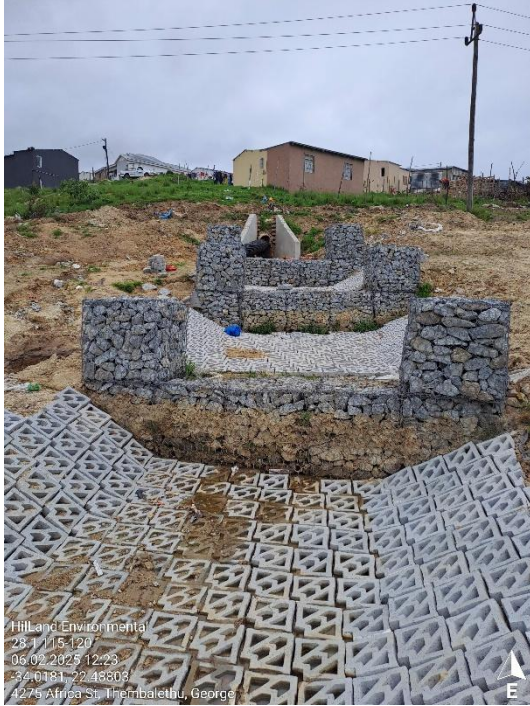
Construction site.

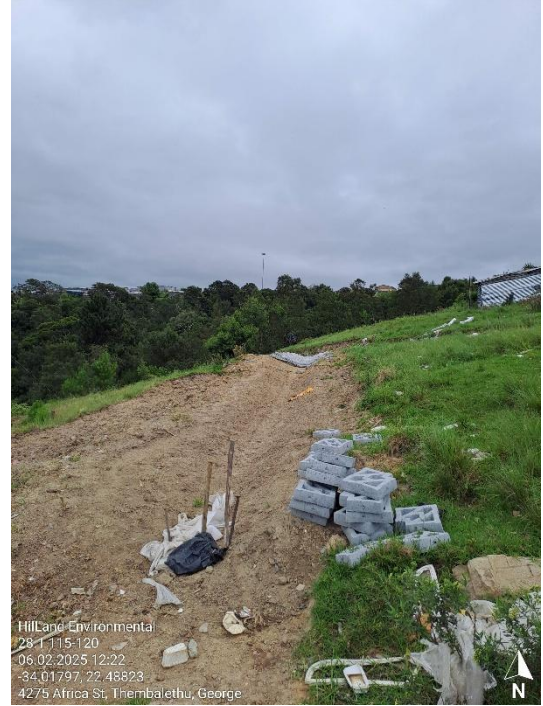
Shaping and installation of the armorflex in progress.

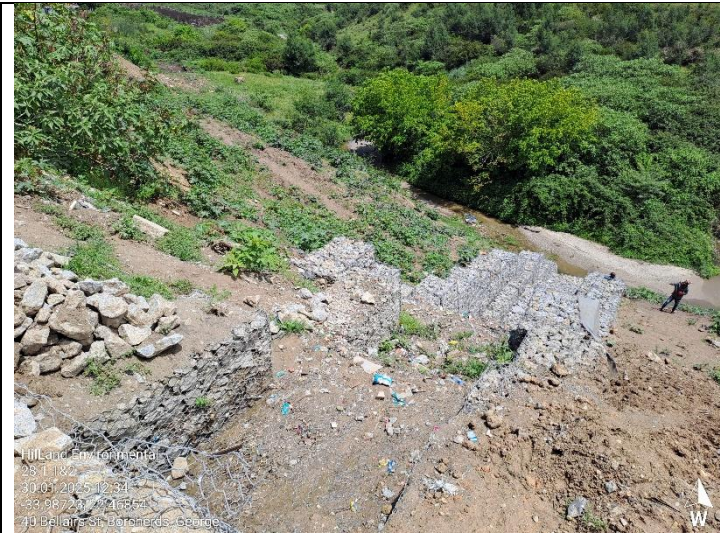
Gabion structure construction completed – tie in and clean-up in progress.

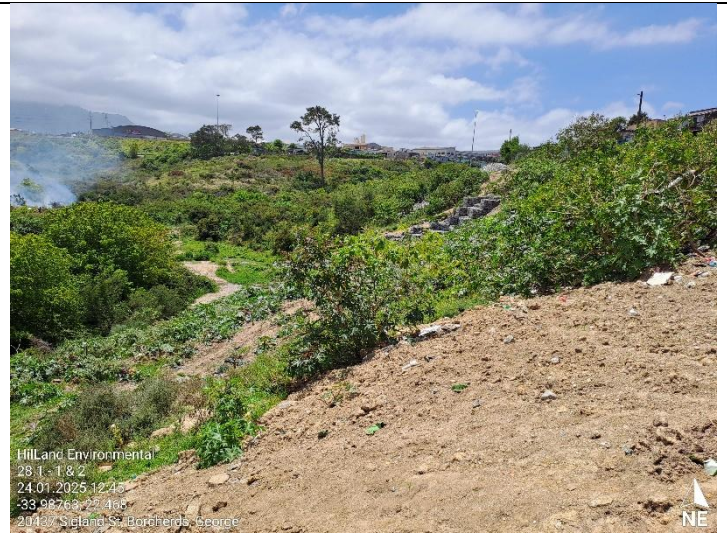
Access track shaping is done.

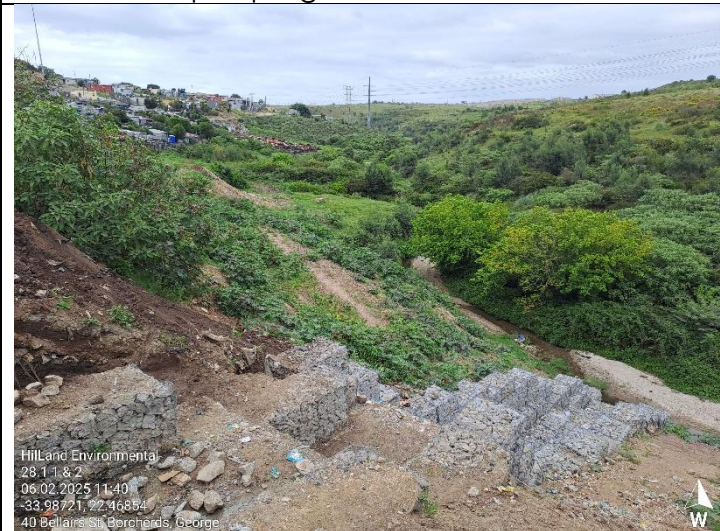
Access area to be rehabilitated with grass seed/sod mix and erosion protection (small silt fences). The invasive alien plants on the access slope must be removed.

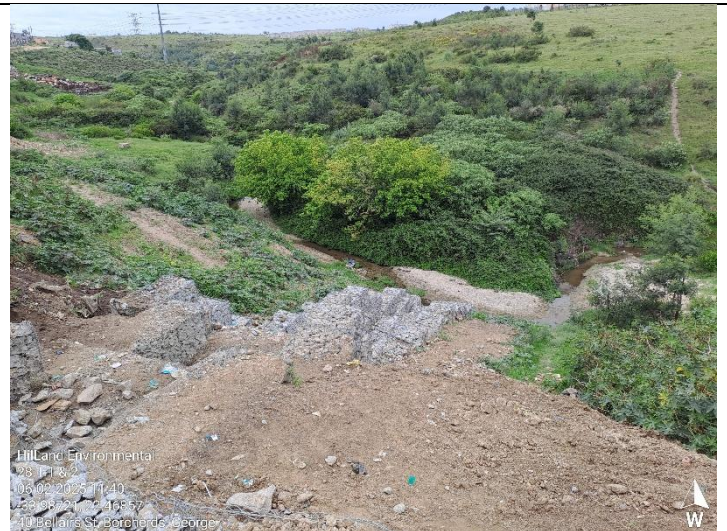
Backfilling completed.

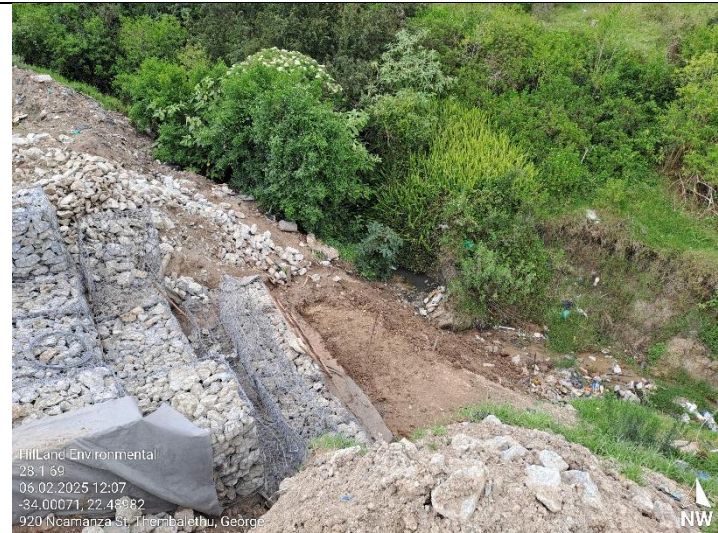
Construction progress (69a).

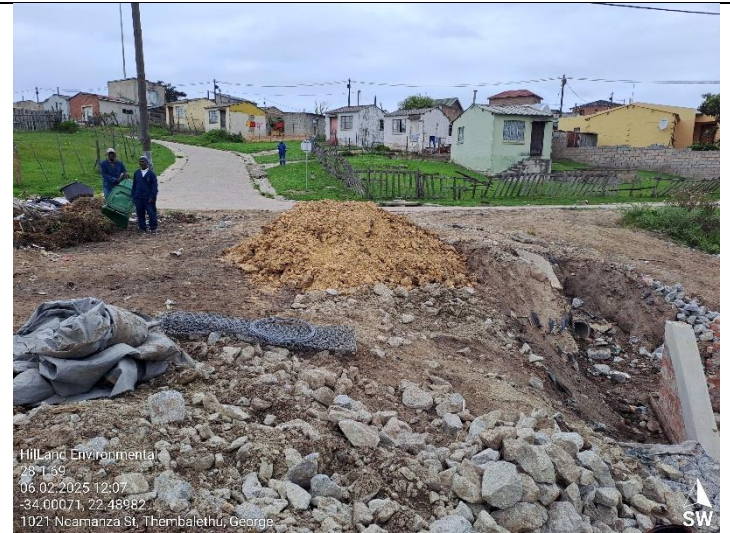
Contractor progress (69a) and construction material stockpile area. Note local residents busy dumping waste out of a wheely bin.

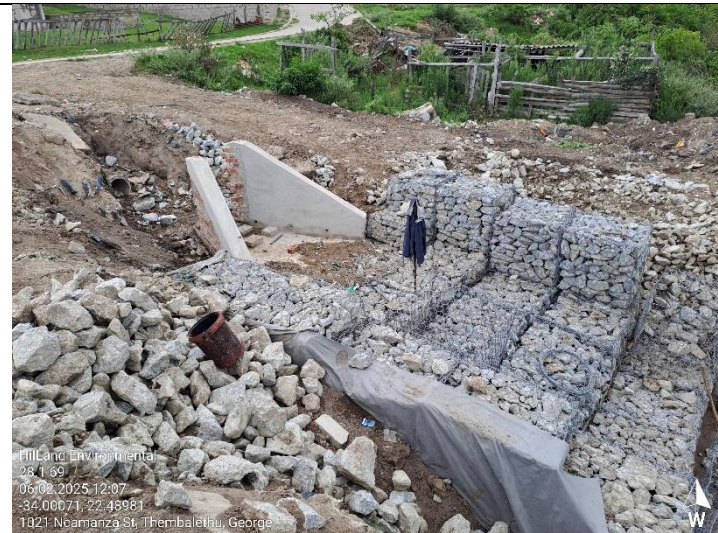
Construction progress (69a).

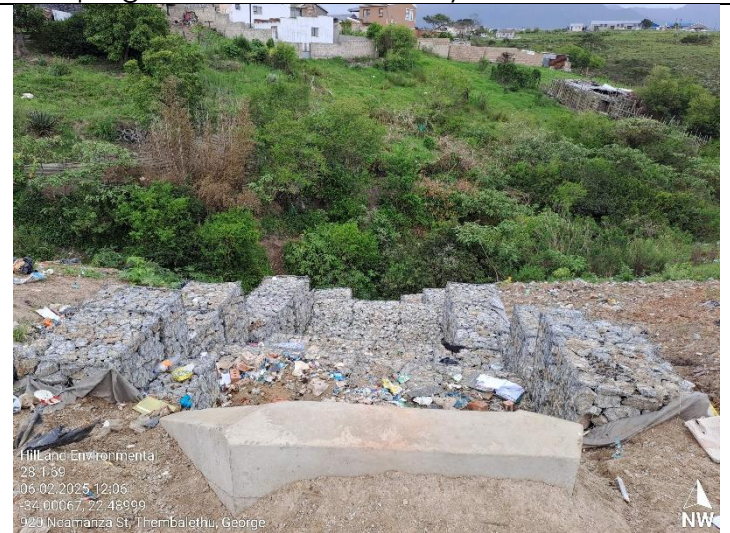
Construction footprint (69b). backfilling completed

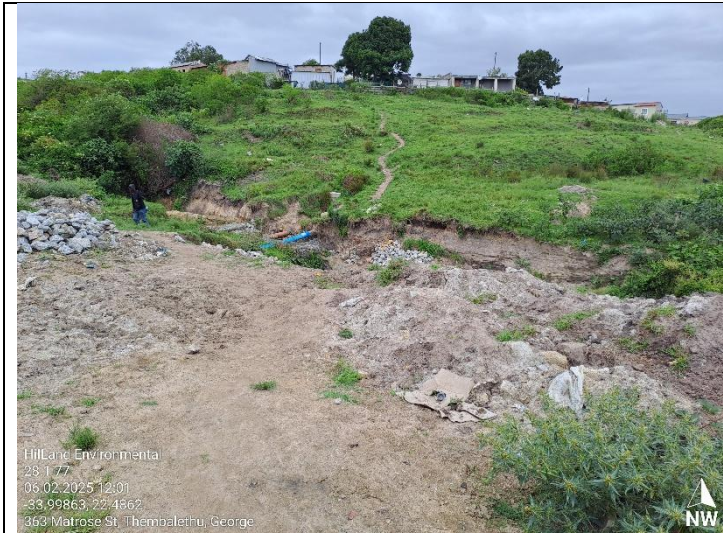
Construction site.

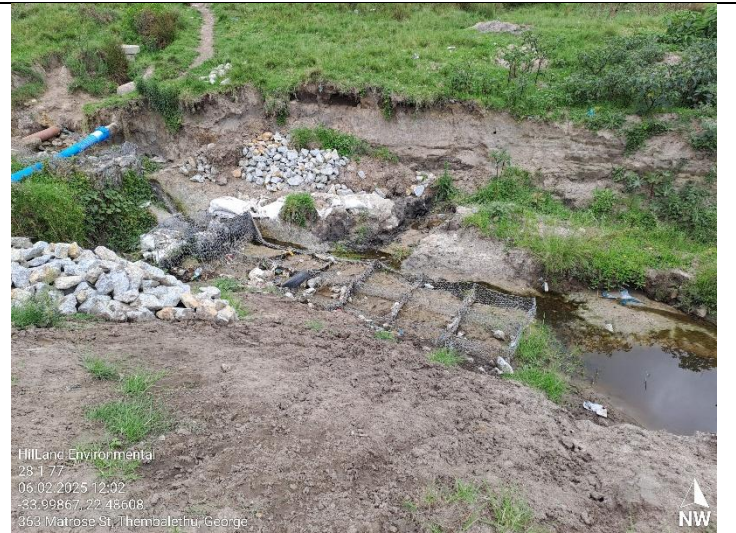
Construction progress.
