## ENVIRONMENTAL MONITORING REPORT 6

*Maintenance to and Management of the stormwater infrastructure for  
Project 28(1) – Flood damage repair in George Municipal area*

**GEO25/1252/20**

**February to 7 March 2025**

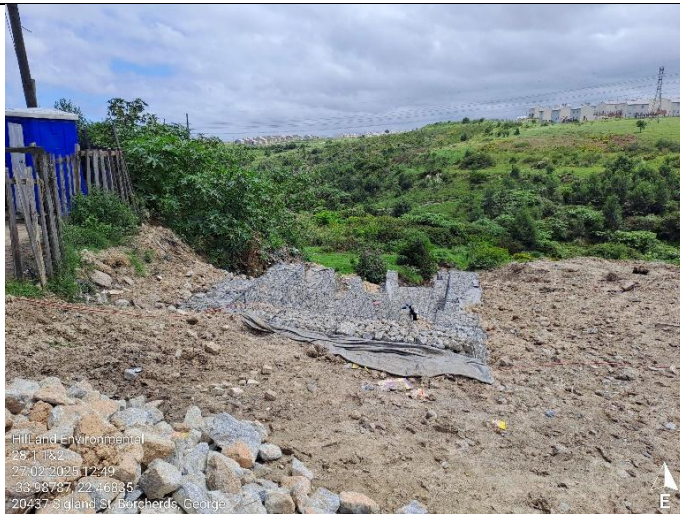
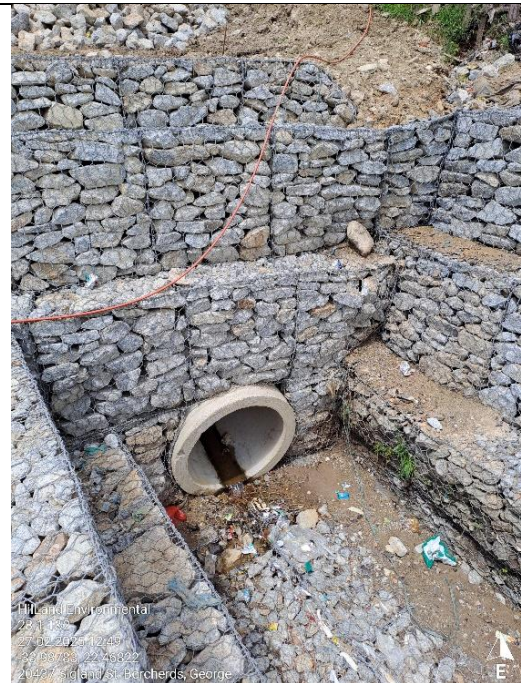
Construction progress.

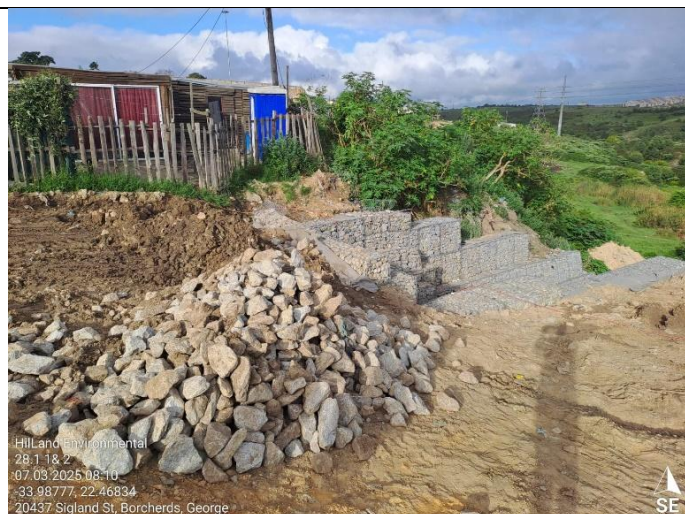
Stockpile area – at the site

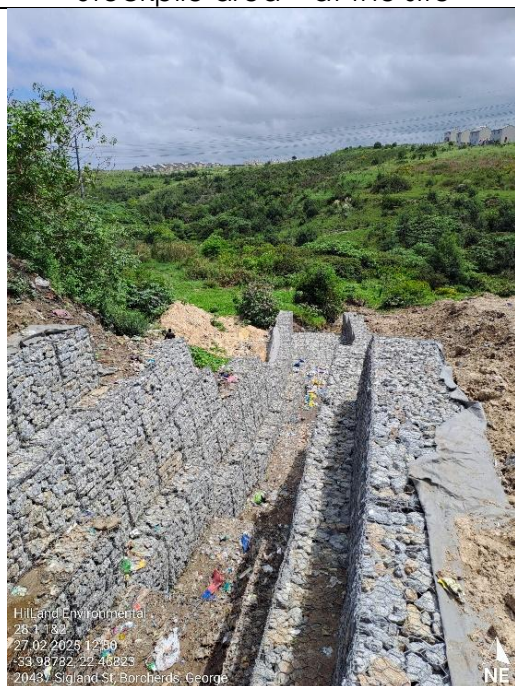
Construction progress – backfilling behind the gabion structure and shaping will start in due course.

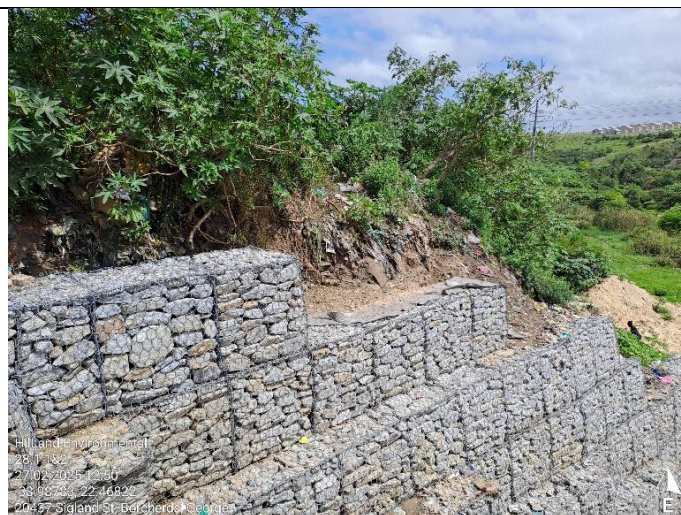
Construction progress.

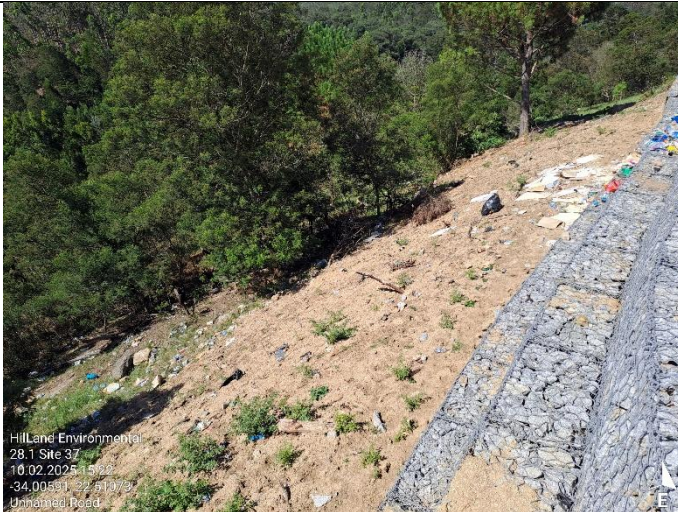
Gabion retaining wall construction completed. Continual dumping of waste and litter remains an ongoing issue.

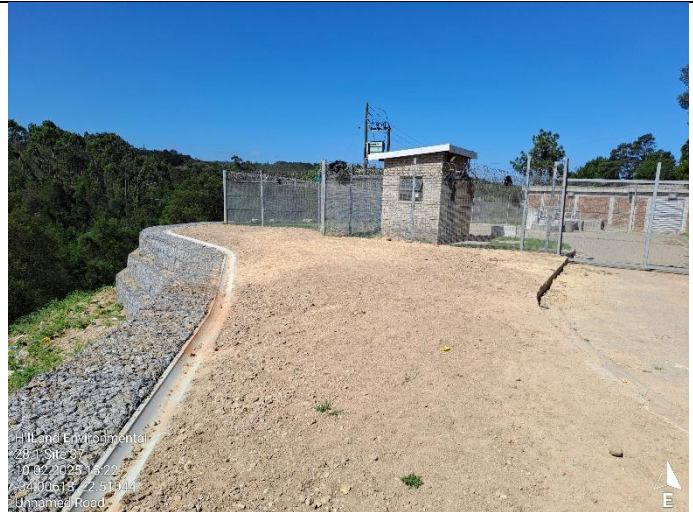
Backfilling completed – rehabilitation (topsoil and grass seed/sods) still to be completed.

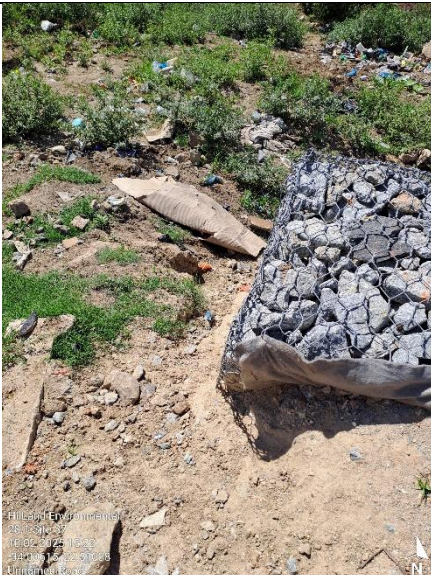
Final shaping and tie in at the ends of the gabion structure to be finalised – small concrete channel.

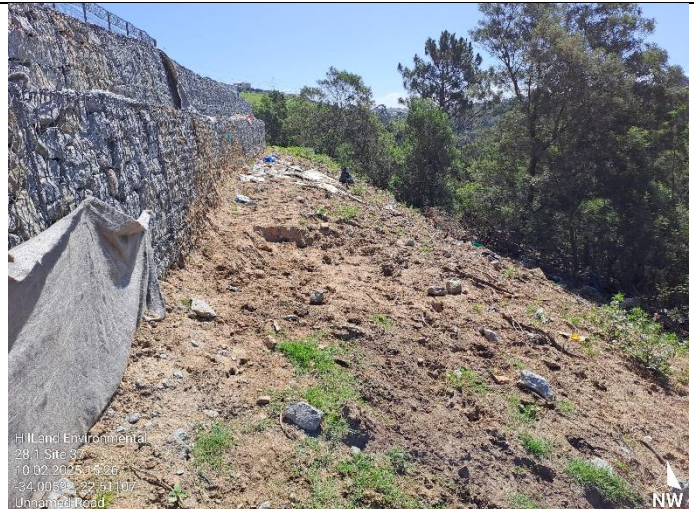
The slope below the gabion structure has been shaped.

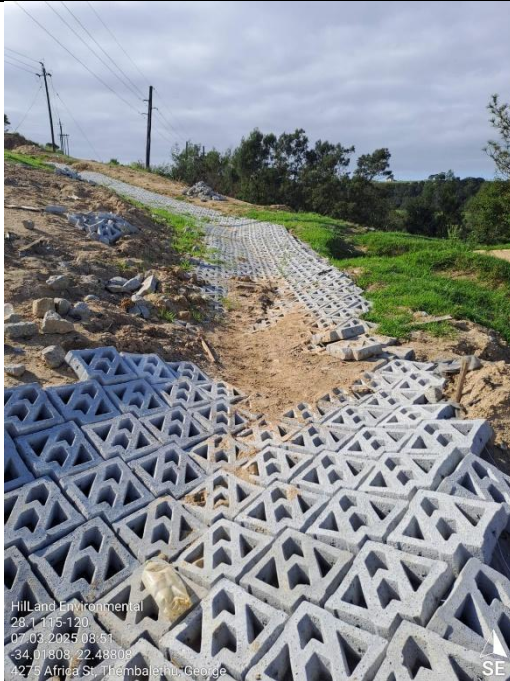
Construction progress – armorflex stormwater channel.

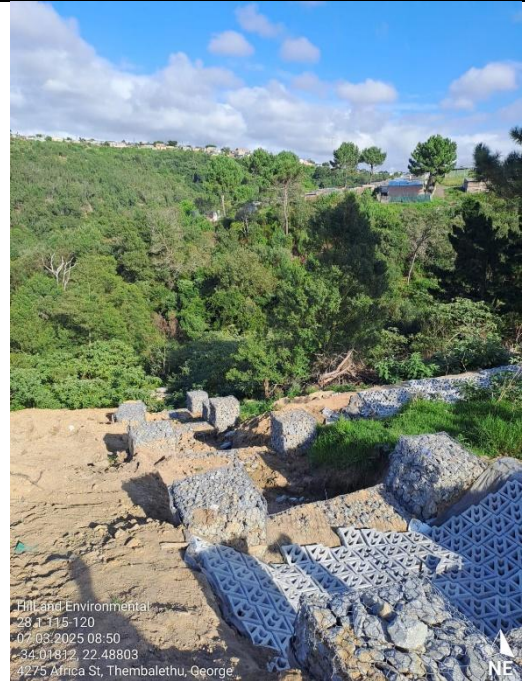
Construction progress.

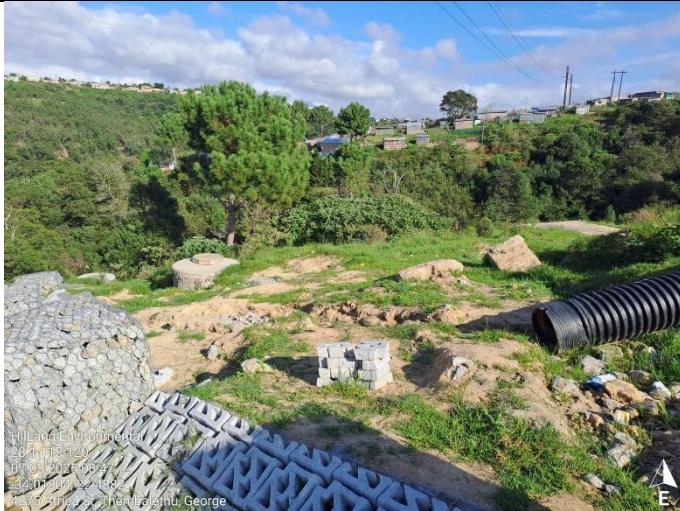
Construction site – existing erosion trenches will be rehabilitated at the end of construction.

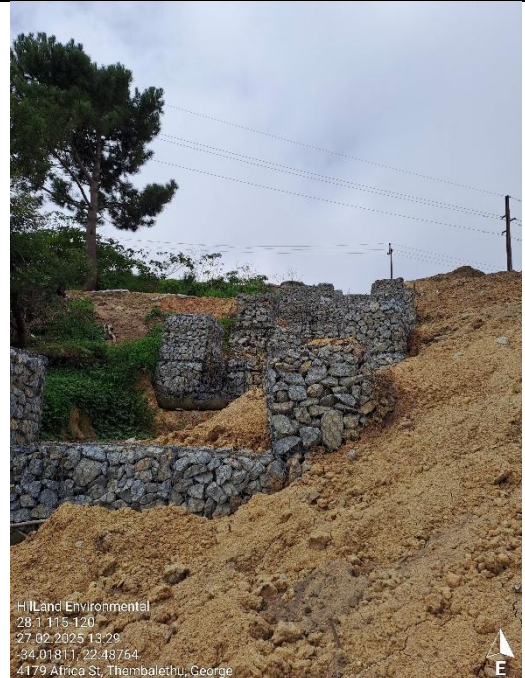
Construction progress – gabion installation. The slope will be shaped to tie in with the armorflex channel.

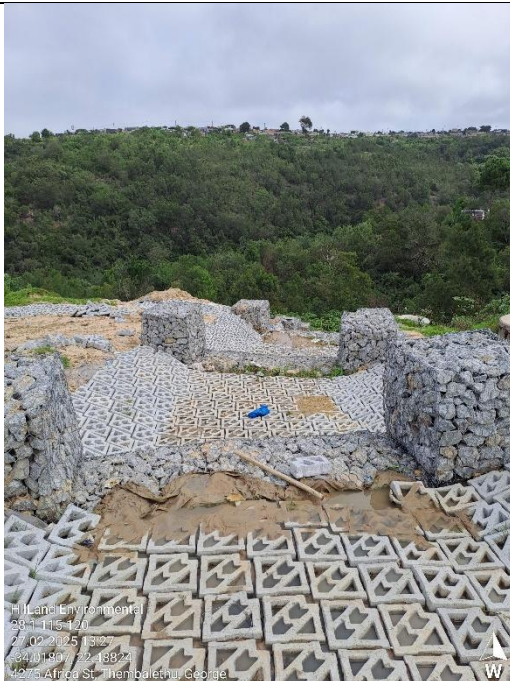
Construction site – silt is captured in the armorflex.

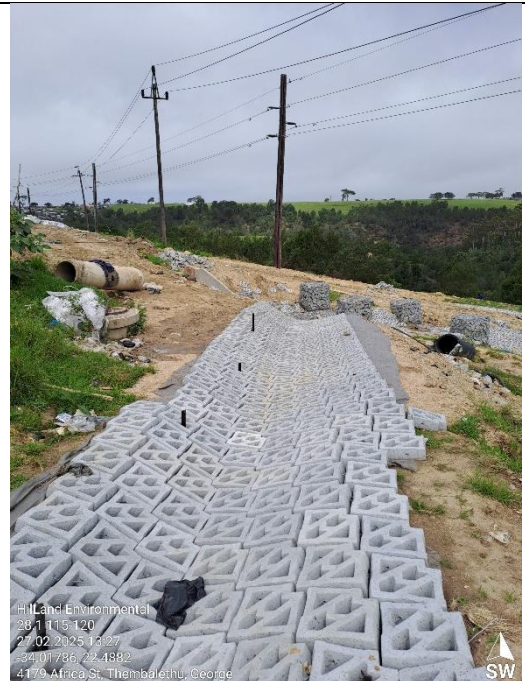
Shaping and installation of the armorflex in progress.

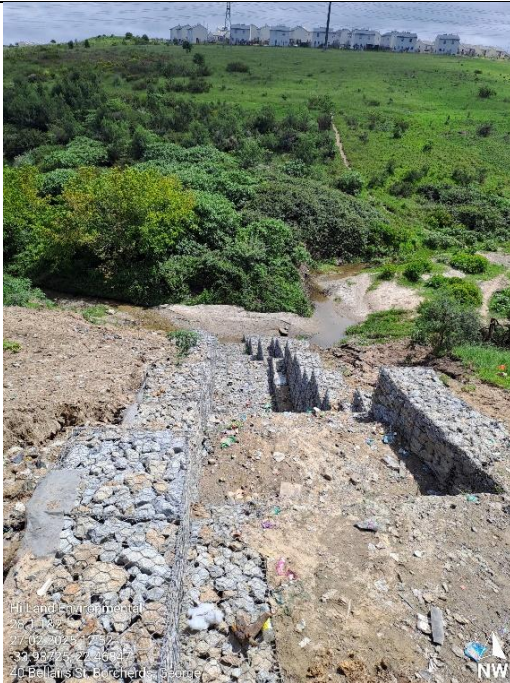
Gabion structure construction is completed. Note that the reno-mattress section captures silt as designed.

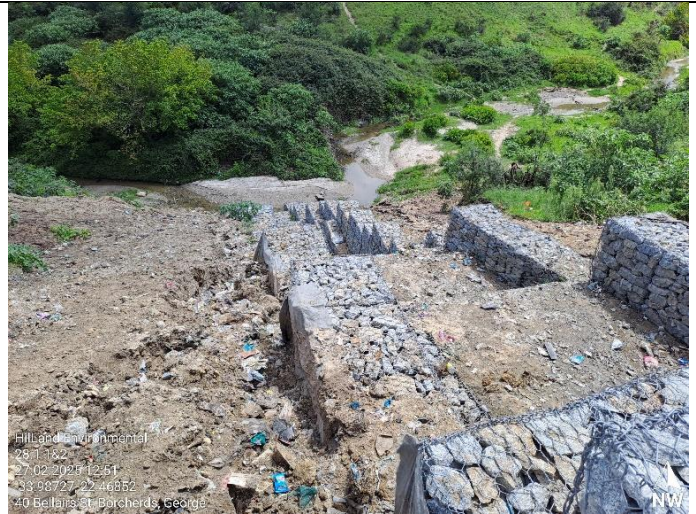
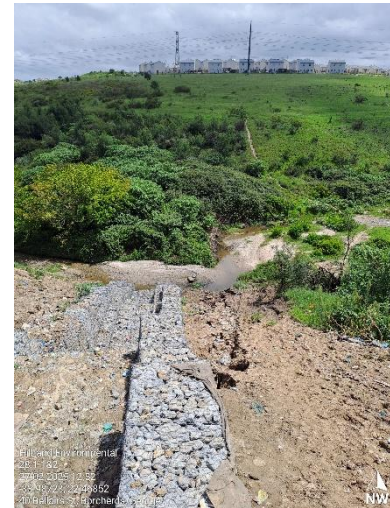
- Construction of the main gabion structure is complete.
- Shaping and backfilling done, however after the recent rain there is erosion damage on the sides of the structure. This was inspected on Friday (7 March 2025) with the engineer and contractor and a suitable solution was discussed and agreed. Backfilling and rehabilitation will be done in due course.
- The ECO approved access method statement – minor deviation due to the steep slope and stability of the slope. The slope must be rehabilitated with grass seed/sods and small silt fences.

Erosion damage on the sides of the gabion structure will be backfilled and rehabilitated. Additional erosion protection to be installed (mulch sausages, sandbags etc). A gabion will be installed to prevent future erosion.

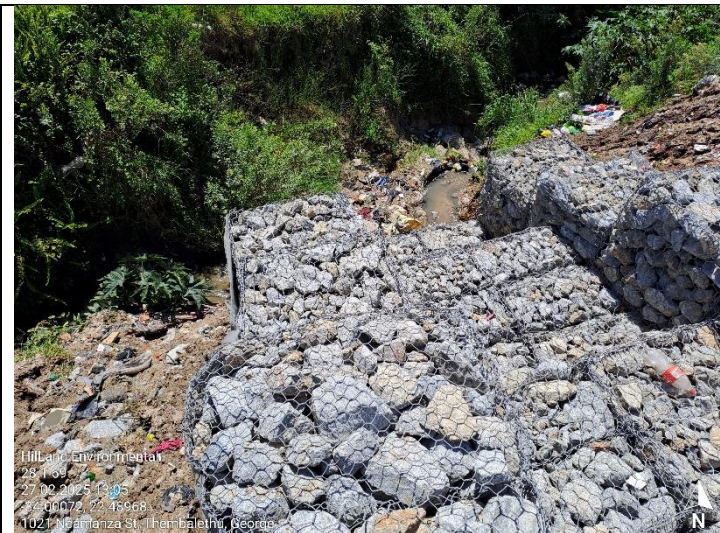
Construction progress (69a).

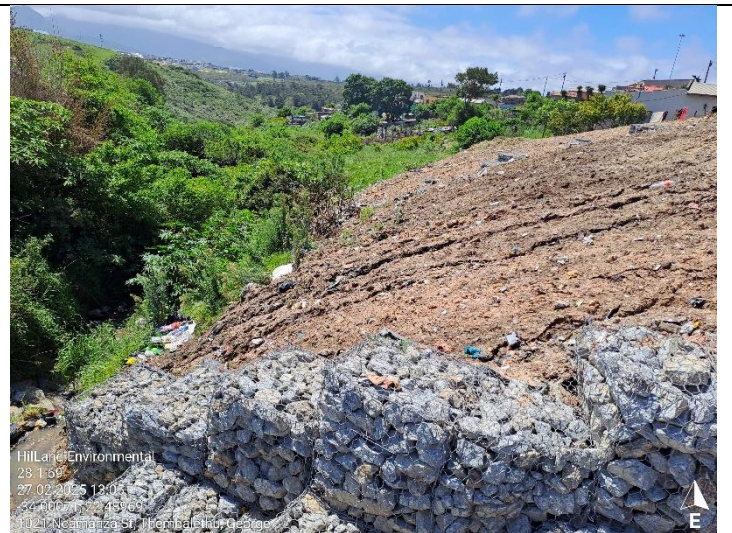
Contractor progress (69b) backfilling and shaping done – additional erosion protection (mulch bags or sandbags) to be used – where feasible.

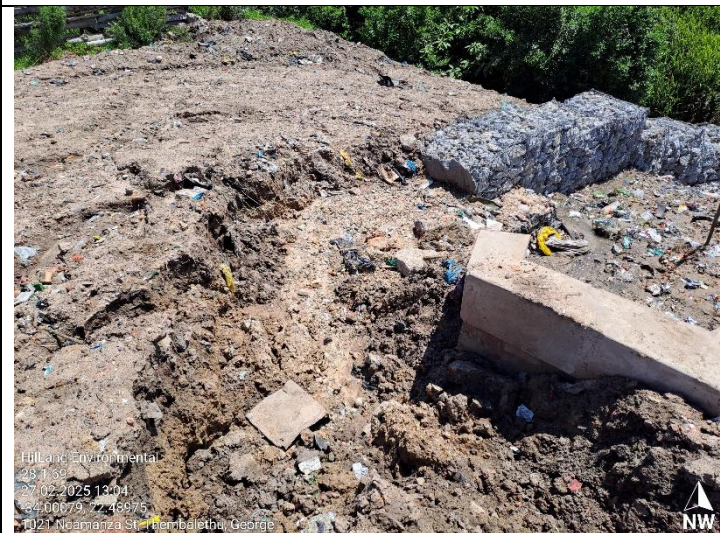
Construction progress (69a) – erosion damage to fixed and rehabilitated. Additional erosion protection (mulch bags or sandbags) to be used – where feasible.

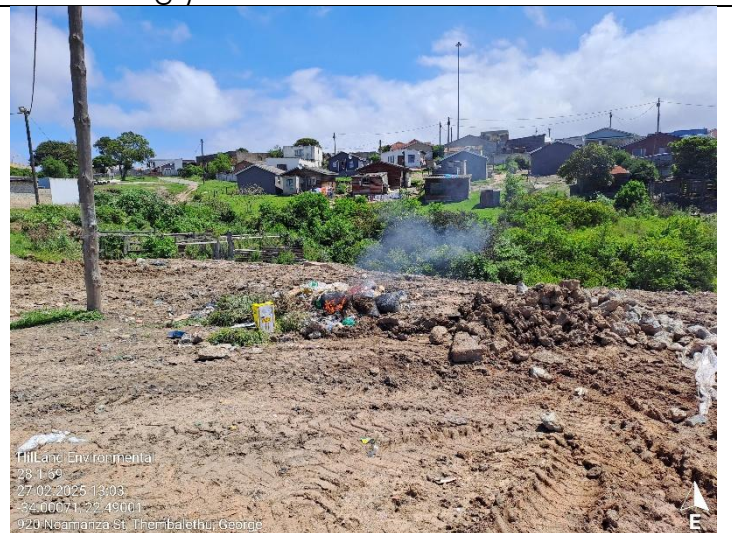
Local residents are burning waste (general and garden refuse) is burned on site – not the contractor.

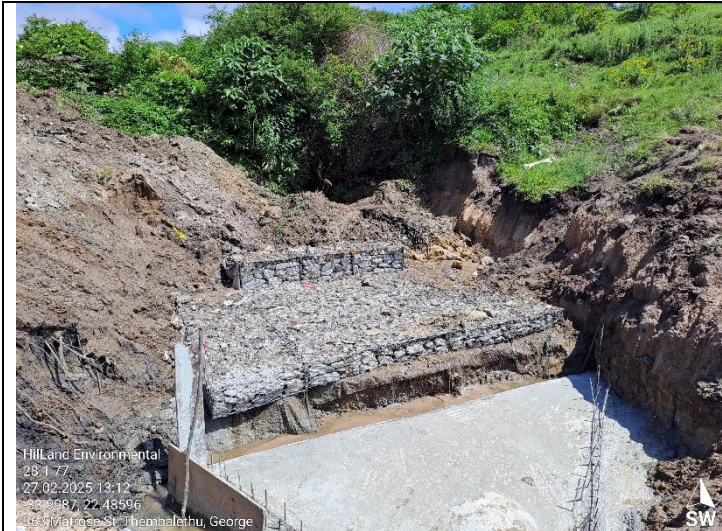
Construction in progress – temporary diversion in placed (left).

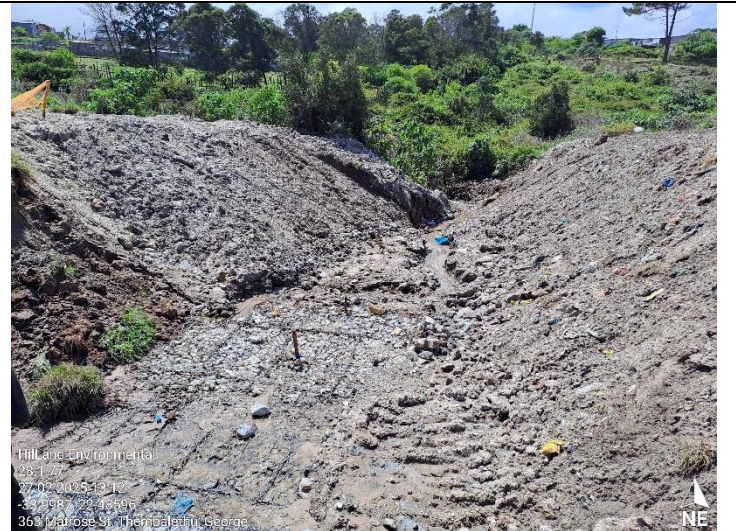
Downstream – gabion installed. Side slopes to be rehabilitated (topsoil) and erosion protection (mulch bags/ sandbags etc.) at the end of construction.

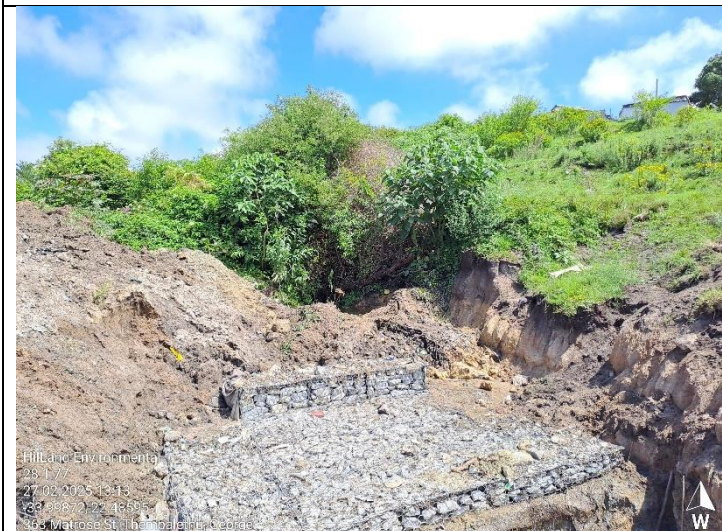
Upstream – gabion installed.

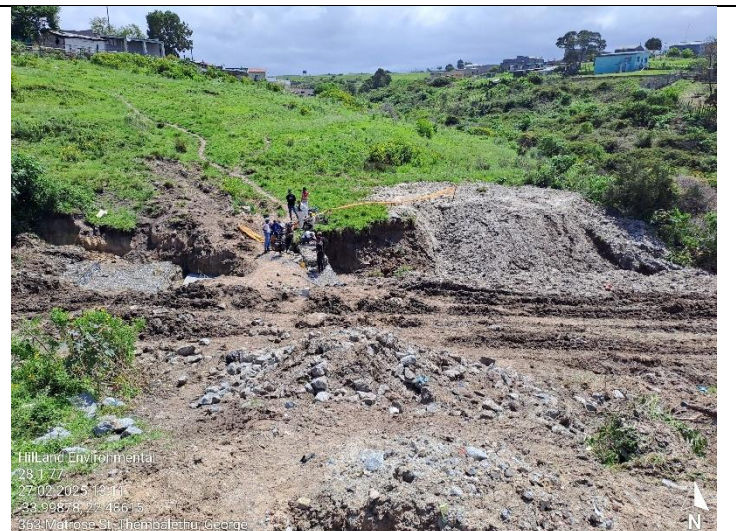
Construction site – pedestrians still use the walkway.
