## FINAL ENVIRONMENTAL MONITORING REPORT 7

*Maintenance to and Management of the stormwater infrastructure for  
Project 28(1) – Flood damage repair in George Municipal area*

**GEO25/1252/21**

**April to October 2025**

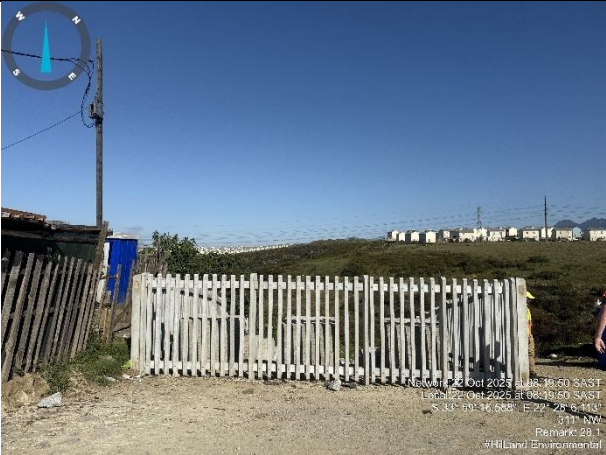
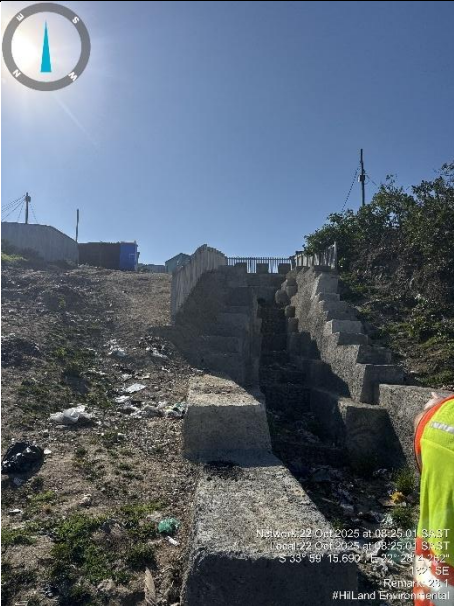
| <p>NEW: 22 Oct 2025 at 08:16:40 SAST<br/>Loc: 22 Oct 2025 at 08:16:40 SAST<br/>S 33° 56' 15.632" E 29° 26' 6.143"<br/>UTM: NS<br/>Remarks: 25.1<br/>#Hiland Environmental</p> | <p>NEW: 22 Oct 2025 at 08:25:01 SAST<br/>Loc: 22 Oct 2025 at 08:25:01 SAST<br/>S 33° 56' 15.632" E 29° 26' 6.143"<br/>UTM: SE<br/>Remarks: 25.1<br/>#Hiland Environmental</p> <p>Completed gabion structure</p> |

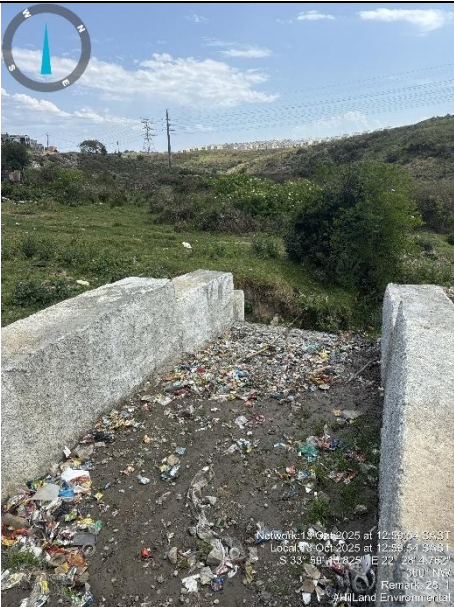
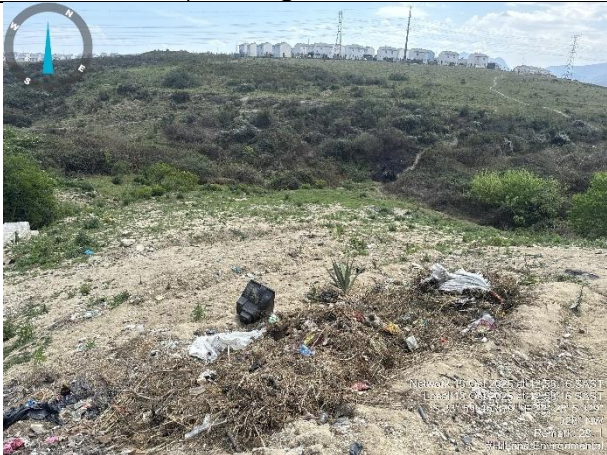
| <p>NEW: 19 Oct 2025 at 12:48:51 SAST<br/>Loc: 19 Oct 2025 at 12:48:51 SAST<br/>S 33° 56' 15.632" E 29° 26' 6.143"<br/>UTM: NS<br/>Remarks: 25.1<br/>#Hiland Environmental</p> <p>Litter and "dumping" remains and ongoing issue</p> | <p>NEW: 19 Oct 2025 at 12:50:16 SAST<br/>Loc: 19 Oct 2025 at 12:50:16 SAST<br/>S 33° 56' 15.632" E 29° 26' 6.143"<br/>UTM: NS<br/>Remarks: 25.1<br/>#Hiland Environmental</p> <p>Stockpile area and access tracks were shaped and rehabilitated (seed mix). Note that this area has high pedestrian traffic, which limits regrowth</p> |

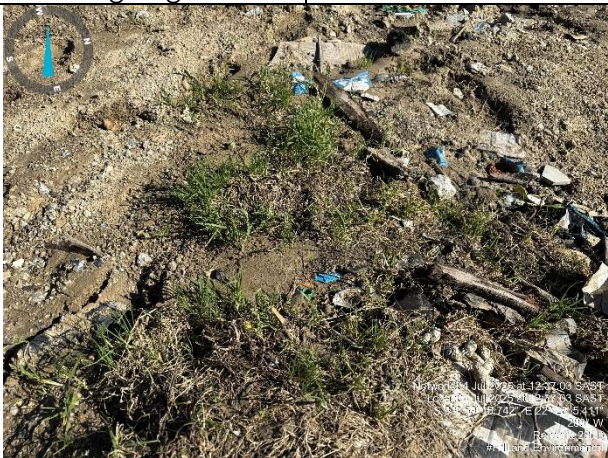
| <p>NEW: 19 Jul 2025 at 12:57:09 SAST<br/>Loc: 19 Jul 2025 at 12:57:09 SAST<br/>S 33° 56' 15.632" E 29° 26' 6.143"<br/>UTM: NS<br/>Remarks: 25.1<br/>#Hiland Environmental</p> <p>Grass seed growing</p> | |

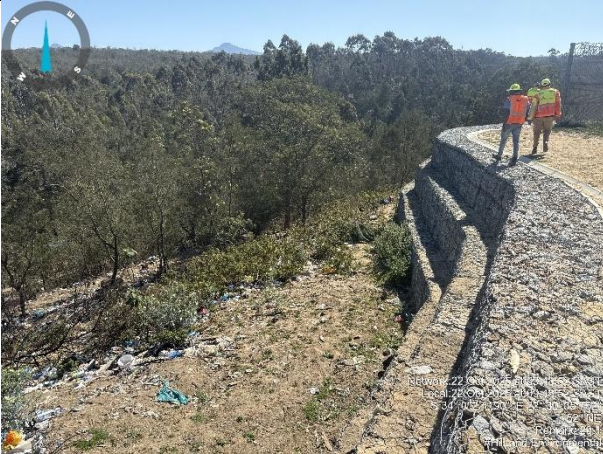
Gabion retaining wall construction completed. Continual dumping of waste and litter remains an ongoing issue.

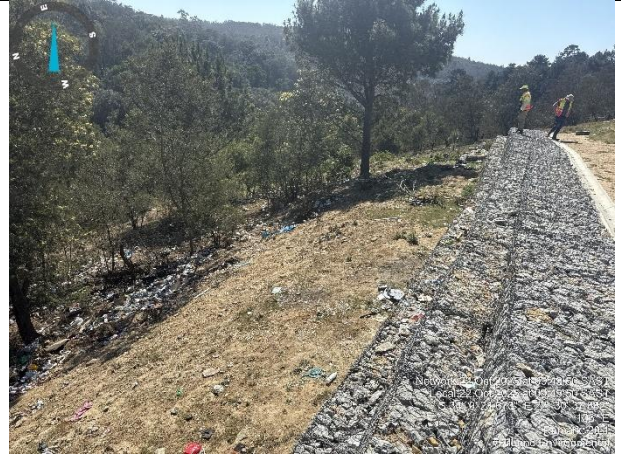
Backfilling completed – rehabilitation (shaping) has been done.

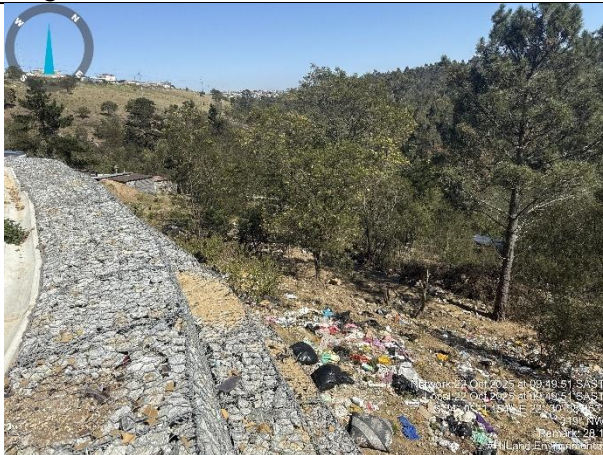
Final shaping and tie in at the ends of the gabion structure have been finalised.

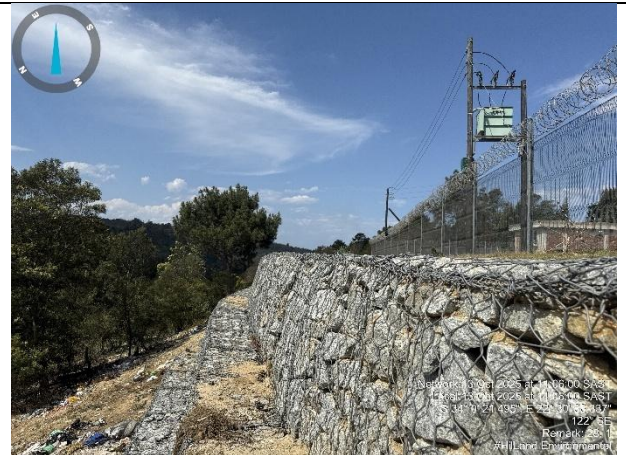
Construction completed.

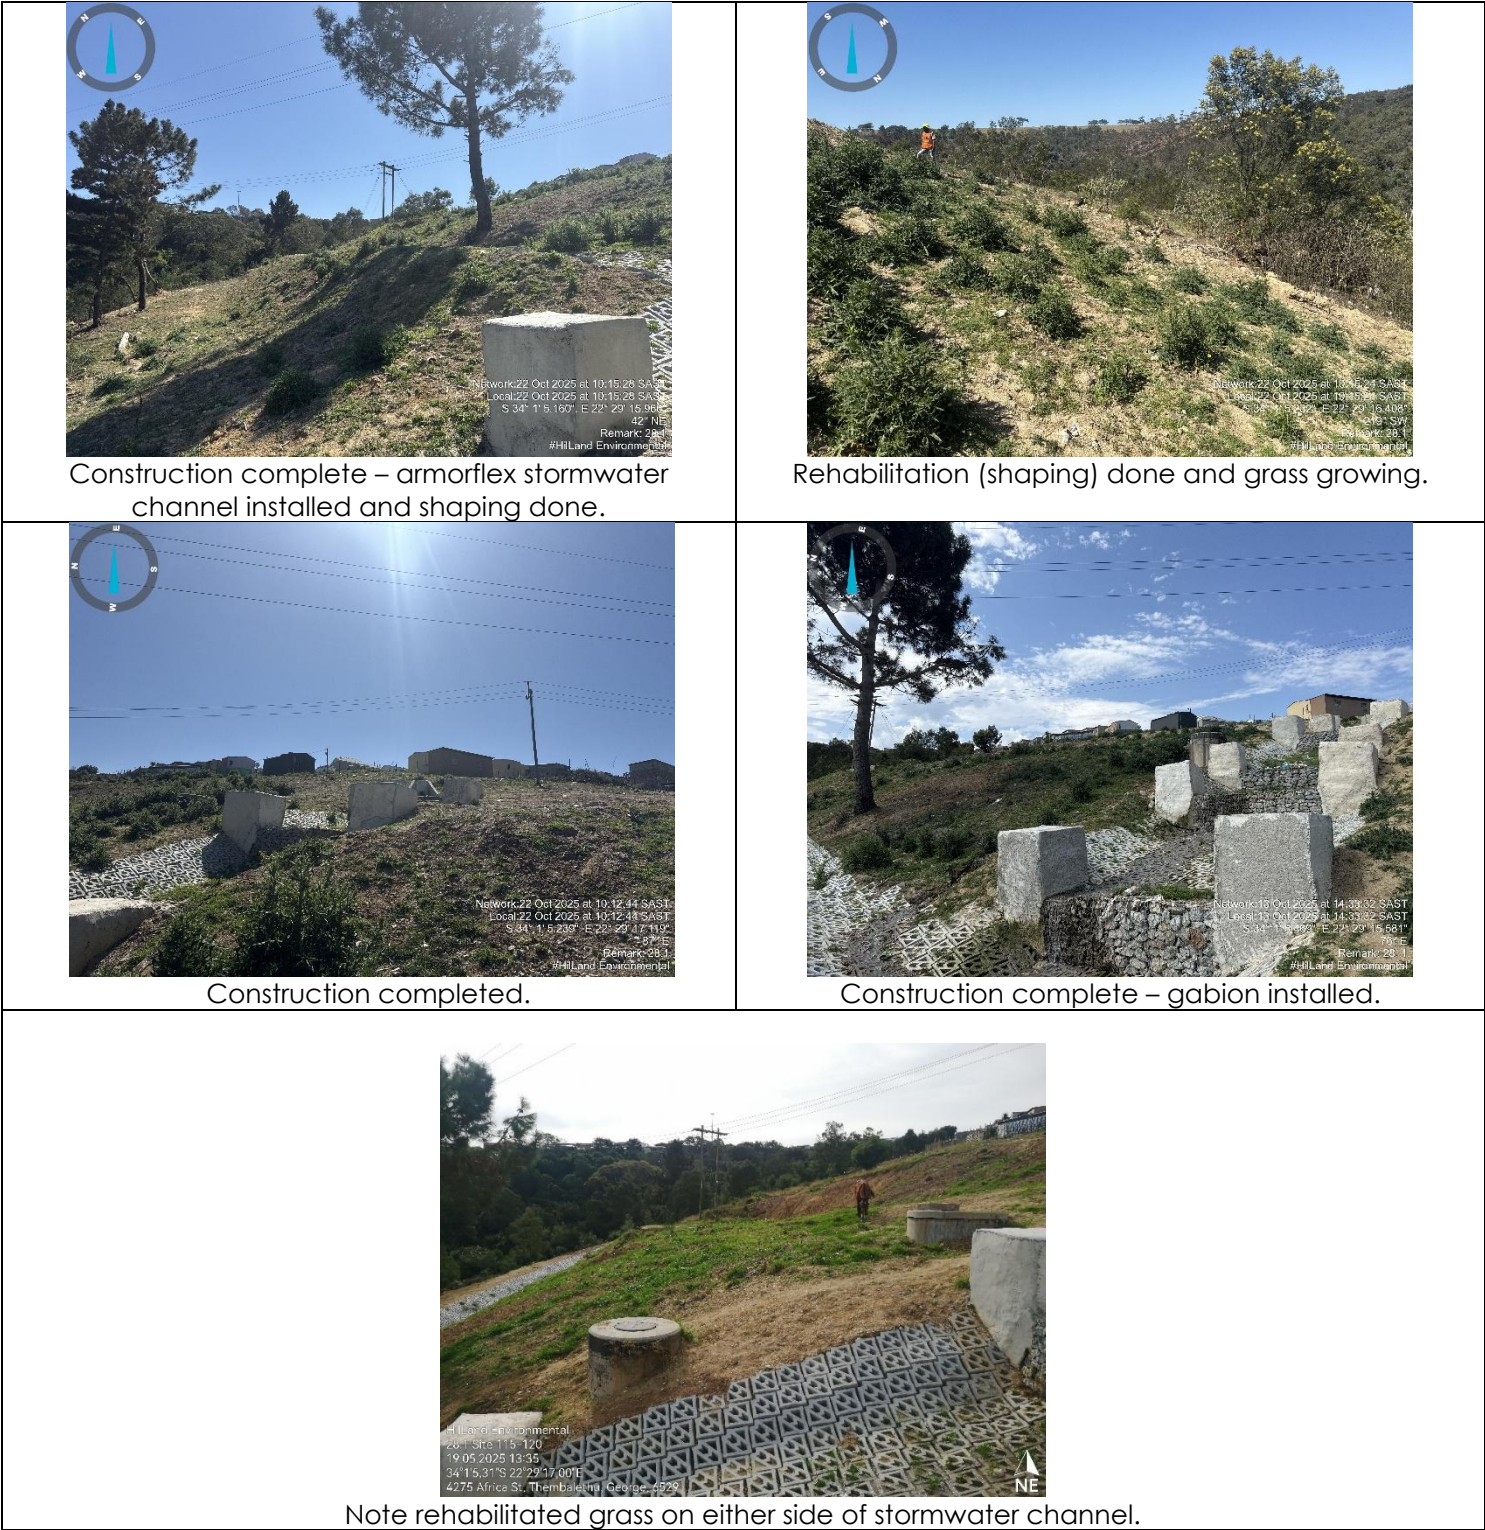
**Site 28(1).115-120**

- Construction and shaping/sloping are complete, and grass seed was spread – follow up was required in July 2025 and are now growing.
- Surveyor pegged the stormwater structure (gabion and armorflex blocks) footprint.
- Construction footprint was kept as small as possible, but due to continual blockage and overflow of the municipal sewer manhole, the contractor had to move outside the footprint area – all disturbed areas have been shaped/sloped and seeded.

- Blockage and overflow of the sewer manhole(s) remain an ongoing issue and may lead to undercutting of the armorflex channel(s).

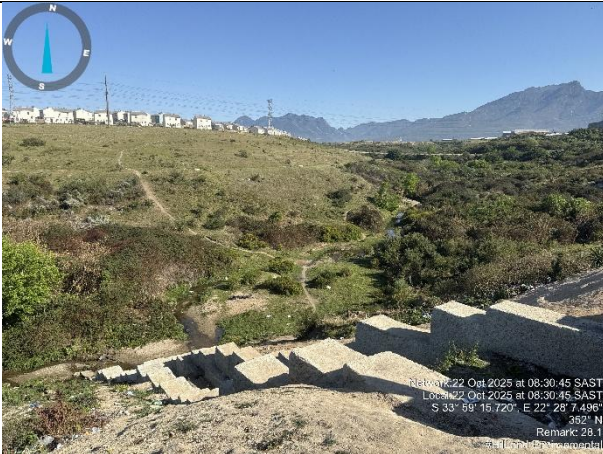
Gabion structure construction is completed.

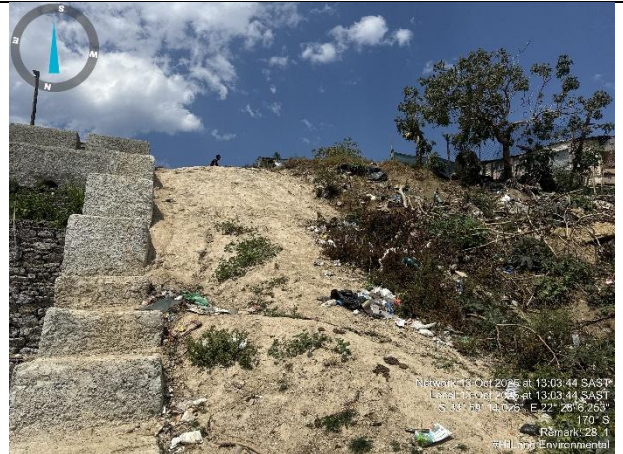
Erosion damage on the sides of the gabion structure has been backfilled and rehabilitated. Additional erosion protection has been installed (soil berms).

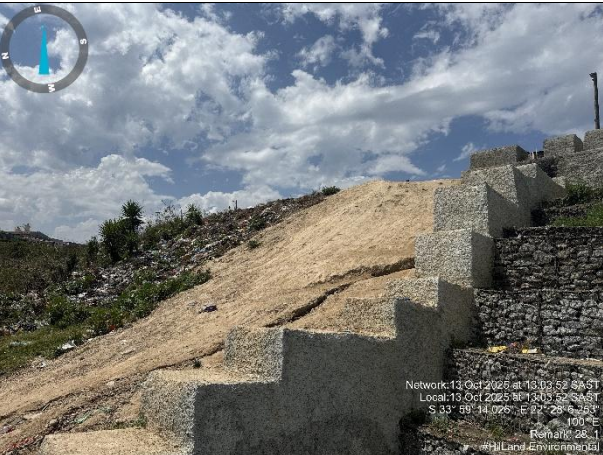
There are bare spots next to the gabion structure. Rehabilitation was damaged possibly due to high pedestrian traffic. The municipality can use excess topsoil from similar projects to replace on these bare spots.

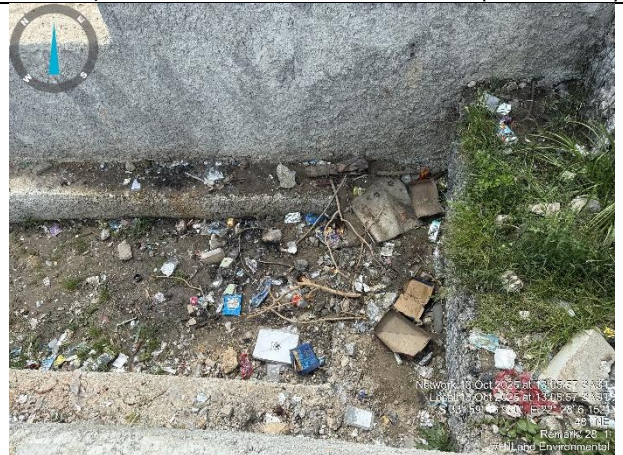
Litter in the stormwater network remains a problem

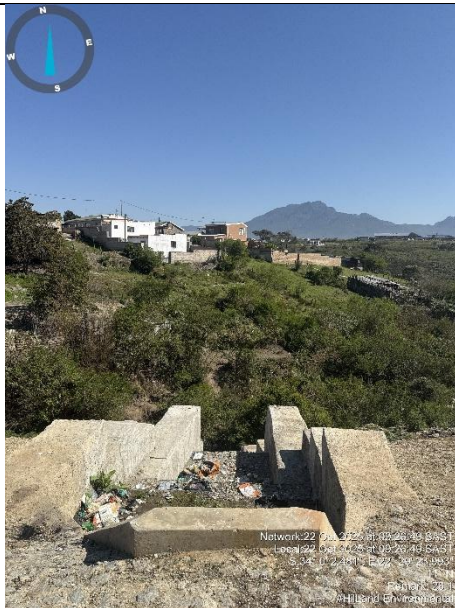
Construction of 69a & 69b is complete.

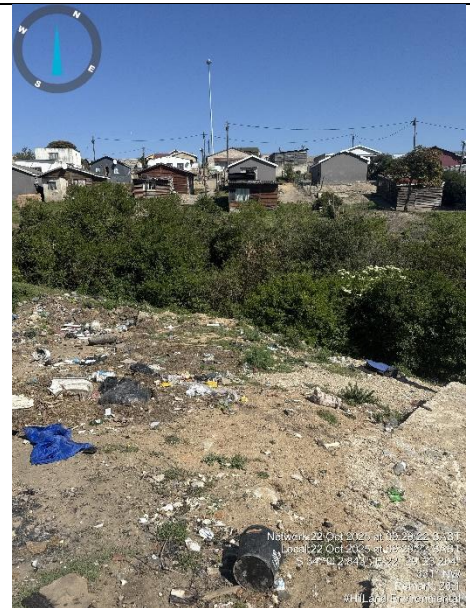
Ongoing dumping and littering remain an ongoing issue.

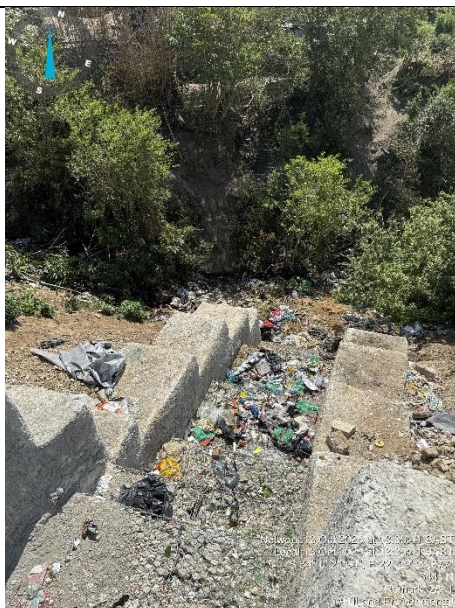
Construction of the gabion structure is complete.

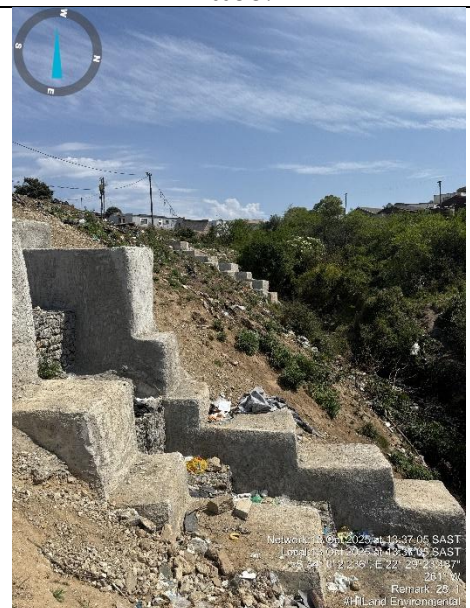
No new erosion noted on the side slopes.

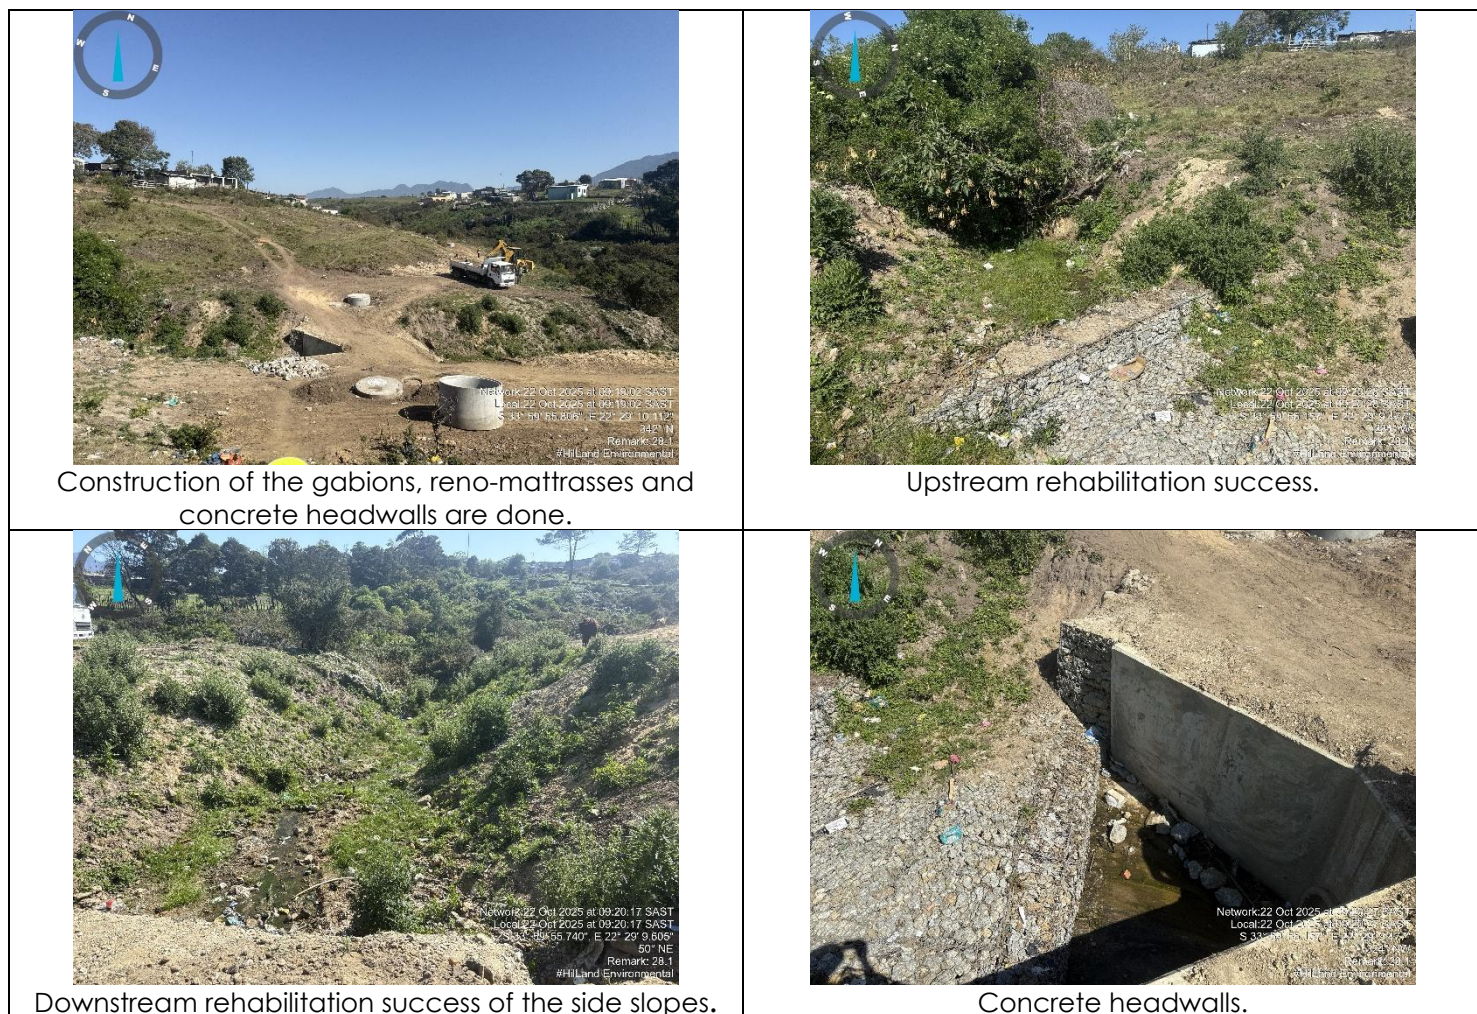
### Site 28(1).77

- Construction of the gabion structure and headwall is complete. Shaping and sloping was done, and a soil berm was created to divert surface water away from the slope. Grass seed was spread on the side slopes. There are signs of grass growth.
- Surveyor pegged the stormwater outlet structure.
- Construction material stockpiled next to the municipal road.
- Access to the site was gained via the existing track to the municipal pump station.
