**THE MAINTENANCE ACTIVITIES OF TRUNK ROAD  
33/4 BETWEEN KM 4.6 AND KM 14.4 ALONG THE  
MEINRINGSPOORT PASS, WITHIN THE PRINCE  
ALBERT AND OUDTSHOORN LOCAL  
MUNICIPALITIES, WESTERN CAPE.**

**EXTERNAL ENVIRONMENTAL AUDIT **CLOSURE** REPORT  
IN TERMS OF REGULATION 34 OF THE NEMA EIA  
REGULATIONS, 2014 (AS AMENDED).**

DEFF REF. NO. 14/12/16/3/3/1/2226

**3 December 2025**

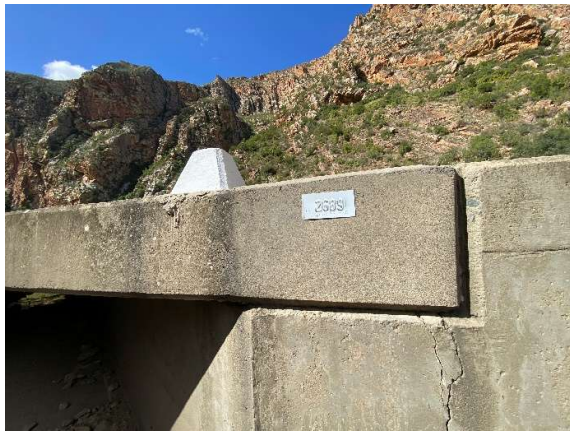
Newly installed structure number plates.

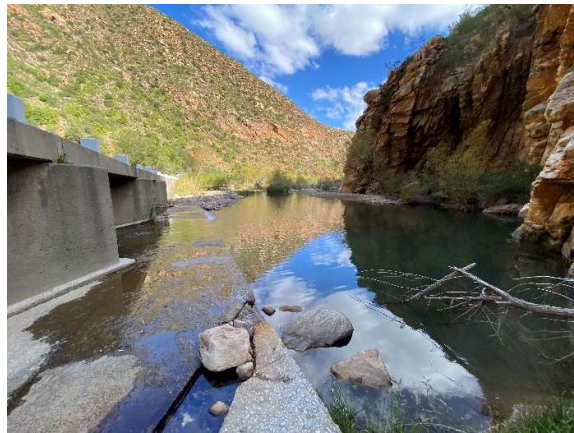
Downstream of causeway No 4 B2689 with a cleared watercourse flow path.

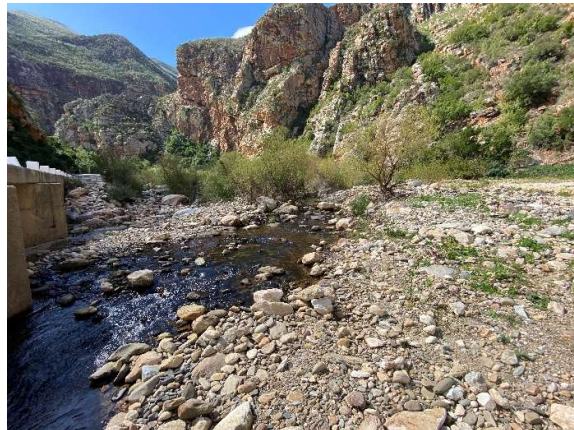
Upstream of causeway No 4 B2689 with a cleared watercourse flow path.

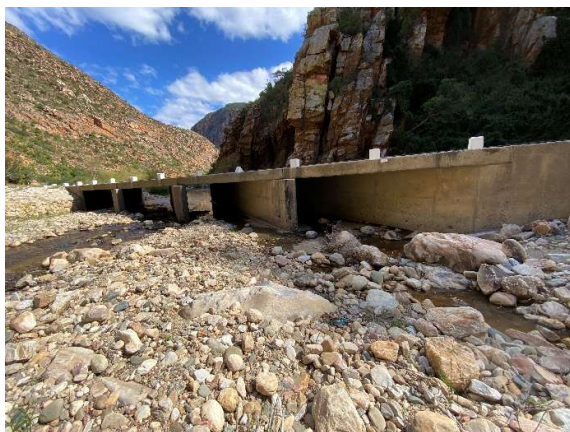
Visual upstream of the of the causeway with vegetation and sedimentation removed.

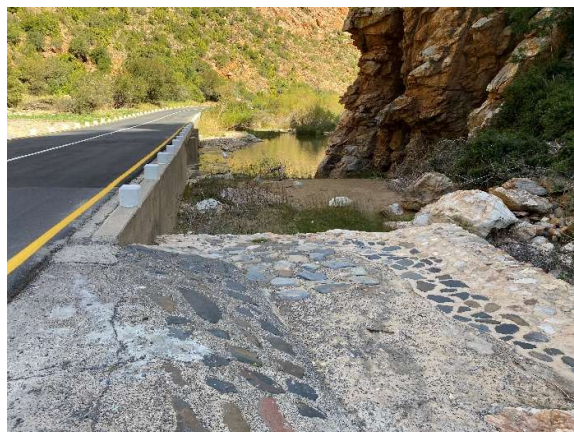
Stone-pitched side drains repaired downstream of Causeway 4.

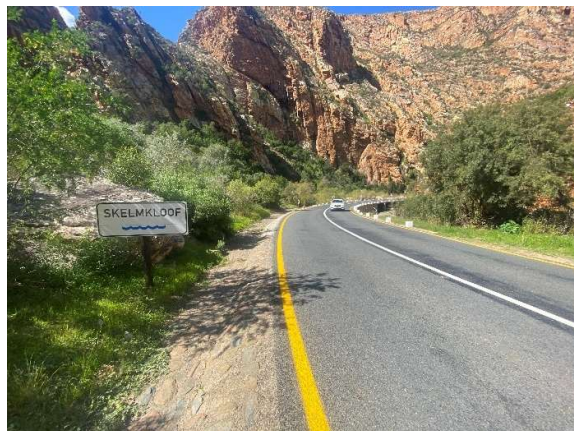
Indication of the skelmkloof causeway and stone-pitched side drains.

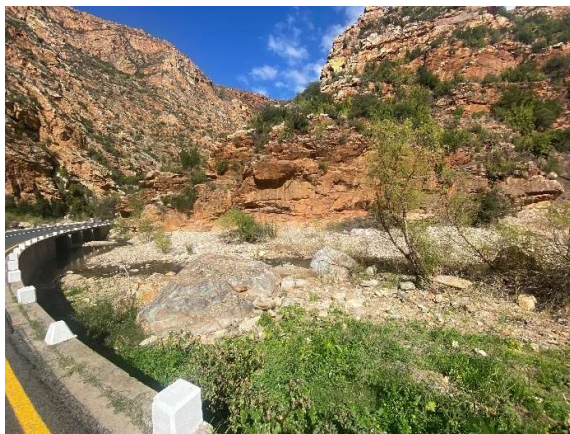
Downstream of causeway No 5 B2698A with cleared watercourse flow path.

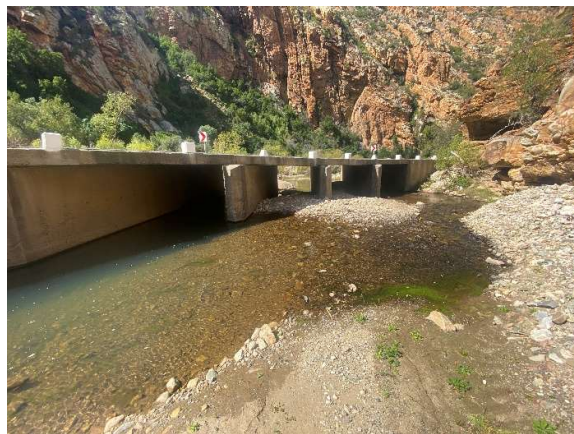
Downstream of causeway No 5 B2698A with cleared watercourse flow path.

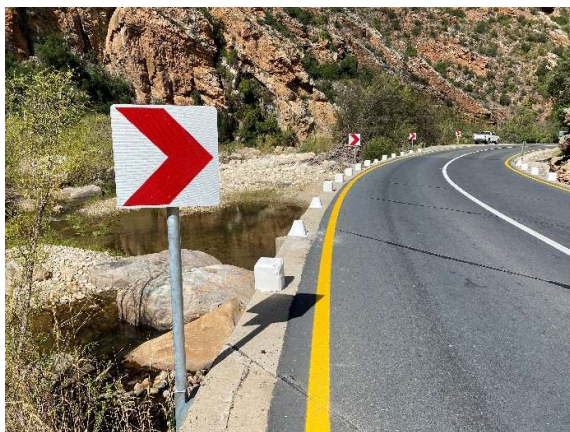
Evidence of strengthened bridge decks, reinstated cell joint fillers, and sealed deck expansion joints.

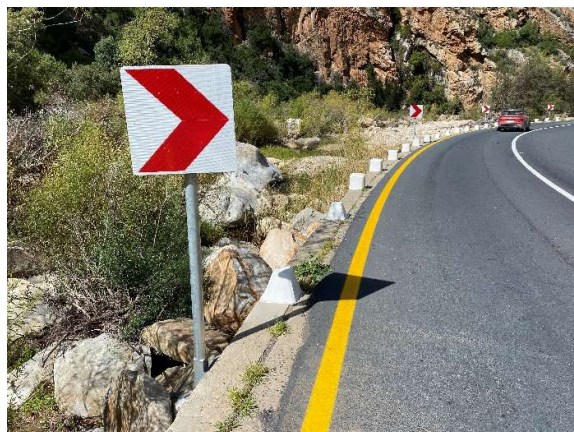
Repaired traffic notice boards.

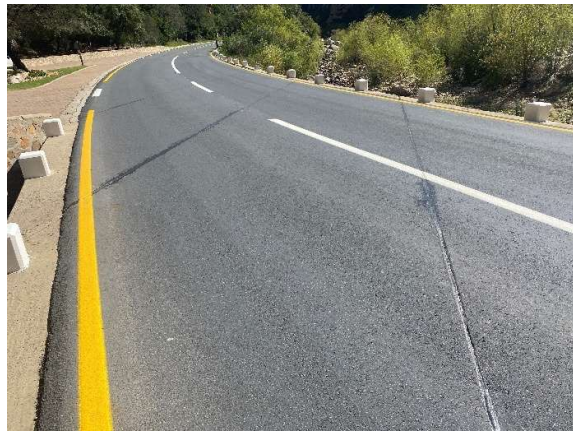
Evidence of strengthened bridge decks, reinstated cell joint fillers, and sealed deck expansion joints.

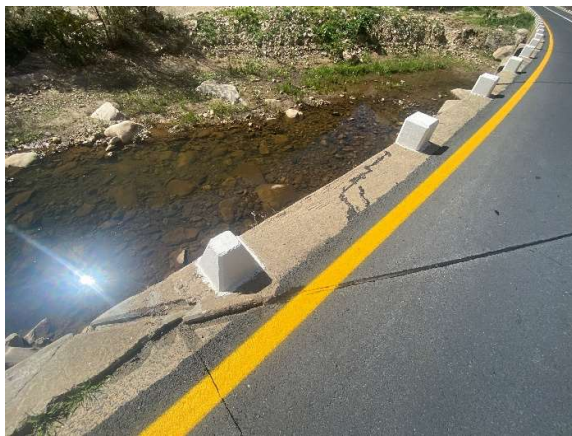
Vegetation debris cleared upstream of causeway 6.

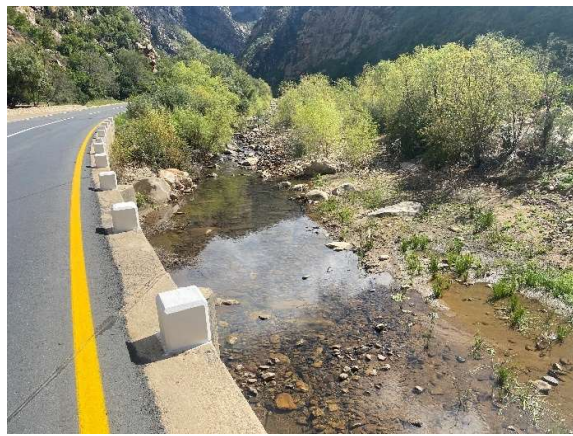
Vegetation debris cleared upstream of causeway 6.

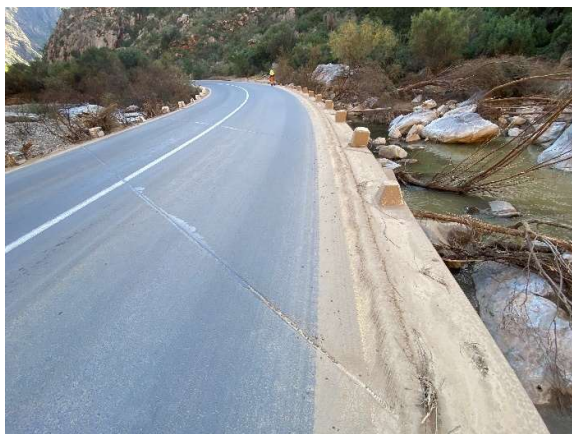
Evidence of strengthened bridge decks, reinstated cell joint fillers, and sealed deck expansion joints.

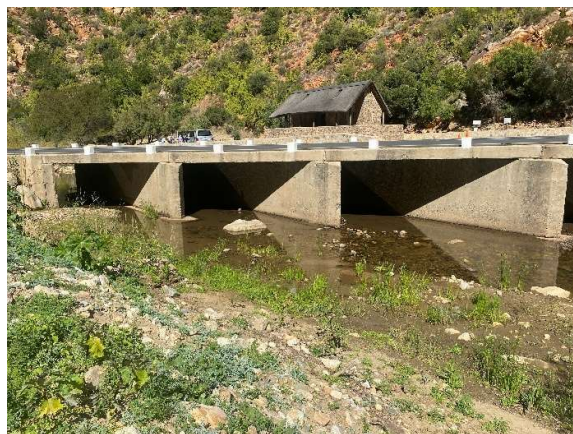
Repaired spalling and cracking with fibre polymer modified cementitious repair mortar.

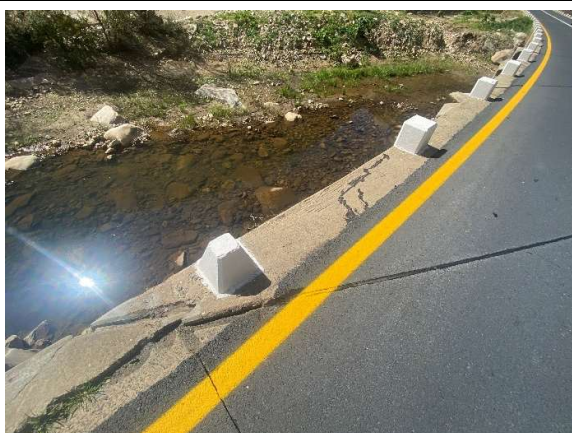
Repaired cell joint fillers and mortar works downstream of causeway 6.

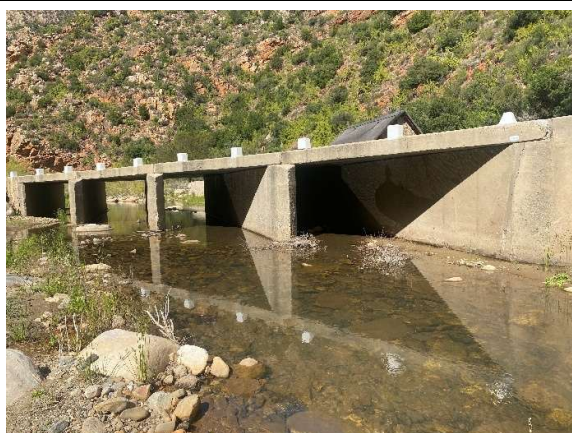
Repaired spalling and cracking with fibre polymer modified cementitious repair mortar.

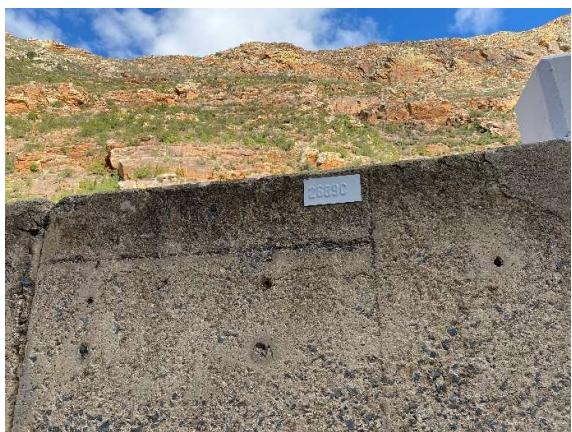
Newly installed structure number plate.

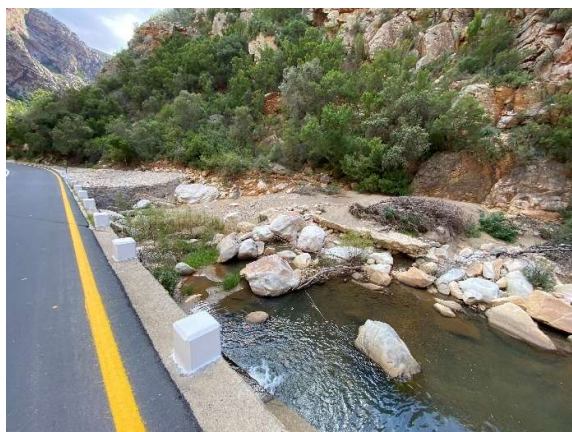
Upstream of Causeway No 7 B2698C with cleared watercourse flow path.

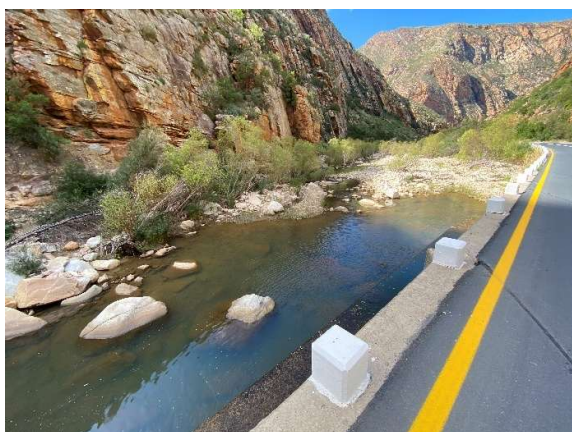
Downstream of Causeway No 7 B2698C with cleared watercourse flow path.

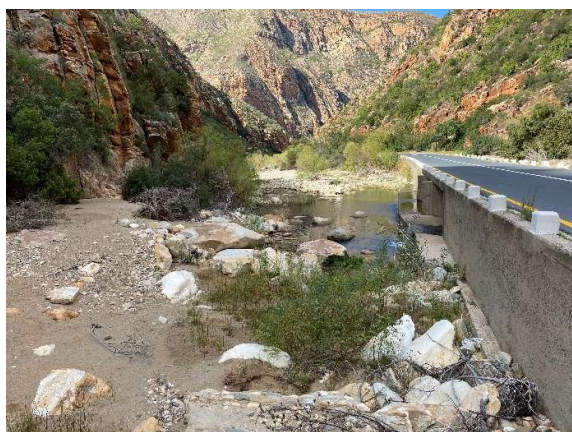
Downstream of Causeway No 7 B2698C with cleared watercourse flow path.

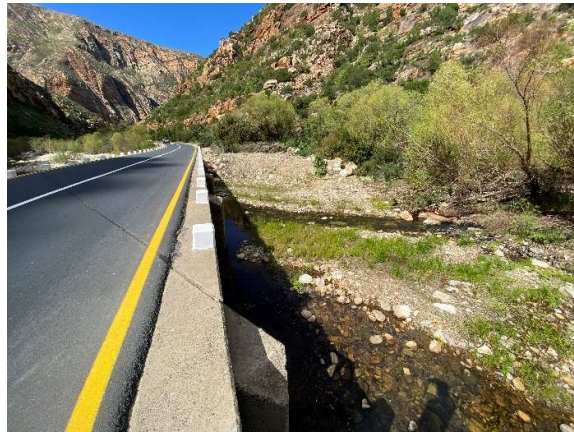
Repaired spalling and cracking with fibre polymer modified cementitious repair mortar.

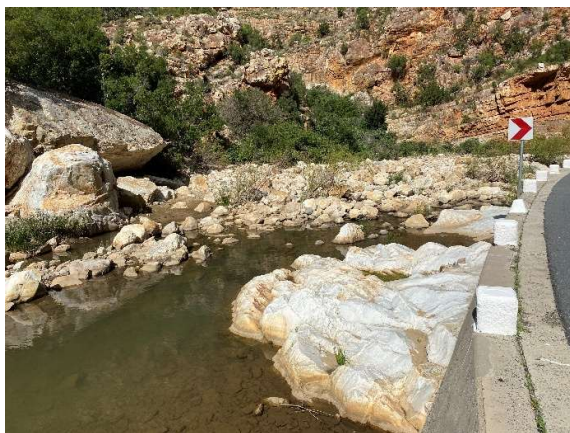
Repaired deck edge breaks upstream of causeway 8.

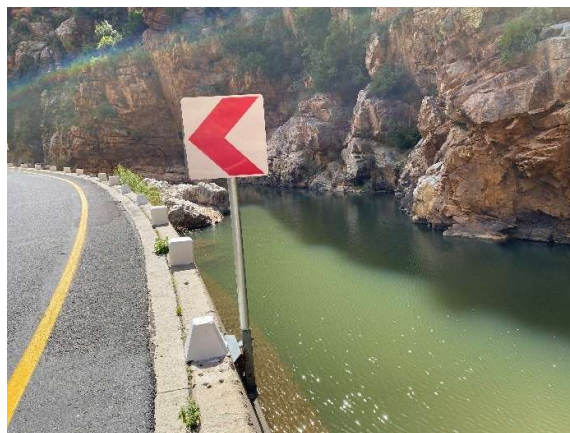
Damages of guard railings and notice boards repaired upstream of causeway 8.

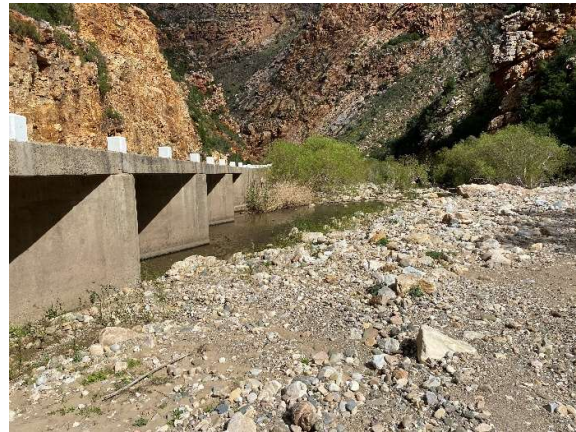
Maintenance of Causeway No 8 B2690 with cleared watercourse flow path.

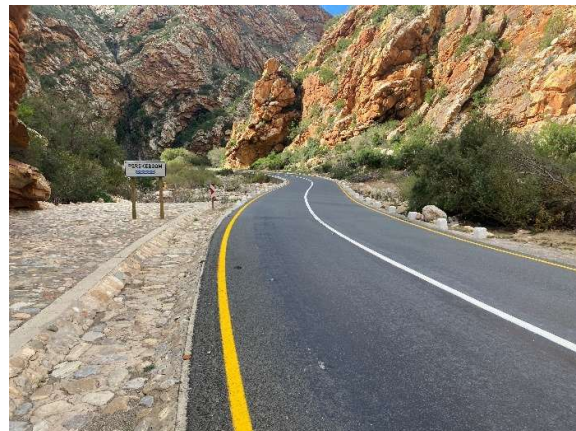
Newly installed stone-pitched side drains at causeway 9.

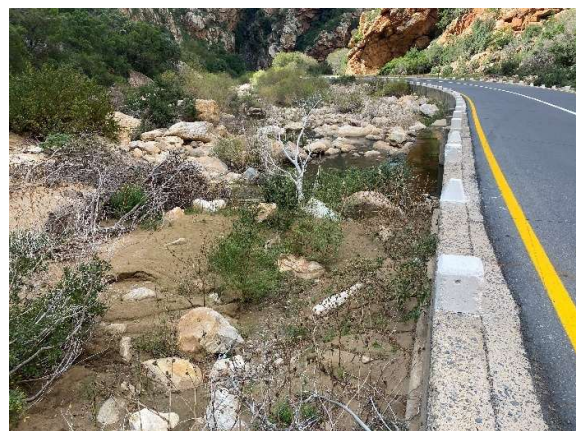
Visual upstream of causeway 9 with some vegetation debris.

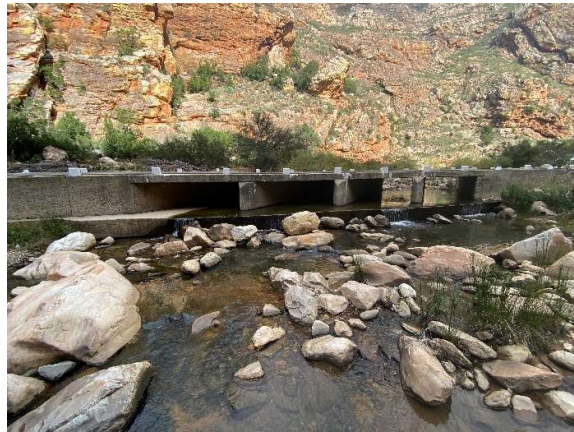
Maintenance of Causeway No 9 with cleared watercourse flow path.

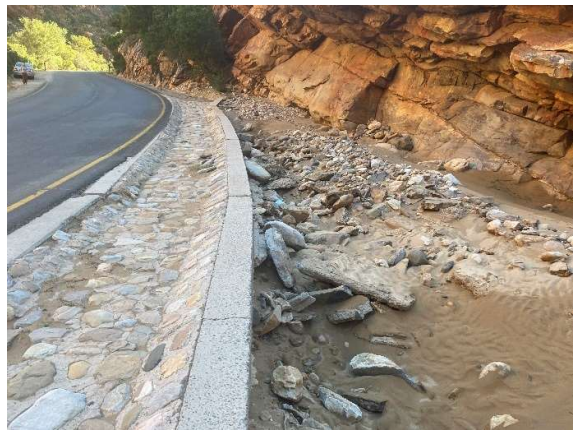
Stone-pitched side drains downstream of causeway 9.

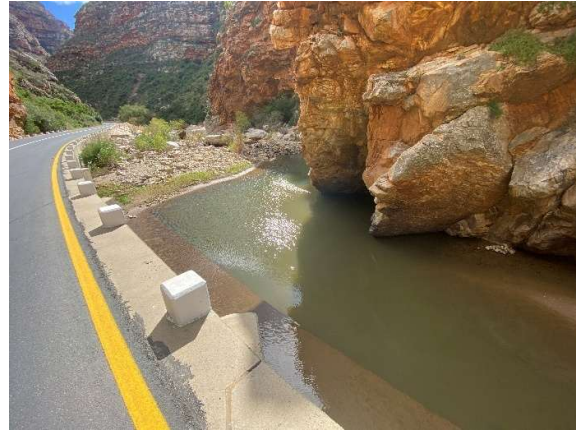
Evidence of reinstated cell joint fillers, and sealed deck expansion joints upstream of causeway 10.

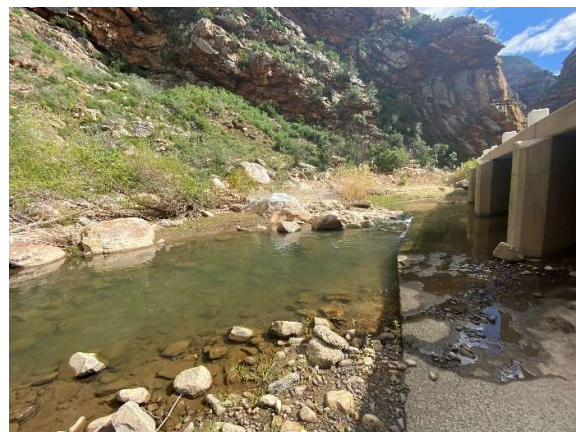
Downstream of Causeway No 10 with cleared watercourse flow path.

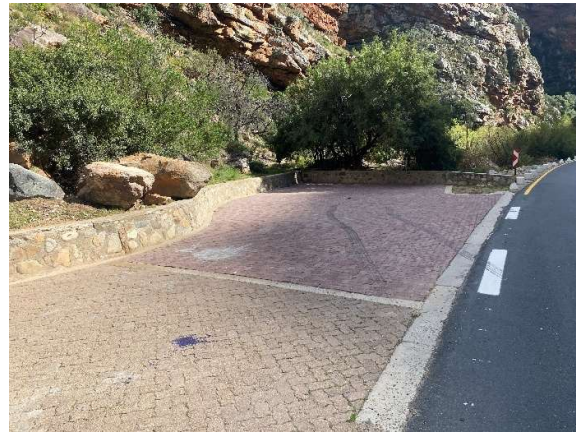
Repaired public parking area at causeway 11.

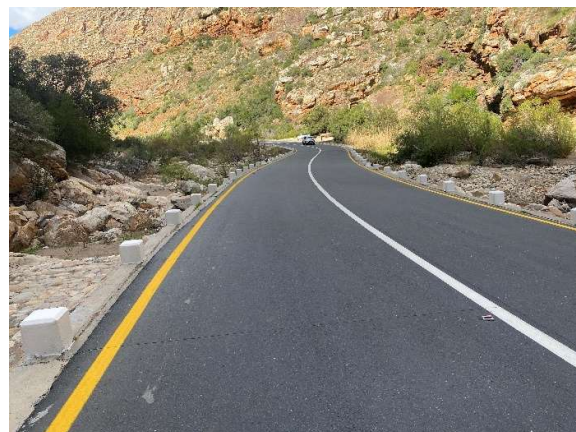
Evidence of strengthened bridge decks, reinstated cell joint fillers, and sealed deck expansion joints

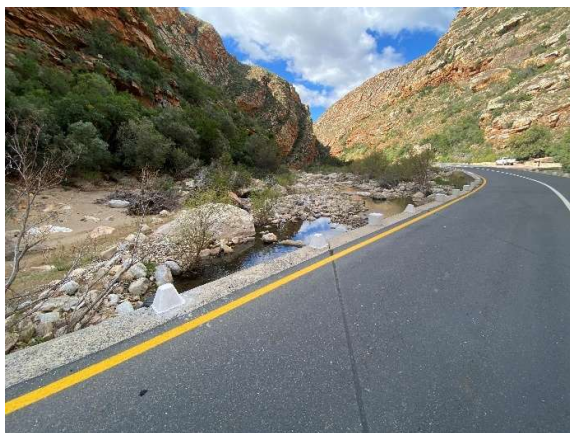
Cleared vegetation upstream of causeway 11.

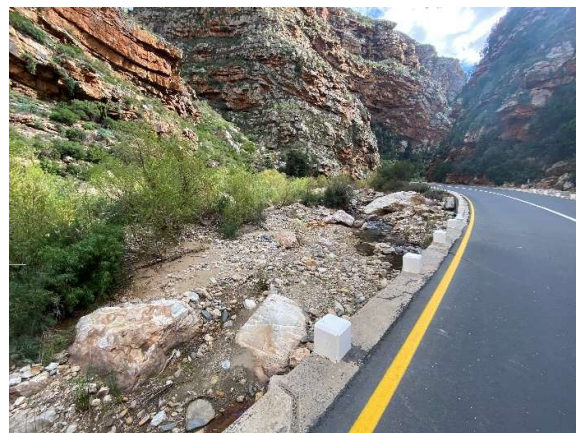
Cleared vegetation downstream of causeway.

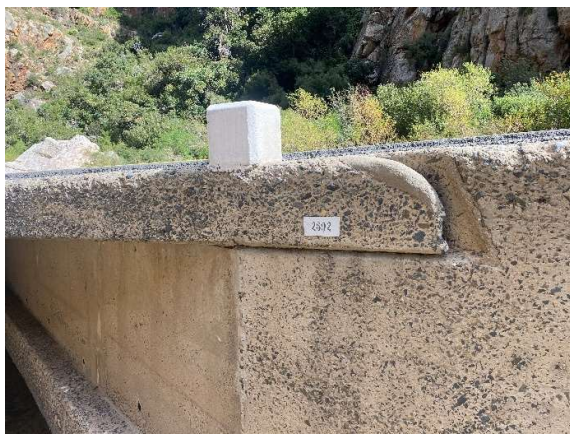
Newly installed structure number plate.

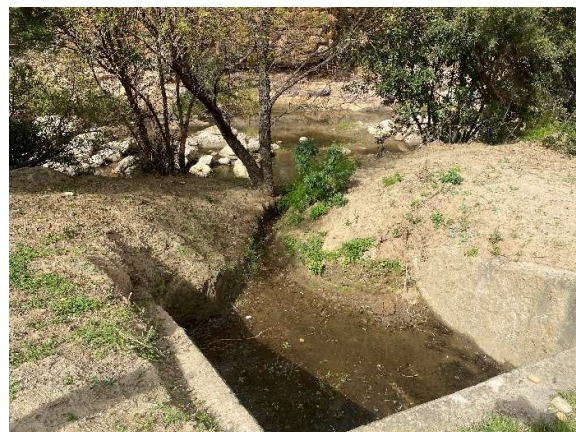
Cleared pipe culvert adjacent the causeway.

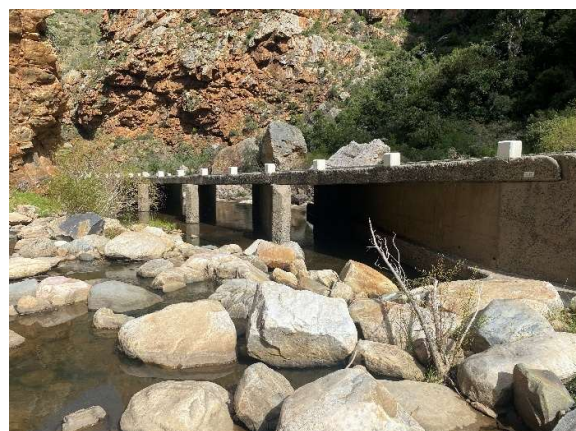
Repaired cell joint fillers, which has been dislodged during the recent floods.

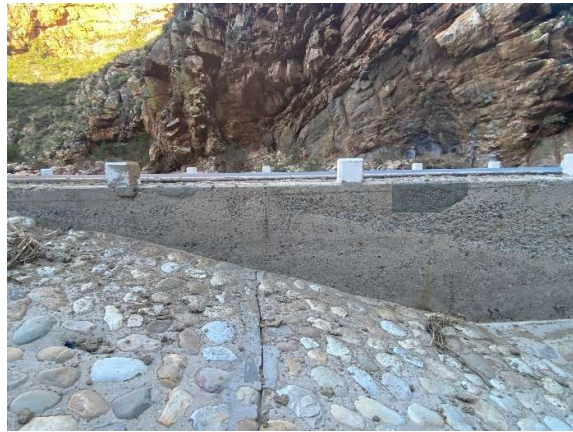
Repaired and strengthened deck edge breaks.

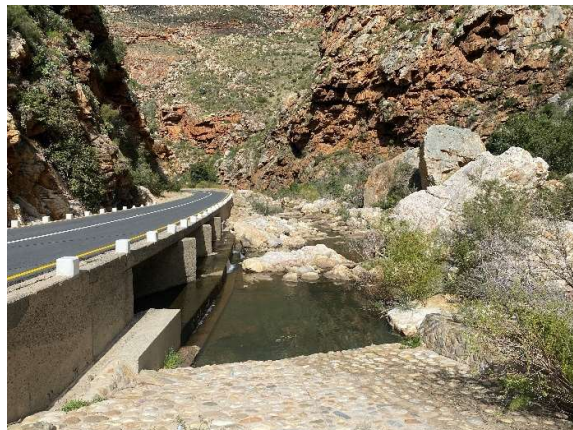
Stone-pitched side drains downstream of causeway 12.

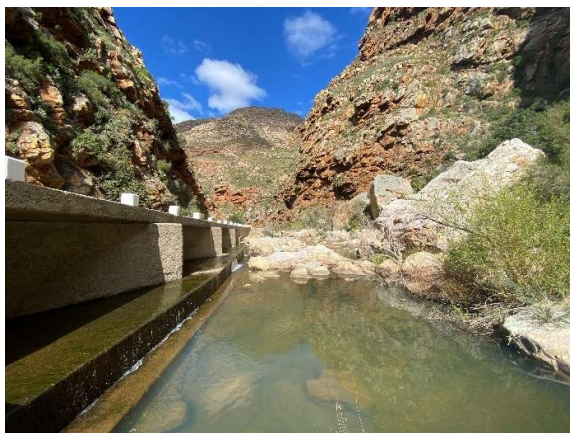
Downstream of Causeway No 12 B2692 with cleared watercourse flow path.

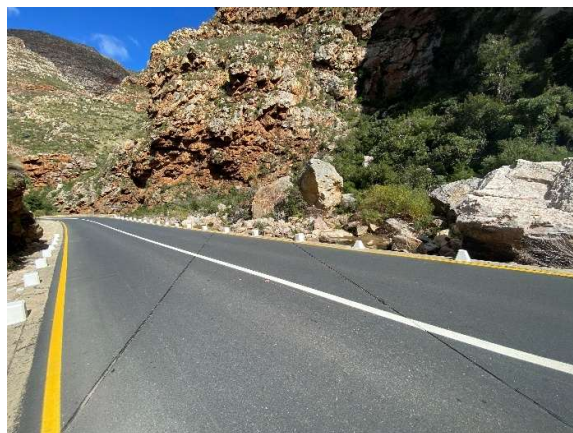
Evidence of strengthened bridge decks, reinstated cell joint fillers, and sealed deck expansion joints.

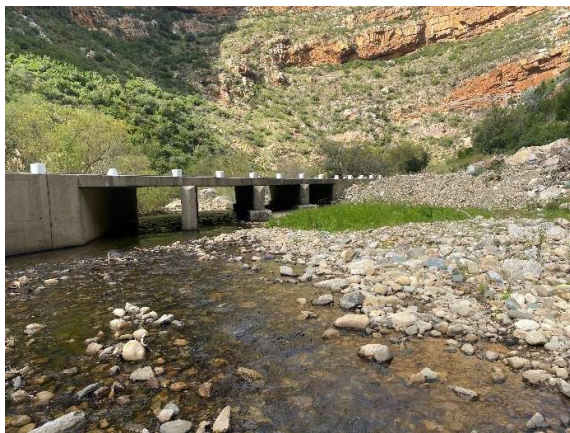
Downstream of causeway No 13 B2692A with cleared watercourse flow path and repair works evident.

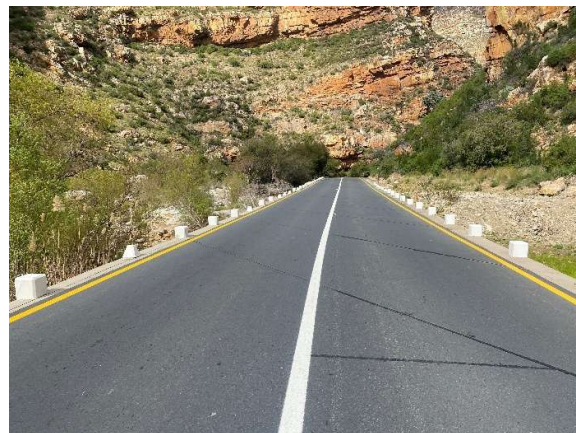
Evidence of strengthened bridge decks, reinstated cell joint fillers, and sealed deck expansion joints.

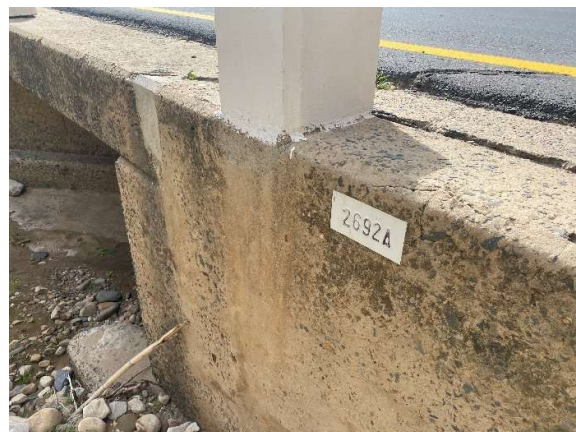
Newly installed name plate.

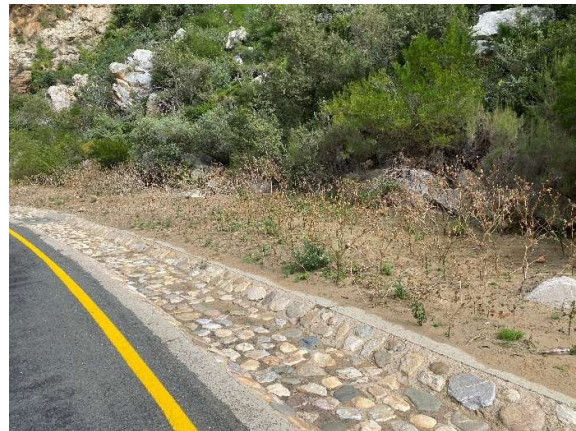
Stone-pitched side drains with new vegetation regrowth.

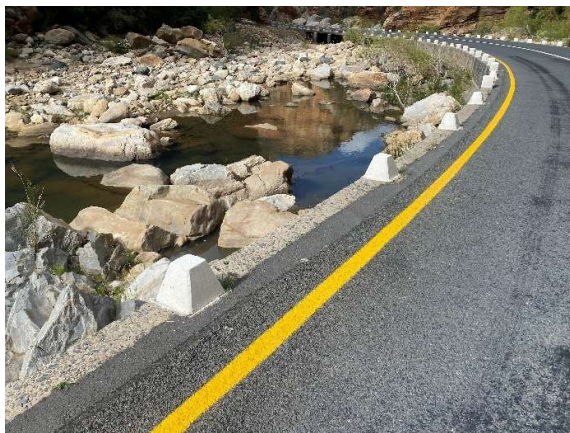
Upstream of causeway No 13 B2692A with cleared watercourse flow path and repair works evident.

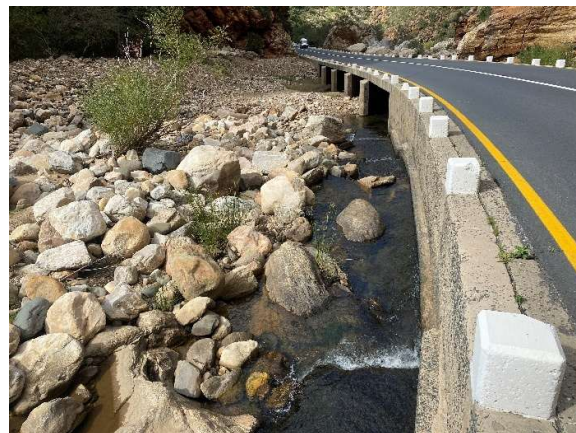
Upstream of causeway No 13 B2692A with no debris present and repair works evident.

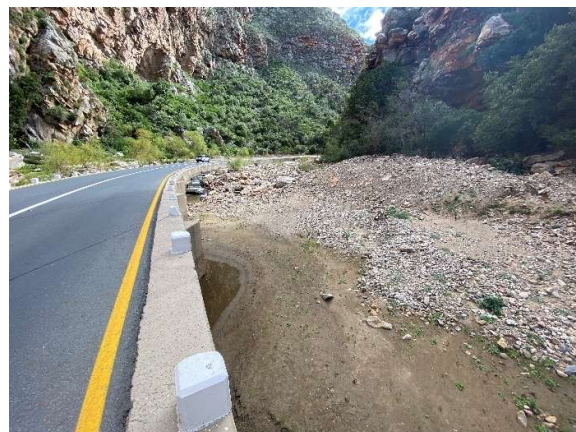
Downstream of causeway No 13 B2692A with no debris present and repair works evident.

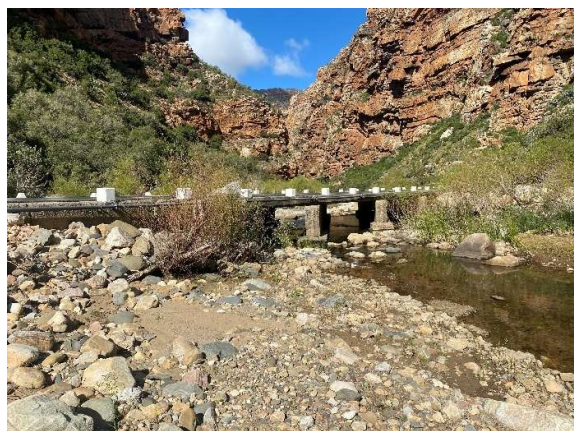
Maintenance of Causeway No 15 B2694 with cleared watercourse flow path.

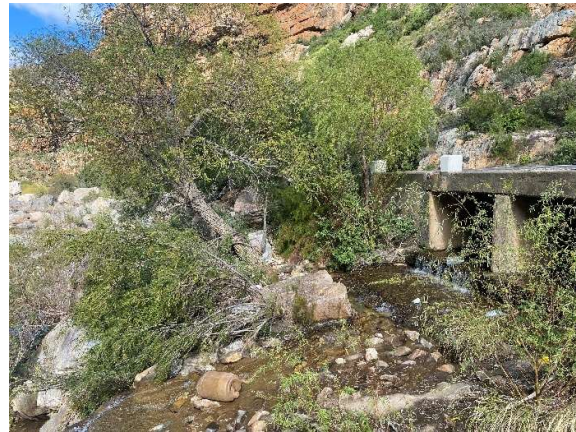
Cleared and revegetated culvert along causeway 15.

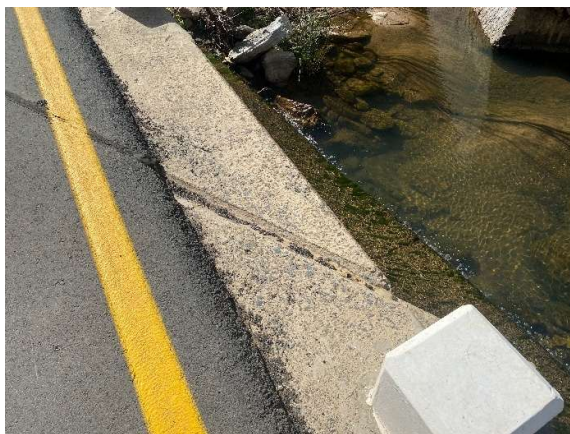
Repaired deck edge breaks and cell joint fillers downstream of causeway 15.

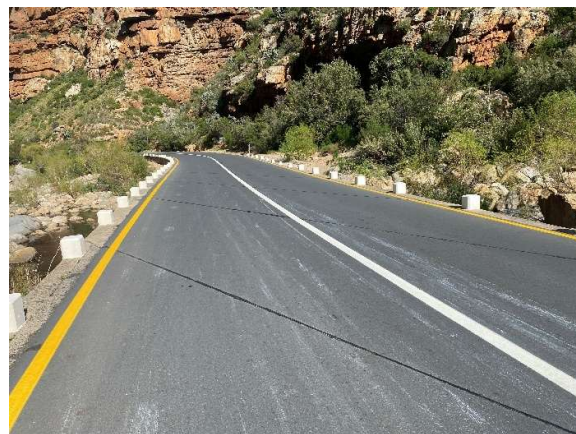
Evidence of strengthened bridge decks, reinstated cell joint fillers, and sealed deck expansion joints.

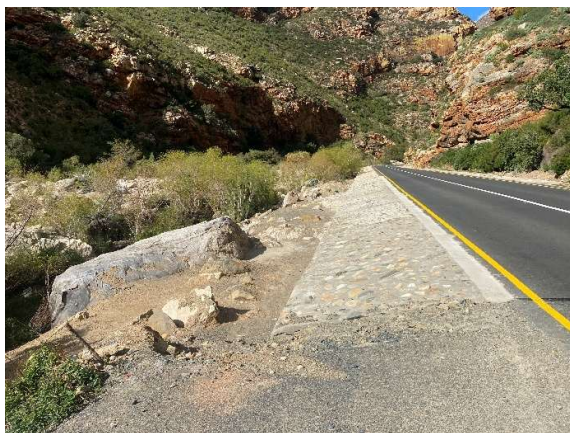
Stone-pitched side drains upstream of causeway 15.

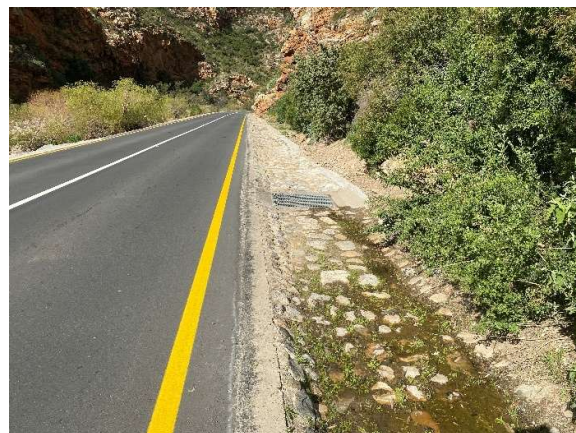
Stone-pitched side drains upstream of causeway 15.

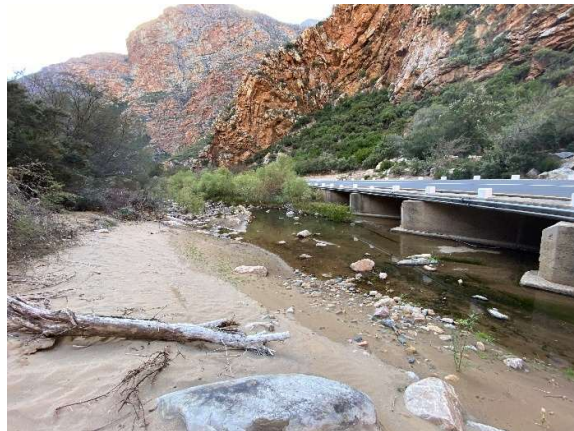
Potable water pipeline downstream of causeway 16 still in good condition.

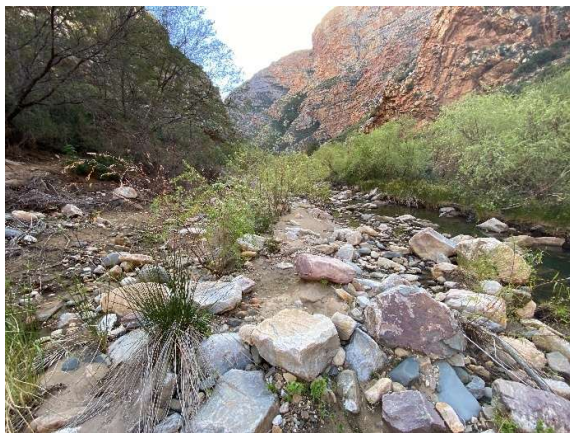
Some vegetation debris and sedimentation from recent floods downstream of causeway 16.

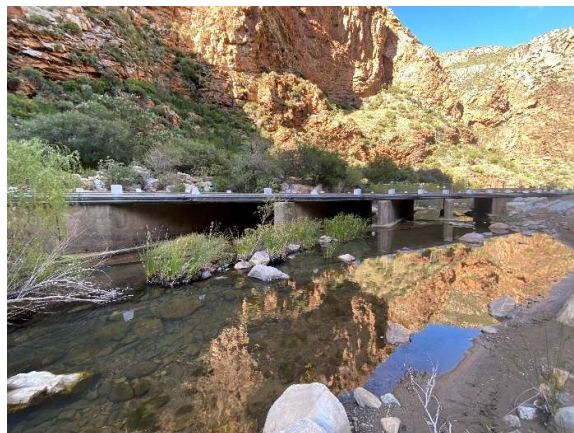
Sedimentation and vegetation debris removed downstream of causeway 16.

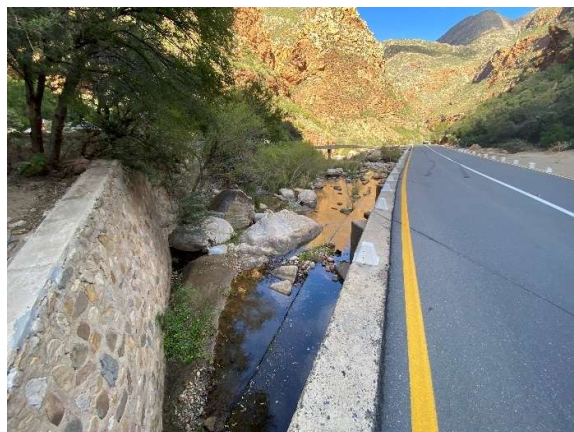
Evidence of strengthened bridge decks, reinstated cell joint fillers, and sealed deck expansion joints

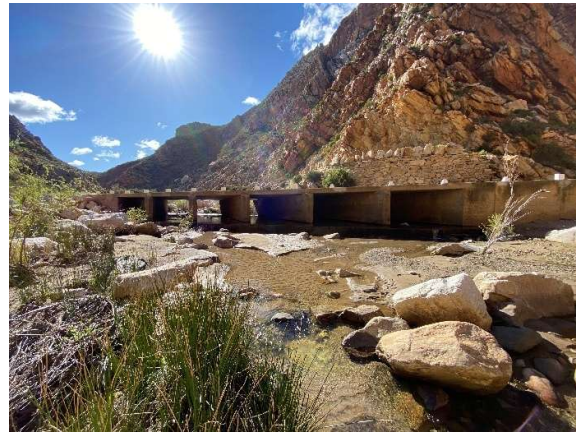
Repaired deck edge breaks and cement works evident downstream of causeway 18.
