**THE PERIODIC MAINTENANCE OF TRUNK ROAD 33/4 (DE RUST-KLAARSTROOM) AND TRUNK ROAD 34/2 (PRINCE ALBERT-KLAARSTROOM),  
WESTERN CAPE**

DEA&DP Ref: 14/12/16/3/3/1/2226 (EA)

**FORMAL ECO AUDIT REPORT**

31 May 2023

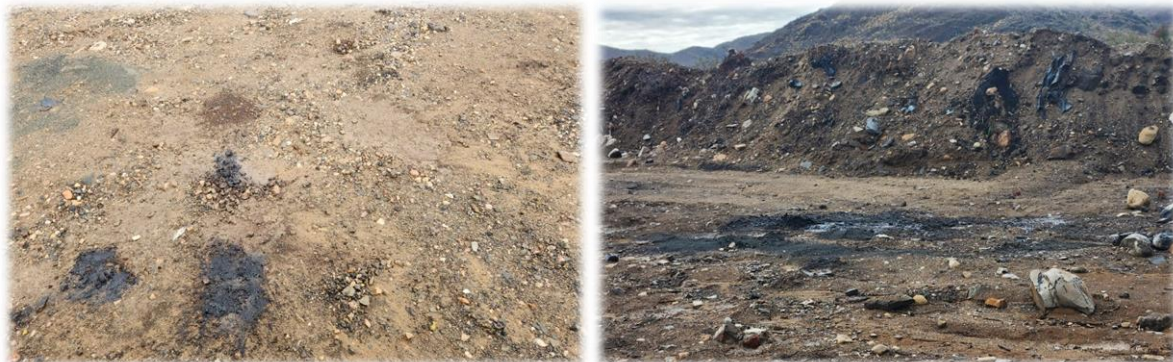
Bitumen remains were noted next to and behind the site camp area at Klaarstroom. All bitumen remains must please be removed.

| | Finding | Close Out Recommendation |
|---|---|---|
| 2 | <p><b>Bitumen</b></p> <p>Millings found within the Pass within the no-go area and next to the road.</p> <p>Bitumen remains found at the Klaarstroom stockpile area.</p> | <p>Remove all millings next to the road and within vegetation to be appropriately disposed.</p> <p>Remove all bitumen remains to be appropriately disposed.</p> |

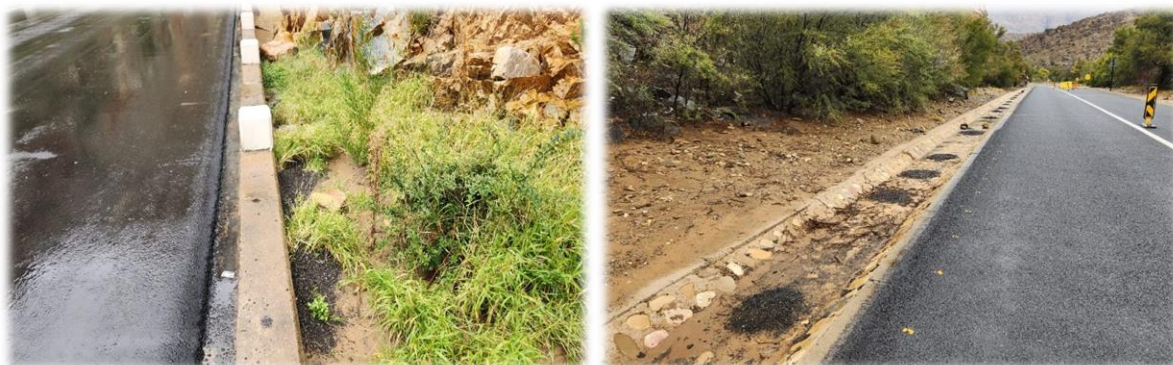
Bitumen millings were found next to the road within the Pass, and in the vegetation. The contractor was advised to please ensure all millings are removed from site and in the vegetation.

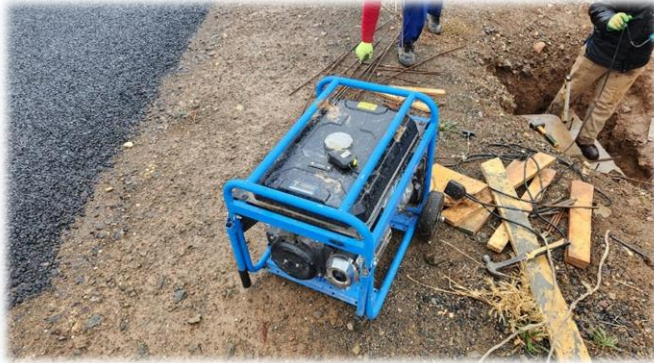
A generator was noted at the culvert on Km 25, the contractor was advised to please supply the generator with a drip tray.

| | Finding | Close Out Recommendation |
|---|---|---|
| 4 | <p><b>Fuel storage</b></p> <p>Generator found on site without a drip tray.</p> | Please supply all generators with drip trays. |

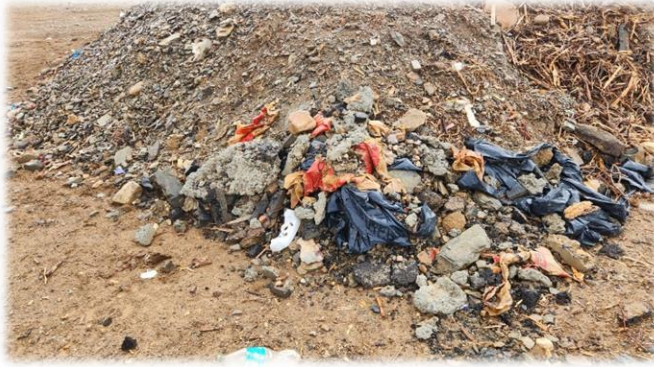
The contractor is advised to please pick up empty cement bags on the day they were used to prevent blowing around on site.

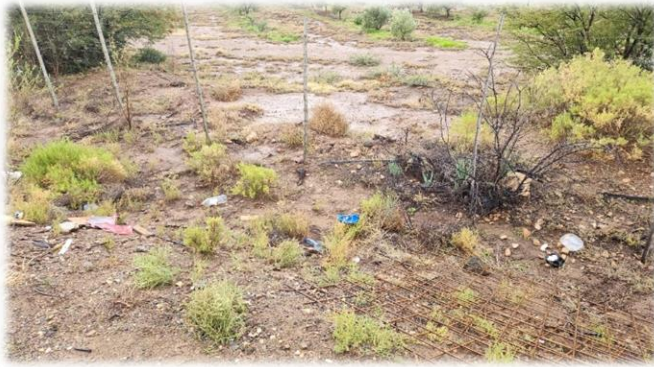
Litter was seen on Km 25 at the culvert, the contractor was advised to please ensure a bin is placed on site and to dispose of the litter. No toilet was seen on site at the works on the culvert. The contractor is advised to please supply the workers with a toilet.

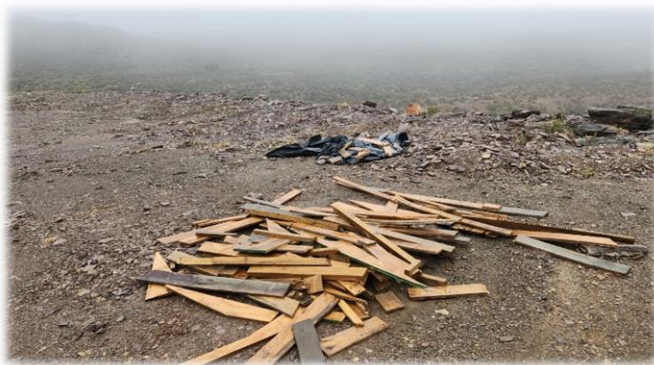
Litter was found at Km 28 at the side drain construction, the contractor was advised to please remove the litter from site.

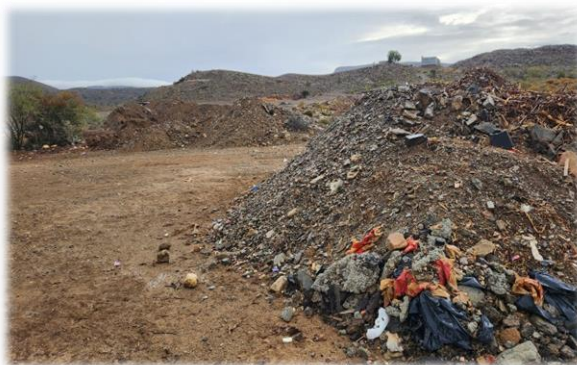
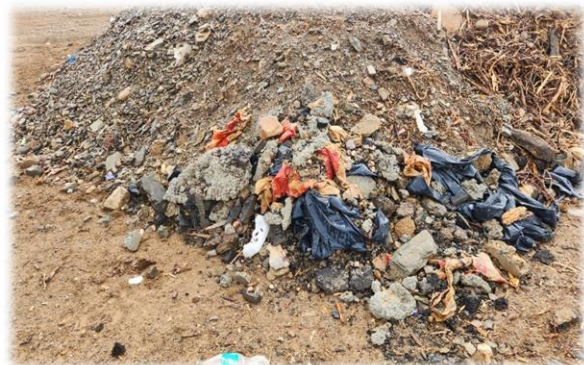
Litter was also found at the Klaarstroom stockpile area, the stockpile area has been cleared but the litter was dumped on the rubble. The contractor is advised to please dispose of the litter.

| | Finding | Close Out Recommendation |
|---|---|---|
| 3 | <p><b>Litter</b></p> <p>Litter found on site at the stockpile area and next to the road.</p> | Please remove all litter from site. |

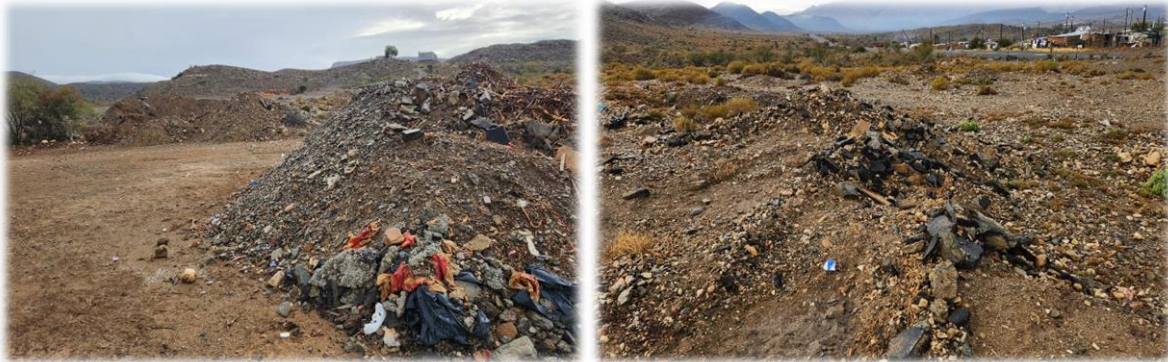
Rubble stockpiled at the Klaarstroom stockpile area must please be removed, the contractor is advised to please ensure that all rubble is screened for litter before disposal.

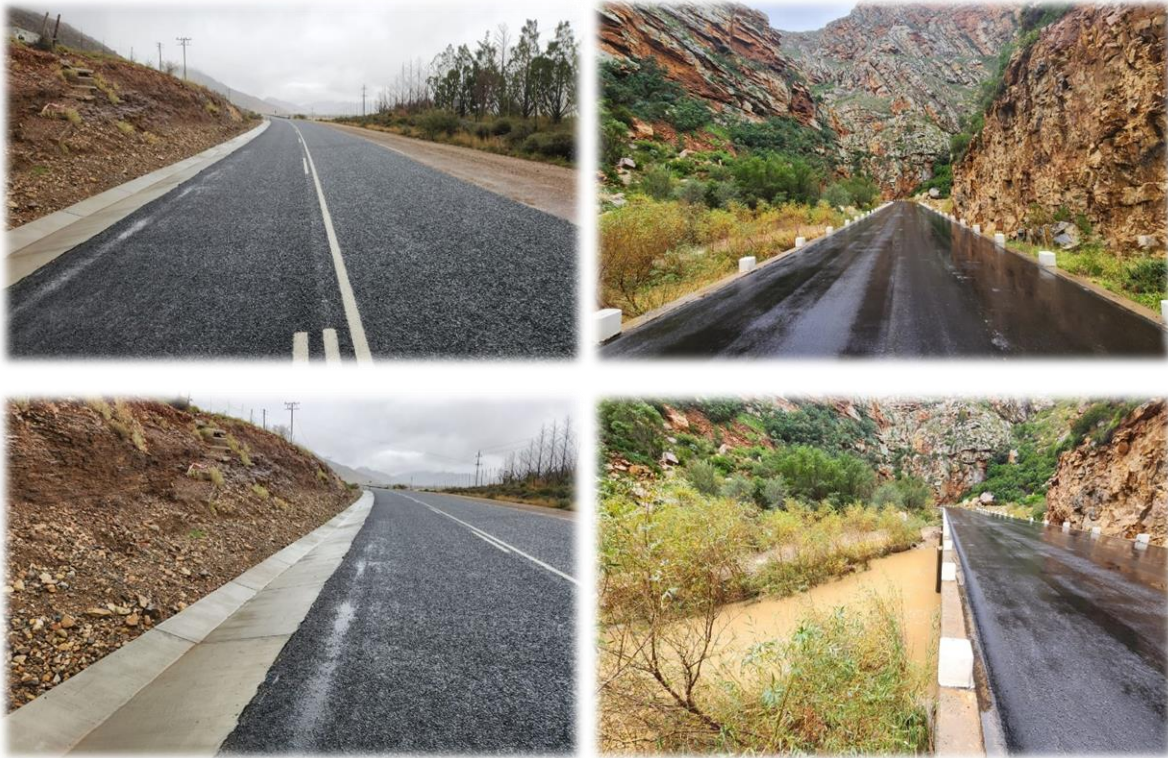
Within the poort section the seal has been completed and the asphalt over the bridges were underway.
