ANNEXURE A – SITE PHOTOGRAPHS

Site Camp and Stockpiles @ km 25

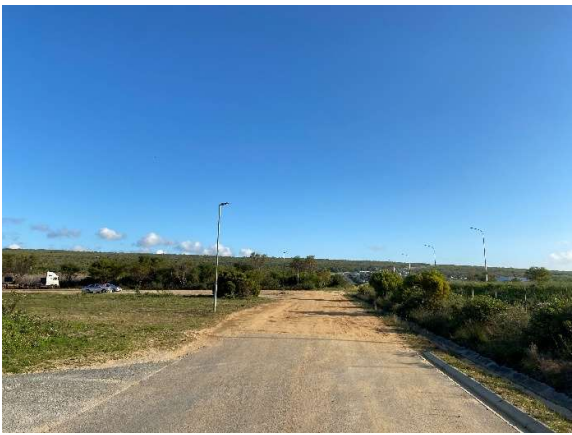
| <p>The current condition of Stockpile area 1 where all stockpiled material has been removed.</p> | <p>The current condition of Stockpile area 1 where all stockpiled material has been removed.</p> |

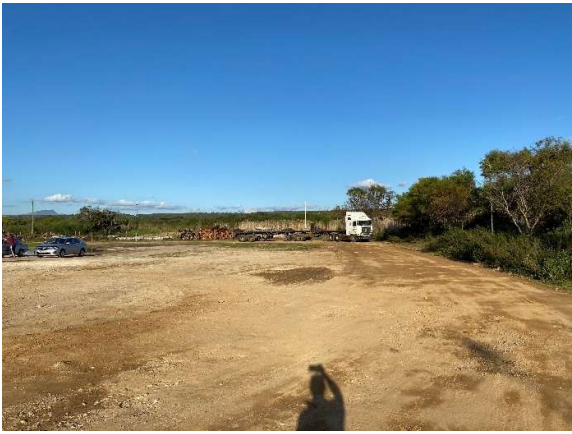
| <p>The current condition of Stockpile area 1 where all stockpiled material has been removed.</p> | <p>The current condition of Stockpile area 1 where all stockpiled material has been removed.</p> |

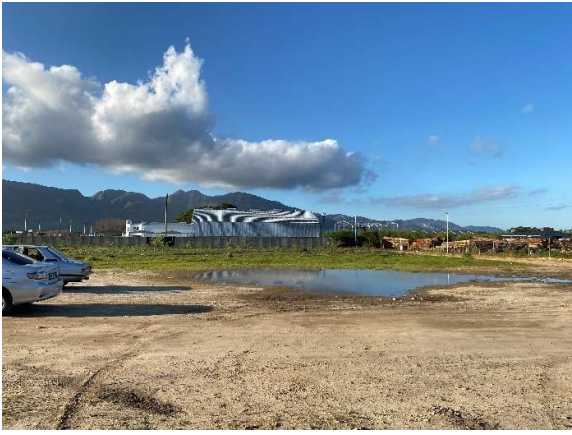
| <p>The current condition of Stockpile area 1 where all stockpiled material has been removed.</p> | <p>The current condition of Stockpile area 1 where all stockpiled material has been removed.</p> |

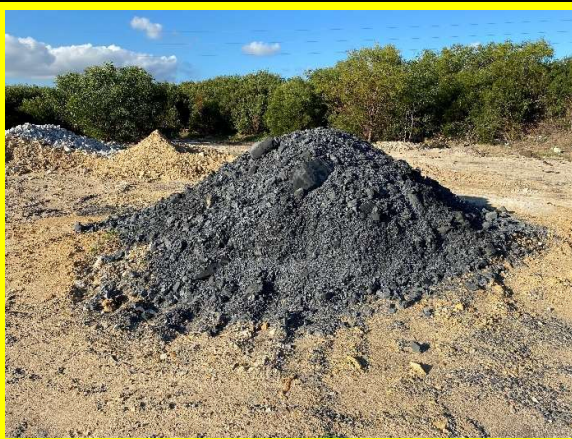
Millings and stockpiled material to be removed.

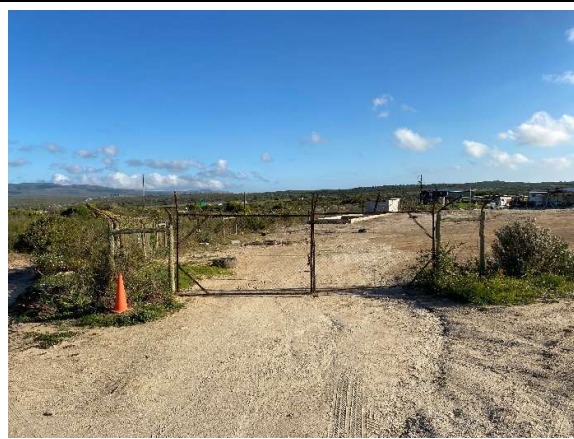
The condition of the site camp. Some infrastructure improvements were retained on request of the landowner.

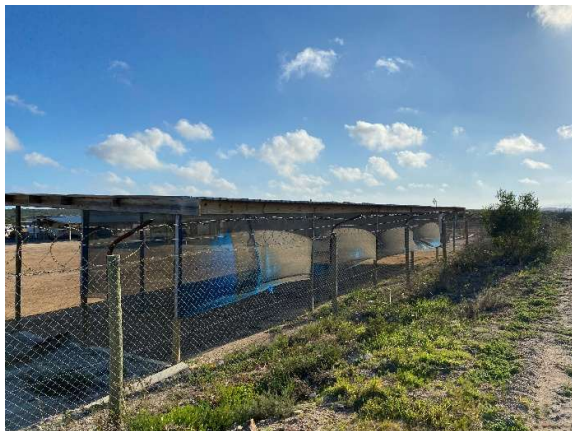
The condition of the site camp. Some infrastructure improvements were retained on request of the landowner.

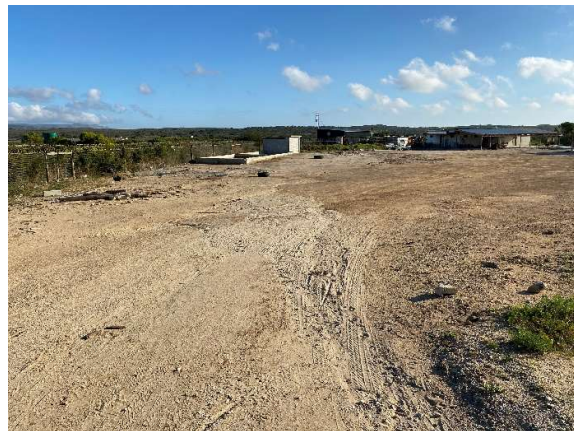
The condition of the site camp. Some infrastructure improvements were retained on request of the landowner.

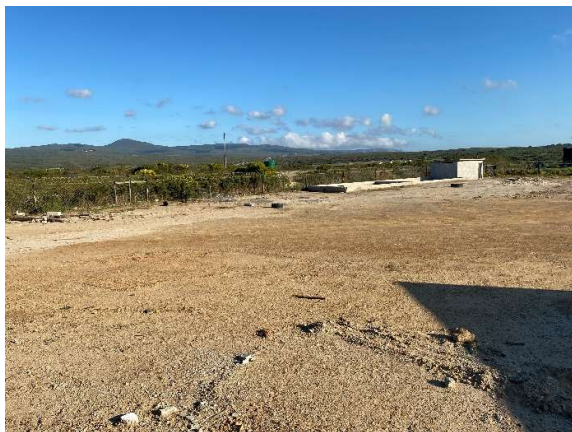
The condition of the site camp. Some infrastructure improvements were retained on request of the landowner.

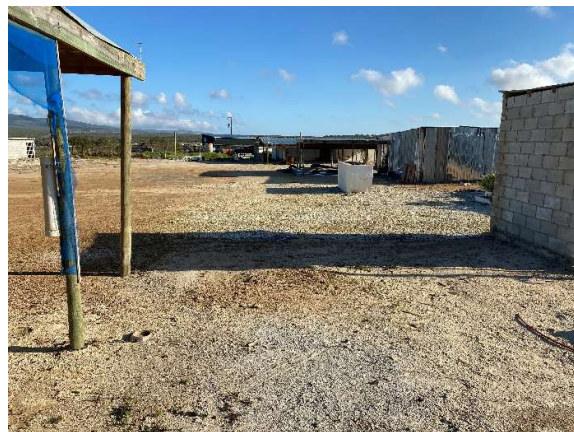
The condition of the site camp. Some infrastructure improvements were retained on request of the landowner.

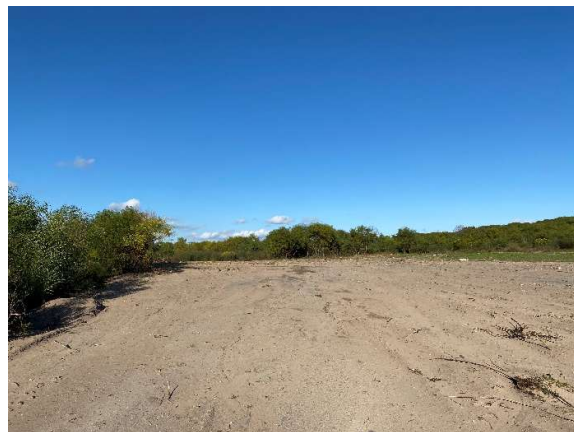
Stockpile area 2, at approximately km 27.5 where all stockpiled material has been removed and the area ripped.

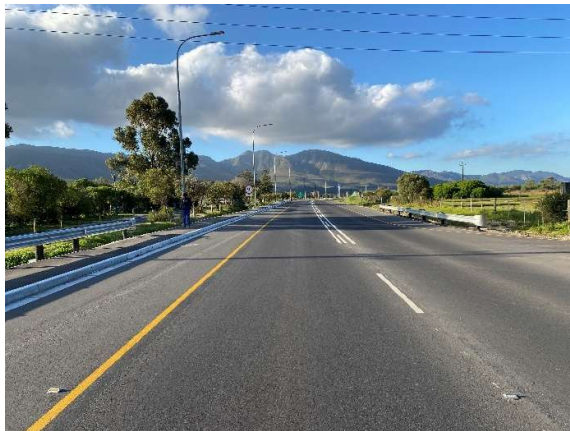
The condition of the road surface and guardrails at Km 24 seen towards the north.

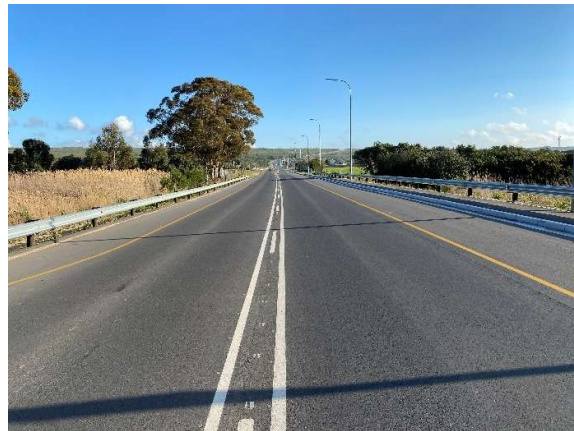
The condition of the road surface and guardrails at Km 24 seen towards the south.

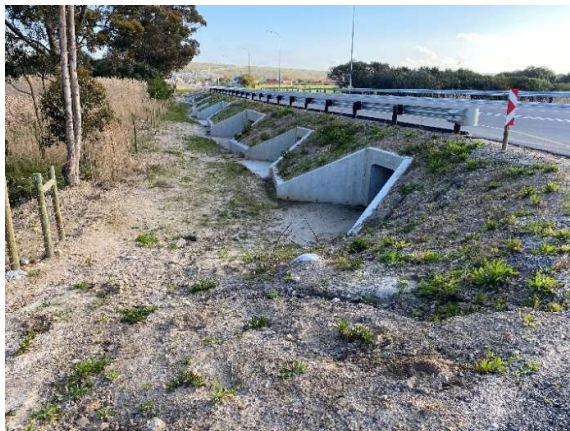
The current condition along the eastern upstream end of the completed box culverts at Km 24 as seen towards the south.

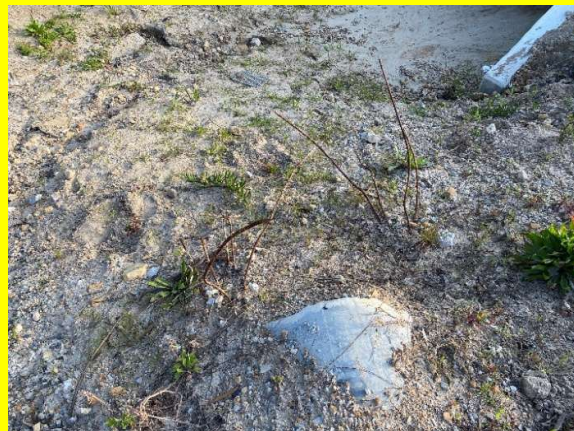
Some steel reinforcement along the east of the new box culverts which need to be removed.

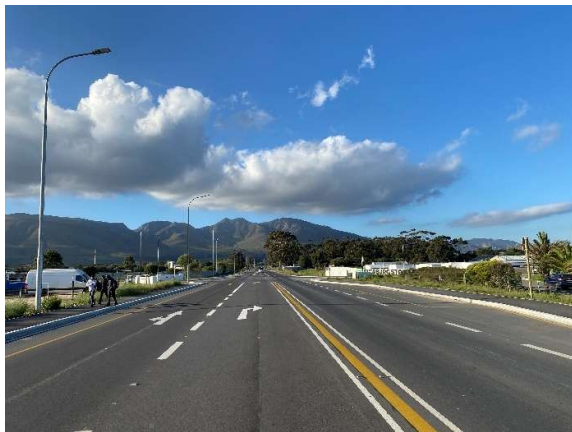
The current condition of the road surface along Km25 as seen towards the north.

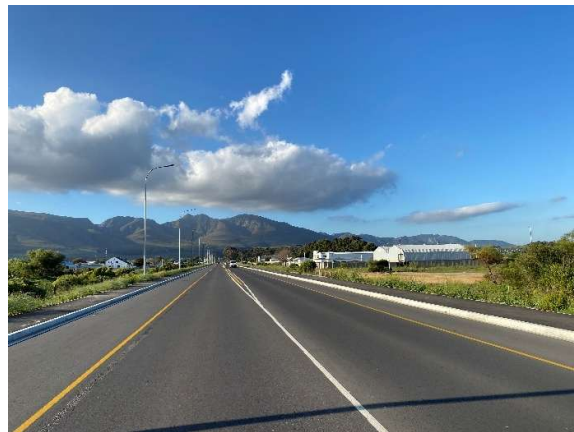
The current condition of the road surface along Km25 as seen towards the north.
