## APPENDIX A – SITE PHOTOGRAPHS

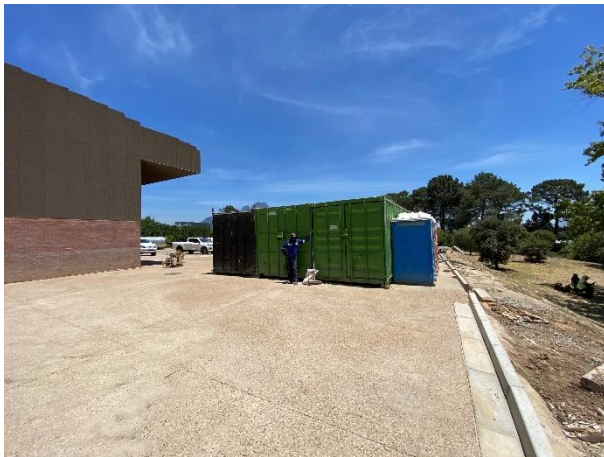
Storage container adjacent to the existing facility.

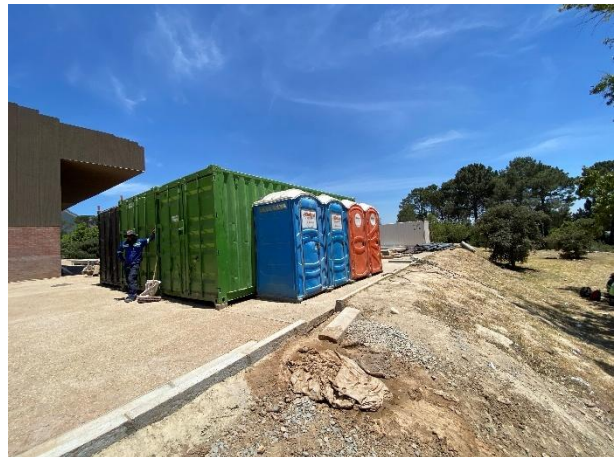
Chemical toilets available adjacent to the current works area.

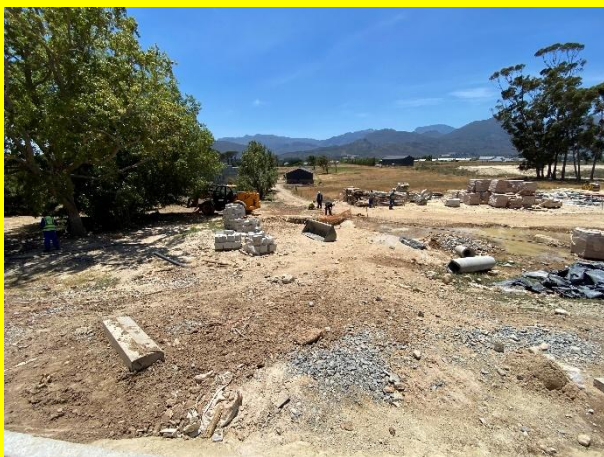
Construction material laydown area where the expansion is to occur. No buffer demarcation in place for wetland B

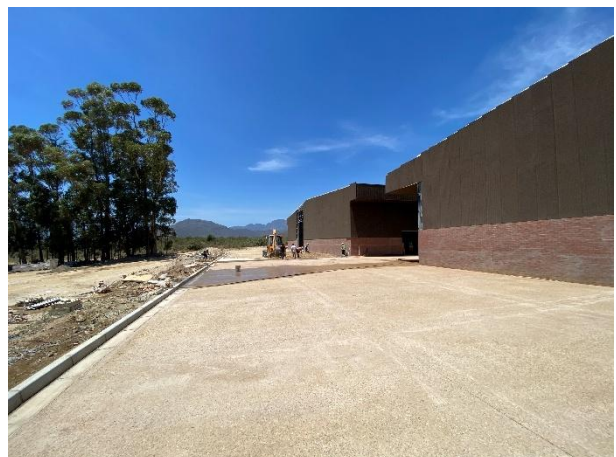
The completed extended facility as seen along its northern boundary in an eastern direction.

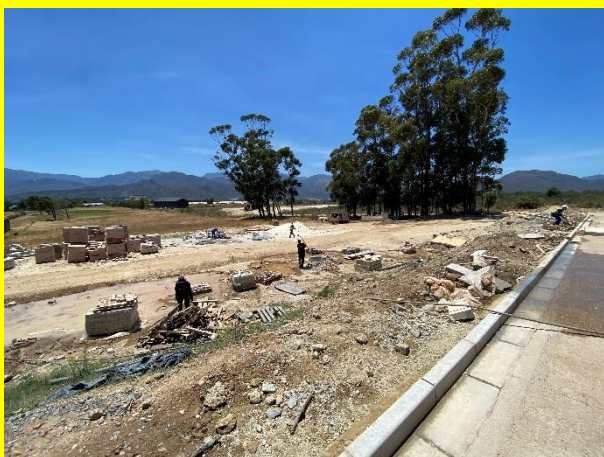
Construction material laydown area where the expansion is to occur. No buffer demarcation in place for wetland B

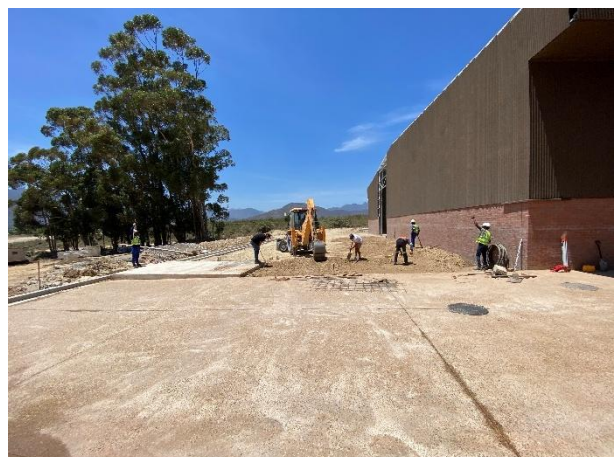
Current construction activities underway along the completed northern boundary of the facility.

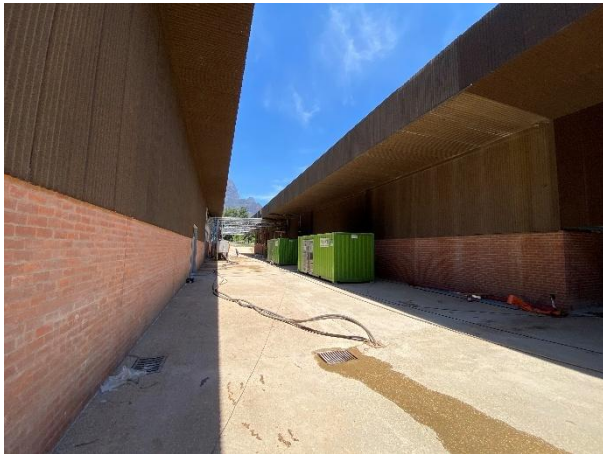
The walkthrough area between the two buildings, with the existing to the right and the new to the left.

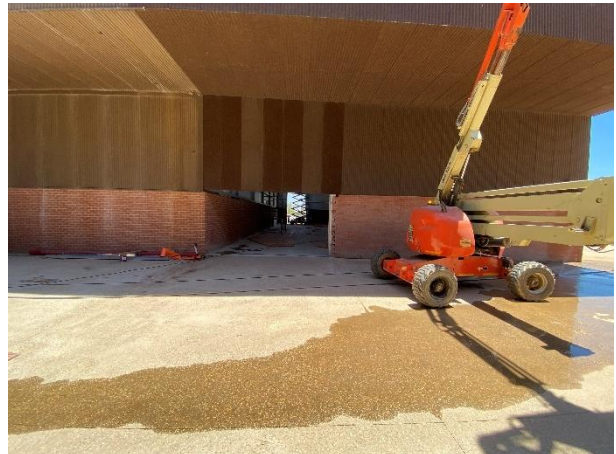
A picture demonstrating the completed extension of the existing facility.

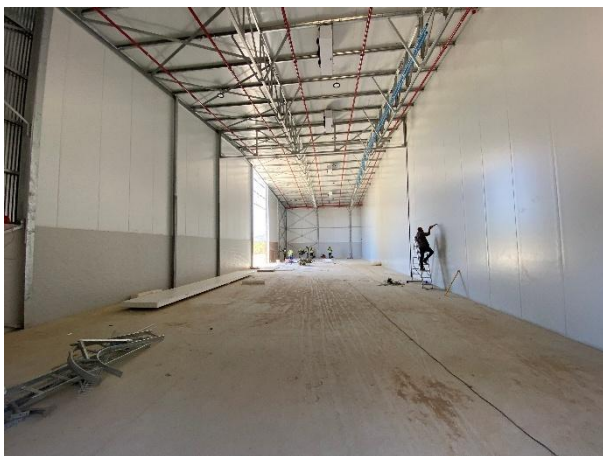
Internal section of the newly built sparkling wine facility, indicating finalised structural elements.

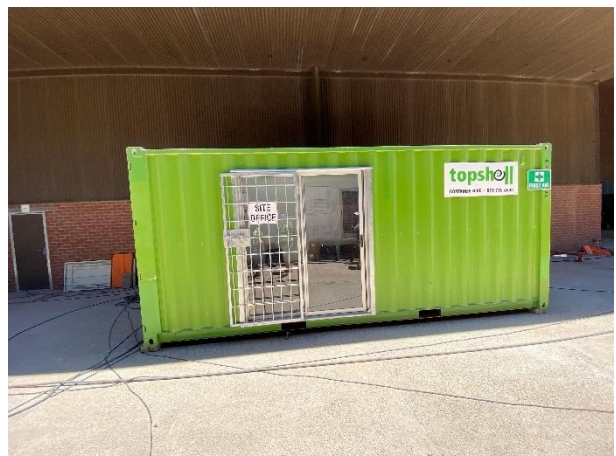
Site Office container placed within the walkthrough area.

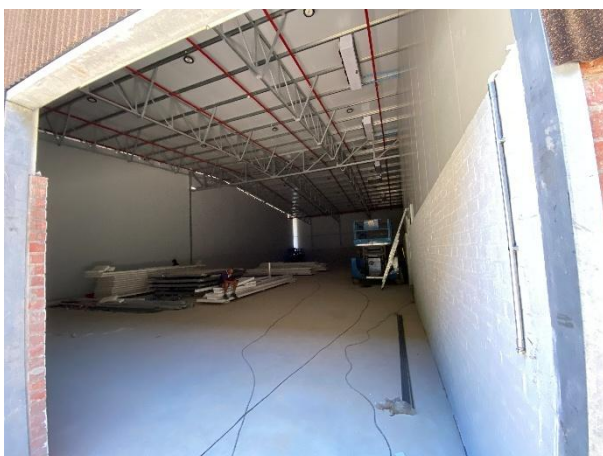
Internal section of the newly built sparkling wine facility, indicating finalised structural elements.

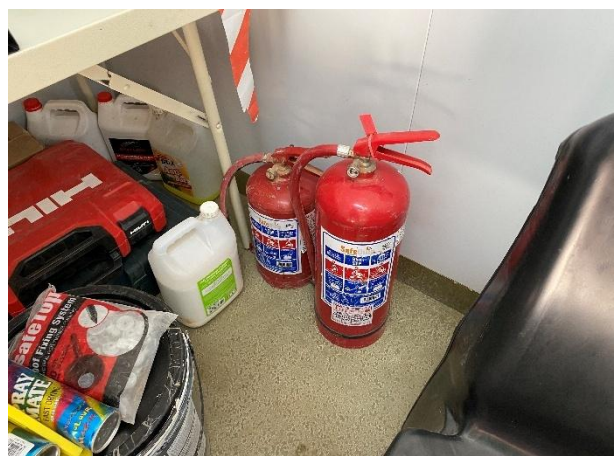
Appropriate firefighting equipment within the site office.

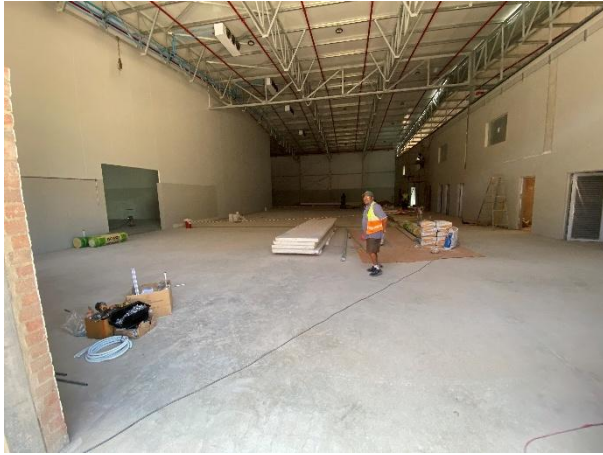
Internal section of the newly built sparkling wine facility, indicating finalised structural elements.

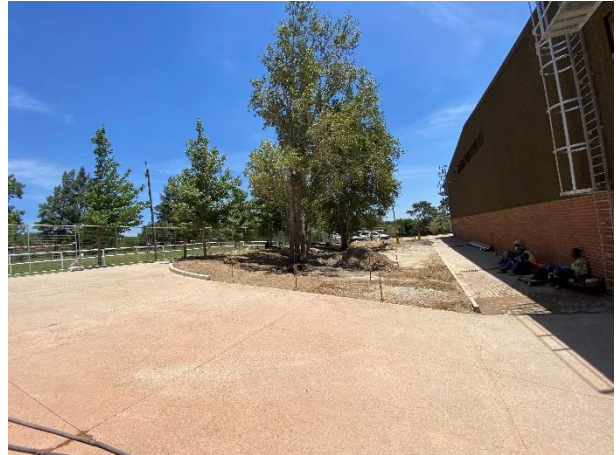
Southwest side of the existing as seen towards the west. All tree lines have been retained.

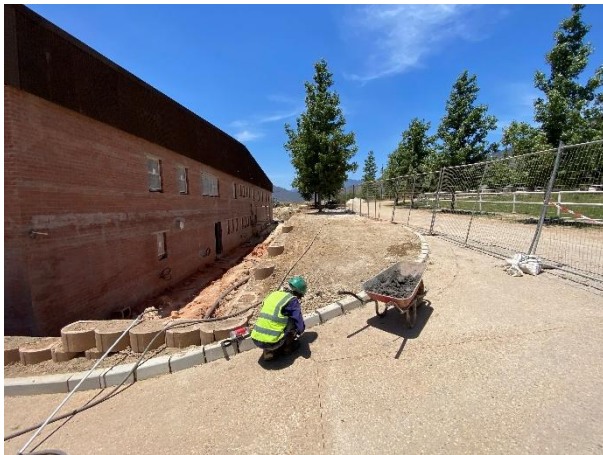
South of the newly constructed facility as seen towards the east. All tree lines have been retained.

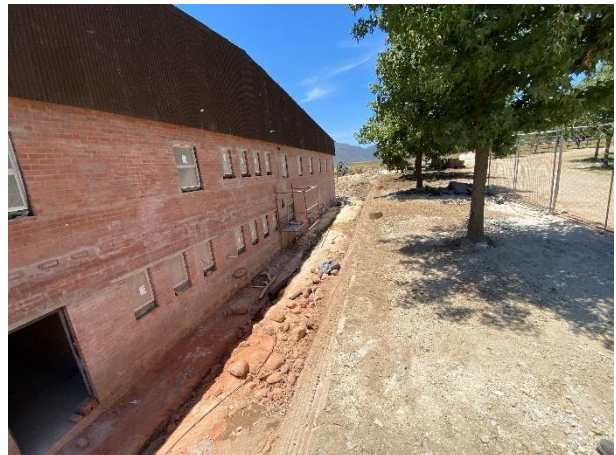
South of the newly constructed facility as seen towards the east. All tree lines have been retained.

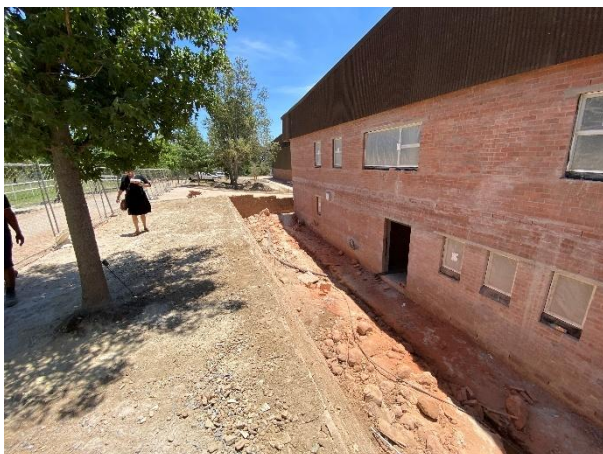
South of the newly constructed facility as seen towards the west. All tree lines have been retained.

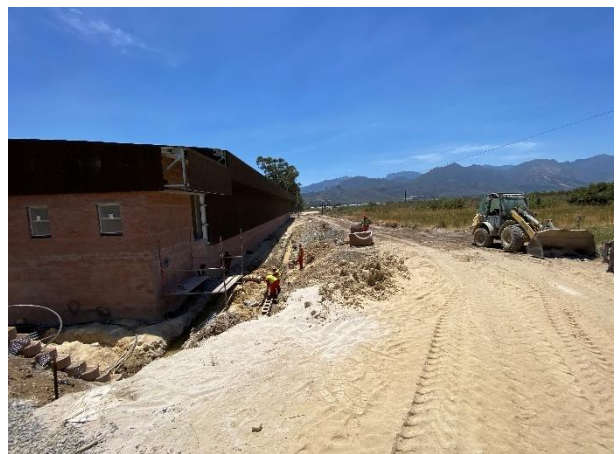
View towards the northeast along the boundary of the new facility where demarcation is in place to the right.

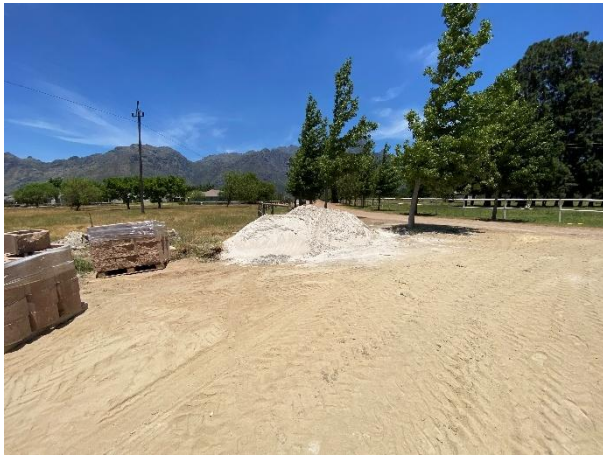
Stockpile area adjacent to the current works area towards the south of the facility.

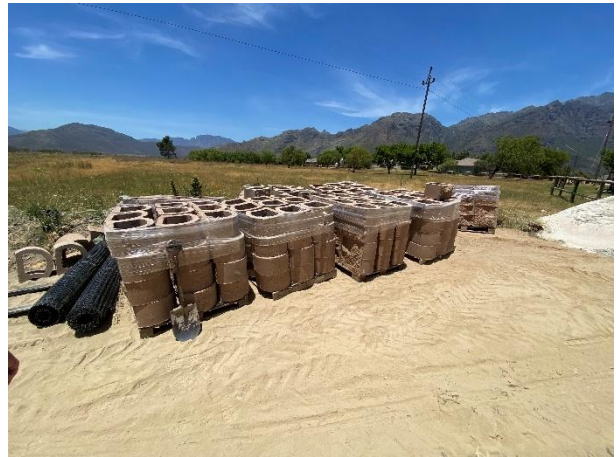
Stockpile area adjacent to the current works area.

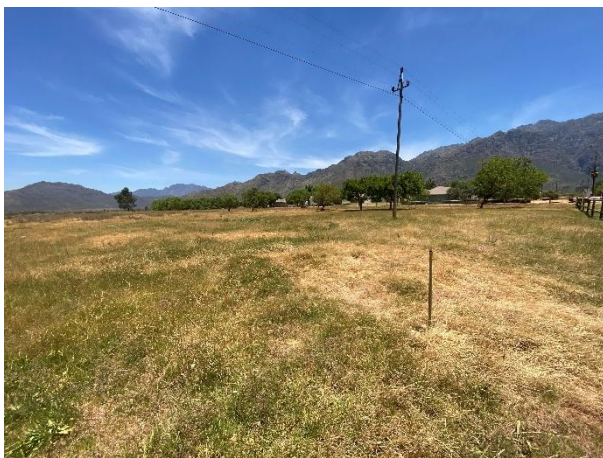
View towards the remnant fynbos and Wetland A adjacent to the sparkling wine facility.

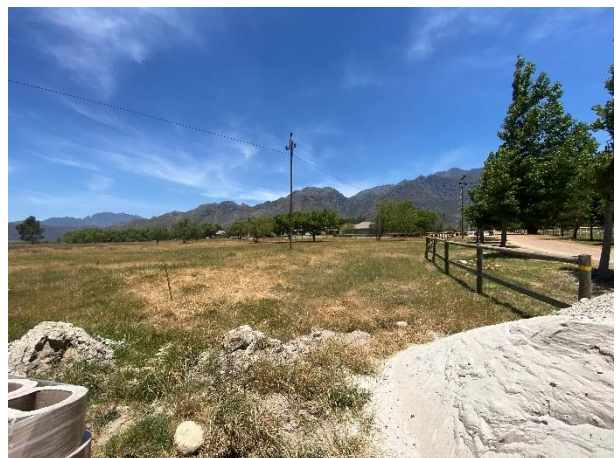
View towards Wetland A adjacent to the expanded facility.

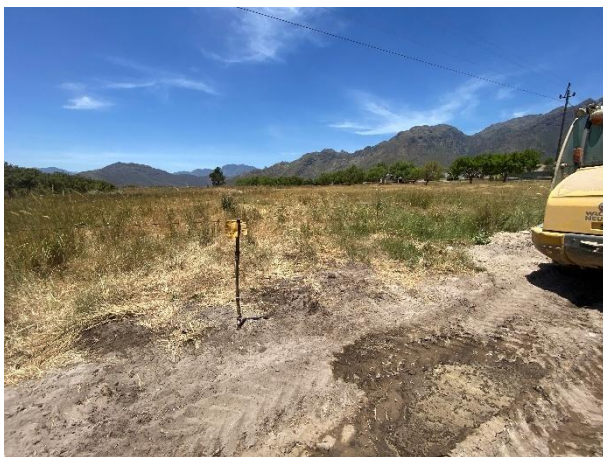
View towards the remnant fynbos and Wetland A with demarcation and no-go signage in place.

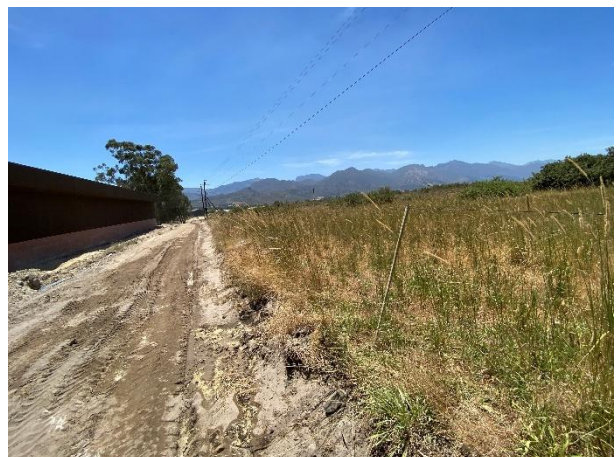
View towards the remnant fynbos and Wetland A with demarcation and no-go signage in place.

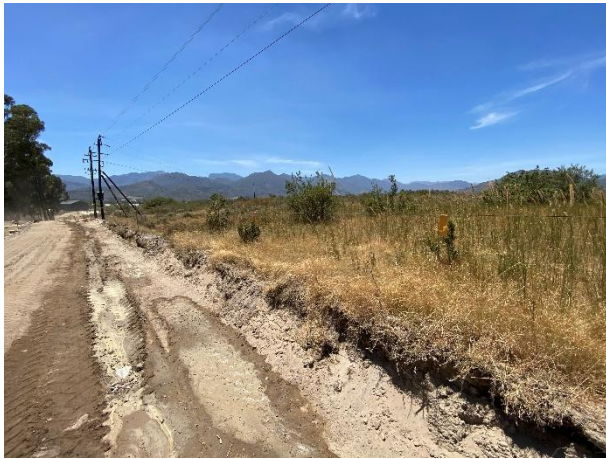
View towards the remnant fynbos and Wetland A with demarcation and no-go signage in place.

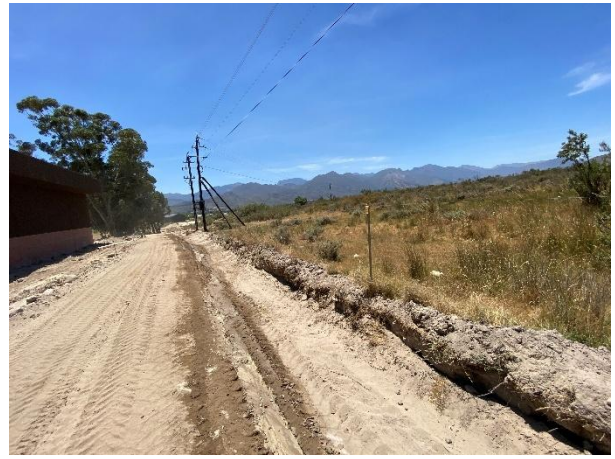
View towards the remnant fynbos and Wetland A with demarcation and no-go signage in place.

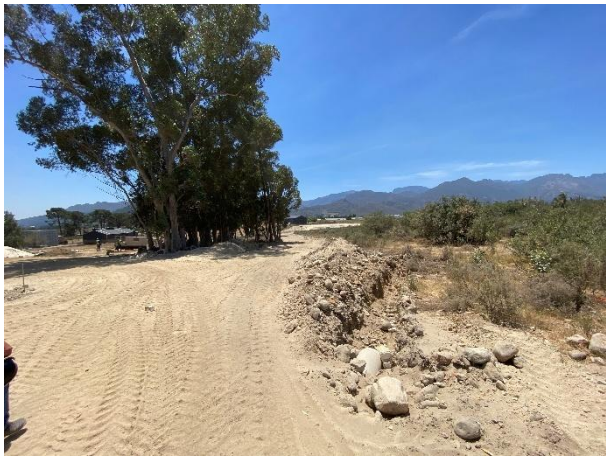
View towards the north with Wetland B to the left of picture.

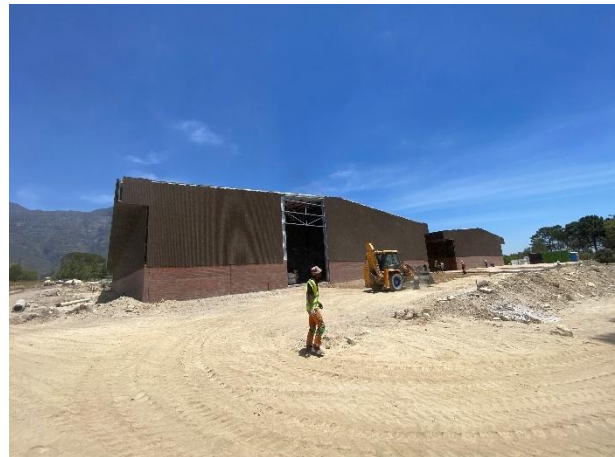
Construction progress of the facility adjacent to the new facility seen towards the southwest.

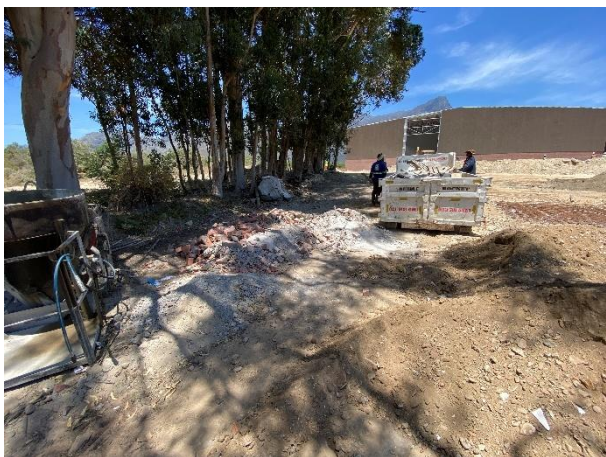
Builders rubble and waste material being loaded onto mobile skip for transportation.

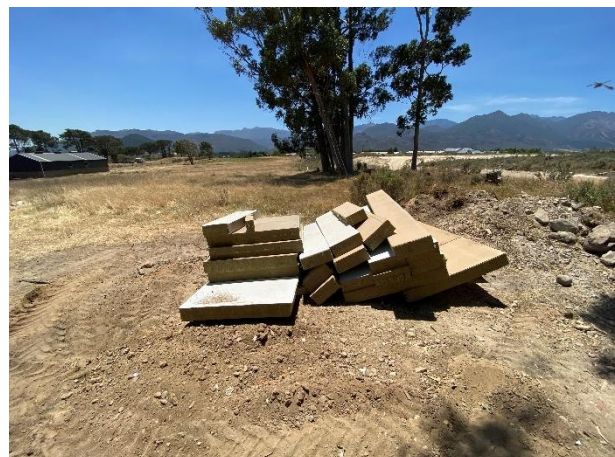
Material laydown area with Wetland B to the back of picture.

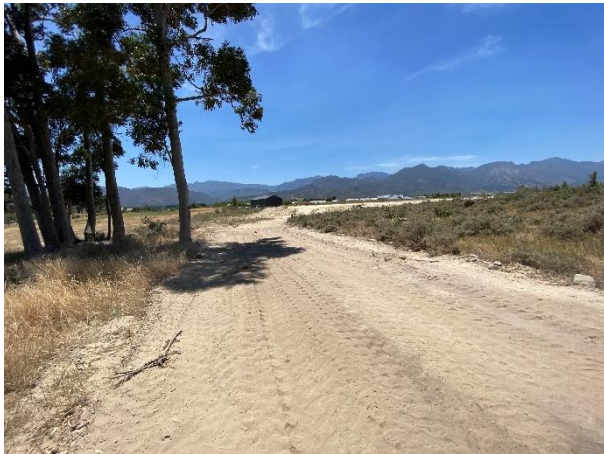
Gravel access road leading towards the material spoil used as platform for the approved future PV plant.

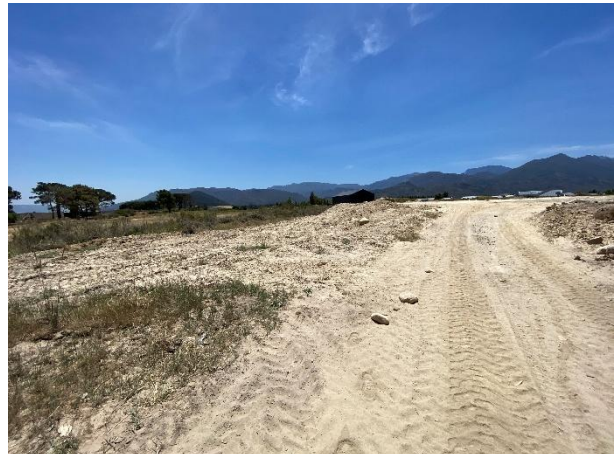
Gravel access road leading towards the material spoil used as platform for the approved future PV plant.

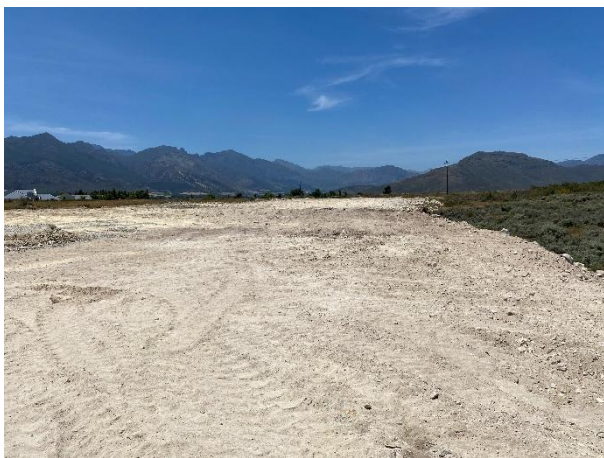
Excavated material spoil used as platform for approved future PV plant towards the northeast of the site.

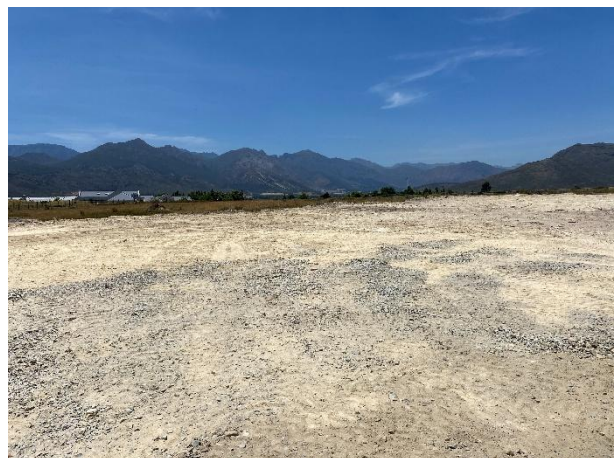
Excavated material spoil used as platform for approved future PV plant towards the northeast of the site.

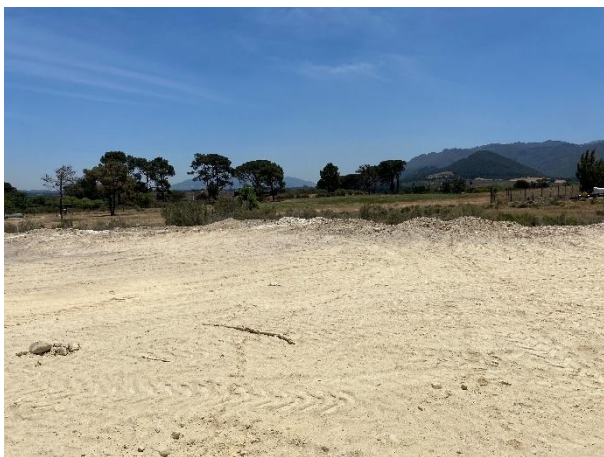
Construction access roads along the remnant fynbos section.

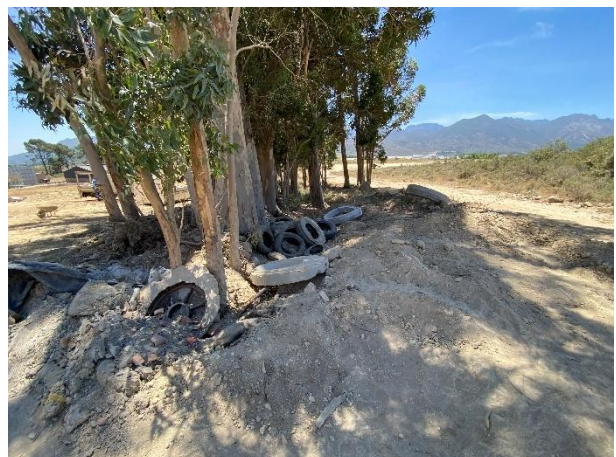
Discarded vehicle tyres to be removed within the tree line adjacent to Wetland B.

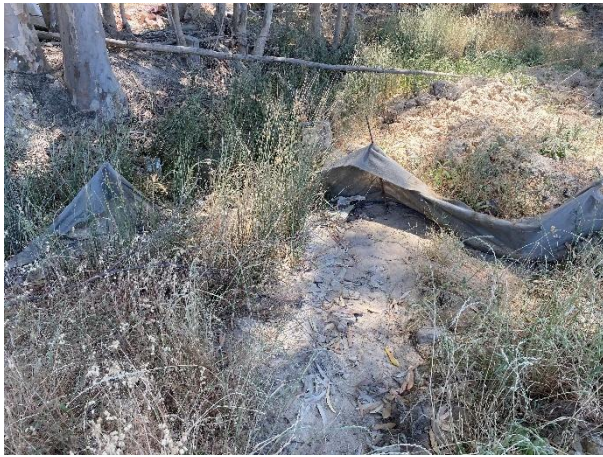
Silt fence installed along the Eucalyptus trees where a drainage line is in place adjacent Wetland B.

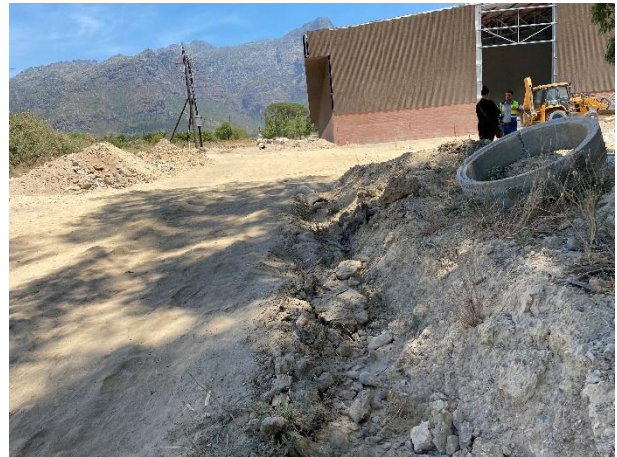
Along the Eucalyptus trees where a drainage line is in place as seen towards the south.

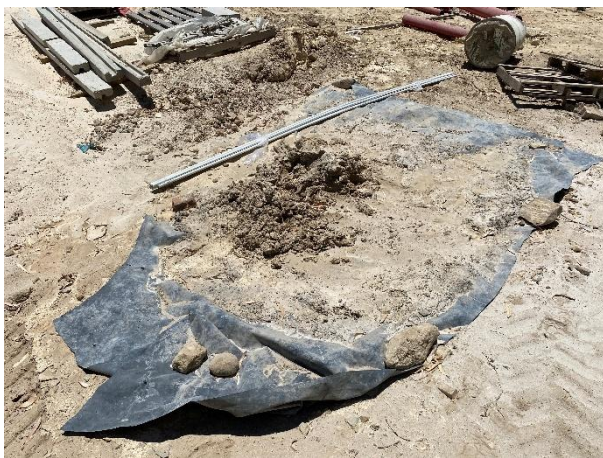
Cement batching taking place on an impermeable surface.

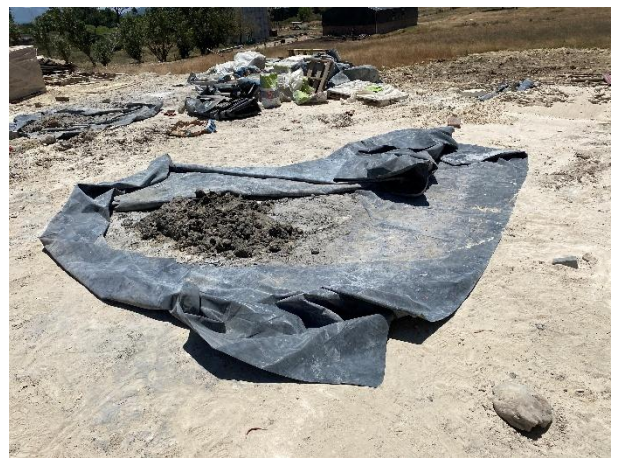
Cement batching taking place on an impermeable surface.

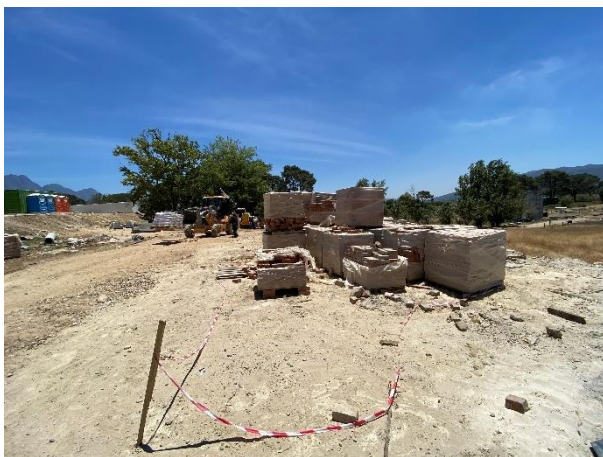
Construction laydown area adjacent Wetland B.

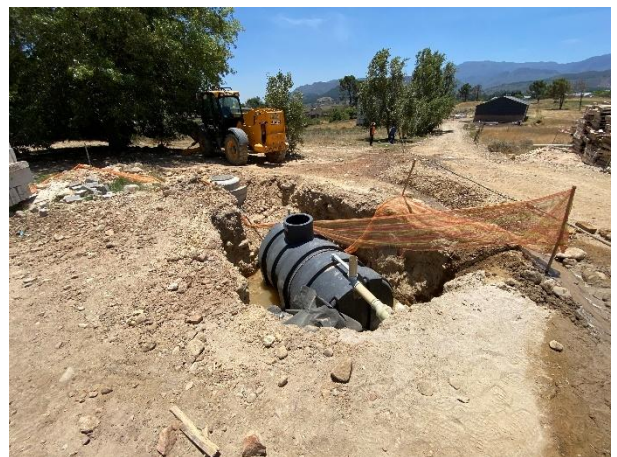
An underground sewage tank being installed immediately north of the existing facility.

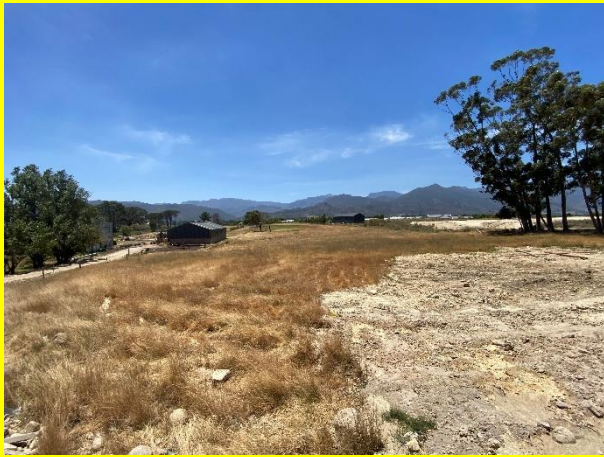
View towards Wetland B where the laydown footprint protrudes into a section thereof.

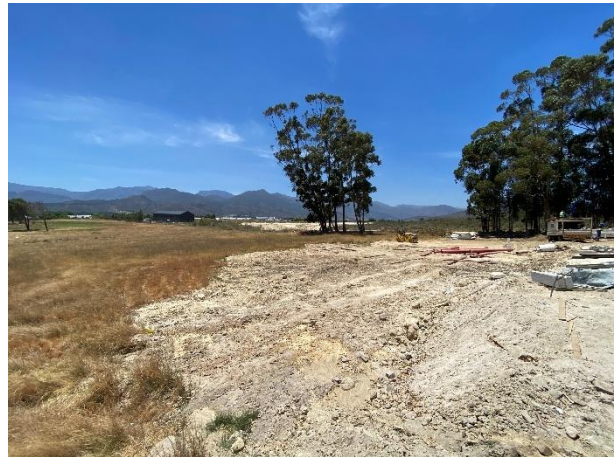
View Wetland B as seen from the laydown area towards the north.

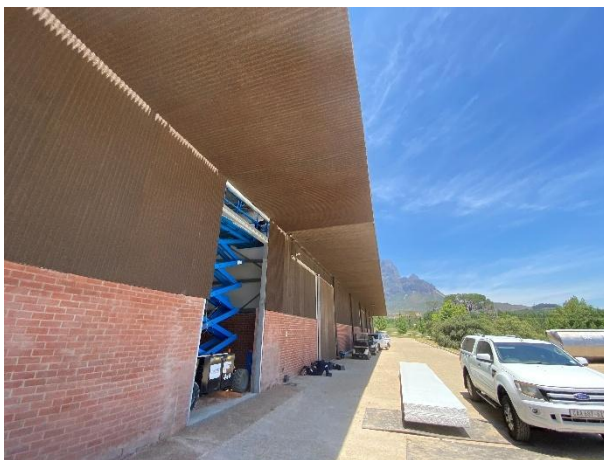
A picture demonstrating the completed extension of the existing facility as seen towards the south.

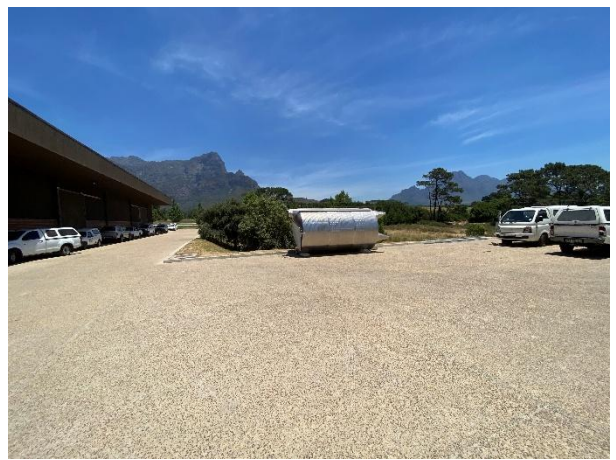
Parking area west of the existing facility with a wine tank temporarily placed as seen towards the south.

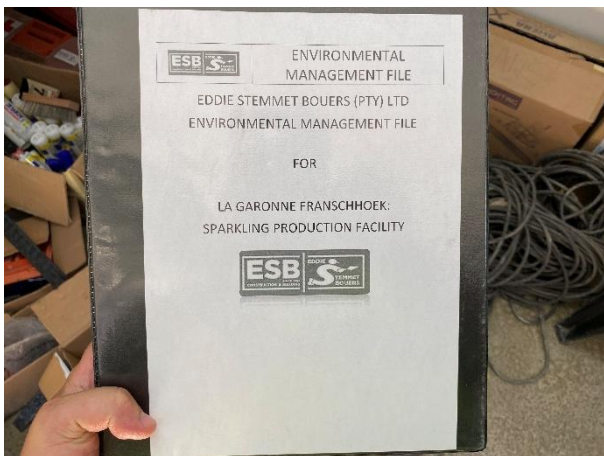
Environmental File within the site office.

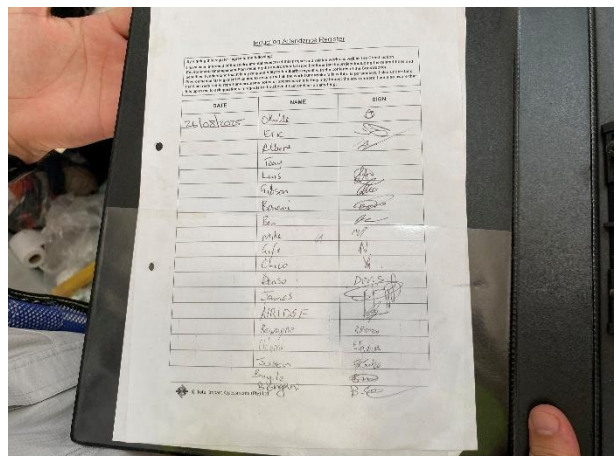
Induction Register.
