**ENVIRONMENTAL MONITORING REPORT No. 11**  
**FOR**

***The Development of the Garden Walk on the Remainder of Portion 58  
of the Farm Hartenbosch 217, Hartenbos***

**MOS25/1262/31**

**January 2026**

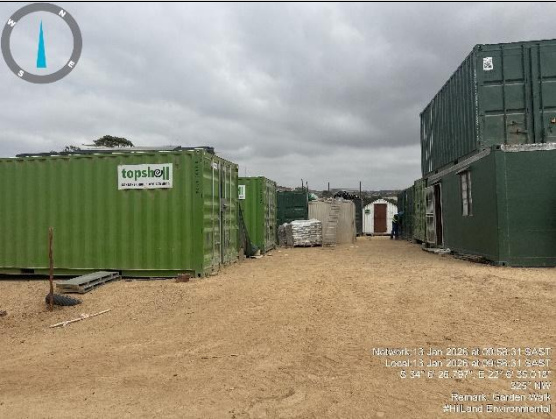
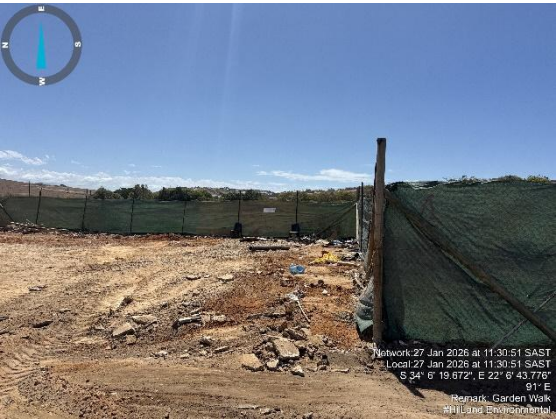
| EMPr Requirement | Level of Compliance | Comments / Findings | Photo's (if applicable) |
|---|---|---|---|
| The site camp area must be indicated and approved by the ECO. | DONE | <p>The site camp method statement (MBC) was approved by the ECO. The site camp is set up on RE/219 as per the method statement. Based on the survey data, the area in front of the site camp is also on RE/219, refer to non-compliance notification mentioned above.</p> <p>MBC started to dismantle the site camp. The area must be fully rehabilitated (remove any/all foreign material, replace topsoil and spread the seed mix – water and aftercare).</p> <p>Civil and sub-contractor's site camp/material storage area is within the fenced off development footprint (parking area).</p> | <p>Network: 13 Jan 2026 at 09:58:31 SAST<br/> Local: 13 Jan 2026 at 09:58:31 SAST<br/> S 34° 16' 46.451" E 22° 0' 50.000" W<br/> Remark: Garden Walk<br/> WHL Land Environmental</p> <p><b>Sub-contractor's site camp</b></p> <p>Network: 27 Jan 2026 at 11:30:51 SAST<br/> Local: 27 Jan 2026 at 11:30:51 SAST<br/> S 34° 6' 19.672" E 22° 6' 43.776" E<br/> Remark: Garden Walk<br/> WHL Land Environmental</p> <p><b>MBC site camp – in the process of dismantling.</b></p> |

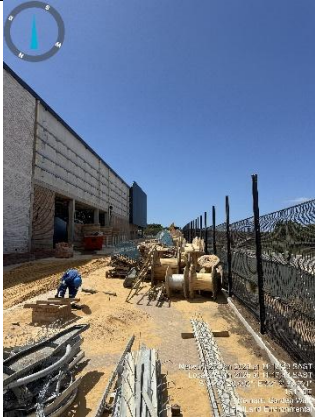
| <p>Storage sites for construction material and access must be approved by the ECO prior to commencing (and areas will require rehabilitation after use).</p> | <p>Compliant</p> | <p>All construction material is currently stored in the development site (fenced off area).</p> <p>Construction access is directly off the R102 to the construction site – shopping centre entrance point.</p> <p>Stormwater infrastructure and external road works construction material stockpile area is generally limited within the development zone (shopping centre), however there are limited material stockpiling on the outside where active construction is taking place.</p> | <p>Construction materials stored on site</p> |

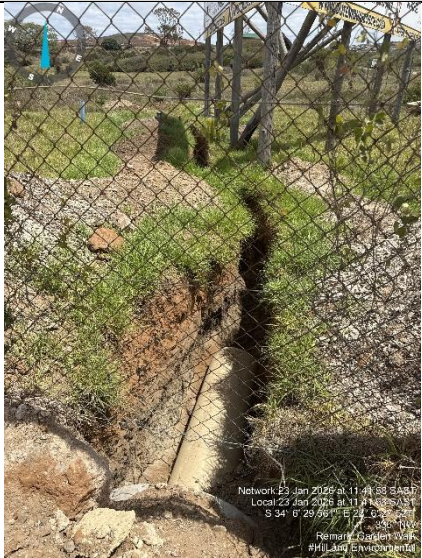
| <p>Silt fencing must be installed at the stormwater outlet point until the site is re-vegetated and silt is no longer evident.</p> | <p><b>Action required</b></p> | <p>Installation of the stormwater infrastructure in process. Silt trap must be installed at the stormwater outlet point (on RE/101/217).</p> <p>The southern stormwater channel has been constructed with a gabion dissipator – done.</p> | <p>Network: 23 Jan 2025 at 11:44:53 SAST<br/> Locat: 22 Jan 2025 at 11:44:53 SAST<br/> S: 34° 6' 29.86" E: 21° 0' 0" W<br/> Remark: Garden Walk<br/> #HillLandEnvironmental</p> <p><b>Stormwater outlet point on RE/101/217 as per the municipal services agreement</b></p> |

| The silt fencing needs to be installed where indicated by the ECO. | Action required | Silt trap must be installed at the stormwater outlet as soon as possible. | |

Silt trap (bidim fence or hay bales) must be installed and maintained at the stormwater outlet.

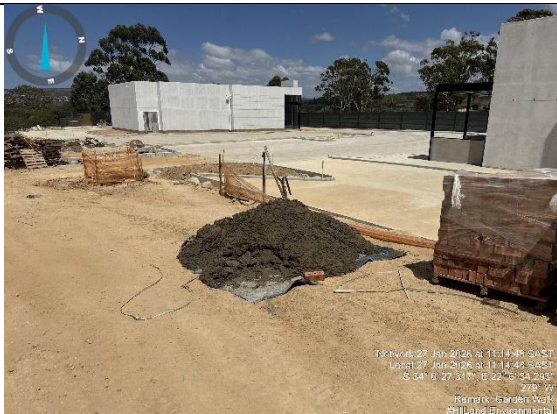
| <p>In the case of contaminated water run-off, silt can be stopped by means of sandbags and following the rain the contaminated area should be cleaned.</p> | <p>Ongoing</p> <p>Not yet required for this reporting period.</p> | <p>There is no contaminated run-off noted outside the demarcated site.</p> <p>Silt trap must be installed at the stormwater outlet as soon as possible.</p> <p>No contaminated runoff noted from the cement mixing areas – internal on hard surface.</p> | <p>Network: 27 Jan 2025 at 11:14:48 SAST<br/> Locat: 27 Jan 2025 at 11:14:48 SAST<br/> S: 34° 6' 27.31" E: 22° 45' 21.24" W<br/> Remark: Garden Walk<br/> #HillLandEnvironmental</p> |

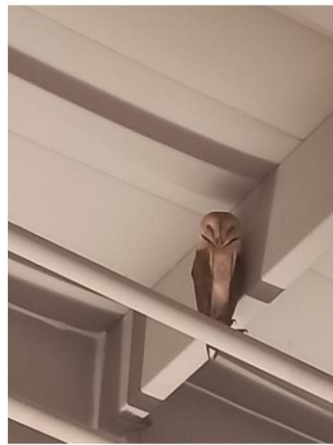
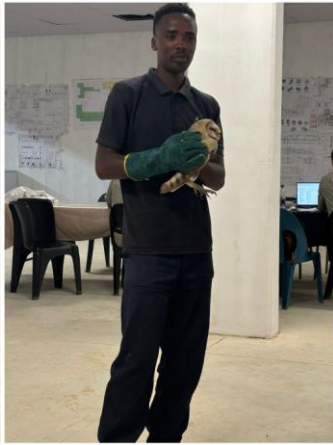
| Should any animal be caught up or trapped in the construction area, the ECO should be requested to assist. | Compliant | <p>A Barn Owl was rescued from the construction site by the SPCA. The owl entered the shopping centre after hours and was noted early the next morning. the DEO notified the SPCA and the owl was rescued.</p> <p>The ECO was notified on the day – 26 January 2026.</p> | |

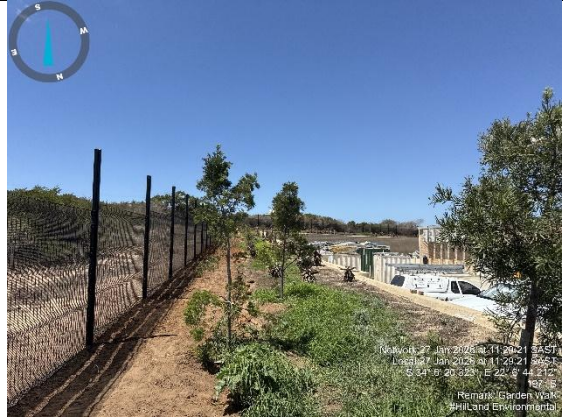
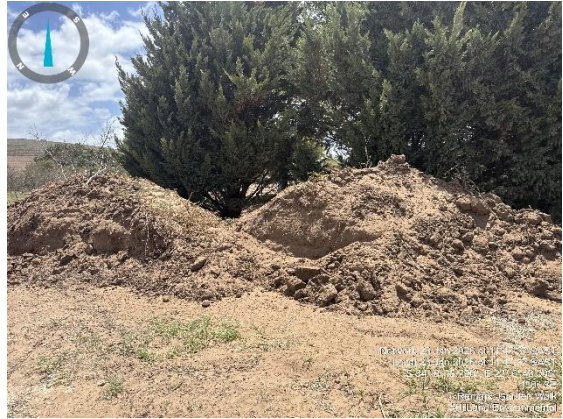
| All topsoil on the site will be stripped at least 200mm Deep, approx. 2500m <sup>3</sup> of topsoil will be retained on site for future use in the landscaping area. | | for the rehabilitation and landscaping – currently in process.<br><br>The contractor must ensure that the topsoil stockpile is free from invasive alien plants ( <i>Datura sp.</i> ). | <p>Phase 1 rehabilitation report – progress.</p> <p>Topsoil stockpile</p> |

| The stockpiles must be protected against erosion including wind (vegetation can be permitted to grow on the stockpile to keep it secure and prevent wind movement. No alien invasive plants may grow on the stockpile). | Ongoing | Grass cover is allowed to grow on the stockpile – some grass cover noted.<br>The contractor must ensure that the topsoil stockpiles are free from invasive alien plants ( <i>Datura sp.</i> ). | |

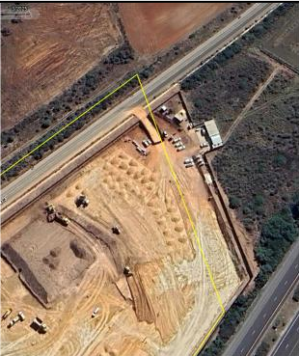
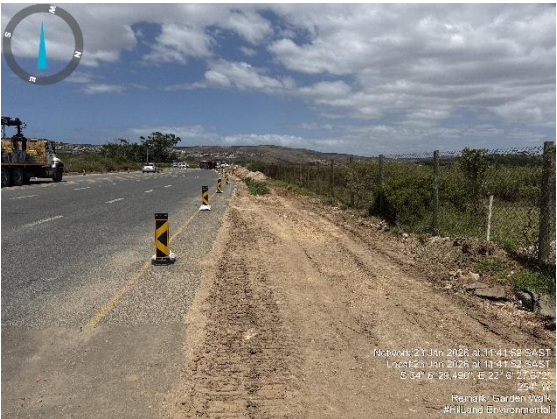
| Working Areas & Demarcation | | | |
|---|---|---|---|
| <p>All areas outside of the property will be regarded as 'no-go' areas (except where installation of services will be required).</p> | <p>Ongoing</p> | <p>The non-compliance was reported to DEADP. DEADP Law Enforcement S24G process in progress.</p> <p>R102 intersection and upgrades are in process.</p> | <div><p><b>Yellow line showing the cadastral boundary.</b></p><p>06/06/2025 20:14:58 SAST<br/>06/06/2025 20:14:58 SAST<br/>S 34° 5' 23.458" E 22° 0' 00.000"<br/>Zona 35<br/>Project: Garden Walk<br/>#Hilland Environmental</p></div> |

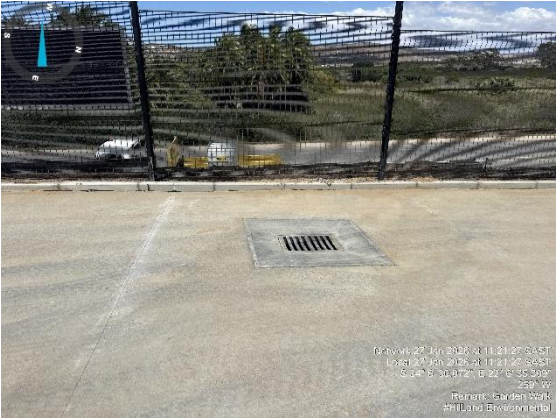
| <p>No-Go areas will be required to be demarcated by the contractor to ensure that they are visible at all times, to all personnel.</p> <p>The total footprint of a building zone / phase should be demarcated with 1.5 m (height) shade cloth for the entire period of the construction.</p> | Compliant | <p>Clear-vu fence (permanent fence) is being installed. The construction demarcation fence is being removed as the installation of the clear-vu fence progresses.</p> | <p>Network 27 Jan 2025 at 11:21:27 EAST<br/> Location 30.072111 149.053555<br/> S 30.072111 E 149.053555<br/> 25M W<br/> Remotely Operated Vehicle<br/> 4000m Resolution</p> |

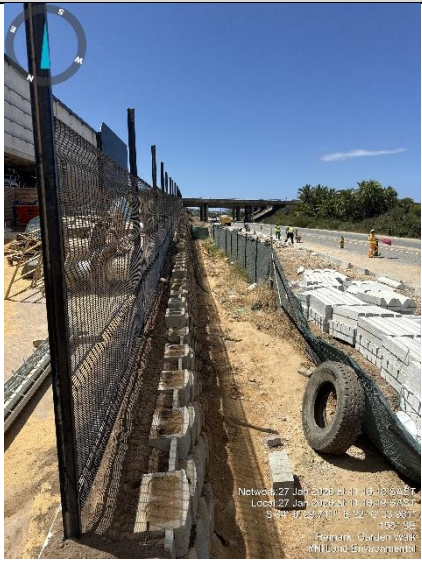
| <p>All stockpile sites to be approved by the ECO and/or landowner, prior to the commencement of stockpiling.</p> <p>All stockpile sites within the development area are to be demarcated with silt-fences and/or danger tape, where necessary.</p> | Compliant & ongoing | <p>Main construction material stockpile area is within the demarcated zone.</p> <p>The construction material stockpile in the development zone is demarcated with orange netting fencing.</p> <p>Limited construction material stockpiled outside the shopping centre for the external services (road, sewage and stormwater).</p> | <p>Network 27 Jan 2025 at 11:18:15 EAST<br/> Location 30.072111 149.053555<br/> S 30.072111 E 149.053555<br/> 100M W<br/> Remotely Operated Vehicle<br/> 4000m Resolution</p> <p><b>Curbs stockpiled next to the sidewalk</b></p> |

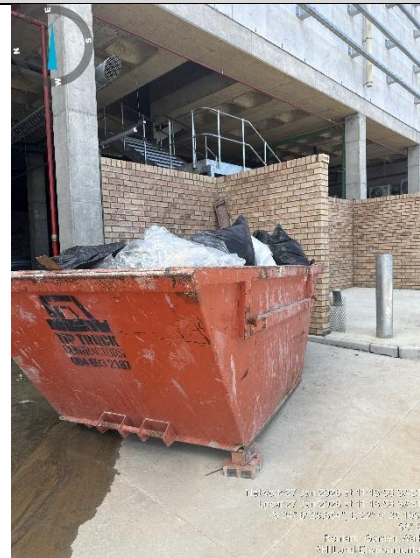
| It is <b>recommended</b> that an integrated waste management approach must be used that is based on waste minimisation and must include reduction, recycling, re-use and disposal where appropriate. | Compliant / Ongoing | Keeping general waste separate from construction rubble. Scrap metal is stockpiled separately in a skip for recycling. | |
| Recycling must be encouraged on-site and recycling bins must be provided and clearly marked. | | <p>Construction rubble stockpiles must not have litter (papers and plastic) – <b>ongoing</b>.</p> <p>Subcontractors (shopfitters) must be encouraged to separate their waste – recycling.</p> <p>Additional skips have been brought to site to try and limit littering. Skips must have a cover to prevent wind blowing litter.</p> | |

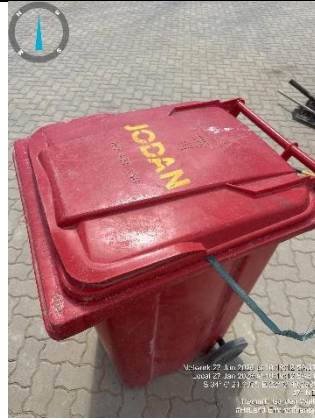
| Litter to be removed from the site on a daily basis and kept in closable bins. | Compliant & ongoing | Litter noted during ECO site inspection(s) have been reported to the contractor and are actioned accordingly – this will be ongoing.<br><br>Regular litter picking is done. | <p>waste bins/skips on site</p> |

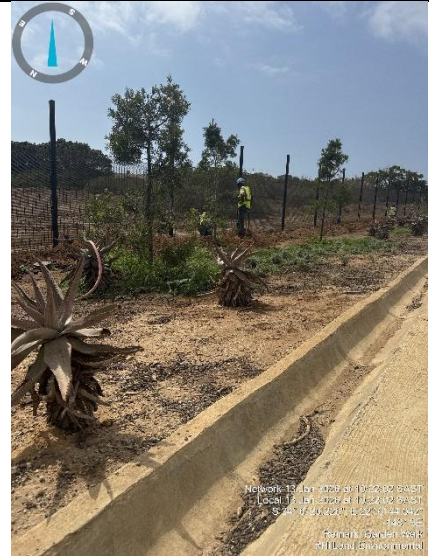
| Any damage to private property or open space areas must be reinstated to the state it was before construction commenced and must be done to the satisfaction of the landowner and ECO. | Ongoing | Refer to the non-compliance letter / comment. Rehabilitation of the area above the retaining wall will in process – refer to the ECO rehabilitation monitoring report. | |

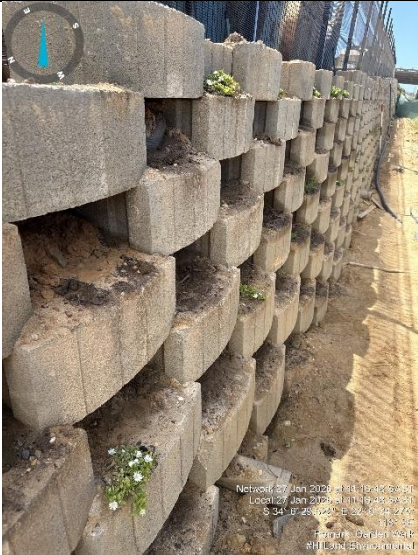
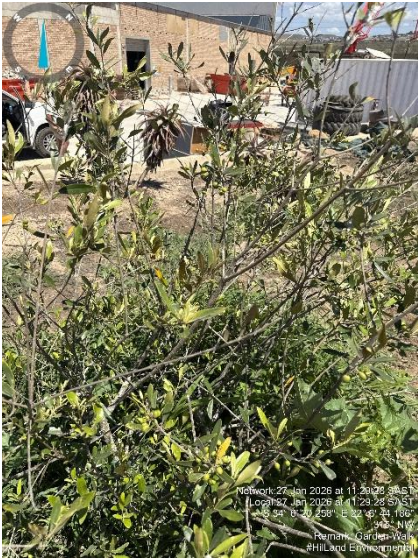
| <p>Reinstate the vegetation in accordance with the Landscape Master Plan.</p> | <p>Ongoing</p> | <p>Rehabilitation / revegetation of the retaining wall / embankment has been done (phase 1) – refer to the ECO rehabilitation monitoring report.</p> <p>Landscape master plan was circulated to the ECO.</p> | <div data-bbox="1473 193 1888 750"><p>Network: 27 Jan 2026 at 11:29:29 S/E<br/>Local: 27 Jan 2026 at 11:29:29 S/E<br/>5 34 0' 45" 2026 15 32 40' 24" 100°<br/>Purnell, Garden Walk<br/>Hill and Environment</p></div> <p>Retaining wall / embankment landscaping started</p> <div data-bbox="1473 783 1888 1345"><p>Network: 27 Jan 2026 at 11:29:29 S/E<br/>Local: 27 Jan 2026 at 11:29:29 S/E<br/>5 34 0' 45" 2026 15 32 40' 24" 100°<br/>Purnell, Garden Walk<br/>Hill and Environment</p></div> |

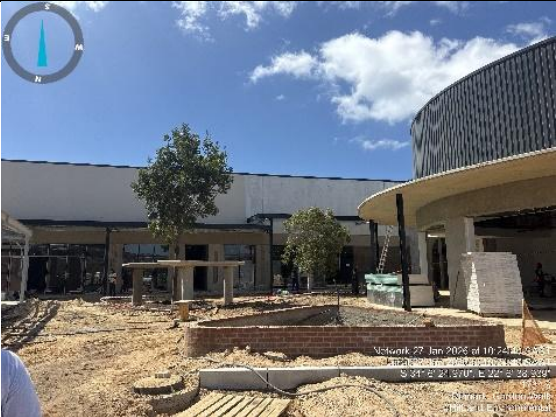
| All landscaping areas to be planted and maintained. | Ongoing | Rehabilitation will be complete once construction is complete. | |

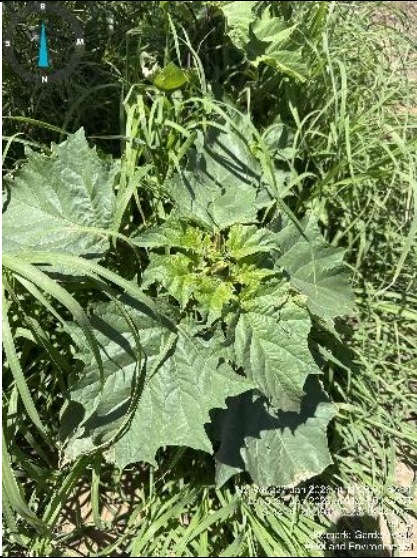
| Alien invasive vegetation to be removed | Ongoing | The contractor must ensure ongoing hand-pulling of the <i>Datura</i> plants – ECO can assist with identification if required. It is important to remove these plants before they start producing seeds and spreading. | |
