**ENVIRONMENTAL MONITORING REPORT No. 12**  
**FOR**

***The Development of the Garden Walk on the Remainder of Portion 58  
of the Farm Hartenbosch 217, Hartenbos***

**February 2026**

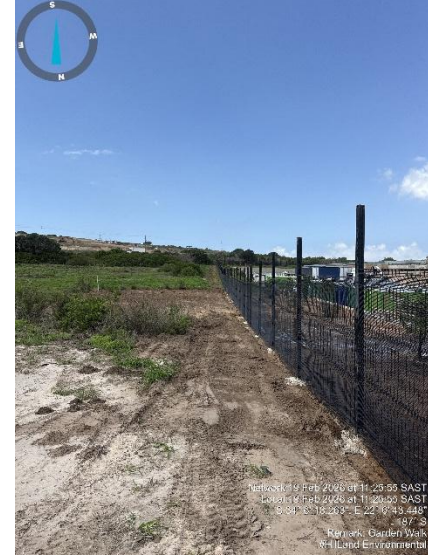
| EMPr Requirement | Level of Compliance | Comments / Findings | Photo's (if applicable) |
|---|---|---|---|
| The site camp area must be indicated and approved by the ECO. | DONE | <p>The site camp method statement (MBC) was approved by the ECO. The site camp is set up on RE/219 as per the method statement. Based on the survey data, the area in front of the site camp is also on RE/219, refer to non-compliance notification mentioned above.</p> <p>The MBC site camp has been dismantled. The area must be fully rehabilitated (remove any/all foreign material, replace topsoil and spread the seed mix – water and aftercare).</p> <p>Civil and sub-contractor's site camp/material storage area is within the fenced off development footprint.</p> | <p>MBC site camp area – rehabilitation to start.</p> |

MBC site camp area to be rehabilitated.

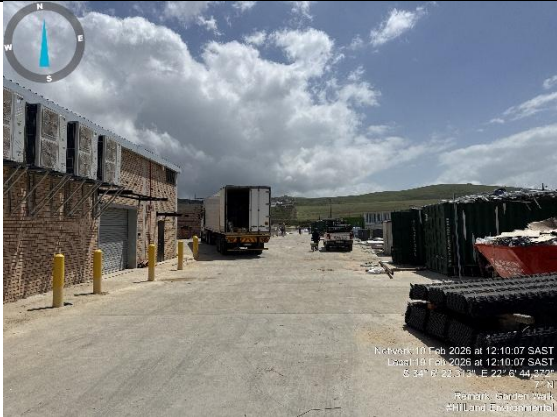
| | | | <p>Sub-contractor site camp area.</p> |

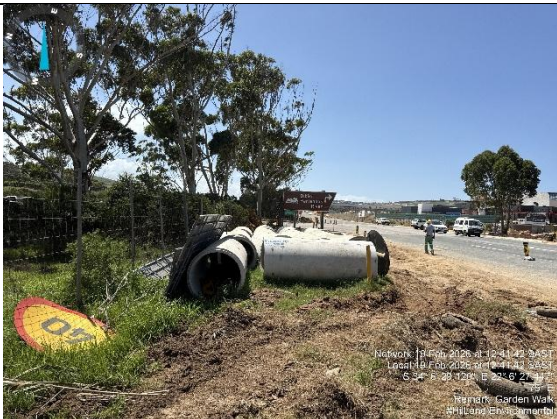
| Storage sites for construction material and access must be approved by the ECO prior to commencing (and areas will require rehabilitation after use). | Compliant | <p>All construction material is currently stored in the development site (fenced off area).</p> <p>Construction access is directly off the R102 to the construction site – now using the approved entrances.</p> <p>Stormwater infrastructure and external road works construction material stockpile area is generally limited within the development zone (shopping centre), however there are limited material stockpiling on the outside where active construction is taking place.</p> | <p>Construction materials stored in the road reserve.</p> |

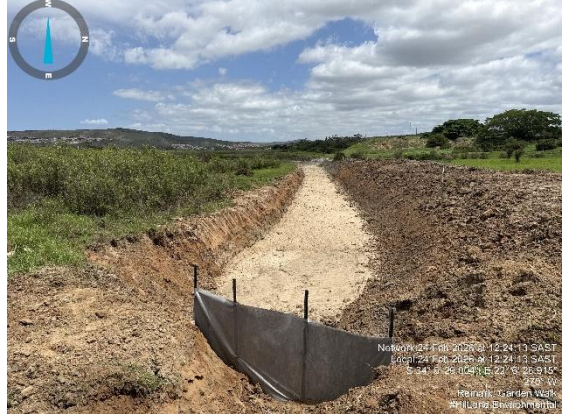
| Silt fencing must be installed at the stormwater outlet point until the site is re-vegetated and silt is no longer evident. | Ongoing | <p>Installation of the stormwater infrastructure in process. Silt trap (bidim) has been installed at the stormwater outlet point (on RE/101/217).</p> <p>The stormwater outlet (earth channel) will need to be rehabilitated with indigenous grass seed mix and “wetland” type plants.</p> <p>The southern stormwater channel has been constructed with a gabion dissipator – done.</p> | |

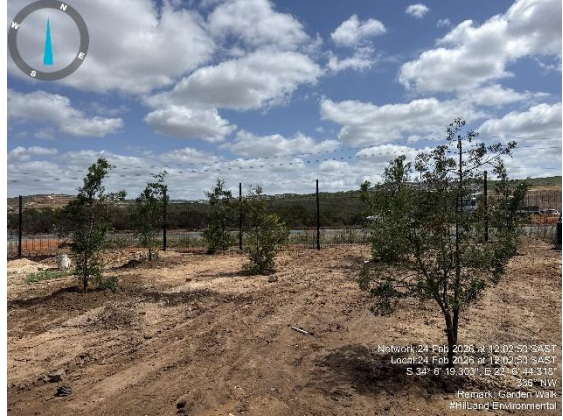
| Topsoil must be stripped to stockpile from all construction areas before work commences in that specific area.<br><br>All topsoil on the site will be stripped at least 200mm Deep, approx. 2500m <sup>3</sup> of topsoil will be retained on site for future use in the landscaping area. | DONE | Topsoil has been stripped. Only the required volume (approximately 2500m <sup>3</sup> ) of topsoil for rehabilitation and landscaping has been stockpiled. Stockpiled topsoil is being used for the rehabilitation and landscaping – currently in process.<br><br>The contractor must ensure that the topsoil stockpile is free from invasive alien plants ( <i>Datura sp.</i> ). | |

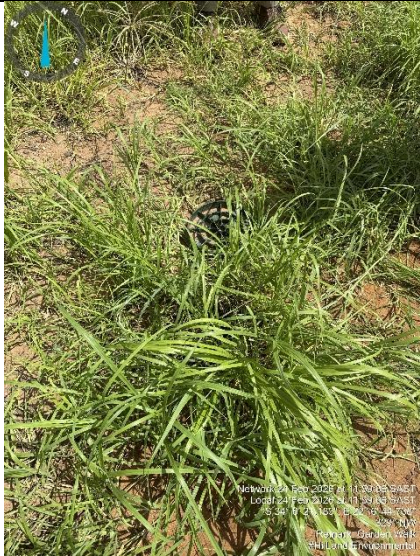
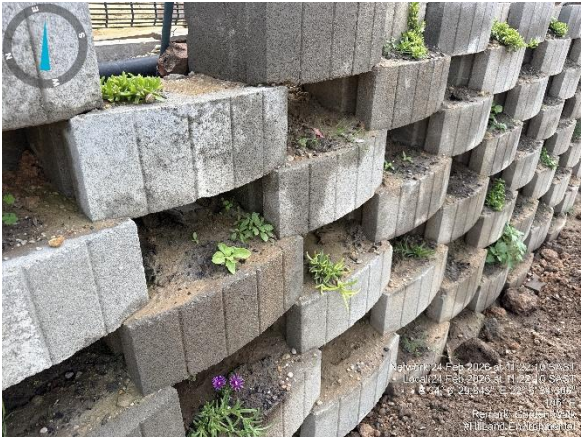
| The stockpiles must be protected against erosion including wind (vegetation can be permitted to grow on the stockpile to keep it secure and prevent wind movement. No alien invasive plants may grow on the stockpile). | Ongoing | Grass cover is allowed to grow on the stockpile – some grass cover noted.<br>The contractor must ensure that the topsoil stockpiles are free from invasive alien plants ( <i>Datura</i> sp.). | |

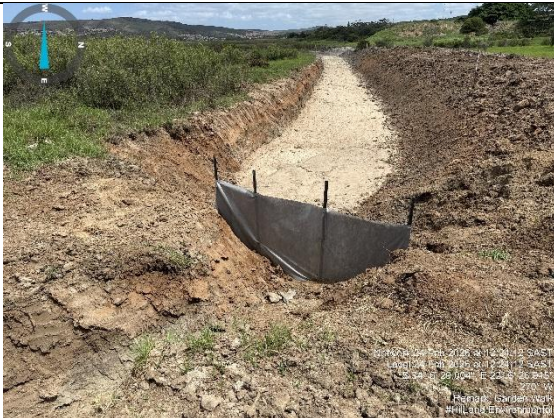
| The silt fencing needs to be installed where indicated by the ECO. | compliant | Bidim silt fence at the stormwater outlet must be maintained until the earth channel has established. | |

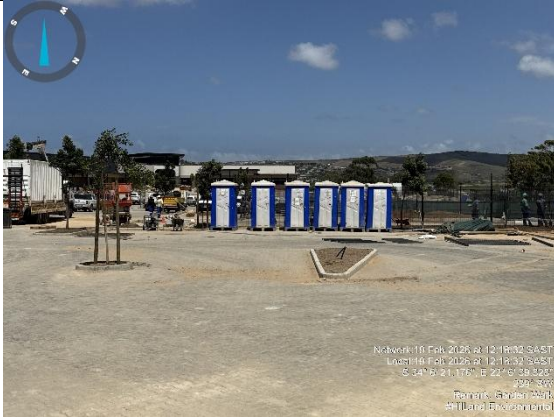
| Ablution facilities (chemical toilets) are to be provided at the campsite for use of the staff (one toilet per 15 people). | Compliant | Sufficient ablution facilities are provided on site, for Jodan Construction, MBC and shopfitters of the various shops. | |

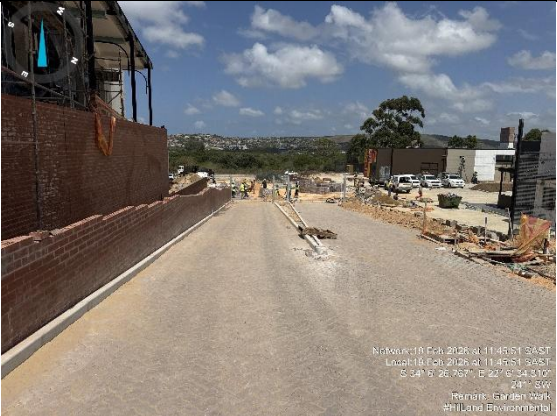
| Primary access has been approved from the MR344 (R102) at a point approximately 280m north-east of the intersection between the R102 (MR344) and DR6804. | Compliant | Controlled construction access to the site is from the R102 and SANRAL piece. | <p>Network: 18 Feb 2026 at 11:05:51 SAST<br/> Location: 18 Feb 2026 at 11:05:51 SAST<br/> S: 34° 5' 26.765" E: 22° 6' 34.510"<br/> 223: SW<br/> Remark: Garden Walk<br/> #HILand Environmental</p> |

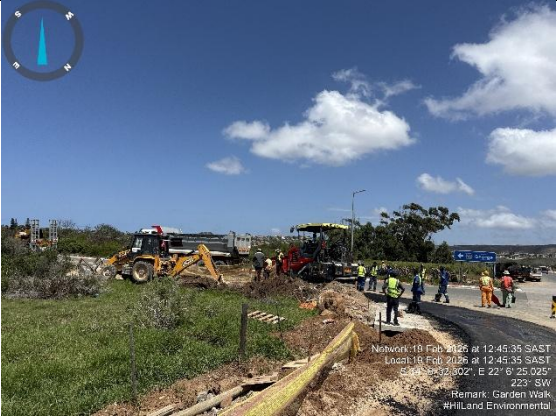
| The contractor(s) must ensure that vehicles leaving the site are clean and, wherever possible, do not deposit mud, any other earth material and concrete on the road surface. Where this is unavoidable, it must be cleaned on a daily basis and may not be permitted to enter the storm water system. | Ongoing | <p>Minimal mud deposits noted. Majority of the development area is hardened surface (paving).</p> <p>External services in process – upgrades to the existing R102 – turn lanes etc.</p> | <p>Network: 18 Feb 2026 at 12:45:35 SAST<br/> Location: 18 Feb 2026 at 12:45:35 SAST<br/> S: 34° 5' 26.765" E: 22° 6' 34.510"<br/> 223: SW<br/> Remark: Garden Walk<br/> #HILand Environmental</p> |

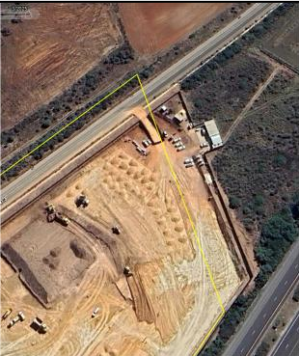
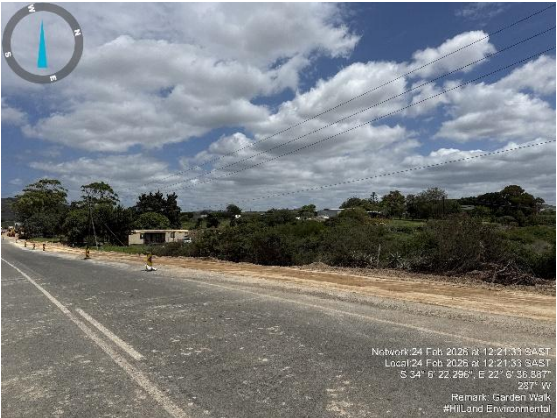
| Working Areas & Demarcation | | | |
|---|---|---|---|
| All areas outside of the property will be regarded as 'no-go' areas (except where installation of services will be required). | Ongoing | <p>The non-compliance was reported to DEADP. DEADP Law Enforcement S24G process in progress.</p> <p>R102 intersection and upgrades are in process.</p> | <div><p>Yellow line showing the cadastral boundary.</p></div> |

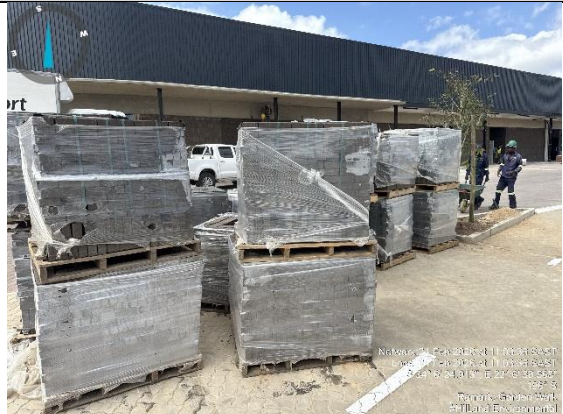
| Storage of Construction Material | | | |
|---|---|---|---|
| <p>All stockpile sites to be approved by the ECO and/or landowner, prior to the commencement of stockpiling.</p> <p>All stockpile sites within the development area are to be demarcated with silt-fences and/or danger tape, where necessary.</p> | Compliant & ongoing | <p>Main construction material stockpile area is within the demarcated zone.</p> <p>The construction material stockpile in the development zone.</p> <p>Limited construction material stockpiled outside the shopping centre for the external services (road, sewage and stormwater) – within the road reserve.</p> | |

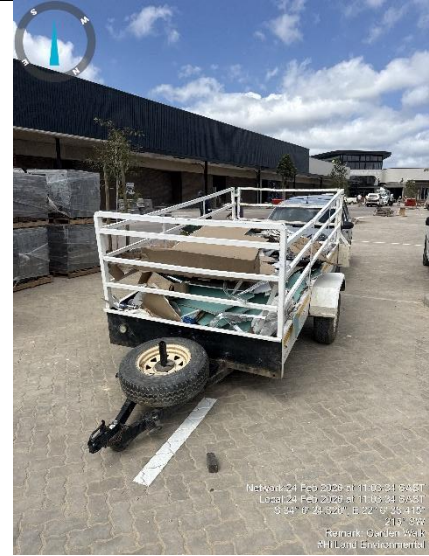
| Litter to be removed from the site on a daily basis and kept in closable bins. | Compliant & ongoing | <p>Litter noted during ECO site inspection(s) have been reported to the contractor and are actioned accordingly – this will be ongoing.</p> <p>Regular litter picking must be done, with specific focus to the shopfitter stockpile / site area (back of house)</p> | |

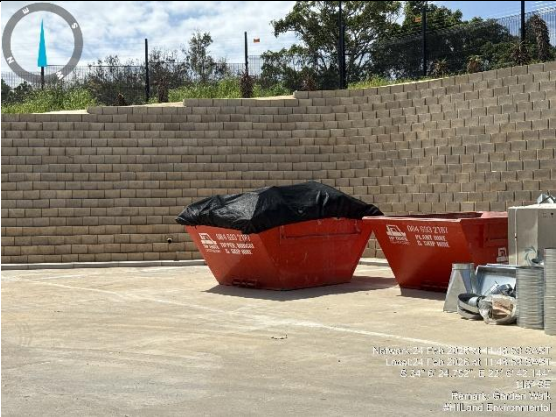
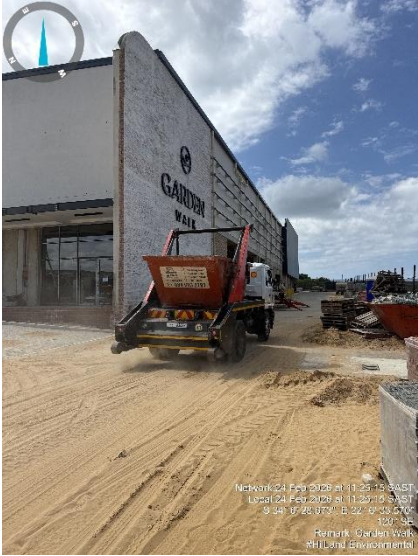
| | | Additional skips have been brought to site to try and limit littering. Skips must have a cover to prevent wind blowing litter. | |

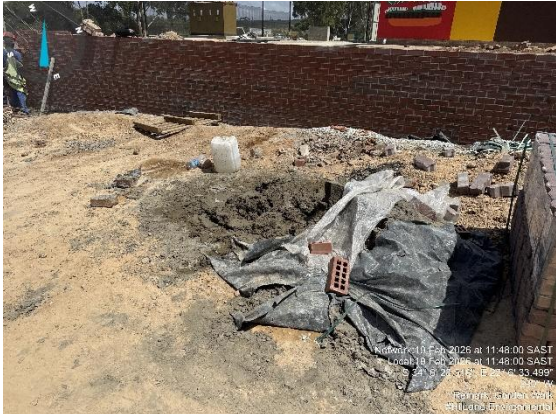
| | | with the ECO. Suitable bunding must always be in place to avoid contaminated water runoff. | <p>Plastic sheet is used as protective layer</p> |

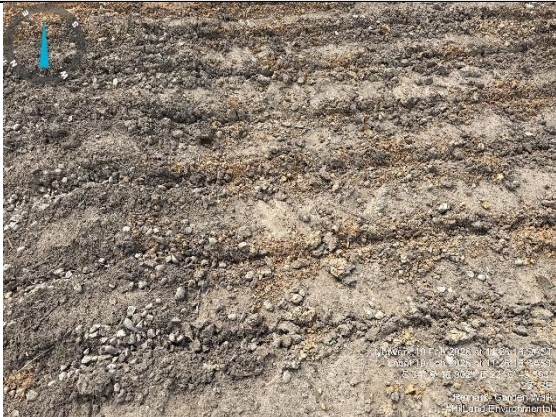
| Any damage to private property or open space areas must be reinstated to the state it was before construction commenced and must be done to the satisfaction of the landowner and ECO. | Ongoing | Refer to the non-compliance letter / comment. Rehabilitation of the area above the retaining wall will in process – refer to the ECO rehabilitation monitoring report.<br><br>MBC site camp area must still be rehabilitated: <ul style="list-style-type: none"><li>• All foreign material to be removed.</li><li>• Topsoil to be replaced (at least 300mm)</li><li>• Seed with indigenous grass seed mix.</li></ul> | |

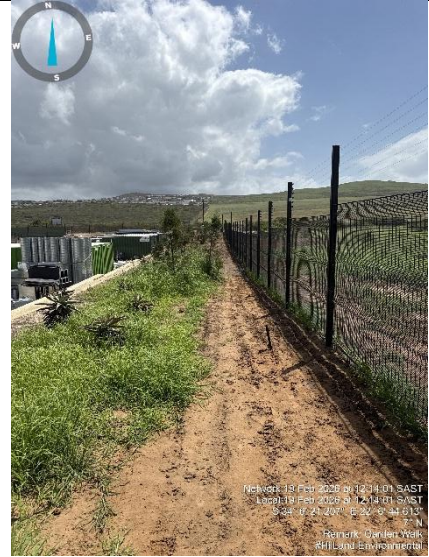
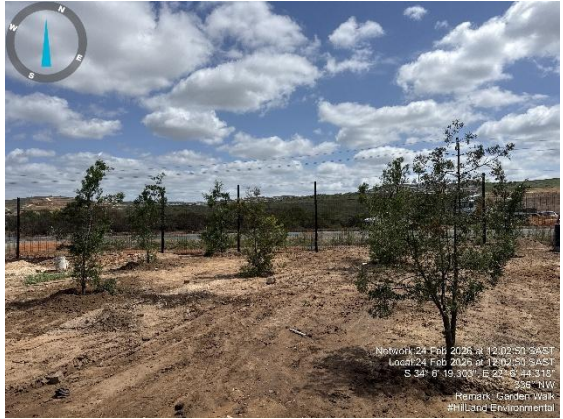
| Compacted topsoil must be raked loose. | Action required | The area above the retaining wall – phase 1 where the fibre sleeves were installed.<br>Phase 2 in the northern corner. | <p>Phase 1</p> <p>Phase 2</p> |

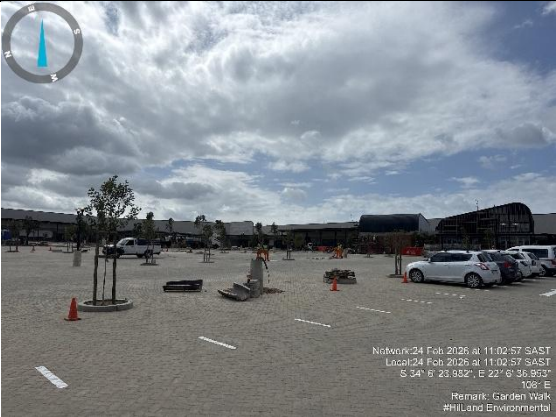
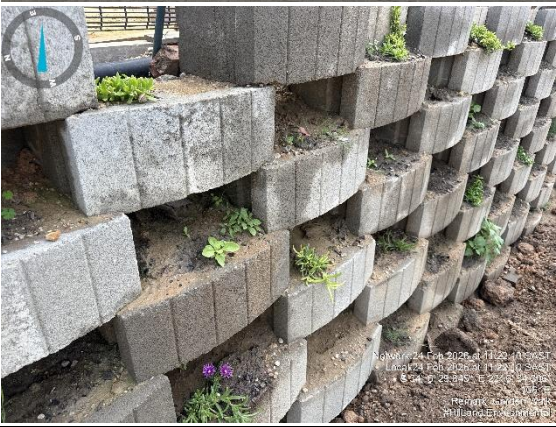
| <p>Reinstate the vegetation in accordance with the Landscape Master Plan.</p> <p>All landscaping areas to be planted and maintained.</p> | <p>Ongoing</p> | <p>Rehabilitation / revegetation of the retaining wall / embankment has been done (phase 1)<br/>– refer to the ECO rehabilitation monitoring report.</p> <p>Landscape in process.</p> | <div><p>Nakwon: 24 Feb 2026 at 11:02:57 SAST<br/>Local: 24 Feb 2026 at 11:02:57 SAST<br/>S 34° R 23.952° E 22° G 36.953°<br/>108° E<br/>Remarks: Garden Walk<br/>#Hilland Environmental</p></div> <div><p>Nakwon: 24 Feb 2026 at 11:02:57 SAST<br/>Local: 24 Feb 2026 at 11:02:57 SAST<br/>S 34° R 23.952° E 22° G 36.953°<br/>108° E<br/>Remarks: Garden Walk<br/>#Hilland Environmental</p></div> |

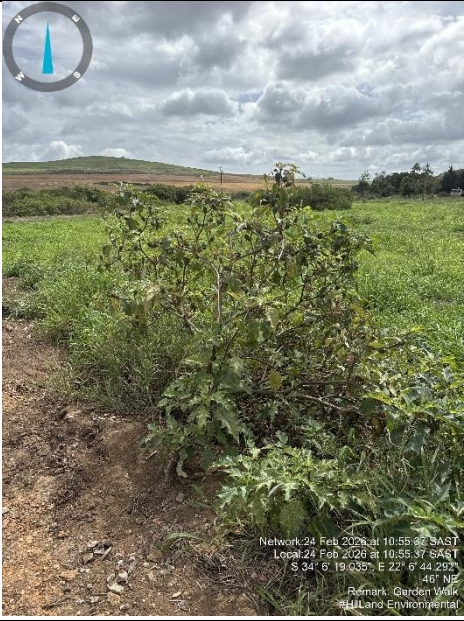
| Alien invasive vegetation to be removed | Ongoing | The contractor must ensure ongoing hand-pulling of the <i>Datura</i> plants. It is important to remove these plants before they start producing seeds and spread. | <div></div> |
