## ENVIRONMENTAL MONITORING REPORT No. 1

*The Development of the Garden Walk on the Remainder of Portion 58  
of the Farm Hartenbosch 217, Hartenbos*

**January and February 2025**

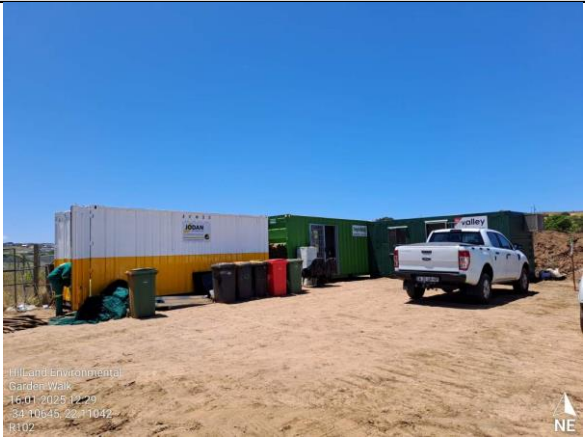
| EMPr Requirement | Level of Compliance | Comments / Findings | Photo's (if applicable) |
|---|---|---|---|
| The site camp area must be indicated and approved by the ECO. | DONE | <p>The site camp was approved by the ECO.</p> <p>Earthworks contractor: The site camp is within the fenced off development footprint.</p> <p>Building contractor: site camp situated in areas as per the approved method statement.</p> | <p>Hill and Environmental<br/>Garden Walk<br/>30.01.2025 12:29<br/>34.10635, 22.11047<br/>R102</p> <p>NE</p> <p><b>Earthworks contractor site camp</b></p> |

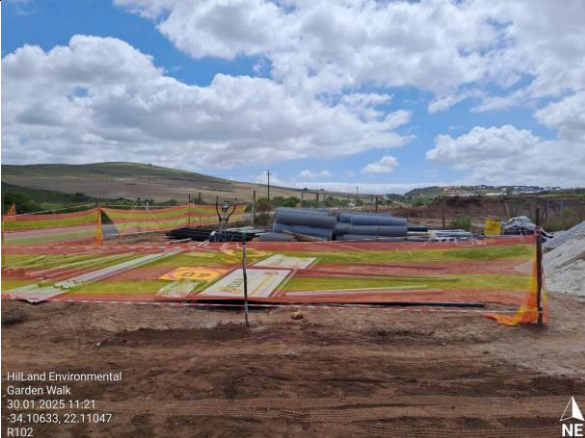
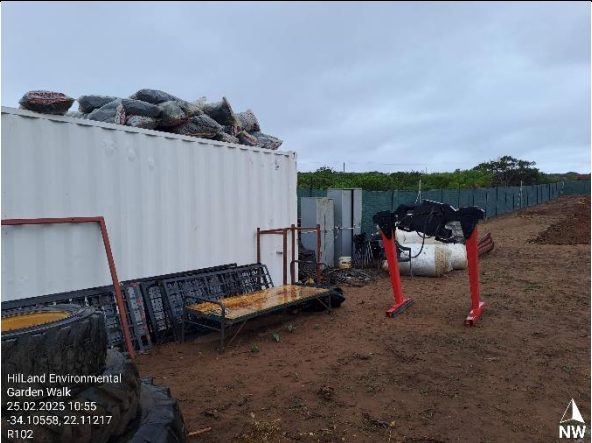
| EMPr Requirement | Level of Compliance | Comments / Findings | Photo's (if applicable) |
|---|---|---|---|
| Storage sites for construction material and access must be approved by the ECO prior to commencing (and areas will require rehabilitation after use). | Compliant | <p>All construction material is currently stored in the development footprint/site.</p> <p>Existing access to the property used.</p> <p>Access point will shift to the access as indicated on the site plan in due course.</p> | <p>Hill and Environmental<br/>Garden Walk<br/>30.01.2025 11:21<br/>34.10633, 22.11047<br/>R102</p> <p>NE</p> |

| | | | <div><p>Hilland Environmental<br/>Garden Walk<br/>25.02.2025 10:55<br/>-34.10558, 22.11217<br/>R102</p><p>NW</p></div> <p>Site camp and screen fence in place</p> |

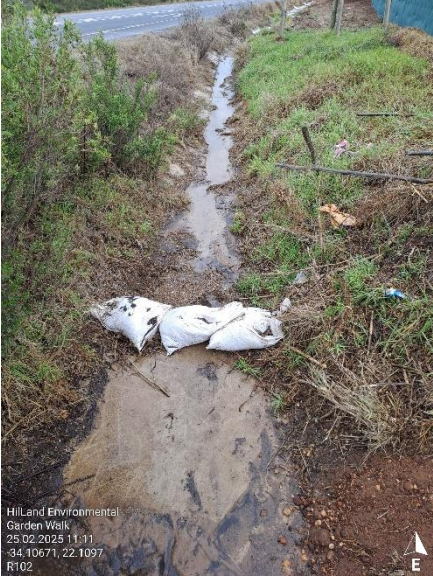
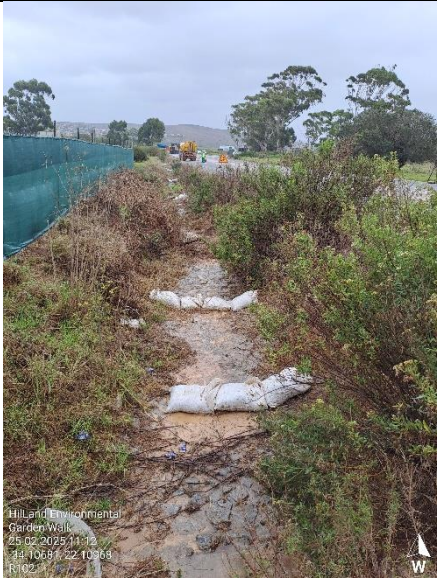
| Stormwater Management | | | | |
|---|---|---|---|--|
| <p>Silt fencing must be installed at the stormwater outlet point until the site is re-vegetated and silt is no longer evident.</p> | <p>Compliant</p> | <p>Sandbags were placed in stormwater channel of the provincial road, to capture any silt from the site. These "silt traps" are cleaned out regularly as observed on site.</p> <p>The stormwater outlet point is not yet installed.</p> | | |

| | | | <div><p>Hill and Environmental<br/>Garden Walk<br/>25.02.2025 14:12<br/>21410681 22-10868<br/>P102117721</p><p>W</p></div> <p>Sandbags in place in stormwater channels</p> |

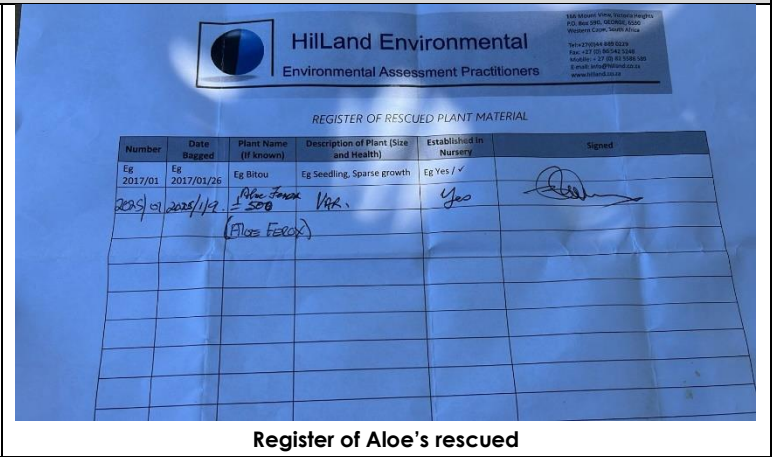
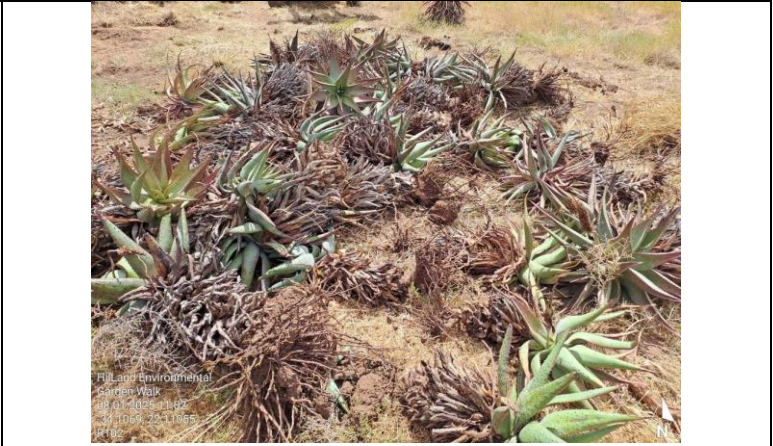
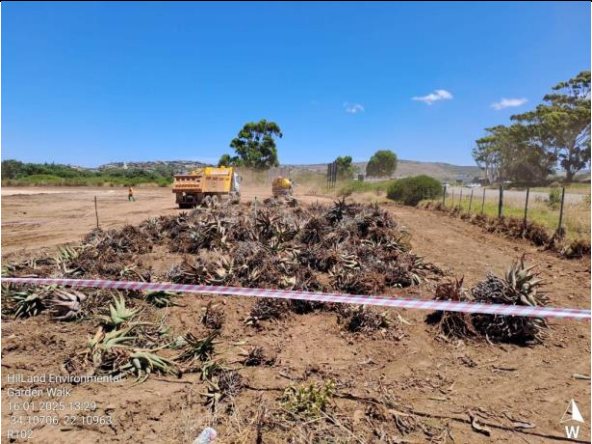
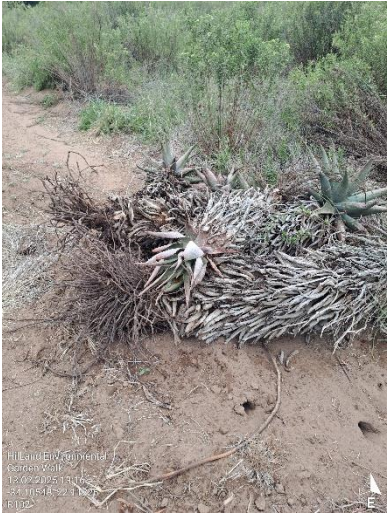
| <p>A record of the rescued plants must be kept.</p> | <p>Compliant /<br/>DONE</p> | <p>Extensive plant rescued was done prior to vegetation clearing and earthworks commenced.</p> <p>A record of plants rescued is in place:<br/>Approximately 1000 Aloes' were rescued.</p> <p>The local nursery is looking after some of the aloes that will be replanted during rehabilitation phase. Extra rescued plants were donated to neighbouring estates to use in their rehabilitation programme.</p> <p>One (1) milkwood was transplanted/rescued in accordance with the NFA permit.</p> | |
| <p>Any transplantable species (tree seedlings, shrubs, succulents, geophytes etc.) which occur within the construction areas (development footprint) should be stored in an on-site / off-site nursery for later use in the landscaping phase.</p> | <p>Compliant</p> | <p>All visible aloes were rescued /transplanted. Some of the aloes went to an off-site nursery adjacent to the property for safekeeping and to be planted into rehabilitation.</p> | |

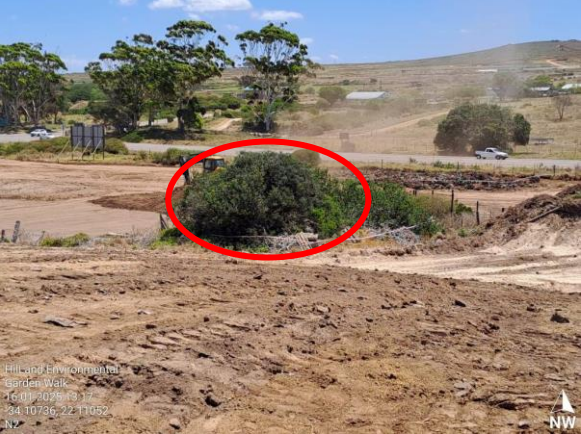
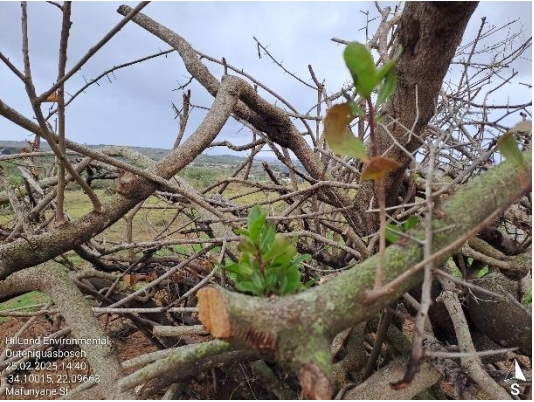
| <p>The removal, pruning, transplant and / or disturbance of the protected Milkwood tree will require a Section 15 NFA licence.</p> | <p>DONE</p> | <p>An NFA licence was obtained (licence number WC-GR-0238-2024-25) for the single Milkwood tree in the development footprint.</p> <p>The Milkwood tree was removed and transplanted in the open space in Outeniquabosch Lifestyle Village (across the R102 from the Garden Walk property).</p> | <p><b>Transplanted Milkwood already sprouting new leaves</b></p> |

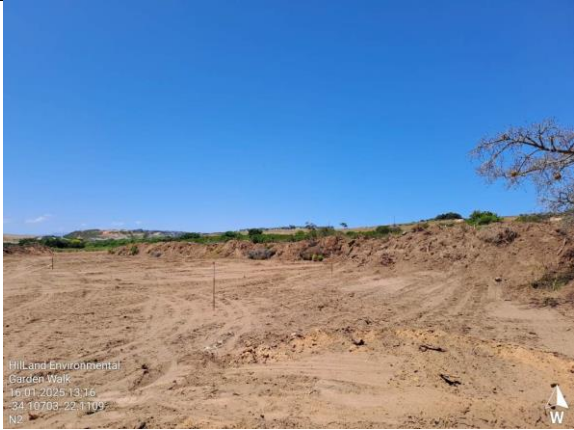
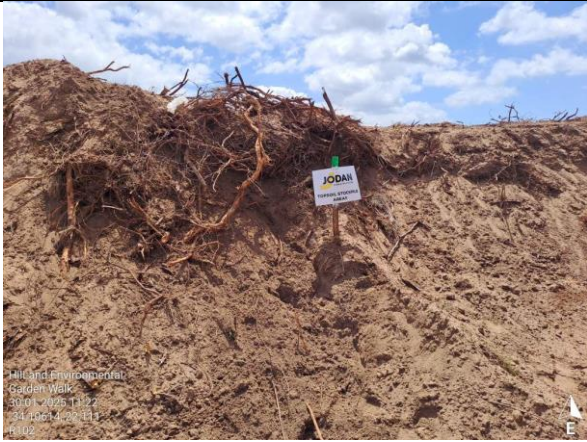
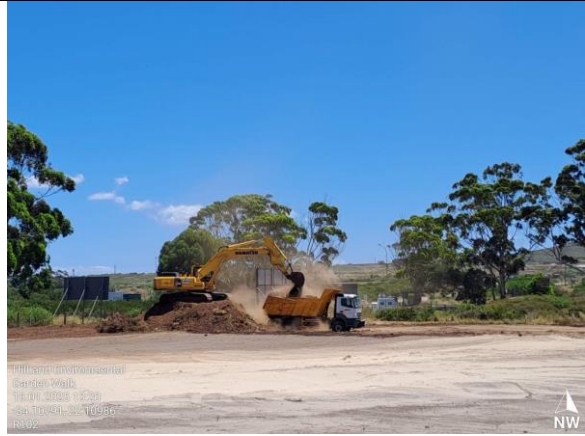
| Topsoil must be stripped to stockpile from all construction areas before work commences in that specific area. | DONE | Topsoil has been stripped. Only the required volume (approximately 2500m <sup>3</sup> ) of topsoil for rehabilitation and landscaping has been stockpiled and demarcated with signs. The excess has been removed from the site as agreed by the ECO. | |
| The topsoil must be stockpiled for use in rehabilitation and landscaping and must not be contaminated with other building materials and / or subsoil. | Compliant | The topsoil has been stockpiled for rehabilitation and landscaping and demarcated – signs. | |

| All topsoil on the site will be stripped at least 200mm Deep, 2500m <sup>3</sup> of topsoil will be retained on site for future use in the landscaping area. | Compliant | Approx. 2500m <sup>3</sup> of topsoil was stockpiled on site – the rest was removed from the site as according to the amount of topsoil required for rehabilitation and landscaping. | <p>Hill and Environmental<br/>Garden Walk<br/>06.02.2025 12:59<br/>34°6'23.27"S 22°6'37.82"E<br/>R102</p> |

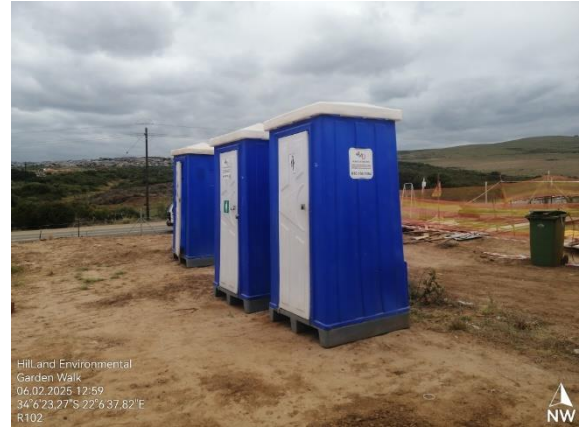
| Ablution facilities (chemical toilets) are to be provided at the campsite for use of the staff (one toilet per 15 people). | Compliant | Sufficient ablution facilities are provided on site, both for Jodan Construction and MBC. | <p>Hill and Environmental<br/>Garden Walk<br/>06.02.2025 12:59<br/>34°6'23.27"S 22°6'37.82"E<br/>R102</p> |

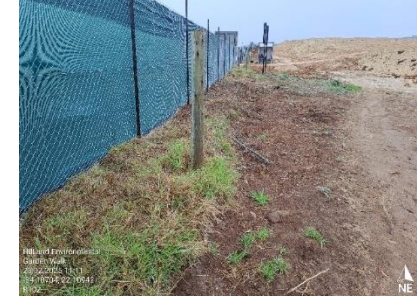
| Primary access has been approved from the MR344 (R102) at a point approximately 280m north-east of the intersection between the R102 (MR344) and DR6804. | Compliant | Controlled access to the site is from the R102. | <p>Heritage Environmental<br/>Garden Walk<br/>28.02.2025 11:11<br/>24.106422, 18.641<br/>10205 - 21.01.2025</p> <p>NE</p> <p><b>Controlled access</b></p> |

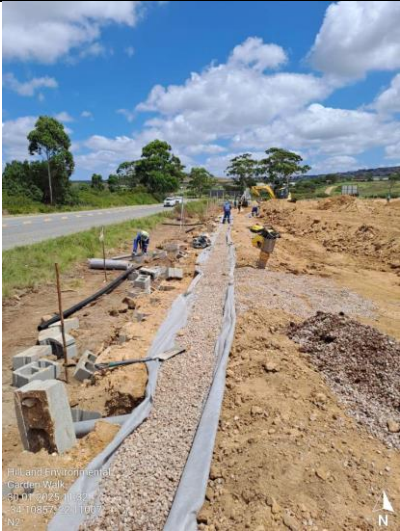
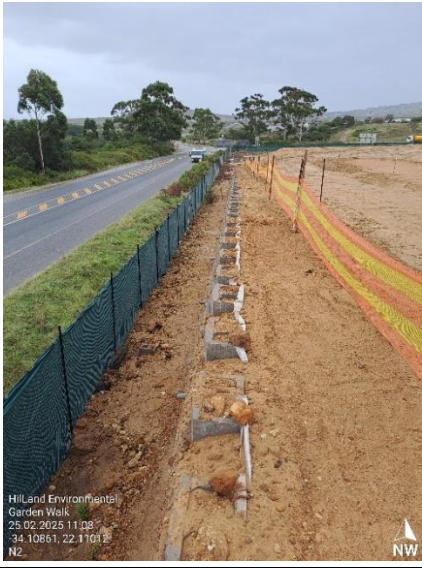
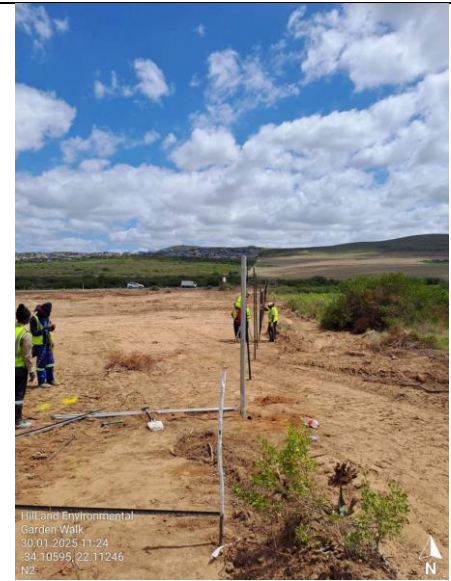
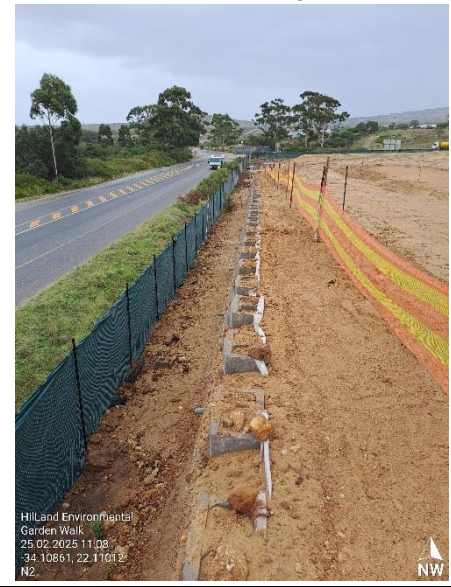
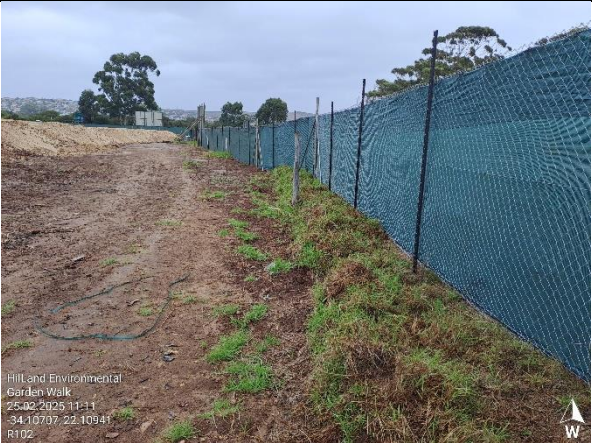
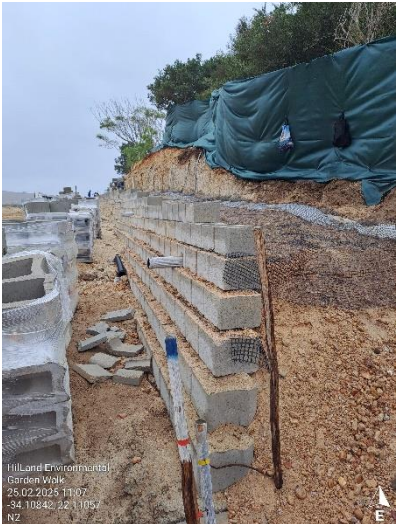
| <p>No-Go areas will be required to be demarcated by the contractor to ensure that they are visible at all times, to all personnel.</p> | <p>Compliant</p> | <p>The working area (development site) is being demarcated with a 1.8m wire fence and shade netting.</p> | <div data-bbox="1494 193 1892 726"><p>HillLand Environmental<br/>Garden Walk<br/>25.02.2025 11:08<br/>34.10861, 22.11012<br/>N</p></div> <div data-bbox="1482 729 1901 1299"><p>HillLand Environmental<br/>Garden Walk<br/>25.02.2025 11:08<br/>34.10861, 22.11012<br/>NW</p></div> |

| <p>The total footprint of a building zone / phase should be demarcated with 1.5 m (height) shade cloth for the entire period of the construction.</p> | <p>Compliant</p> | <p>The development zone is demarcated with a 1.8m wire fence and shade netting.</p> | <div data-bbox="1464 191 1912 774"> <p>Hilland Environmental<br/>Garden Walk<br/>30.01.2025 11:24<br/>34.10995, 22.11246<br/>N2</p> </div> <p><b>Installation in progress</b></p> <div data-bbox="1464 805 1912 1393"> <p>Hilland Environmental<br/>Garden Walk<br/>25.02.2025 11:08<br/>34.10861, 22.11013<br/>N2</p> </div> |

| | | | <div><p>HillLand Environmental<br/>Garden Walk<br/>25.02.2025 11:11<br/>34.10702 22.10941<br/>R102</p></div> <p>Site clearly demarcated</p> <div><p>HillLand Environmental<br/>Garden Walk<br/>25.02.2025 11:07<br/>34.10842 22.11057<br/>NZ</p></div> <p>Retaining wall construction in progress with demarcation of working zone</p> |

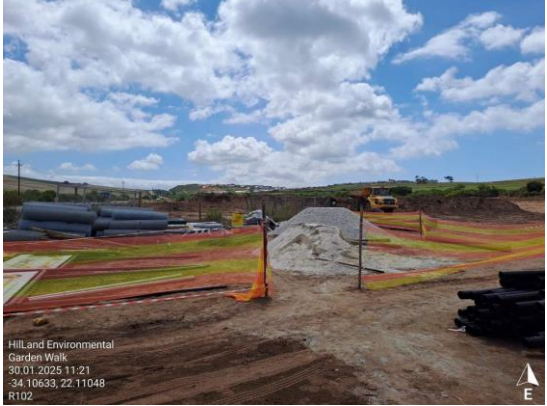
| Storage of Construction Material | | | |
|---|---|---|---|
| All stockpile sites within the development area are to be demarcated with silt-fences and/or danger tape, where necessary. | Compliant & ongoing | The construction material stockpile in the development zone is demarcated with orange netting fencing. | |

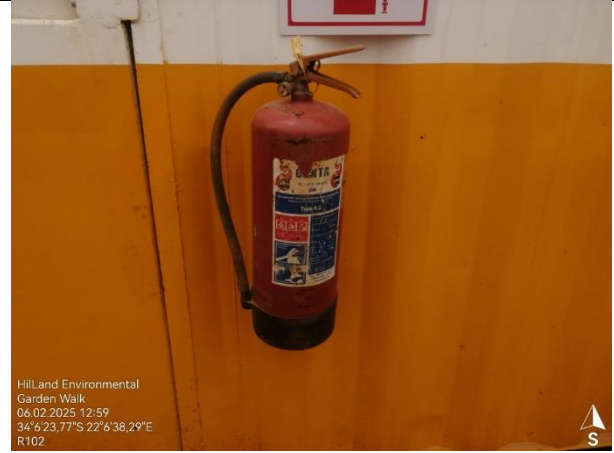
| No open fires or naked flames for heating or cooking shall be allowed anywhere on site. | Compliant | No open fires or naked flames have been noted on site. Firefighting equipment is available on site. | <p>HillLand Environmental<br/>Garden Walk<br/>06.02.2025 12:59<br/>34°6'23.77"S 22°6'38.29"E<br/>R102</p> <p><b>Firefighting equipment is in place</b></p> |

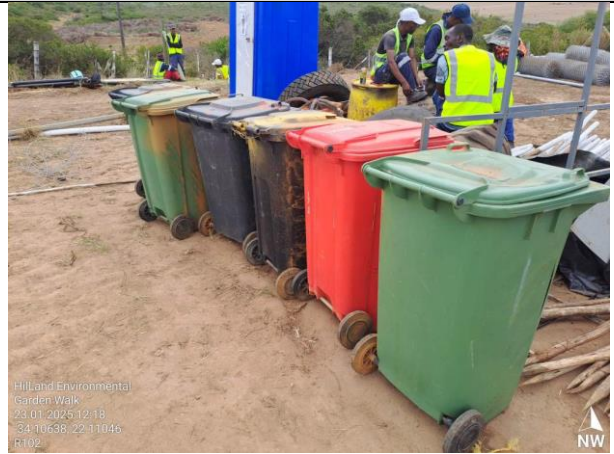
| A dedicated area must be created within the campsite for refuse and waste management. | Compliant | A dedicated waste area is in the site camp. | <p>HillLand Environmental<br/>Garden Walk<br/>23.01.2025 12:18<br/>34°10'38.22"S 110°46'<br/>R102</p> |

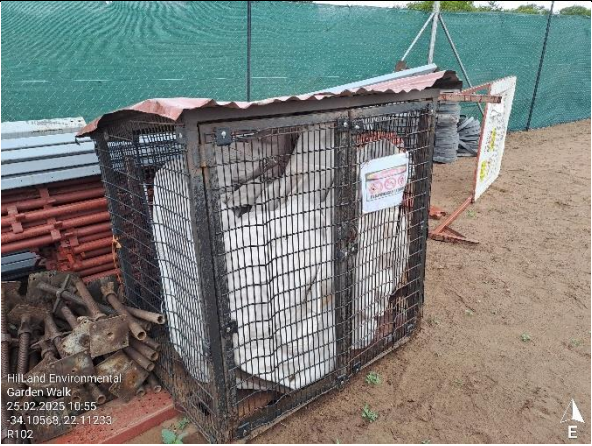
| Disposal of all waste materials must be done at suitable facilities. No dumping of any waste material on or off-site is permitted. | Compliant | No dumping noted during the ECO site inspections. | <p>Hazardous material storage area</p> |

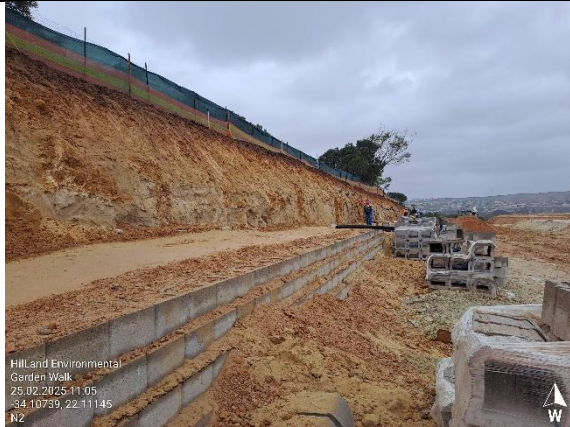
| Litter to be removed from the site on a daily basis and kept in closable bins. | Compliant & ongoing | Limited to no litter noted during ECO site inspections. Regular litter picking is done. | <p>Hill and Environmental<br/>Garden Walk<br/>25.02.2025 11:05<br/>-34.10739, 22.11145<br/>N2</p> <p>Site is free of litter</p> |

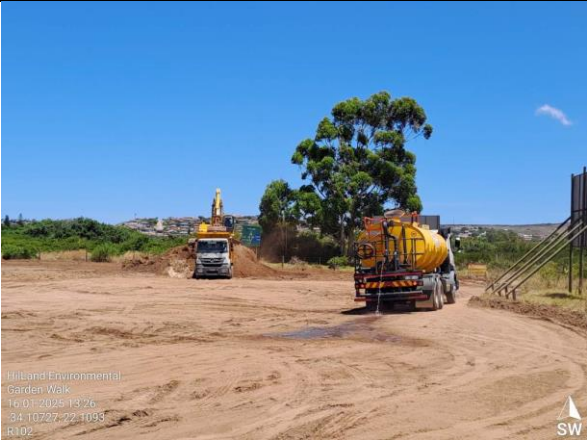
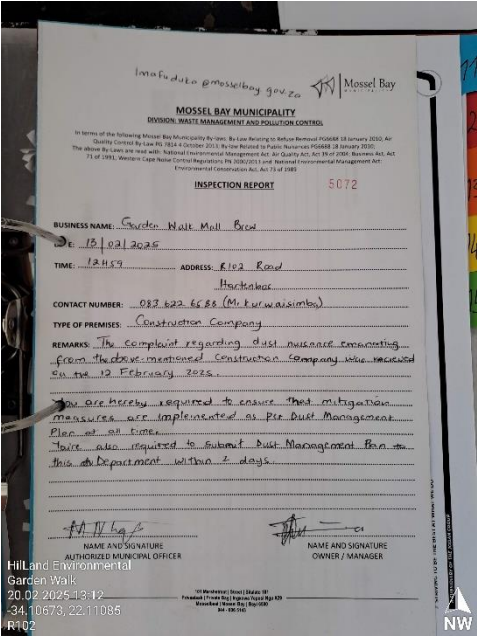
| <p>Dust mitigation measures should be implemented as required.</p> | <p>ongoing</p> | <p>Dust complaint(s) are recorded in environmental file. Regular dust suppression is done – watering exposed areas.</p> <p>Excessive wind on 12 February 2025 has resulted in dust nuisance. A dust nuisance complaint was received, and Municipal inspection was done on 13 February 2025 – dust mitigation record sheet is kept in the environmental file.</p> | <div data-bbox="1402 193 1986 635"><p>Hilland Environmental<br/>Garden Walk<br/>16.01.2025 13:26<br/>34.10727, 22.1093<br/>R102</p></div> <div data-bbox="1456 671 1930 1310"><p>Municipal inspection report</p></div> |

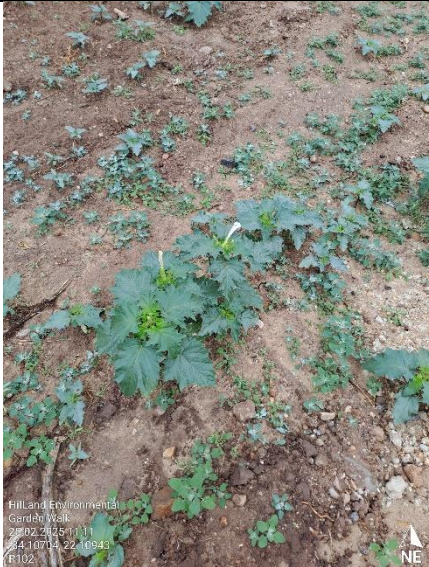
| Alien invasive vegetation to be removed | Ongoing | The contractor must ensure ongoing hand-pulling of the <i>Datura</i> plants – ECO can assist with identification if required. It is important to remove these plants before they start producing seeds and spread. | <div><p>Fulland Environmental<br/>Gordon Walk<br/>28/02/2025 11:11<br/>64-10704 22-10943<br/>B102</p><p>NE</p></div> <p>Alien vegetation within disturbed areas to be hand-pulled</p> |
