## ENVIRONMENTAL MONITORING REPORT No. 2

*The Development of the Garden Walk on the Remainder of Portion 58  
of the Farm Hartenbosch 217, Hartenbos*

**Report period: March 2025**

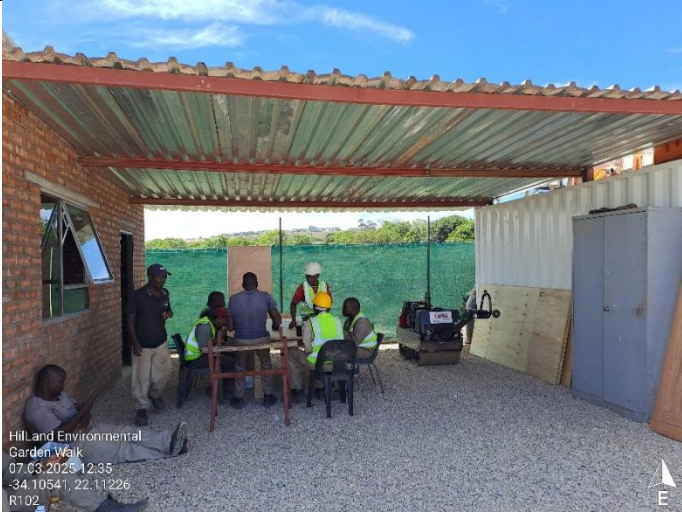
| EMPr Requirement | Level of Compliance | Comments / Findings | Photo's (if applicable) |
|---|---|---|---|
| The site camp area must be indicated and approved by the ECO. | DONE | <p>The site camp was approved by the ECO.</p> <p>Earthworks contractor: The site camp is within the fenced off development footprint.</p> <p>Building contractor: site camp situated in areas as per the agreed method statement – see attached.</p> | <p><b>Dedicated eating area</b></p> |

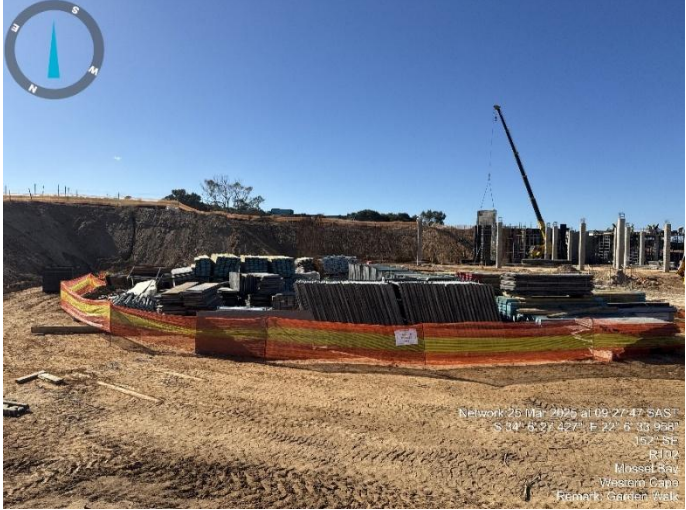
| <p>Storage sites for construction material and access must be approved by the ECO prior to commencing (and areas will require rehabilitation after use).</p> | <p>Compliant</p> | <p>All construction material is currently stored in the development site.</p> <p>Construction access is directly off of R102 to the construction site.</p> <p>Access point will shift to the access as indicated on the site plan in due course.</p> | <p><b>Demarcation of construction materials</b></p> |

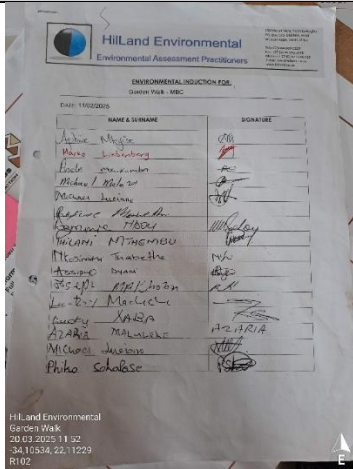
| <p>All construction staff should be briefed by the ECO/DEO in an environmental education programme.</p> | <p>Compliant</p> | <p>Environmental induction was done with all staff on site on 16 January 2024 (Jordan construction).</p> <p>Induction was done with the main contractor (MBC) management team done on 11 February 2025.</p> <p>DEO does inductions with new staff as they arrive on site.</p> | <p><b>Induction done with MBC</b></p> |

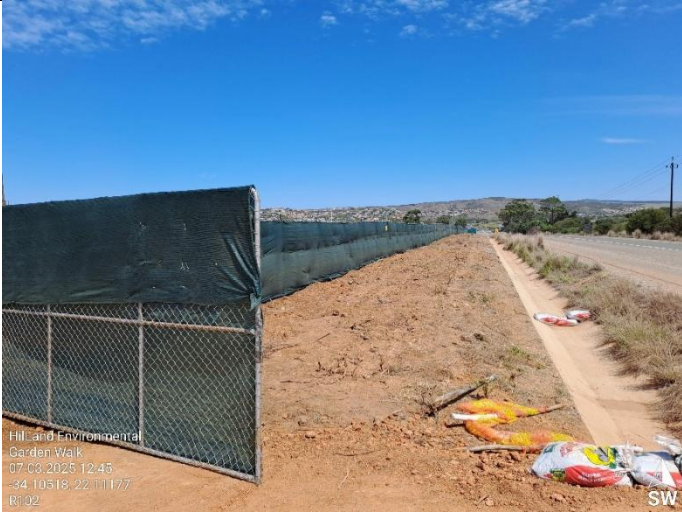
| Silt fencing must be installed at the stormwater outlet point until the site is re-vegetated and silt is no longer evident. | Compliant | <p>Sandbags were placed in existing stormwater channel of the provincial road, to capture any silt from the site. These "silt traps" are cleaned out regularly as observed on site.</p> <p>The stormwater outlet point is not yet installed.</p> <p><i>All low points must be regularly inspected for possible stormwater movement. In the case where there is stormwater movement, the contractor will be required to install erosion protection (bidim silt fence(s) or sandbags).</i></p> | <p style="text-align: center;"><b>Sandbags in place in stormwater channels</b></p> |

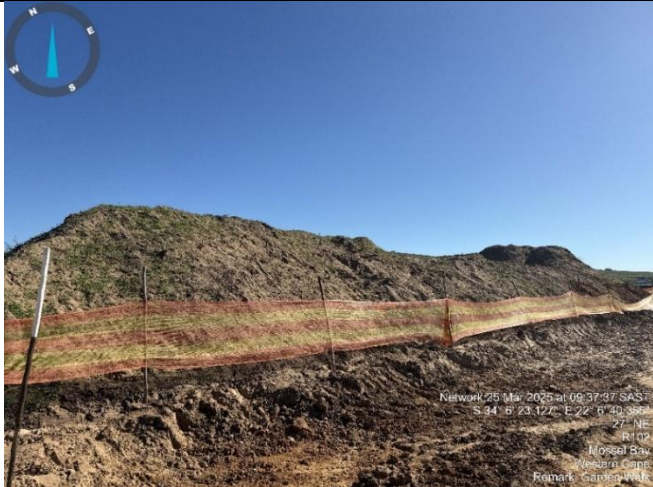
Demarcation of topsoil stockpile

| Topsoil must be stripped to stockpile from all construction areas before work commences in that specific area. | DONE | Topsoil has been stripped. Only the required volume (approximately 2500m <sup>3</sup> ) of topsoil for rehabilitation and landscaping has been stockpiled and demarcated with signs. The excess has been removed from the site as agreed by the ECO.<br><br>The contractor must ensure that the topsoil stockpile is free from invasive alien plants ( <i>Datura sp.</i> ). | |
| The topsoil must be stockpiled for use in rehabilitation and landscaping and must not be contaminated with other building materials and / or subsoil. | Compliant | The topsoil has been stockpiled for rehabilitation and landscaping and demarcated – signs. | |

| The stockpiles must be protected against erosion including wind (vegetation can be permitted to grow on the stockpile to keep it secure and prevent wind movement. No alien invasive plants may grow on the stockpile). | Ongoing | Grass cover is allowed to grow on the stockpile.<br><br>The contractor must ensure that the topsoil stockpile is free from invasive alien plants ( <i>Datura sp.</i> ). | |

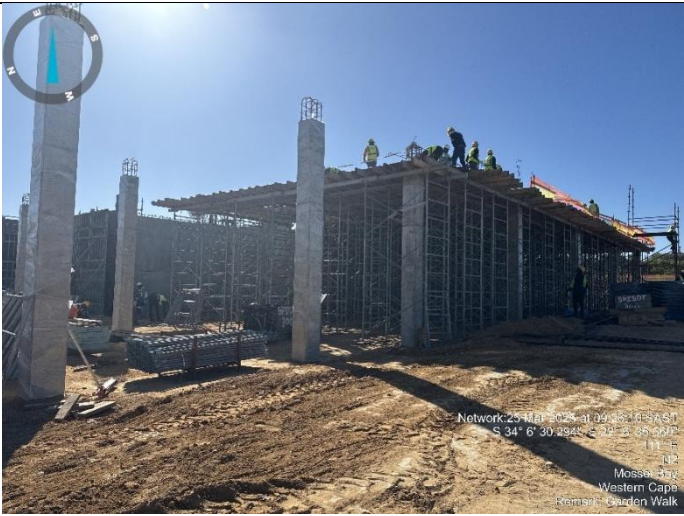
| No bare or exposed areas are to be left for a period of more than 2 months. | Ongoing | Clearing of the entire site was done and construction is in progress. | <p>Network 25-1262-14 at 09:48:16 (S10 S 34° 6' 30.2945\" data-bbox="598 408 902 732"/&gt; <p>Construction in progress</p> </p> |

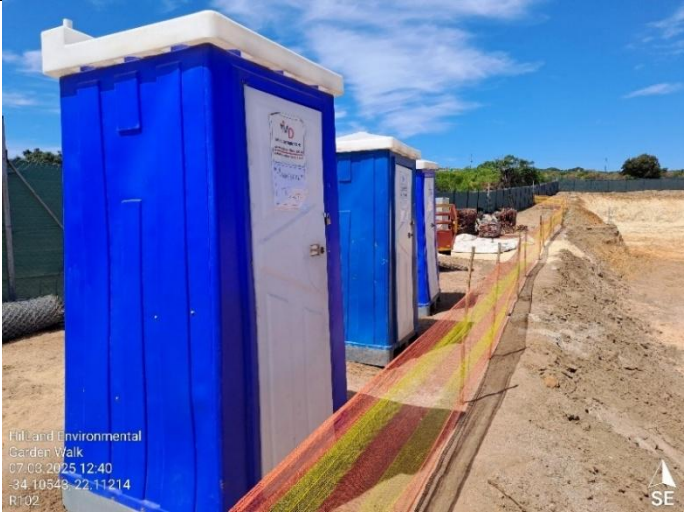
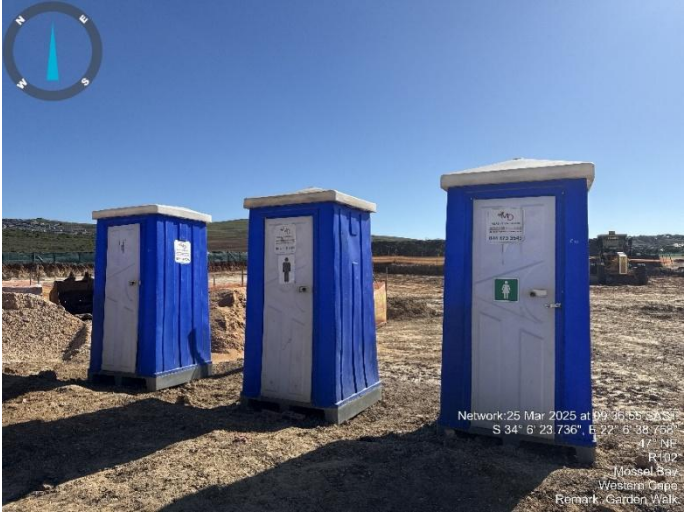
| Ablution Facilities | | | |
|---|---|---|---|
| <p>Ablution facilities (chemical toilets) are to be provided at the campsite for use of the staff (one toilet per 15 people).</p> | <p>Compliant</p> | <p>Sufficient ablution facilities are provided on site, both for Jodan Construction and MBC.</p> | <div> </div> <p>Sufficient ablution facilities provided (both male and female)</p> |

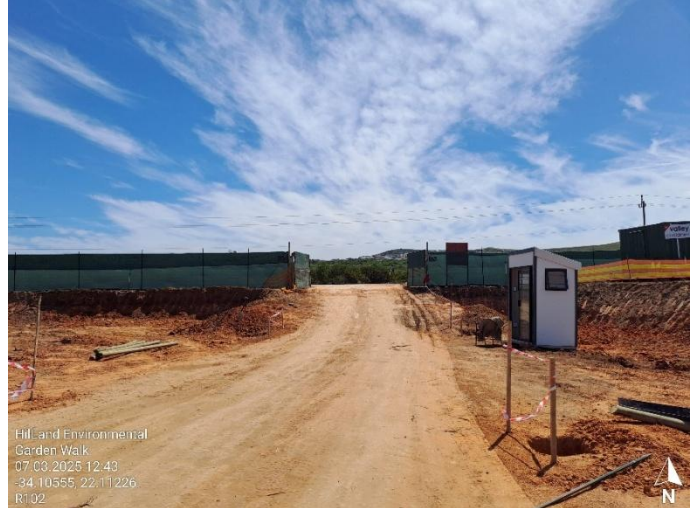
| Primary access has been approved from the MR344 (R102) at a point approximately 280m north-east of the intersection between the R102 (MR344) and DR6804. | Ongoing | Controlled construction access to the site is from the R102. | <p>Hill and Environmental<br/>Garden Walk<br/>07/03/2025 12:43<br/>-34.10355, 22.11226<br/>R102</p> <p><b>Controlled access</b></p> |

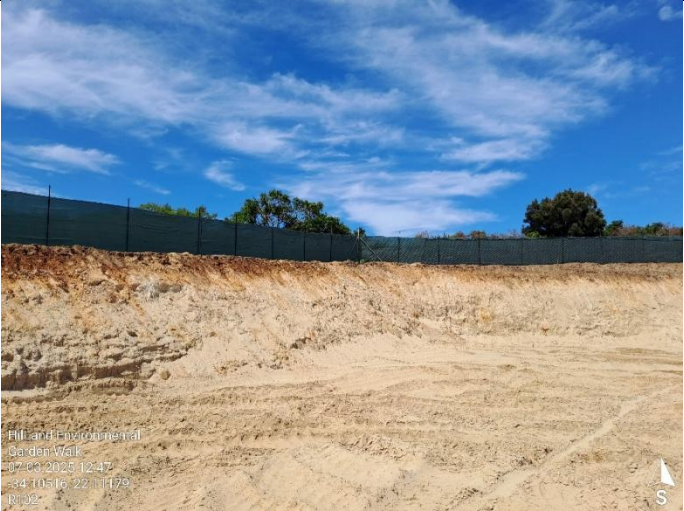
| <p>No-Go areas will be required to be demarcated by the contractor to ensure that they are visible at all times, to all personnel.</p> | <p>Compliant</p> | <p>The working area (development site) is demarcated with a 1.8m wire fence and shade netting.</p> | <div data-bbox="1326 194 2007 707"> <p>HillLand Environmental<br/>Garden Walk<br/>07.03.2025 12:47<br/>34.10516, 22.11179<br/>N2</p> </div> <p>Demarcation of the working zone with green shade netting</p> |

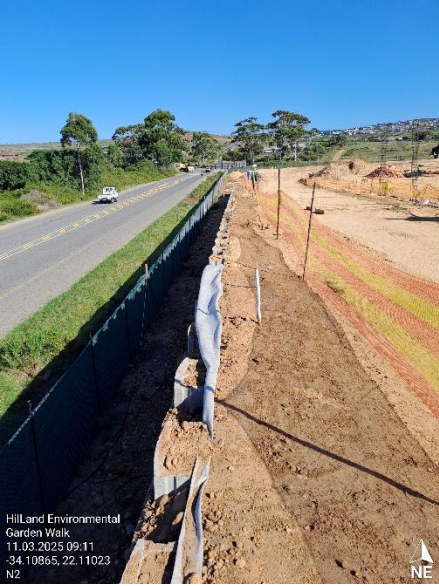
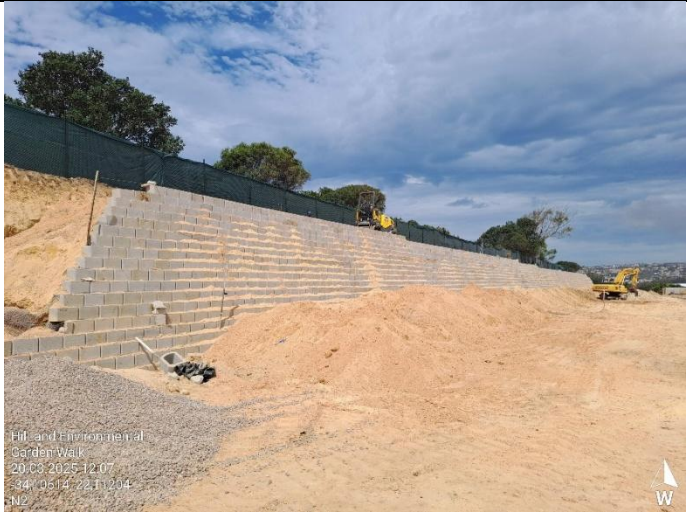
| <p>The total footprint of a building zone / phase should be demarcated with 1.5 m (height) shade cloth for the entire period of the construction.</p> | <p>Compliant</p> | <p>The development zone is demarcated with a 1.8m wire fence and shade netting.</p> | <div data-bbox="1447 746 1883 1334"> <p>HillLand Environmental<br/>Garden Walk<br/>11.03.2025 09:11<br/>34.10865, 22.11023<br/>N2</p> </div> |

| | | | <p>Shade net demarcation in place</p> |

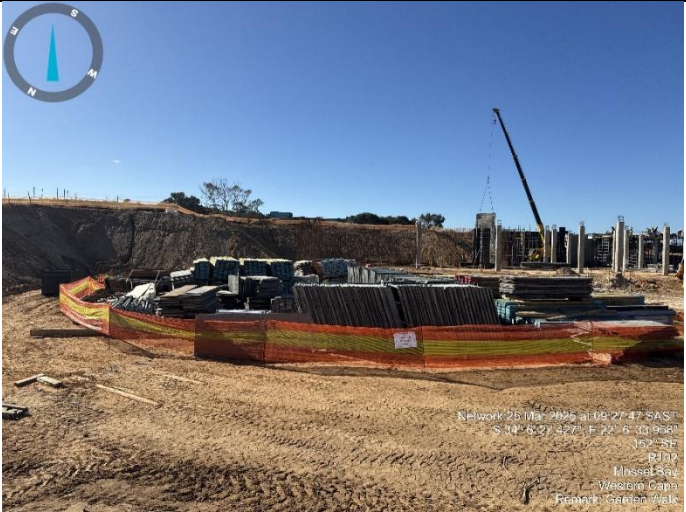
| | | | <p>Shade net demarcation in place</p> |
|---|---|---|---|
| All stockpile sites within the development area are to be demarcated with silt-fences and/or danger tape, where necessary. | Compliant & ongoing | The construction material stockpile in the development zone is demarcated with orange netting fencing. | <p>Demarcation of material storage within the working zone</p> |

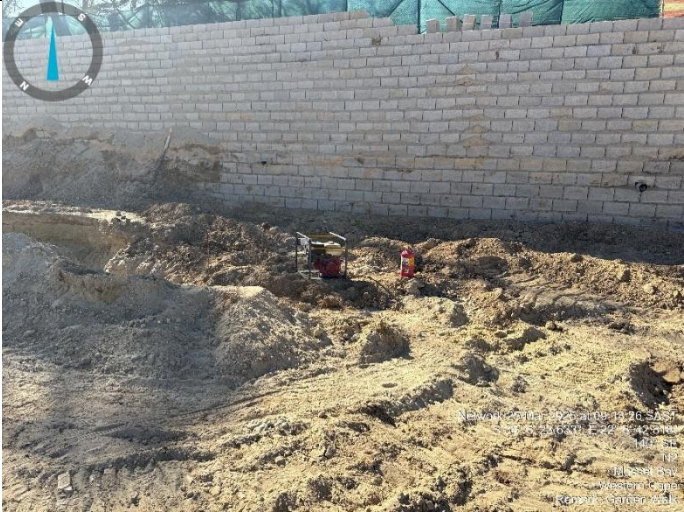
| Fire Protection | | | |
|---|---|---|---|
| Cigarettes may not be disposed of onsite and must be disposed of properly in receptacles for this purpose. | Ongoing | No environmental issues noted. | <p>Firefighting equipment is in place where it is required. Above image shows operating generator with fire extinguisher at hand</p> |

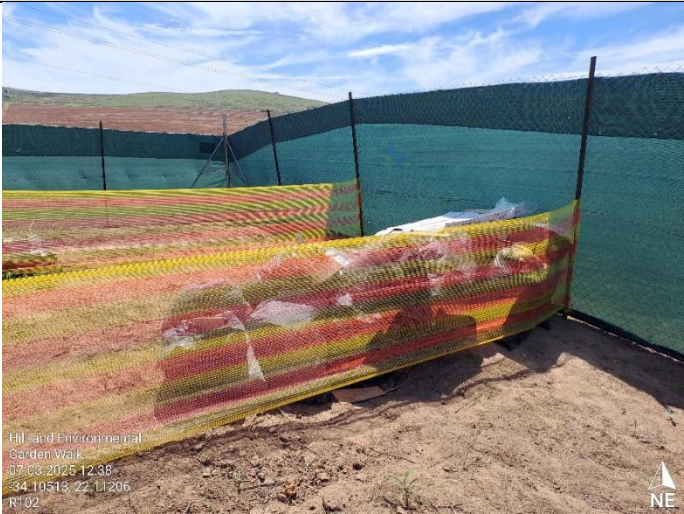
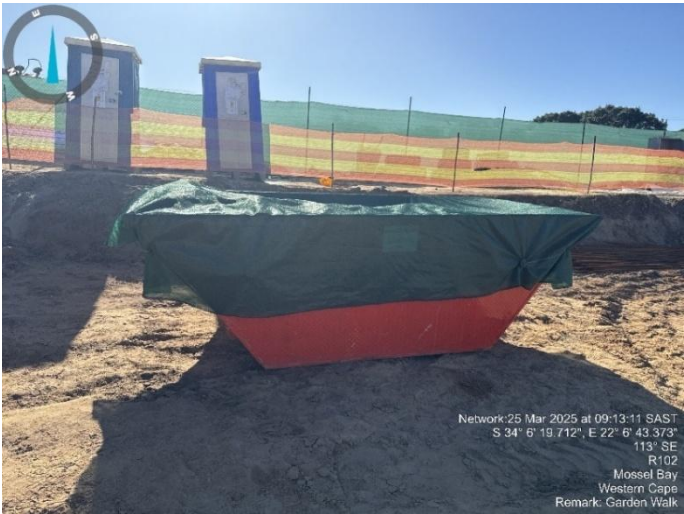
| Waste Management | | | |
|---|---|---|---|
| <p>A dedicated area must be created within the campsite for refuse and waste management.</p> | <p>Compliant</p> | <p>A dedicated waste area is in the site camp.</p> | <div><p>Demarcation of waste (in closed bags)</p><p>Skips remain in place</p></div> |

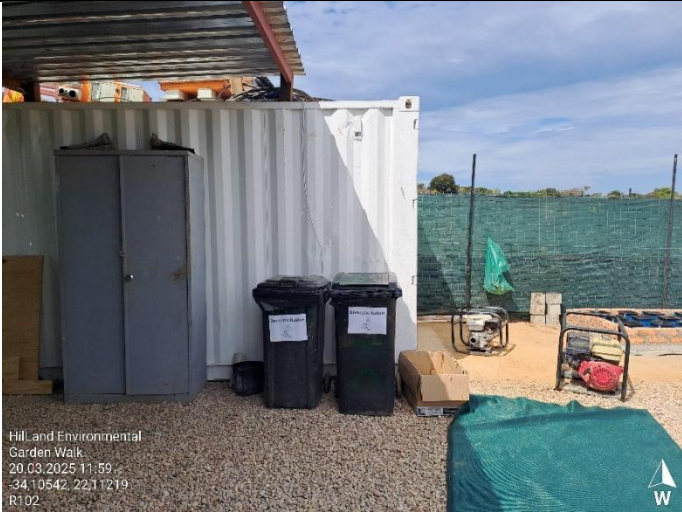
| | | | <p>Hill and Environmental<br/>Garden Walk<br/>20.03.2025 11:59<br/>-34.10542 22.11219<br/>R102</p> <p><b>Bins provided at site camp</b></p> |

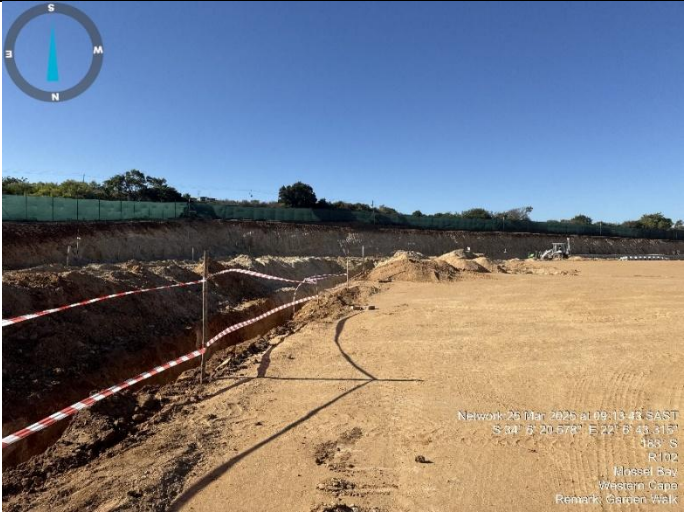
| <p>Litter to be removed from the site on a daily basis and kept in closable bins.</p> | <p>Compliant &amp; ongoing</p> | <p>Limited to no litter noted during ECO site inspections. Regular litter picking is done.</p> | <p>Site is free of litter</p> |

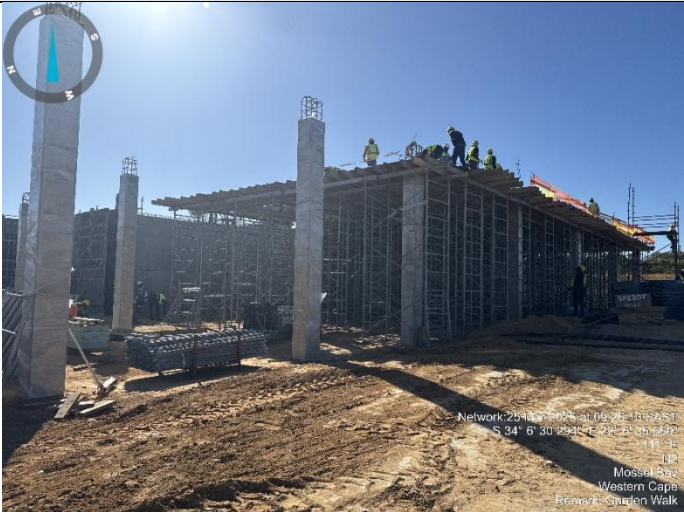
| <p>Any concrete batching plant areas are to be approved by the ECO prior to utilisation.</p> | <p>Ongoing</p> | <p>Mixing are being done within development footprint and as agreed with the ECO. Suitable bunding must always be in place to avoid contaminated water runoff.</p> | <p>Ready-mix and concrete pump is used for the bulk concrete works</p> |

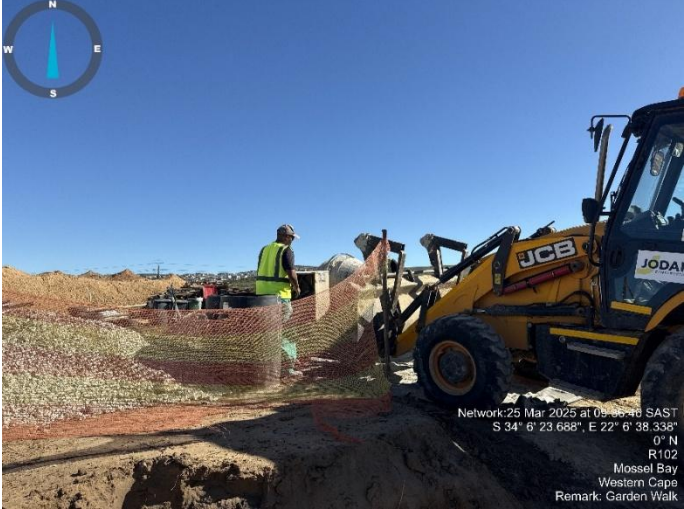
| | | | <p><b>Small cement mixing done in the construction site</b></p> |

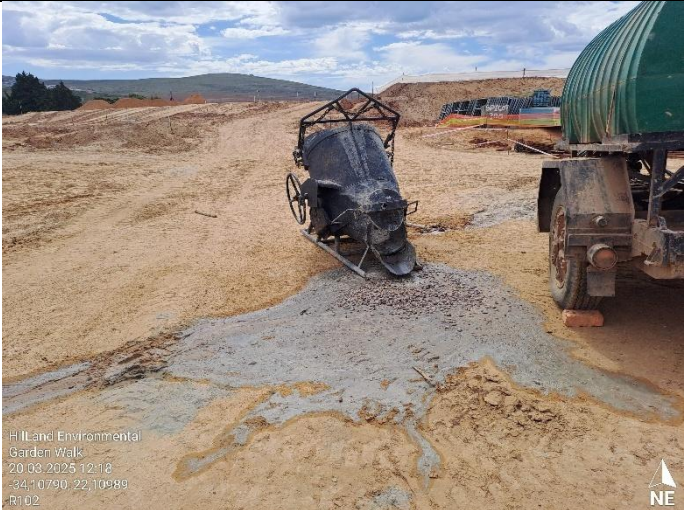
| Any spillage is to be immediately cleaned by the responsible contractor / supplier / owner. | Ongoing | Spill was reported to the site foreman and cleaned up. | |

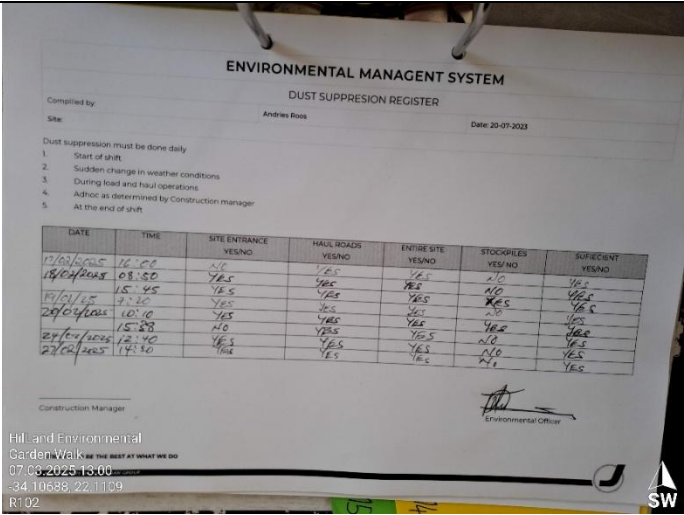
| Dust mitigation measures should be implemented as required. | Ongoing | Dust nuisance complaint(s) are recorded in environmental file. Regular dust suppression is done – watering exposed areas and dust mitigation record sheet is kept in the environmental file. | <p>Dust suppression register being kept up to date</p> |
