## ENVIRONMENTAL MONITORING REPORT No. 4

*The Development of the Garden Walk on the Remainder of Portion 58  
of the Farm Hartenbosch 217, Hartenbos*

**May 2025**

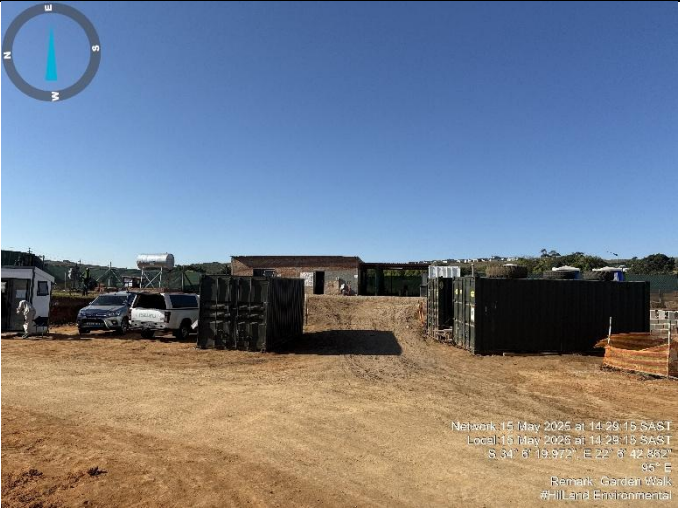
| EMPr Requirement | Level of Compliance | Comments / Findings | Photo's (if applicable) |
|---|---|---|---|
| The site camp area must be indicated and approved by the ECO. | DONE | <p>The site camp method statement (MBC) was approved by the ECO.</p> <p>Civil contractor: The site camp is within the fenced off development footprint.</p> | <p>Civil contractor site camp</p> |

| | | | <div data-bbox="1339 193 2016 703"> <p>Network: 15 May 2025 at 14:29:15 SAST<br/> Local: 15 May 2025 at 14:29:15 SAST<br/> S 34° 6' 19.972" E 22° 6' 42.562"<br/> 96° E<br/> Remark: Garden Walk<br/> #HillLand Environmental</p> </div> <div data-bbox="1525 710 1830 735" data-label="Caption"> <p><b>Building contractor site camp</b></p> </div> |

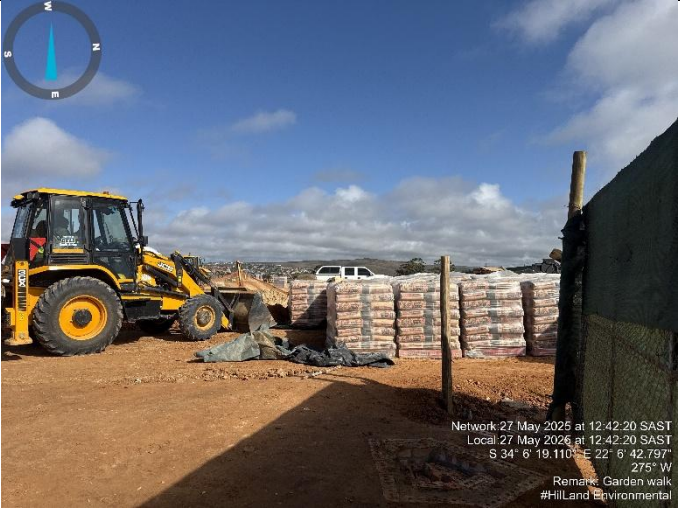
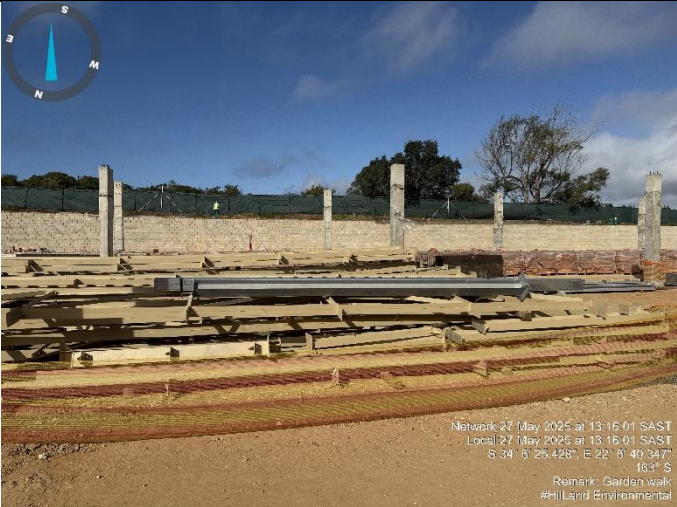
| <p>Storage sites for construction material and access must be approved by the ECO prior to commencing (and areas will require rehabilitation after use).</p> | <p>Compliant</p> | <p>All construction material is currently stored in the development site.</p> <p>Construction access is directly off the R102 to the construction site.</p> <p>Access point will shift to the access as indicated on the site plan at a later stage. The developer is waiting for final approval from DRE on the R102 changes/upgrades.</p> | <div data-bbox="1339 740 2016 1251"> <p>Network: 27 May 2025 at 12:42:20 SAST<br/> Local: 27 May 2025 at 12:42:20 SAST<br/> S 34° 6' 19.110" E 22° 6' 42.797"<br/> 275° W<br/> Remark: Garden walk<br/> #HillLand Environmental</p> </div> |

| | | | <div><p>Construction materials stored on site</p></div> |

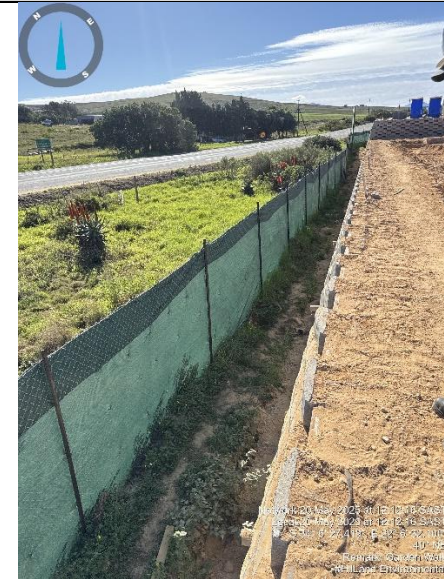
Sandbags were placed in existing stormwater channel of the provincial road (R102), to capture any silt from the site. These "silt traps" are cleaned out regularly as observed on site.

**No stormwater runoff issues noted.**

*All low points must be regularly inspected for possible stormwater movement. In the case where there is stormwater movement, the contractor will be required to install erosion protection (bidim silt fence(s) or sandbags).*

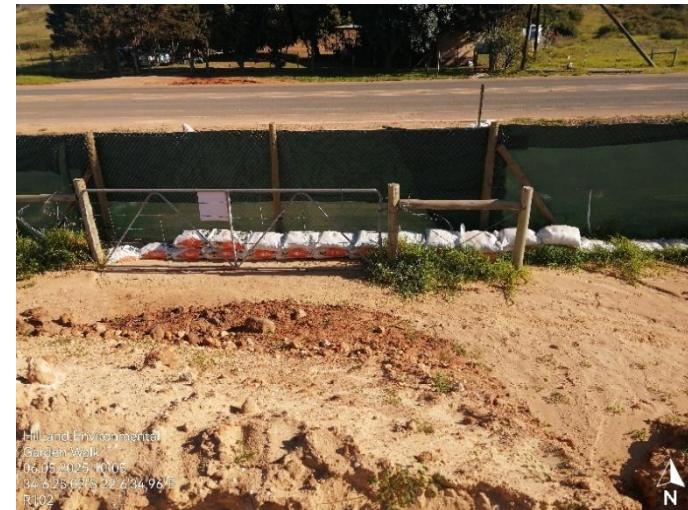
**Additional sandbags were placed at the low point (old access point)**

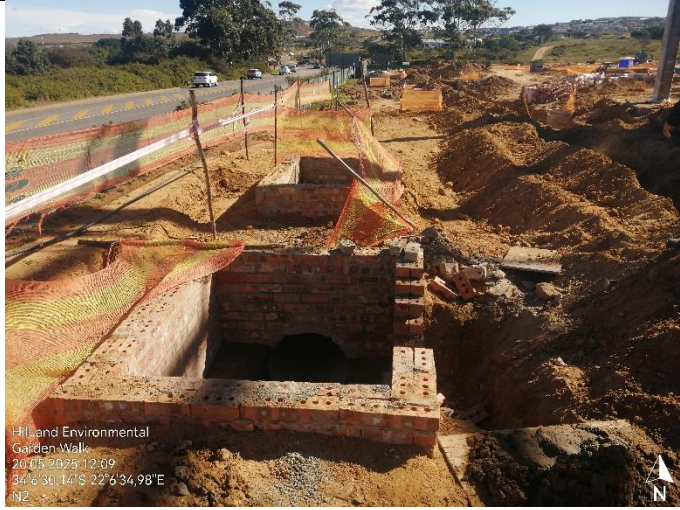
| The stormwater system must be protected through the installation of additional silt-fencing and re-vegetation of exposed areas. | Ongoing | The stormwater system has not yet been fully installed / connected. | <p>Hilland Environmental<br/>Garden Walk<br/>20/05/2025 12:09<br/>34°6'30.14"S 22°6'34.98"E<br/>N2</p> |

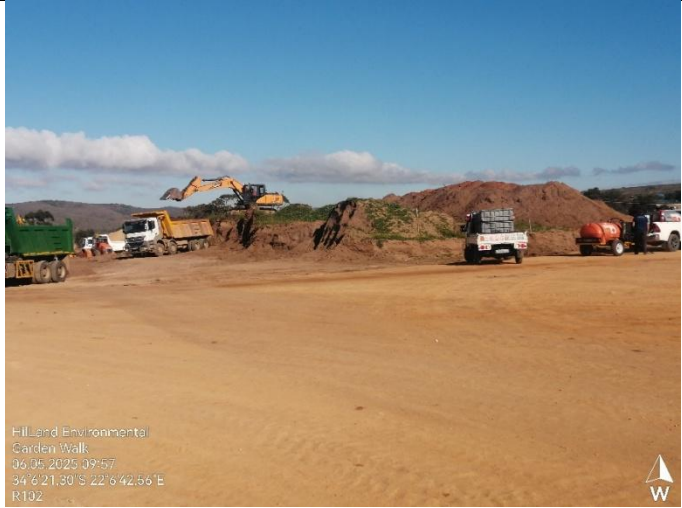
| Topsoil must be stripped to stockpile from all construction areas before work commences in that specific area. | DONE | <p>Topsoil has been stripped. Only the required volume (approximately 2500m<sup>3</sup>) of topsoil for rehabilitation and landscaping has been stockpiled and demarcated with signs. The excess has been removed from the site as agreed by the ECO.</p> <p>The topsoil stockpile has been moved to an off-site stockpile area (Outeniquasbosch – within a development area).</p> <p>The contractor must ensure that the topsoil stockpile is free from invasive alien plants (<i>Datura sp.</i>).</p> | <p> <small> Hillend Environmental<br/> Garden Walk<br/> 36.05.2025 09:57<br/> 34°6'21.30"S 22°6'42.56"E<br/> R102 </small> </p> <p><b>Topsoil stockpile was moved to Outeniquasbosch.</b></p> |

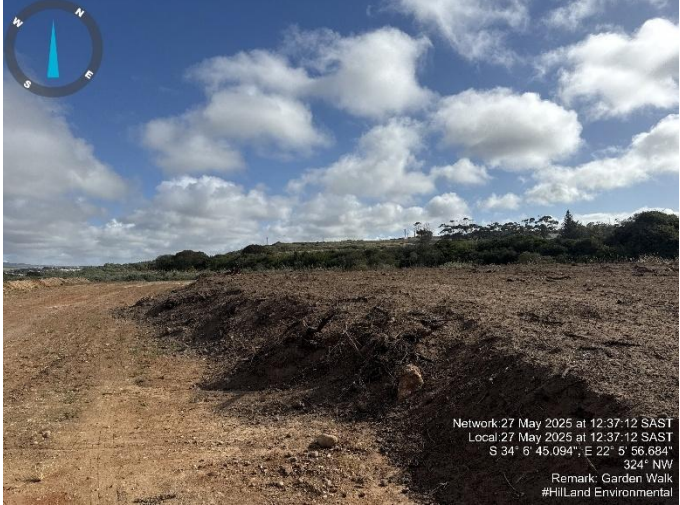
| The topsoil must be stockpiled for use in rehabilitation and landscaping and must not be contaminated with other building materials and / or subsoil. | Compliant | The topsoil has been stockpiled for rehabilitation and landscaping and demarcated – signs. | |

| The stockpiles must be protected against erosion including wind (vegetation can be permitted to grow on the stockpile to keep it secure and prevent wind movement. No alien invasive plants may grow on the stockpile). | Ongoing | <p>Grass cover is allowed to grow on the stockpile.</p> <p>The contractor must ensure that the topsoil stockpile is free from invasive alien plants (<i>Datura sp.</i>).</p> | |

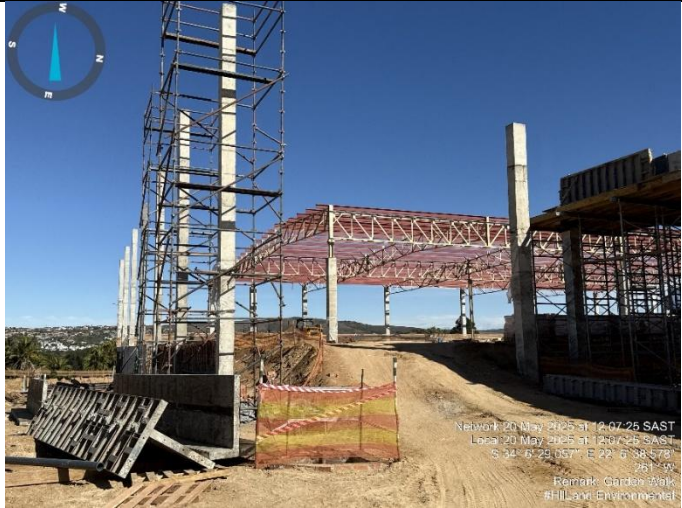
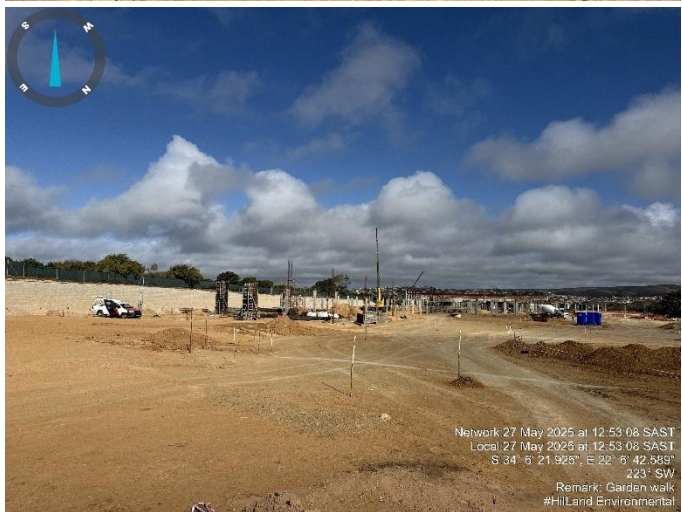
| <p>No bare or exposed areas are to be left for a period of more than 2 months.</p> | <p>Ongoing</p> | <p>Clearing of the entire site was done and construction is in progress over the entire site (civil services and top structure).</p> | <div data-bbox="1339 193 2018 703"><p>Network: 20 May 2025 at 12:07:25 SAST<br/>Local: 20 May 2025 at 12:07:25 SAST<br/>S: 34° 6' 29.057" E: 22° 5' 38.578"<br/>261° SW<br/>Remark: Garden Walk<br/>#HillLand Environmental</p></div> <div data-bbox="1339 703 2018 1217"><p>Network: 27 May 2025 at 12:53:06 SAST<br/>Local: 27 May 2025 at 12:53:06 SAST<br/>S: 34° 6' 21.926" E: 22° 5' 42.686"<br/>223° SW<br/>Remark: Garden walk<br/>#HillLand Environmental</p></div> <p>Construction in progress</p> |

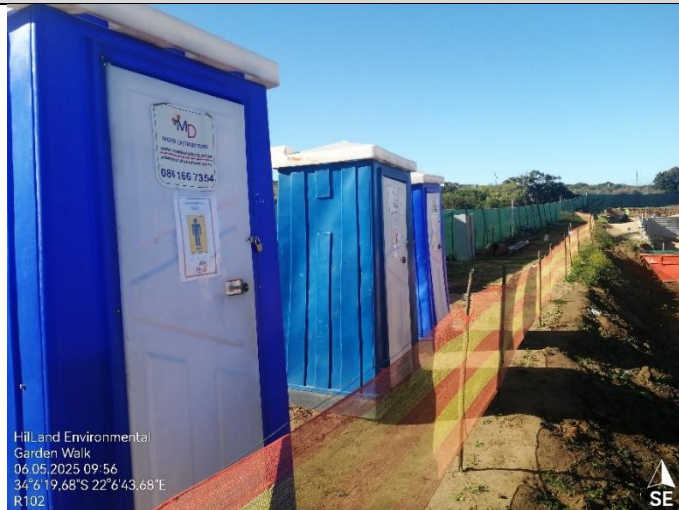
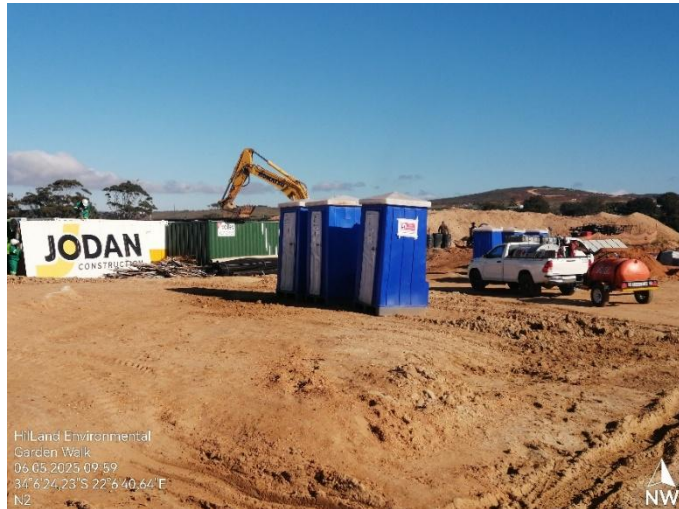
| Ablution Facilities | | | |
|---|---|---|---|
| Ablution facilities (chemical toilets) are to be provided at the campsite for use of the staff (one toilet per 15 people). | Compliant | Sufficient ablution facilities are provided on site, both for Jodan Construction and MBC. | |
| The contractor shall ensure that the toilet(s) are emptied regularly and also before weekends and public holiday periods. | Ongoing | <p>No environmental issues noted. Toilet service provider was noted on site during ECO site inspection.</p> <p>Additional toilets have been added to the site.</p> | |

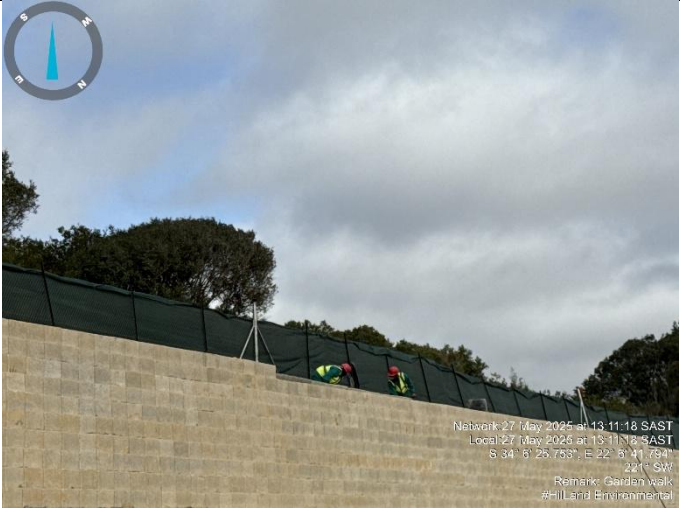
| Working Areas & Demarcation | | | |
|---|---|---|---|
| No-Go areas will be required to be demarcated by the contractor to ensure that they are visible at all times, to all personnel. | Compliant | The working area is demarcated with a 1.8m wire fence and shade netting. | <div></div> <div>Demarcation of the working zone with green shade netting</div> |

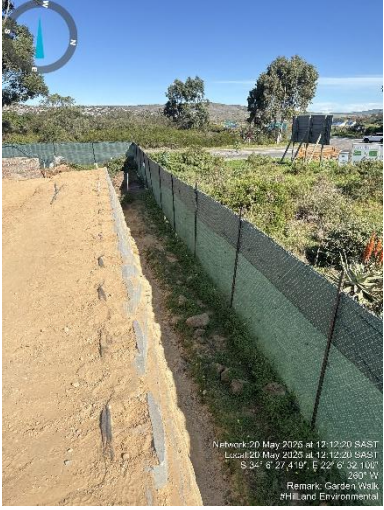
| <p>The total footprint of a building zone / phase should be demarcated with 1.5 m (height) shade cloth for the entire period of the construction.</p> | <p>Compliant</p> | | <p>Network: 20 May 2025 at 12:12:20 SAST<br/> Local: 20 May 2025 at 12:12:20 SAST<br/> S: 34° 6' 27.419" E: 22° 6' 52.104"<br/> 200° W<br/> Remark: Garden walk<br/> #Hilland Environmental</p> |

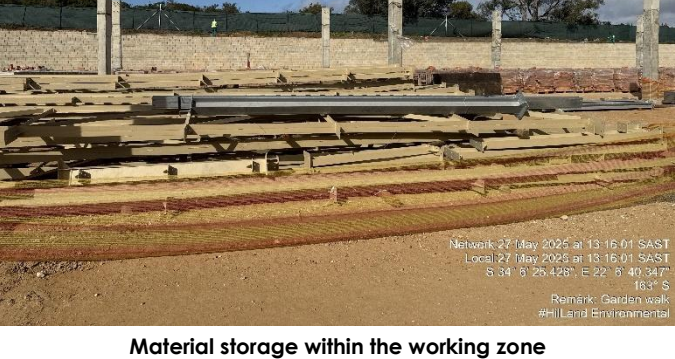
| <p>All stockpile sites within the development area are to be demarcated with silt-fences and/or danger tape, where necessary.</p> | <p>Compliant &amp; ongoing</p> | <p>The construction material stockpile in the development zone is demarcated with orange netting fencing.</p> | <p>Network: 27 May 2025 at 13:16:01 SAST<br/> Local: 27 May 2025 at 13:16:01 SAST<br/> S: 34° 6' 25.428" E: 22° 6' 40.347"<br/> 183° S<br/> Remark: Garden walk<br/> #Hilland Environmental</p> <p><b>Material storage within the working zone</b></p> |

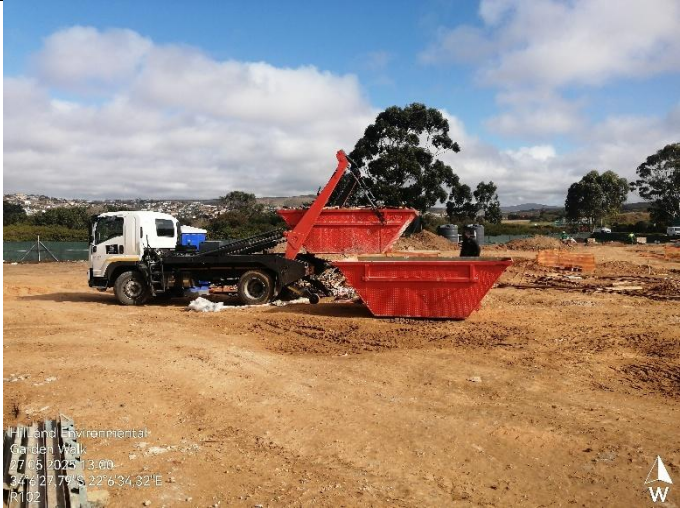
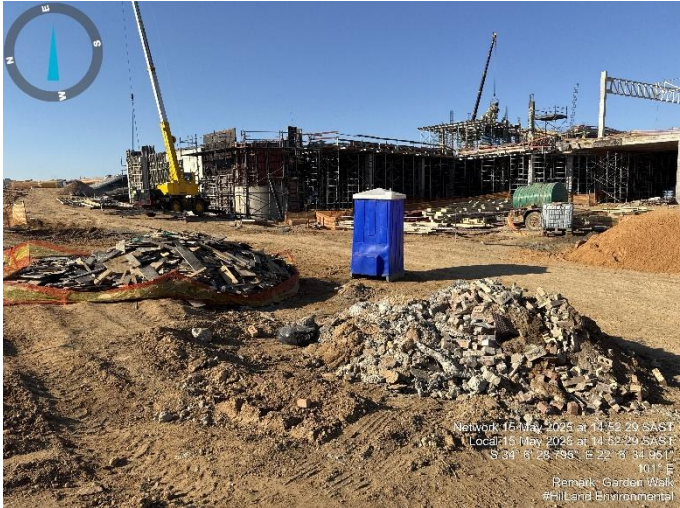
| Waste Management | | | |
|---|---|---|---|
| <p>A dedicated area must be created within the site camp for refuse and waste management.</p> | <p>Compliant</p> | <p>A dedicated waste area is in the site camp.</p> | <div><p>Full skip is removed and replaced with empty skip</p><p>Construction rubble stockpile</p></div> |

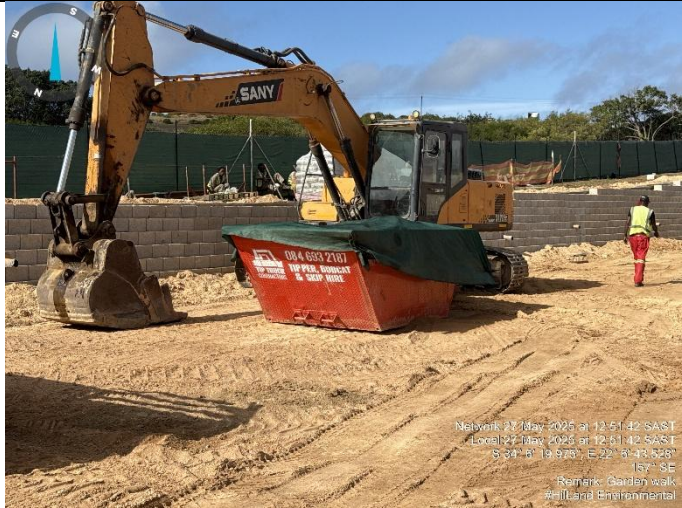
| | | | <p>Skips are available on site and are covered to prevent plastic from blowing away in the wind.</p> |

| It is <b>recommended</b> that an integrated waste management approach must be used that is based on waste minimisation and must include reduction, recycling, re-use and disposal where appropriate. | Ongoing | An integrated waste management system should be implemented – keeping general waste separate from construction rubble. We don't want to see plastic bags/wrapping in the construction rubble stockpile. Construction rubble stockpiles must not have litter (papers and plastic) - ongoing | |

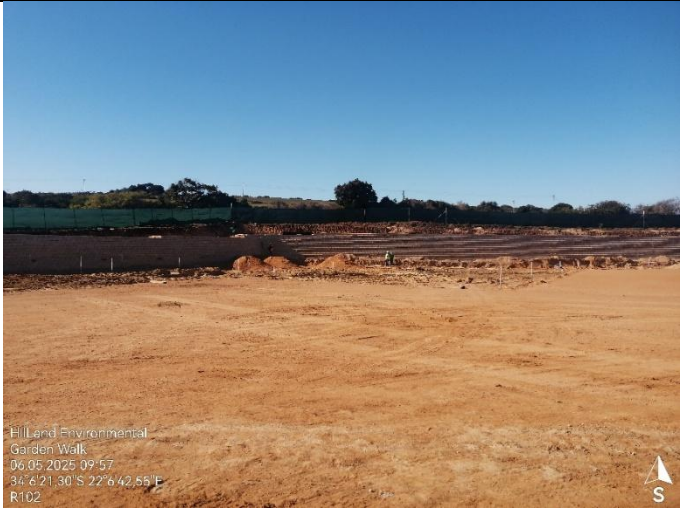
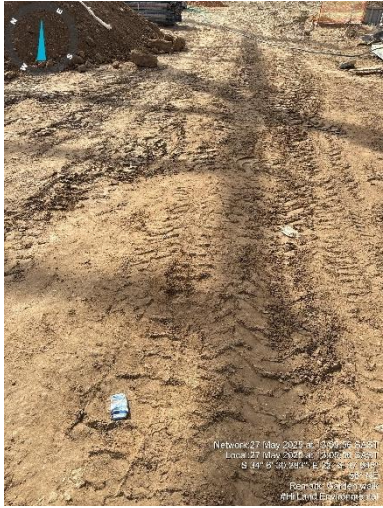
| <p>Litter to be removed from the site on a daily basis and kept in closable bins.</p> | <p>Compliant &amp; ongoing</p> | <p>Limited to no litter noted during ECO site inspections. Regular litter picking is done.</p> | <div data-bbox="1274 193 1951 703"><p>Hill and Environmental<br/>Garden Walk<br/>06.05.2025 09:57<br/>34° 6' 21.30" S 22° 6' 42.55" E<br/>R102</p></div> <div data-bbox="1422 710 1803 1220"><p>Network 27 May 2025 at 10:00 AM<br/>End of May 2025 at 10:00 AM<br/>34° 6' 40.00" S 22° 6' 42.55" E<br/>R102<br/>Hill and Environmental</p></div> <p>Site is generally free of litter</p> |

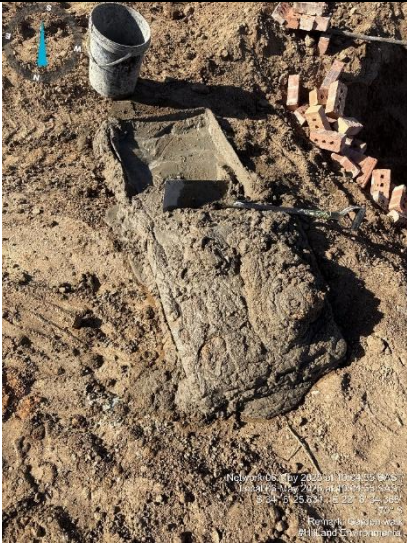
| Concrete and Cement Works | | | |
|---|---|---|---|
| Any concrete batching plant areas are to be approved by the ECO prior to utilisation. | Ongoing | Mixing are being done within development footprint (transformed area) and as agreed with the ECO. Suitable bunding <b>must</b> always be in place to avoid contaminated water runoff. | |

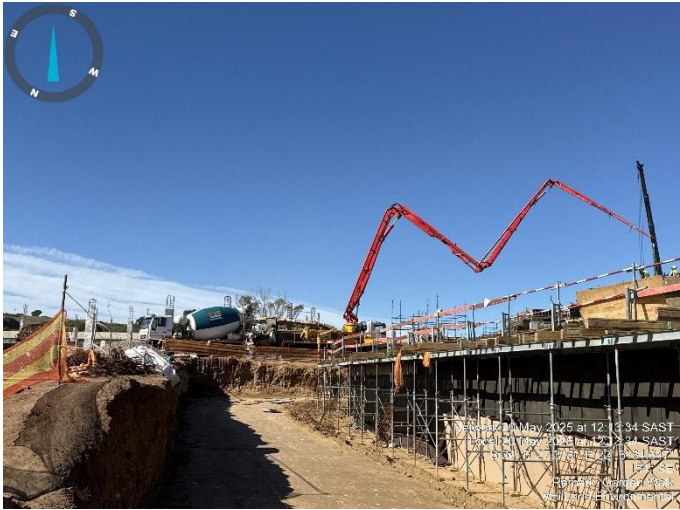
| Concrete and Cement Works | | | |
|---|---|---|---|
| No ready-mix trucks are permitted to rinse their tanks on site or along the access roads to and from the site. | Ongoing | No non-compliance noted during site inspections. | |

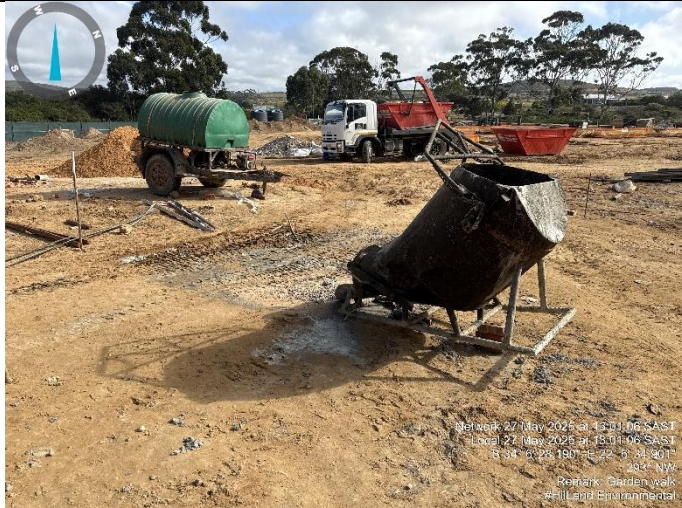
| Any spillage is to be immediately cleaned by the responsible contractor / supplier / owner. | Ongoing | Minor spillage noted within the development zone (transformed area), this was reported to the responsible contractor and cleaned. | <p>Refer to 27 July 2025 at 13:01:06 SAST<br/>Local 27 July 2025 at 13:01:06 SAST<br/>S 34° 4' 28.190" E 22° 0' 31.901"<br/>2025 NW<br/>Remark: Garden walk<br/>Wetland Environmental</p> <p><b>Minor cement spillage – has since been cleaned.</b></p> |

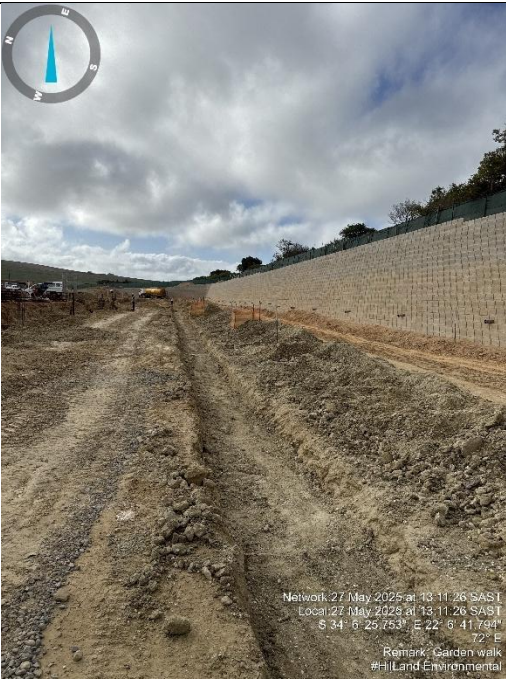
| Reinstate the vegetation in accordance with the Landscape Master Plan. | Ongoing | <p>Rehabilitation / revegetation of the retaining wall / embankment can now start.</p> <p>Landscape master plan to be circulated to the ECO</p> | |

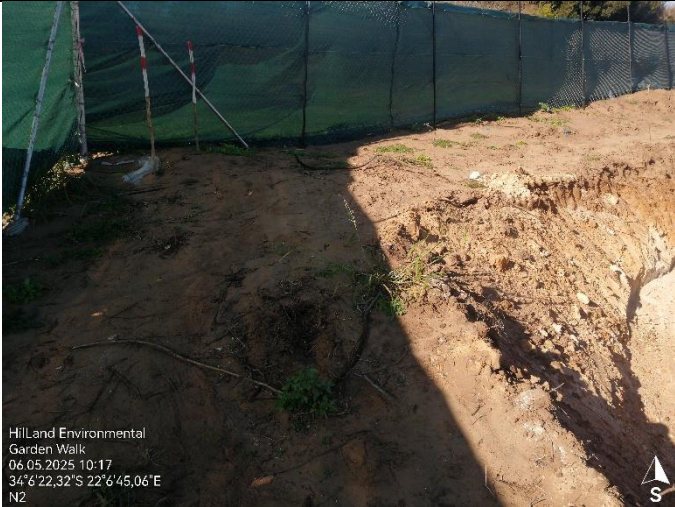
| Alien invasive vegetation to be removed | Ongoing | <p>The contractor must ensure ongoing hand-pulling of the <i>Datura</i> plants – ECO can assist with identification if required. It is important to remove these plants before they start producing seeds and spread.</p> | <div><p>HillLand Environmental<br/>Garden Walk<br/>06.05.2025 10:17<br/>34°6'22,32"S 22°6'45,06"E<br/>N2</p></div> <p><b>Alien vegetation within disturbed areas to be hand-pulled – Note area has been cleared of invasive plants</b></p> |
