## ENVIRONMENTAL MONITORING REPORT No. 5

*The Development of the Garden Walk on the Remainder of Portion 58  
of the Farm Hartenbosch 217, Hartenbos*

**June 2025**

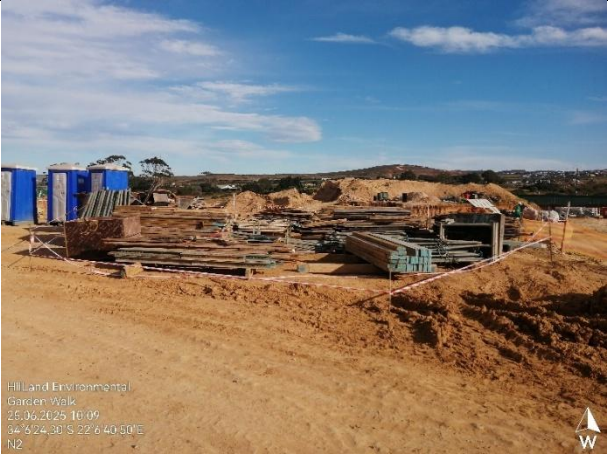
| Storage sites for construction material and access must be approved by the ECO prior to commencing (and areas will require rehabilitation after use). | Compliant | <p>All construction material is currently stored in the development site.</p> <p>Construction access is directly off the R102 to the construction site.</p> <p>Access point will shift to the access as indicated on the site plan at a later stage. The developer is waiting for final approval from DRE on the R102 changes/upgrades.</p> | <p>Hilland Environmental<br/>Garden Walk<br/>25.06.2025 16:09<br/>S 84° 24' 30" E 22° 6' 40" S 0° E<br/>N2</p> |

| | | | <div><p>Hill and Environmental<br/>Garden Walk<br/>12.04.2025 12:22<br/>34° 23' 50" S 22° 5' 36.94" E<br/>R102</p><p>Construction materials stored on site</p></div> |

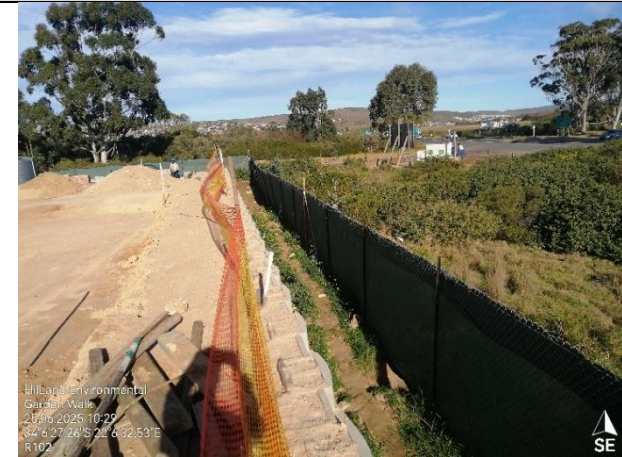
Sandbags were placed in existing stormwater channel of the provincial road (R102), to capture any silt from the site. These "silt traps" are cleaned out regularly as observed on site.

**No stormwater runoff issues outside the demarcation noted.**

*All low points must be regularly inspected for possible stormwater movement. In the case where there is stormwater movement, the contractor will be required to install erosion protection (bidim silt fence(s) or sandbags).*

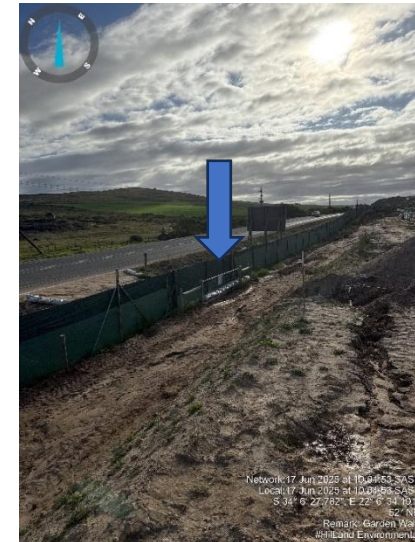
**Additional sandbags were placed at the low point (old access point). Sandbags will be required here to protect the slope (soil erosion risk) until the retaining wall is completed.**

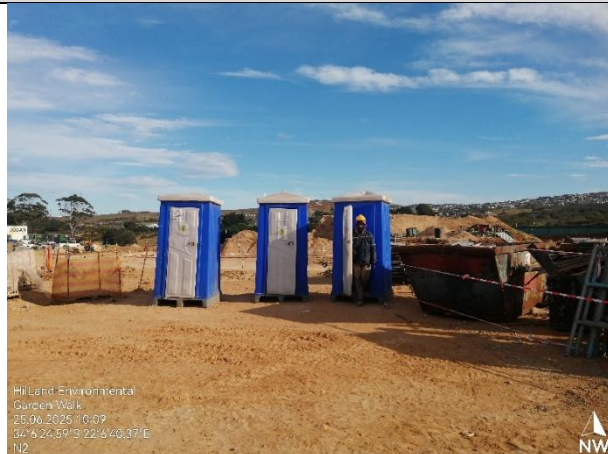
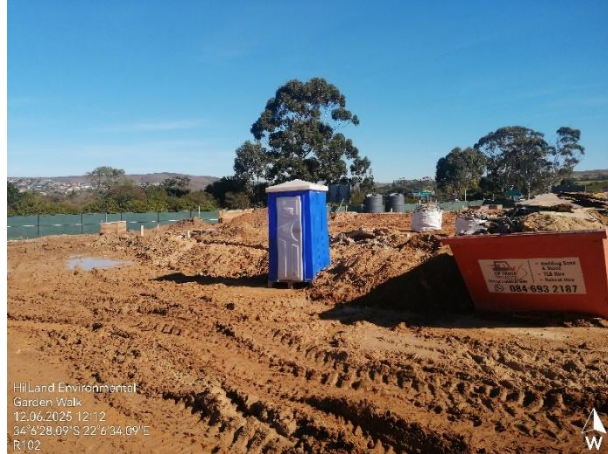
| Ablution Facilities | | | |
|---|---|---|---|
| Ablution facilities (chemical toilets) are to be provided at the campsite for use of the staff (one toilet per 15 people). | Compliant | Sufficient ablution facilities are provided on site, both for Jodan Construction and MBC. | <p>HillLand Environmental<br/>Garden Walk<br/>25.06.2025 10:09<br/>34°4'22.59"S 22°6'40.97"E<br/>N2</p> <p>HillLand Environmental<br/>Garden Walk<br/>12.06.2025 12:12<br/>34°4'28.09"S 22°6'34.09"E<br/>R102</p> |

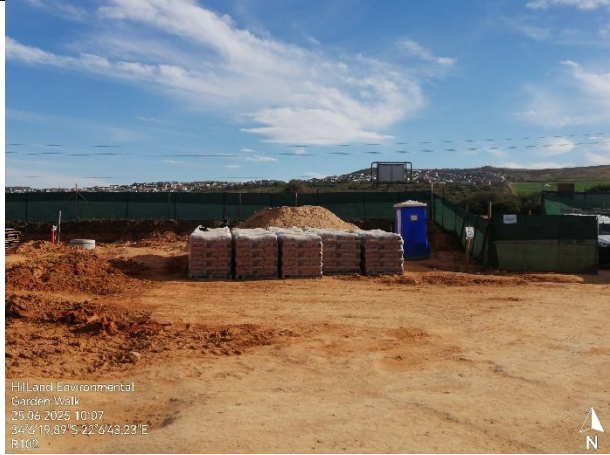
| <p>All stockpile sites within the development area are to be demarcated with silt-fences and/or danger tape, where necessary.</p> | <p>Compliant &amp; ongoing</p> | <p>The construction material stockpile in the development zone is demarcated with orange netting fencing.</p> | |

| | | | <p><b>Material storage within the working zone</b></p> |

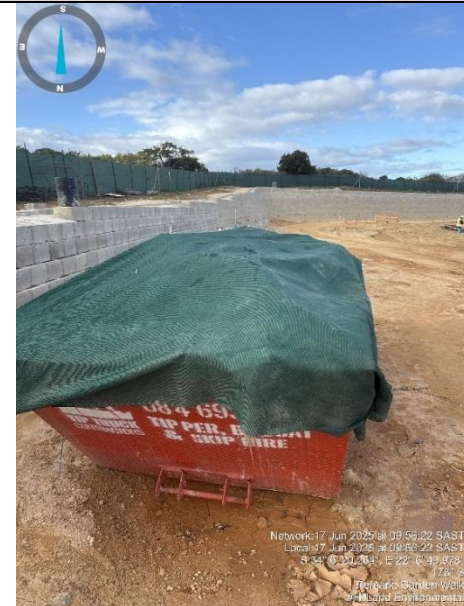
Skips are available on site. Note netting to prevent waste from blowing away.

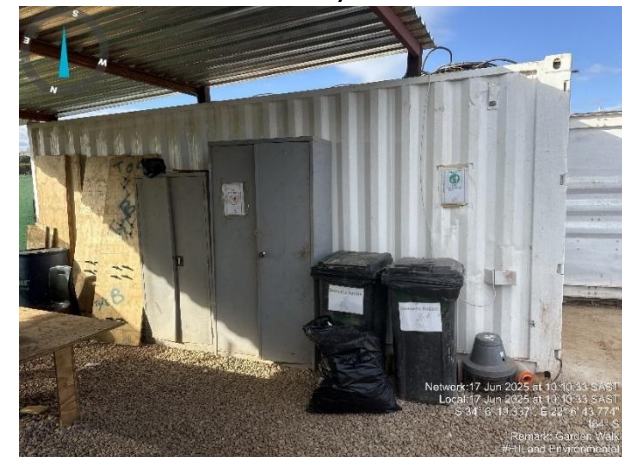
Black bins and refuse bags available in the site camp

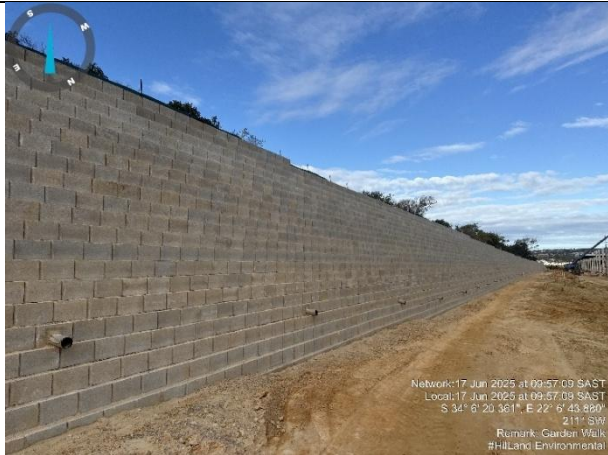
| Reinstate the vegetation in accordance with the Landscape Master Plan. | Ongoing | <p>Rehabilitation / revegetation of the retaining wall / embankment can now start.</p> <p>Landscape master plan to be circulated to the ECO</p> | <p><b>Retaining wall / embankment</b></p> |
