## ENVIRONMENTAL MONITORING REPORT No. 5

*The Development of the Garden Walk on the Remainder of Portion 58  
of the Farm Hartenbosch 217, Hartenbos*

**June 2025**

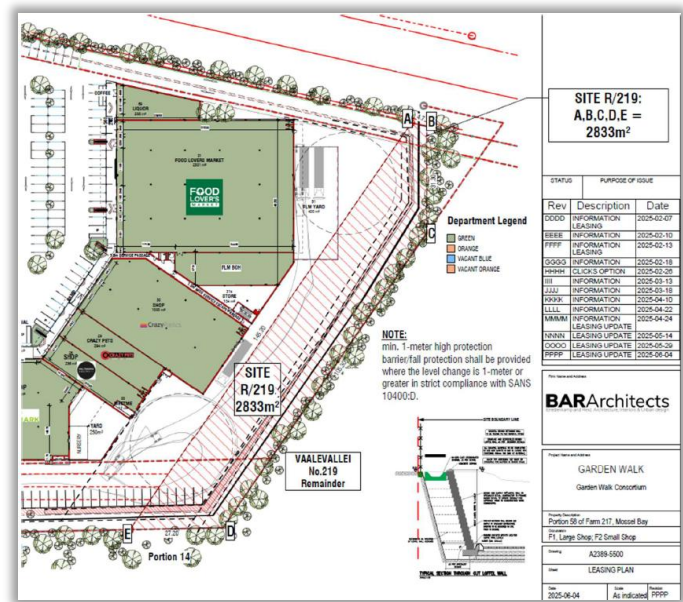
The survey confirmed that the cadastral boundaries have been incorrectly mapped on site and the no-go / site demarcation has been installed on this incorrect line on Remainder of Farm 219. A non-compliance notification letter was subsequently submitted to DEAD on 25<sup>th</sup> June 2025.

Applicant issued an immediate “on hold” for all building works in the affected area (red hashed zone)

Extract of the architect plan overlay with the survey of the current site boundary.

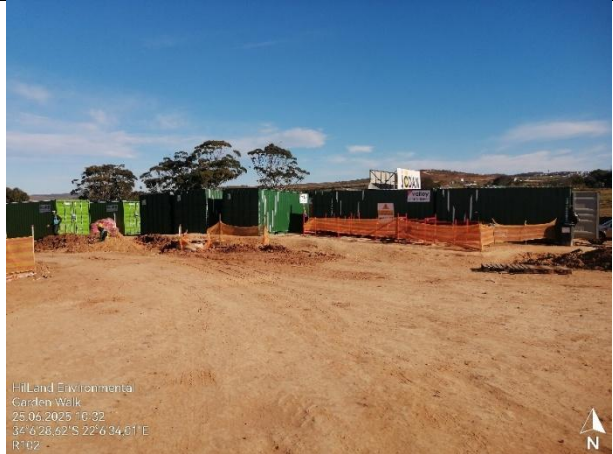
| EMPr Requirement | Level of Compliance | Comments / Findings | Photo's (if applicable) |
|---|---|---|---|
| The site camp area must be indicated and approved by the ECO. | DONE | <p>The site camp method statement (MBC) was approved by the ECO. The site camp is set up on RE/219 as per the method statement. Based on the survey data, the area in front of the site camp is also on RE/219, refer to non-compliance notification mentioned above.</p> <p>Civil contractor: The site camp is within the fenced off development footprint.</p> | <p> <small> Hilland Environmental<br/> Garden Walk<br/> 25.06.2025 10:22<br/> 34°42'28.62"S 22°43'34.61"E<br/> R-02 </small> </p> <p><b>Civil contractor site camp</b></p> |

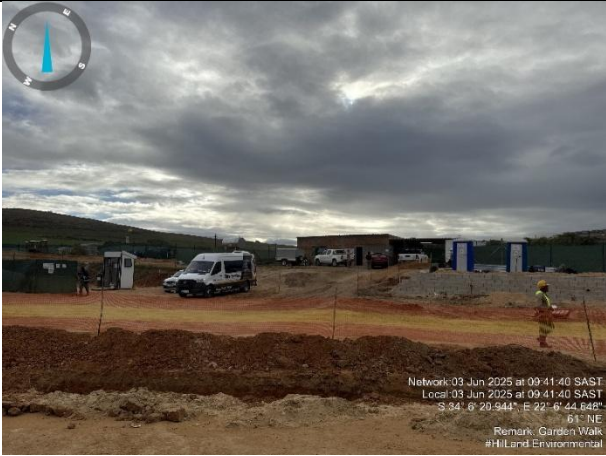
| | | | <div><p>Network: 03 Jun 2025 at 09:41:40 SAST<br/>Local: 03 Jun 2025 at 09:41:40 SAST<br/>S 84° 6' 20.944" E 22° 6' 44.846"<br/>61° NE<br/>Remark: Garden Walk<br/>#Hilland Environmental</p></div> <p><b>Building contractor site camp</b></p> |

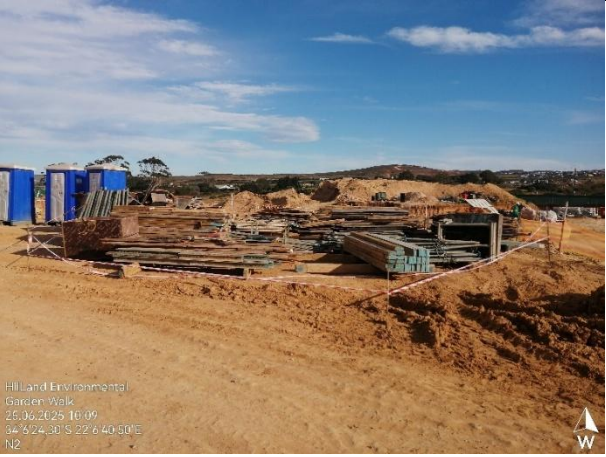
| <p>Storage sites for construction material and access must be approved by the ECO prior to commencing (and areas will require rehabilitation after use).</p> | <p>Compliant</p> | <p>All construction material is currently stored in the development site.</p> <p>Construction access is directly off the R102 to the construction site.</p> <p>Access point will shift to the access as indicated on the site plan at a later stage. The developer is waiting for final approval from DRE on the R102 changes/upgrades.</p> | <div><p>Hilland Environmental<br/>Garden Walk<br/>25.06.2025 16:09<br/>S 84° 24' 30" E 22° 6' 40" S 0° E<br/>N2</p></div> |

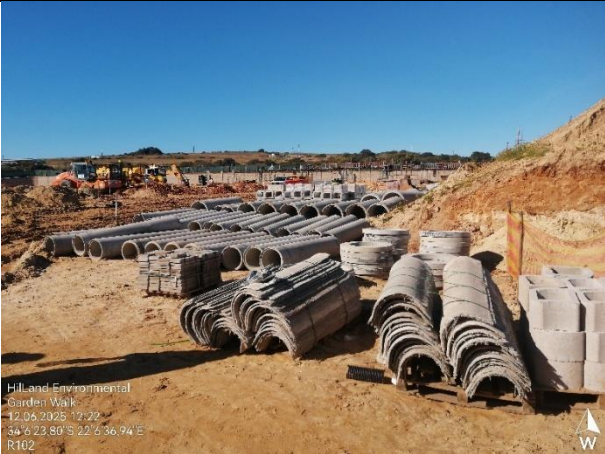
| | | | <div><p>Hilland Environmental<br/>Garden Walk<br/>12.04.2025 12:22<br/>34° 23' 50" S 22° 5' 36.94" E<br/>R102</p></div> <p>Construction materials stored on site</p> |

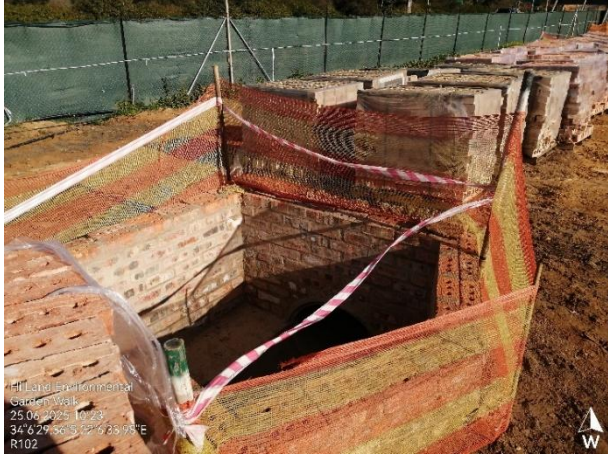
| The stormwater system must be protected through the installation of additional silt-fencing and re-vegetation of exposed areas. | Ongoing | The stormwater system has not yet been fully installed / connected. | <p> <small> Hilland Environmental<br/> Garden Walk<br/> 25.06.2025 10:23<br/> 34°6'29"S 151°16'35"E<br/> R102 </small> </p> |

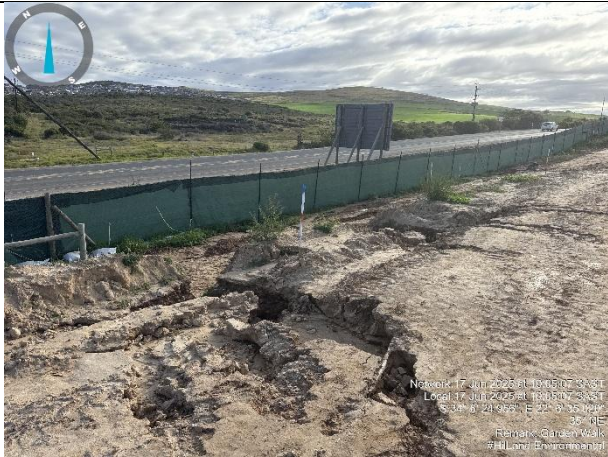
| The silt fencing needs to be installed where indicated by the ECO. | Ongoing | Erosion protection is required at the low point(s) – no silt was noted outside the demarcation. | <p><b>Erosion / silt protection is required</b></p> |

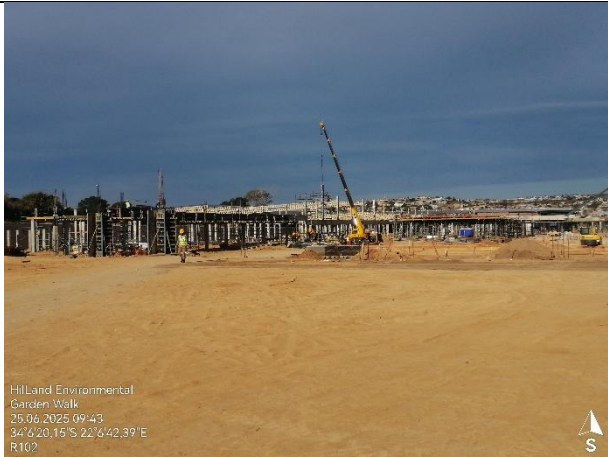
| No bare or exposed areas are to be left for a period of more than 2 months. | Ongoing | Clearing of the entire site was done and construction is in progress over the entire site (civil services and top structure). | |

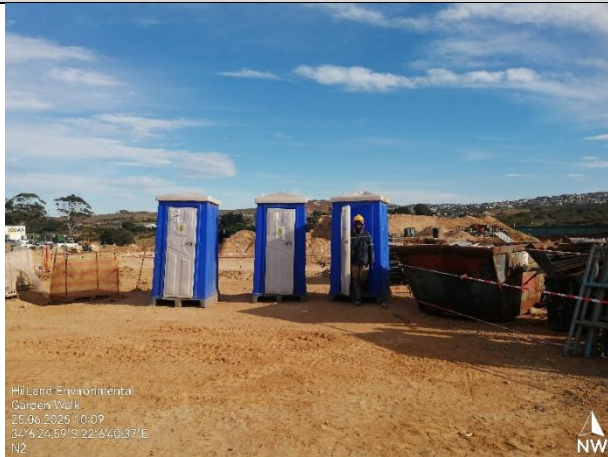
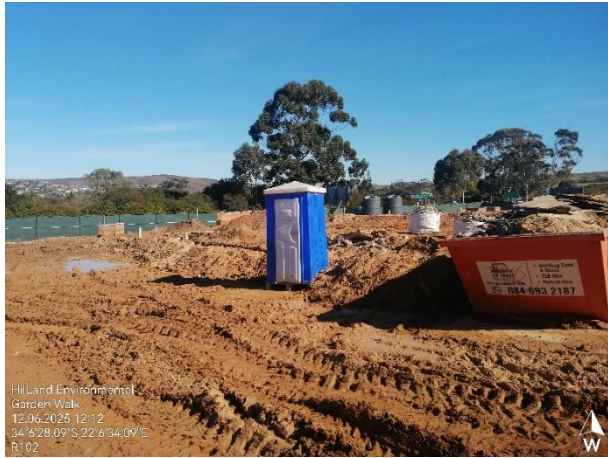
| Ablution Facilities | | | |
|---|---|---|---|
| Ablution facilities (chemical toilets) are to be provided at the campsite for use of the staff (one toilet per 15 people). | Compliant | Sufficient ablution facilities are provided on site, both for Jodan Construction and MBC. | <p>HillLand Environmental<br/>Garden Walk<br/>25.06.2025 10:09<br/>34°4'22.59"S 22°6'40.37"E<br/>N2</p> <p>HillLand Environmental<br/>Garden Walk<br/>12.06.2025 12:12<br/>34°4'28.09"S 22°6'34.09"E<br/>R102</p> |

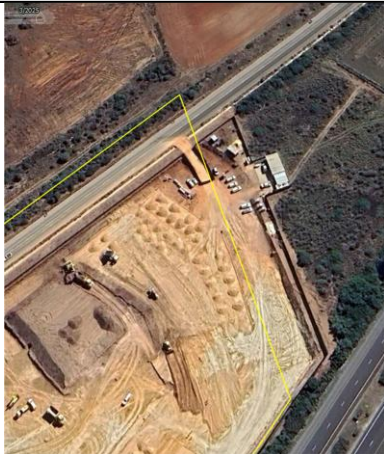
| <p>All areas outside of the property will be regarded as 'no-go' areas (except where installation of services will be required).</p> | <p>Non-compliance reported to DEADP</p> | <p>The non-compliance for the area outside the property boundary as per the survey plan was reported to DEADP on 25<sup>th</sup> June 2025. A meeting will be held with DEADP and Mossel Bay Municipality to determine the way forward.</p> <p>The clearing in the road reserve is for the external services and upgrades/changes to the R102.</p> | <p>Yellow line showing the cadastral boundary.</p> |

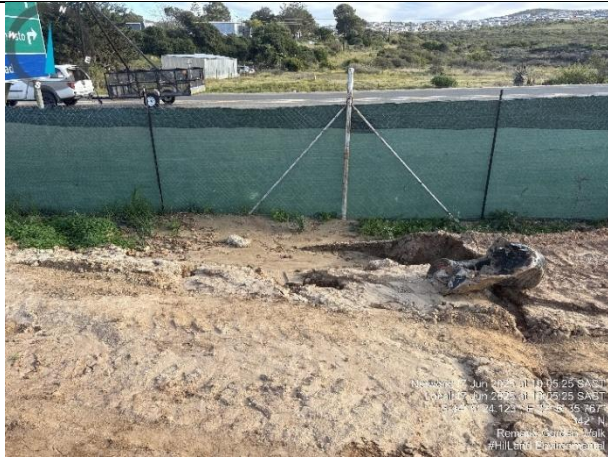
| <p>No-Go areas will be required to be demarcated by the contractor to ensure that they are visible at all times, to all personnel.</p> | <p>Compliant</p> | <p>The working area is demarcated with a 1.8m wire fence and shade netting.</p> | <p>Demarcation of the working zone with green shade netting</p> |

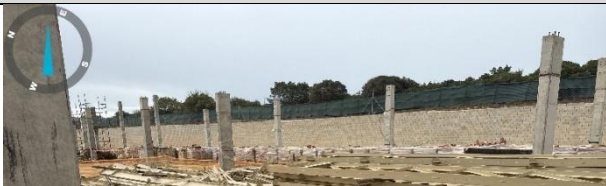
| <p>All stockpile sites to be approved by the ECO and/or landowner, prior to the commencement of stockpiling.</p> | <p>Compliant &amp; ongoing</p> | <p>Current construction material stockpile area is within the demarcated zone.</p> <p>Topsoil stockpiled in Outeniquasbosch (landowner approval letter to be submitted to the ECO for record keeping).</p> | |

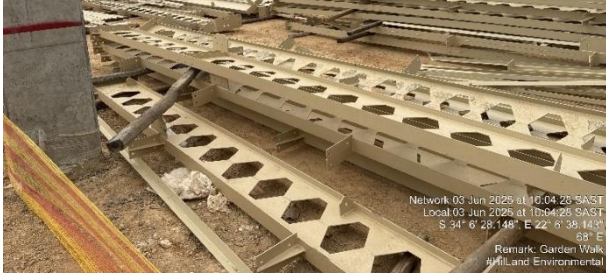
| <p>All stockpile sites within the development area are to be demarcated with silt-fences and/or danger tape, where necessary.</p> | <p>Compliant &amp; ongoing</p> | <p>The construction material stockpile in the development zone is demarcated with orange netting fencing.</p> | |

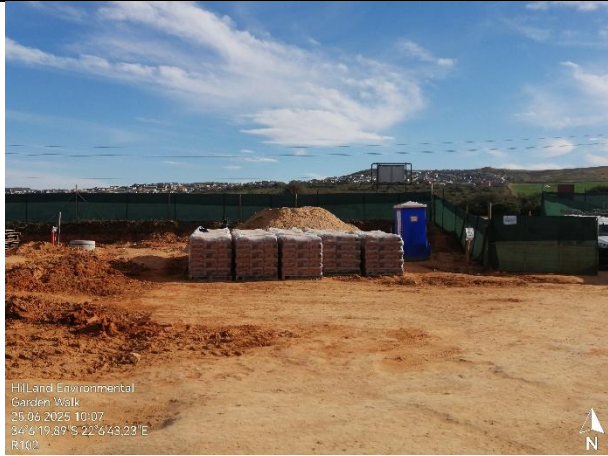
| | | | <p>Hilland Environmental<br/>Garden Walk<br/>25.06.2025 10:07<br/>54° 5' 19.89" S 22° 4' 43.23" E<br/>R1100</p> <p><b>Material storage within the working zone</b></p> |

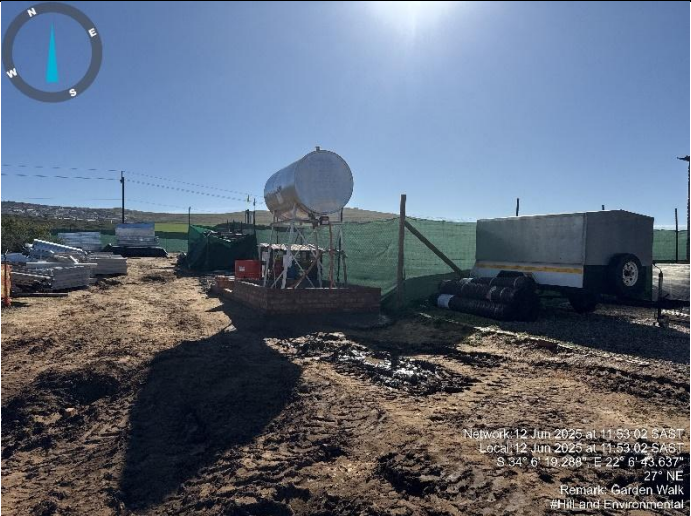
| Written method statement for the storage of hazardous substances must be approved by the ECO. | Ongoing | Method statement for hazardous substances has been submitted to the ECO and approved. | <div><p>Network: 12 Jun 2025 at 11:53:02 SAST<br/>Local: 12 Jun 2025 at 11:53:02 SAST<br/>S 34° 6' 18.288" E 22° 6' 43.637"<br/>27° NE<br/>Remarks: Garden Walk<br/>Hill and Environmental</p><p><b>Fuel storage area is bunded</b></p></div> |

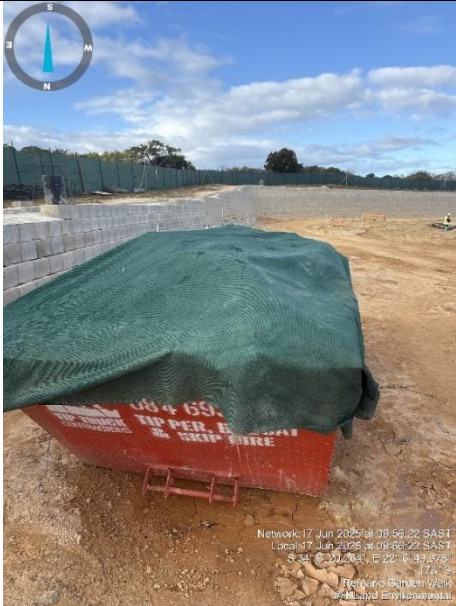
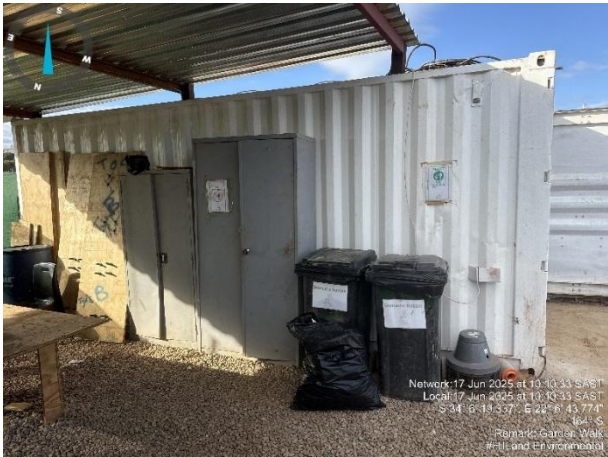
| Waste Management | | | |
|---|---|---|---|
| A dedicated area must be created within the site camp for refuse and waste management. | Compliant | A dedicated waste area is in the site camp. | <div><p>Network: 17 Jun 2025 at 09:59:22 SAST<br/>Local: 17 Jun 2025 at 08:59:22 SAST<br/>S: 34° 0' 31.204" E: 22° 1' 49.879"<br/>172m ASL<br/>Portland Gables, Wals<br/>#11 and 12 Pyrometallol</p></div> <p><b>Skips are available on site. Note netting to prevent waste from blowing away.</b></p> <div><p>Network: 17 Jun 2025 at 10:10:33 SAST<br/>Local: 17 Jun 2025 at 10:10:33 SAST<br/>S: 34° 0' 19.377" E: 22° 1' 43.774"<br/>172m ASL<br/>Portland Gables, Wals<br/>#11 and 12 Pyrometallol</p></div> <p><b>Black bins and refuse bags available in the site camp</b></p> |

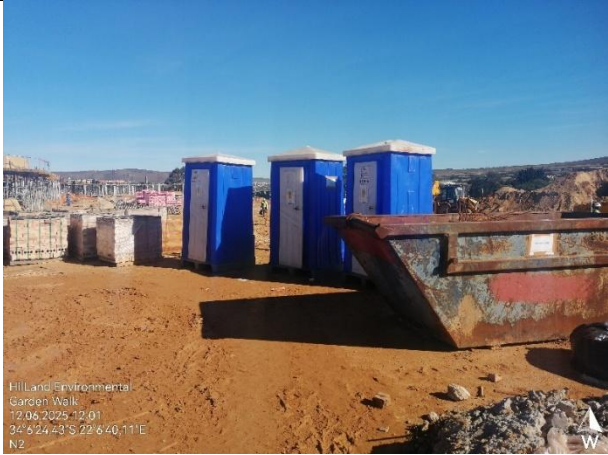
| | | | <p>Hilland Environmental<br/>Garden Walk<br/>12.06.2025 12:01<br/>34° 5' 24.43" S 22° 6' 40.11" E<br/>N2</p> <p><b>Scrap steel skip for metallic waste only.</b></p> |

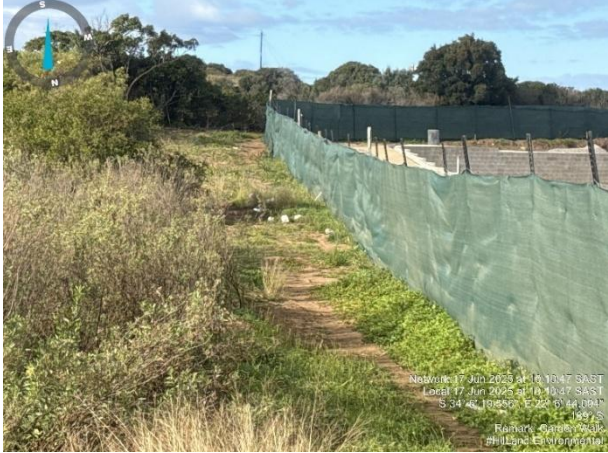
| <p>Litter to be removed from the site on a daily basis and kept in closable bins.</p> | <p>Compliant &amp; ongoing</p> | <p>Litter noted during ECO site inspection(s) – were reported to the contractor and actioned immediately. Regular litter picking is done.</p> | <p>Naamans 17 Jun 2025 14:14:30Z SAST<br/> Locat: 17 Jun 2025 14:14:30Z SAST<br/> S 34 46 180850 E 28 0 44 180850<br/> 1897 S<br/> Remark: Garden Veld<br/> M. L. and E. B. (M. L. and E. B.)</p> |

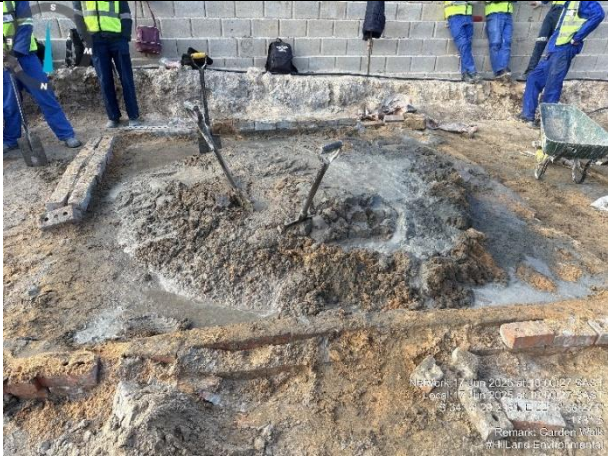
| <p>Any concrete batching plant areas are to be approved by the ECO prior to utilisation.</p> | <p>Ongoing</p> | <p>Mixing are being done within development footprint (transformed area) and as agreed with the ECO. Suitable bunding <b>must</b> always be in place to avoid contaminated water runoff.</p> | <p>Naamans 17 Jun 2025 14:18:22Z SAST<br/> Locat: 17 Jun 2025 14:18:22Z SAST<br/> S 34 46 180850 E 28 0 44 180850<br/> 1897 S<br/> Remark: Garden Veld<br/> M. L. and E. B. (M. L. and E. B.)</p> <p><b>Cement mixed in bunded area.</b></p> |

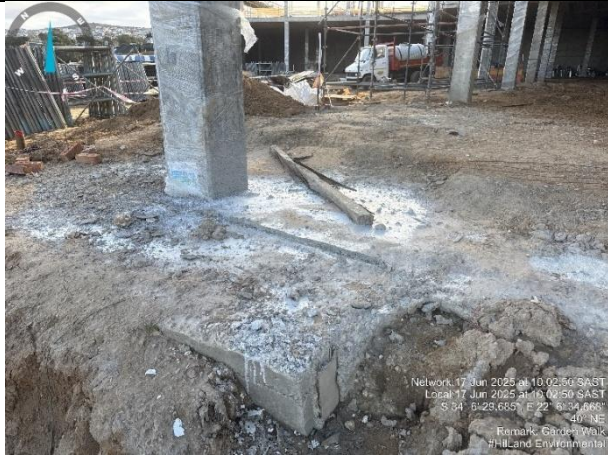
| Any spillage is to be immediately cleaned by the responsible contractor / supplier / owner. | Ongoing | Minor spillage noted within the development zone (transformed area), this was reported to the responsible contractor and cleaned. | <p><b>Cement spillage to be cleaned up to prevent contaminated runoff</b></p> |

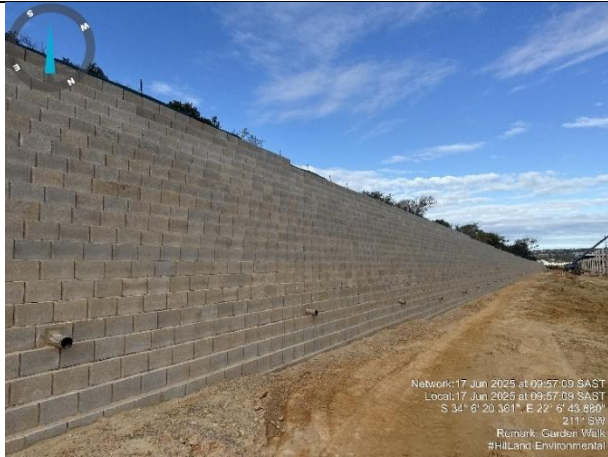
| Reinstate the vegetation in accordance with the Landscape Master Plan. | Ongoing | <p>Rehabilitation / revegetation of the retaining wall / embankment can now start.</p> <p>Landscape master plan to be circulated to the ECO</p> | <p>Network: 17 Jun 2025 at 09:57:09 SAST<br/> Local: 17 Jun 2025 at 09:57:09 SAST<br/> S 34° 6' 20.361" E 22° 6' 43.880"<br/> 211° SW<br/> Rumuk: Garden Walk<br/> #HillandEnvironmental</p> <p><b>Retaining wall / embankment</b></p> |
