## ENVIRONMENTAL MONITORING REPORT No. 7

*The Development of the Garden Walk on the Remainder of Portion 58  
of the Farm Hartenbosch 217, Hartenbos*

**August 2025**

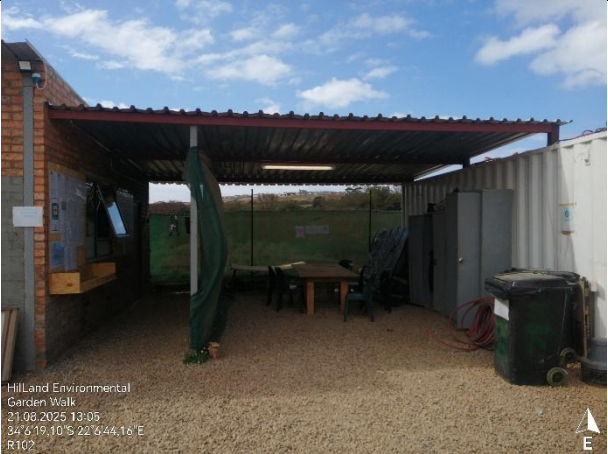
| EMPr Requirement | Level of Compliance | Comments / Findings | Photo's (if applicable) |
|---|---|---|---|
| The site camp area must be indicated and approved by the ECO. | DONE | <p>The site camp method statement (MBC) was approved by the ECO. The site camp is set up on RE/219 as per the method statement. Based on the survey data, the area in front of the site camp is also on RE/219, refer to non-compliance notification mentioned above.</p> <p>Civil contractor: The site camp is within the fenced off development footprint.</p> | <p>Hilland Environmental<br/>Garden Walk<br/>21.08.2025 13:05<br/>34° 5' 19.10" S 22° 5' 44.16" E<br/>R102</p> <p><b>MBC site camp</b></p> |

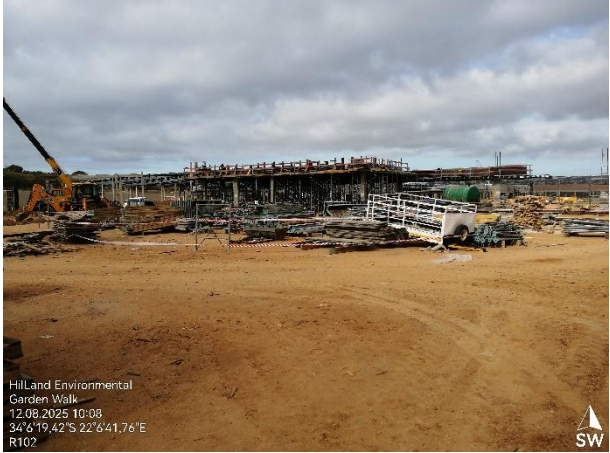
| <p>Storage sites for construction material and access must be approved by the ECO prior to commencing (and areas will require rehabilitation after use).</p> | <p>Compliant</p> | <p>All construction material is currently stored in the development site (fenced off area).</p> <p>Construction access is directly off the R102 to the construction site.</p> <p>Access point will shift to the access as indicated on the site plan at a later stage. The developer is waiting for final approval from DRE on the R102 changes/upgrades.</p> | <p>Construction materials stored on site</p> |

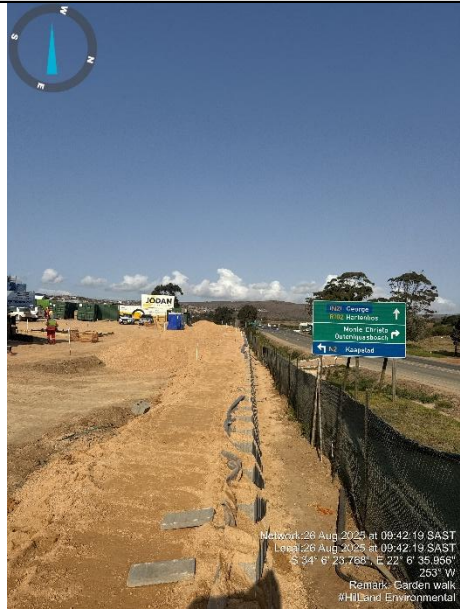
| <p>Silt fencing must be installed at the stormwater outlet point until the site is re-vegetated and silt is no longer evident.</p> | <p>Ongoing</p> | <p>Sandbags were placed in existing stormwater channel of the provincial road (R102), to capture any silt from the site. These "silt traps" are cleaned out regularly as observed on site.</p> <p>Sandbags were placed at the low point (old farm access).</p> <p>The stormwater outlet point is not yet installed.</p> <p><i>All low points must be regularly inspected for possible stormwater movement. In the case where there is stormwater movement, the contractor will be required to install erosion protection (bidim silt fence(s) or sandbags).</i></p> | <p>28 Aug 2025 at 09:42:19 SAST<br/> 28 Aug 2025 at 09:42:19 SAST<br/> S 34° 6' 23.788" E 22° 6' 35.956"<br/> 253° W<br/> Remark: Garden walk<br/> #Hilgard Environmental</p> <p><b>No stormwater runoff issues outside the demarcation noted.</b></p> |

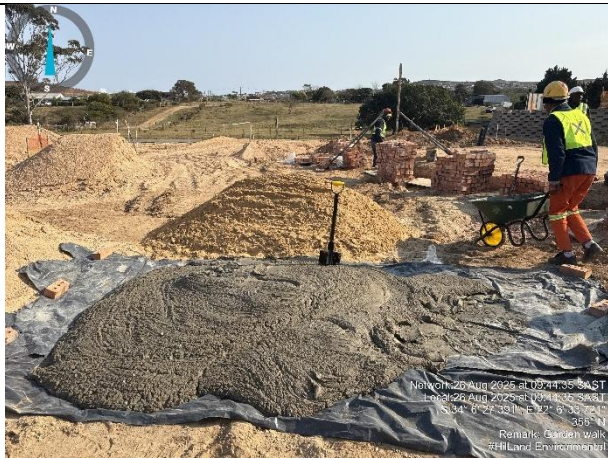
| <p>In the case of contaminated water run-off, silt can be stopped by means of sandbags and following the rain the contaminated area should be cleaned.</p> | <p>Ongoing</p> | <p>There is no contaminated run-off noted outside the demarcated site. Additional sandbags have been placed (proactively) to prevent silt wash / erosion at the old farm access.</p> <p>No contaminated runoff noted from the cement mixing areas.</p> | <p>28 Aug 2025 at 09:41:35 SAST<br/> 28 Aug 2025 at 09:41:35 SAST<br/> S 34° 6' 23.788" E 22° 6' 35.956"<br/> 305° W<br/> Remark: Garden walk<br/> #Hilgard Environmental</p> |

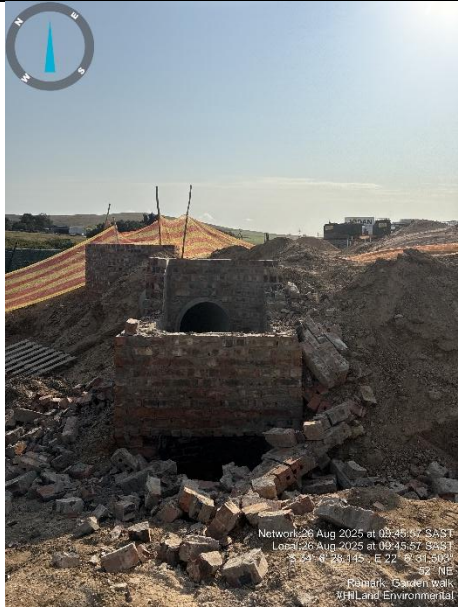
| <p>The stormwater system must be protected through the installation of additional silt-fencing and re-vegetation of exposed areas.</p> | <p>Ongoing</p> | <p>The stormwater system has not yet been fully installed / connected.</p> | |

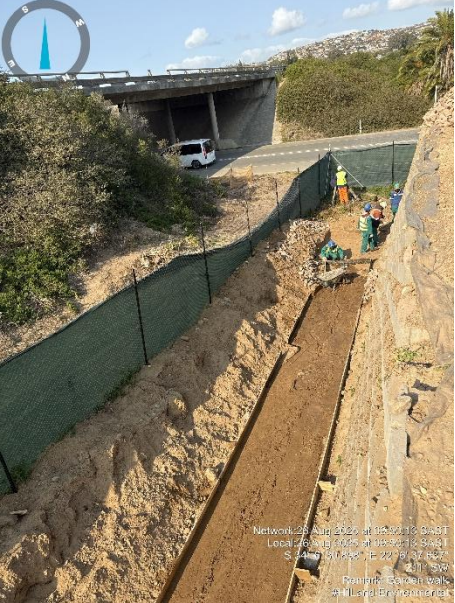
| <p>The silt fencing needs to be installed where indicated by the ECO.</p> | <p>Ongoing</p> | <p>Stormwater control – stone pitching channel is being constructed – no silt was noted outside the demarcation.</p> | <p><b>Stormwater management – stone pitching channel</b></p> |

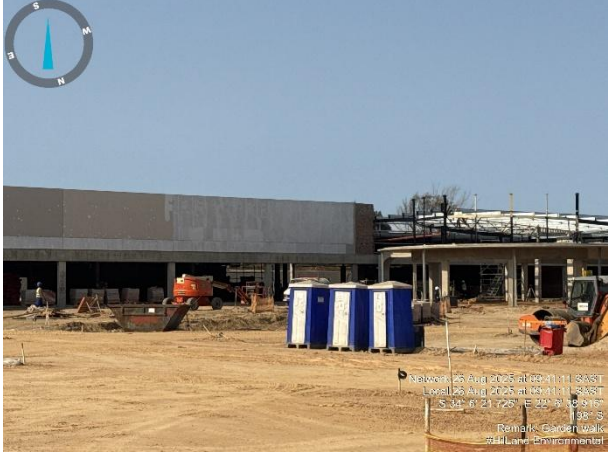
| <p>The contractor shall ensure that the toilet(s) are emptied regularly and also before weekends and public holiday periods.</p> | <p>Ongoing</p> | <p>No environmental issues noted. Toilet service provider was noted on site during ECO site inspection.</p> <p>Additional toilets have been added to the site.</p> | |

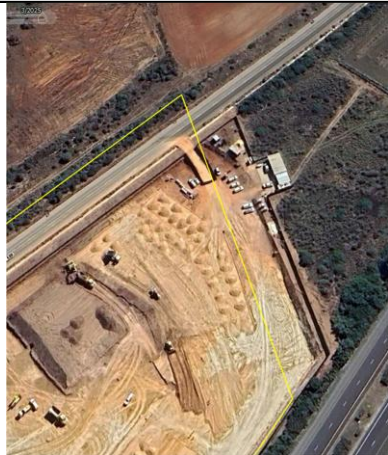
| <p>All areas outside of the property will be regarded as 'no-go' areas (except where installation of services will be required).</p> | <p>Non-compliance reported to DEADP 25 June 2025</p> | <p>The non-compliance for the area outside the property boundary as per the survey plan was reported to DEADP in June 2025. A meeting was held with DEADP and Mossel Bay Municipality to determine the way forward (July 2025).</p> <p>The clearing in the road reserve is for the external services and upgrades/changes to the R102.</p> | <p><b>Yellow line showing the cadastral boundary.</b></p> |

| Any damage to private property or open space areas must be reinstated to the state it was before construction commenced and must be done to the satisfaction of the landowner and ECO. | Ongoing | Refer to the non-compliance letter. Way forward regarding the encroachment on the neighbouring property in progress with DEADP and the Mossel Bay Municipality. | |

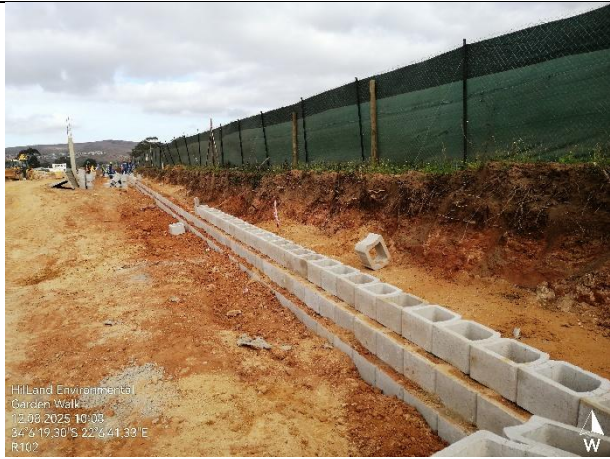
| <p>No-Go areas will be required to be demarcated by the contractor to ensure that they are visible at all times, to all personnel.</p> | <p>Compliant</p> | <p>The working area is demarcated with a 1.8m wire fence and shade netting.</p> | <p><b>Demarcation of the working zone with green shade netting</b></p> |

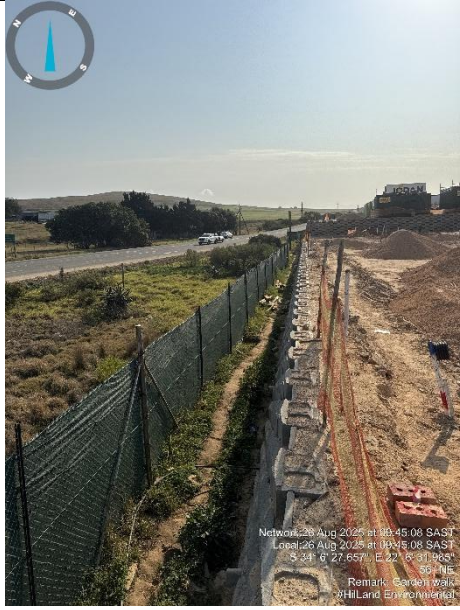
| <p>The total footprint of a building zone / phase should be demarcated with 1.5 m (height) shade cloth for the entire period of the construction.</p> | <p>Compliant</p> | | |

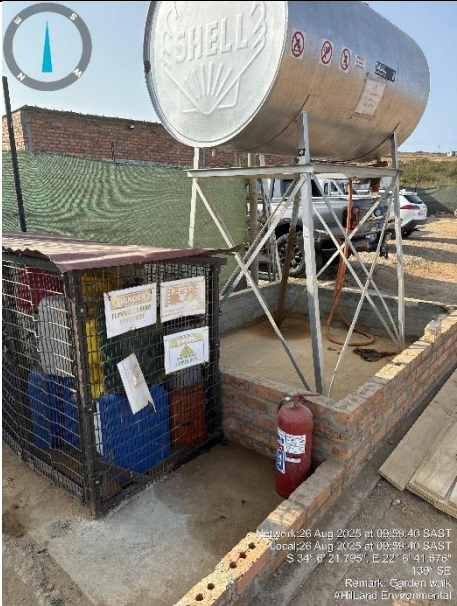
| Written method statement for the storage of hazardous substances must be approved by the ECO. | Ongoing | Method statement for hazardous substances has been submitted to the ECO and approved. | <p>Fuel storage area is bunded</p> |

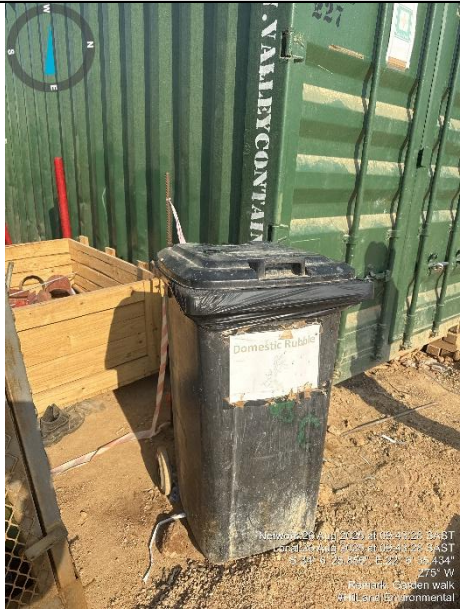
| <p>A dedicated area must be created within the site camp for refuse and waste management.</p> | <p>Compliant</p> | <p>A dedicated waste area is in the site camp.</p> | <p>Litter bin(s) at the site camp(s)</p> |

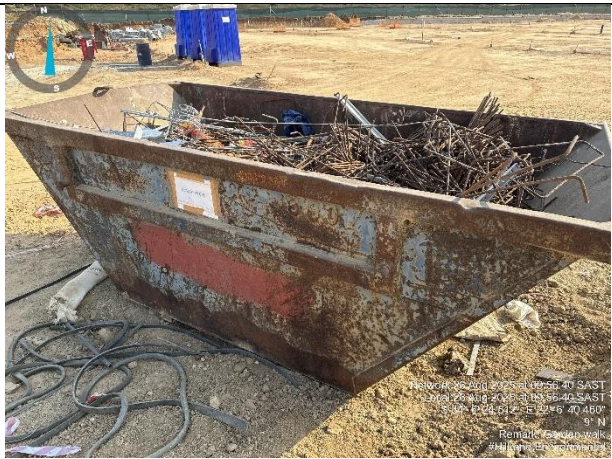
| <p>It is <b>recommended</b> that an integrated waste management approach must be used that is based on waste minimisation and must include reduction, recycling, re-use and disposal where appropriate.</p> | <p>Compliant / Ongoing</p> | <p>Keeping general waste separate from construction rubble. Scrap metal is stockpiled separately in a skip for recycling.</p> <p>Construction rubble stockpiles must not have litter (papers and plastic) – ongoing.</p> | <p>Keeping scrap metal offcuts separate.</p> |

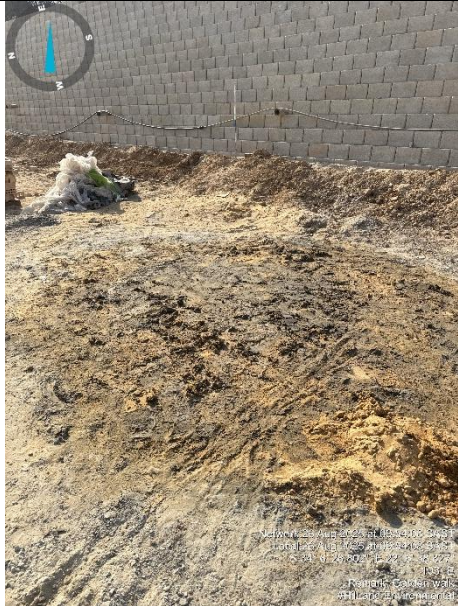
| Any concrete batching plant areas are to be approved by the ECO prior to utilisation. | Ongoing | Mixing are being done within development footprint (transformed area) and as agreed with the ECO. Suitable bunding must always be in place to avoid contaminated water runoff. | |

Cement mixed in bunded area.

| Bunding through the use of sandbag walls around any mixing areas is recommended. | Ongoing | Suitable bunding must always be in place to avoid contaminated water runoff. | |

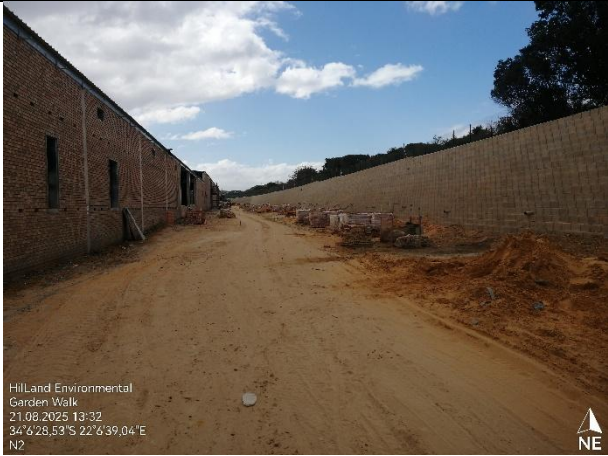
| Reinstate the vegetation in accordance with the Landscape Master Plan. | Ongoing | <p>Rehabilitation / revegetation of the retaining wall / embankment can now start.</p> <p>Landscape master plan was circulated to the ECO</p> | <p><b>Retaining wall / embankment</b></p> |

| All landscaping areas to be planted and maintained. | Not yet necessary | <p>Rehabilitation of the area above the retaining wall / embankment can start.</p> <p>Rehabilitation will be complete once construction is complete.</p> | |
