## ENVIRONMENTAL MONITORING REPORT No. 9

*The Development of the Garden Walk on the Remainder of Portion 58  
of the Farm Hartenbosch 217, Hartenbos*

**October 2025**

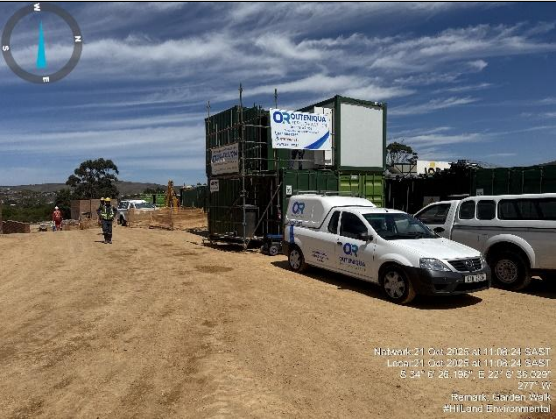
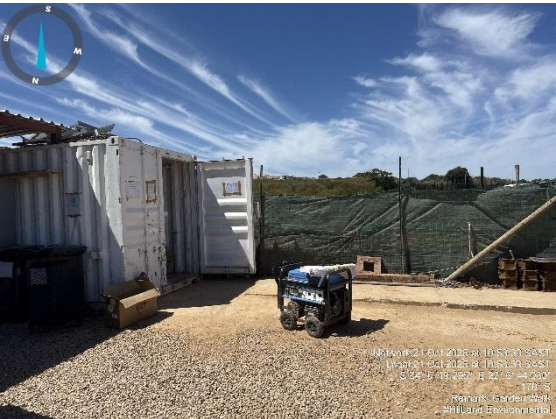
| EMPr Requirement | Level of Compliance | Comments / Findings | Photo's (if applicable) |
|---|---|---|---|
| The site camp area must be indicated and approved by the ECO. | DONE | <p>The site camp method statement (MBC) was approved by the ECO. The site camp is set up on RE/219 as per the method statement. Based on the survey data, the area in front of the site camp is also on RE/219, refer to non-compliance notification mentioned above.</p> <p>Civil and sub-contractor's site camp/material storage area is within the fenced off development footprint (parking area).</p> | <p><b>Sub-contractor's site camp</b></p> <p><b>MBC site camp</b></p> |

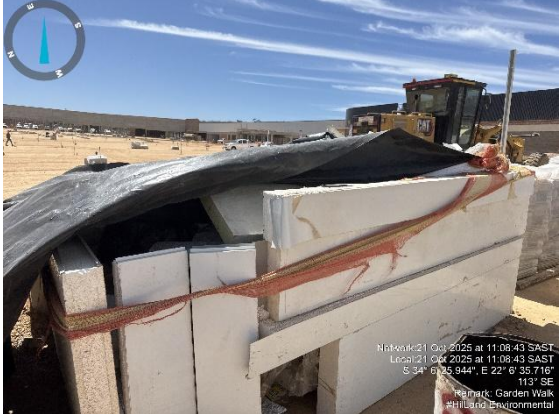
| <p>Storage sites for construction material and access must be approved by the ECO prior to commencing (and areas will require rehabilitation after use).</p> | <p>Compliant</p> | <p>All construction material is currently stored in the development site (fenced off area).</p> <p>Construction access is directly off the R102 to the construction site.</p> <p>Access point will shift to the access as indicated on the site plan at a later stage. The developer is waiting for final approval from DRE on the R102 changes/upgrades.</p> | <p><b>Construction materials stored on site</b></p> |

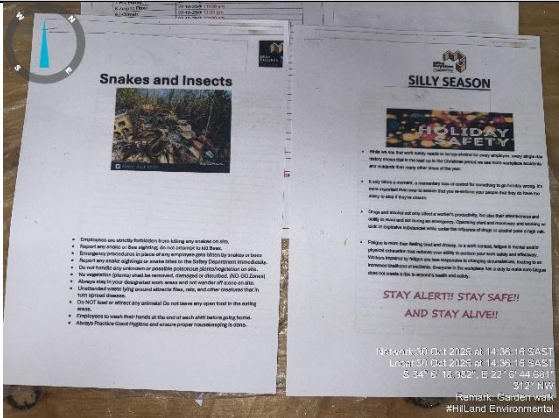
| <p>All construction staff should be briefed by the ECO/DEO in an environmental education programme.</p> | <p>Ongoing</p> | <p>Environmental induction was done with all staff on site in January 2025 (Jordan construction).</p> <p>Induction was done with the main contractor (MBC) management team done in February 2025.</p> <p>The DEO does inductions with new staff as they arrive on site – proof is kept in the environmental file.</p> | <p><b>Snake awareness training done</b></p> |

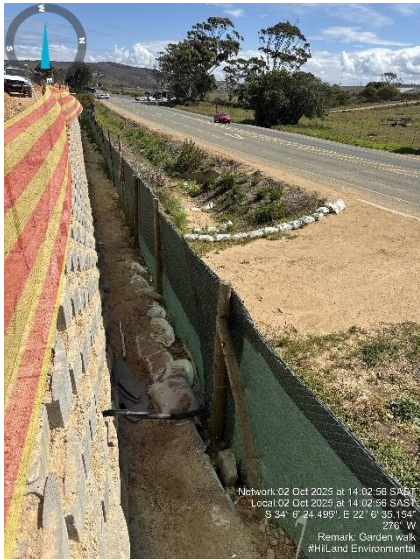
| Stormwater Management | | | |
|---|---|---|---|
| Silt fencing must be installed at the stormwater outlet point until the site is re-vegetated and silt is no longer evident. | Ongoing | <p>Sandbags were placed in existing stormwater channel of the provincial road (R102), to capture any silt from the site. These "silt traps" are cleaned out regularly as observed on site.</p> <p>Sandbags were placed at the low point (old farm access) – no change.</p> <p>The stormwater outlet point is not yet installed.</p> <p>The southern stormwater channel has been constructed with a gabion dissipator.</p> <p><i>All low points must be regularly inspected for possible stormwater movement. In the case where there is stormwater movement, the contractor will be required to install erosion protection (bidim silt fence(s) or sandbags).</i></p> | <div><p>Network: 02 Oct 2025 at 14:02:58 SAST<br/>Local: 02 Oct 2025 at 14:02:58 SAST<br/>S 34° 0' 24.49" E 22° 0' 30.154"<br/>37m W<br/>Remark: Garden walk<br/>#Hilland Environmental</p></div> <p>No stormwater runoff issues noted.</p> |

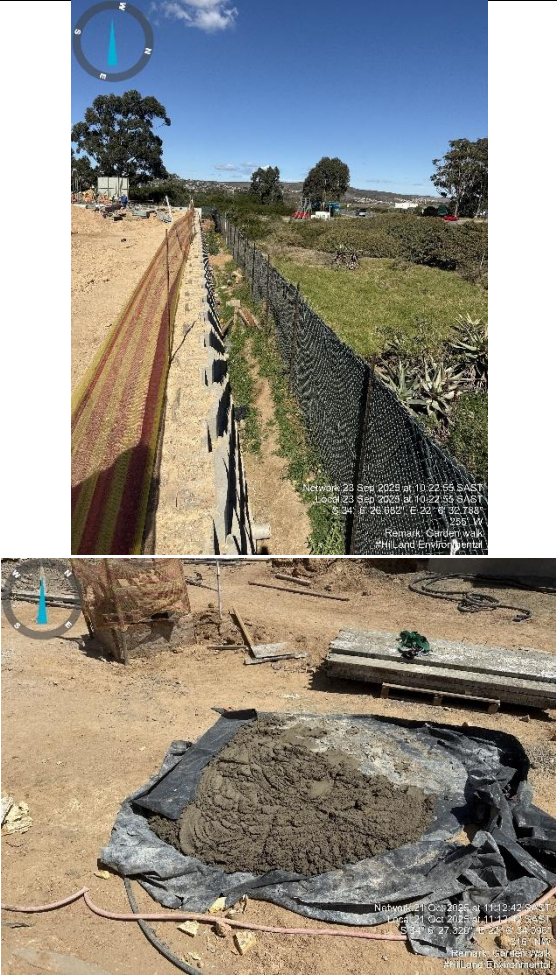
| <p>In the case of contaminated water run-off, silt can be stopped by means of sandbags and following the rain the contaminated area should be cleaned.</p> | <p>Ongoing</p> | <p>There is no contaminated run-off noted outside the demarcated site. Additional sandbags have been places (proactively) to prevent silt wash / erosion at the old farm access.</p> <p>No contaminated runoff noted from the cement mixing areas (outside of the demarcated area).</p> | |

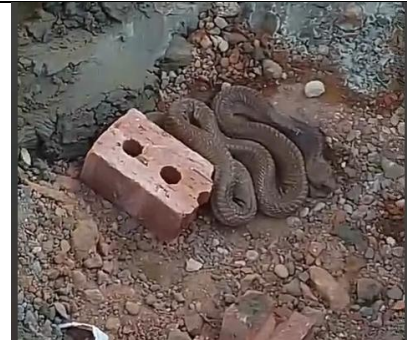
| Should any animal be caught up or trapped in the construction area, the ECO should be requested to assist. | Compliant | The DEO contacted the ECO regarding a snake in the construction site. The DEO attempted to contact a professional snake handler but without success. The snake moved away on its own. No further action required. | <p>Photo/video supplied by the DEO (29 October 2025)</p> |

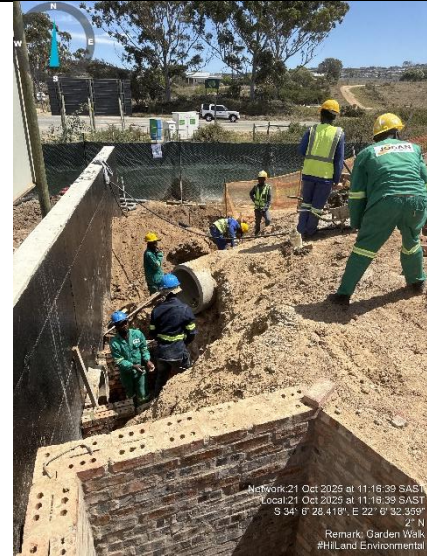
| The silt fencing needs to be installed where indicated by the ECO. | Ongoing | No silt fences required at this stage.<br><br>Stormwater control – stone pitching channel is being constructed – no silt was noted outside the demarcation. | <p>Stormwater manhole</p> |

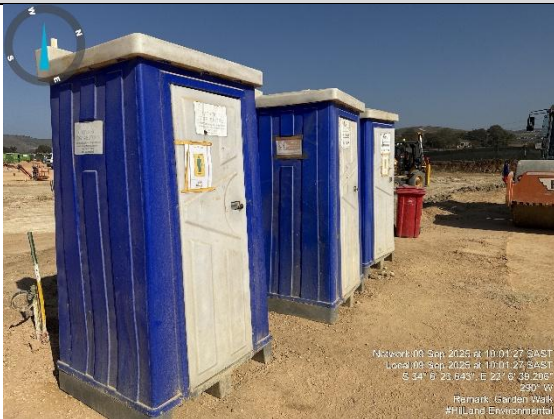
| Ablution Facilities | | | |
|---|---|---|---|
| Ablution facilities (chemical toilets) are to be provided at the campsite for use of the staff (one toilet per 15 people). | Compliant | Sufficient ablution facilities are provided on site, both for Jordan Construction and MBC. | |

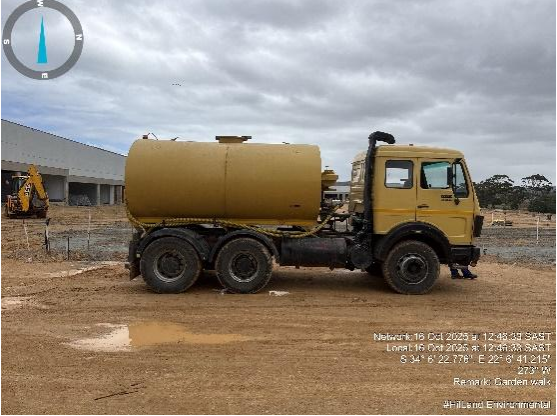
| <p>The contractor(s) must ensure that vehicles leaving the site are clean and, wherever possible, do not deposit mud, any other earth material and concrete on the road surface. Where this is unavoidable, it must be cleaned on a daily basis and may not be permitted to enter the storm water system.</p> | Ongoing | <p>Mud deposits on the R102 are cleaned regularly – <b>ongoing, please continue.</b></p> | <p>Vehicles and machinery are generally kept clean.</p> |

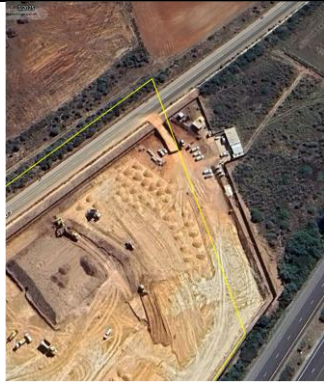
| <p>All areas outside of the property will be regarded as 'no-go' areas (except where installation of services will be required).</p> | Ongoing | <p>The non-compliance was reported to DEADP. DEADP Law Enforcement S24G process in progress.</p> <p>The clearing in the road reserve is for the external services and upgrades/changes to the R102.</p> | <p>Yellow line showing the cadastral boundary.</p> |

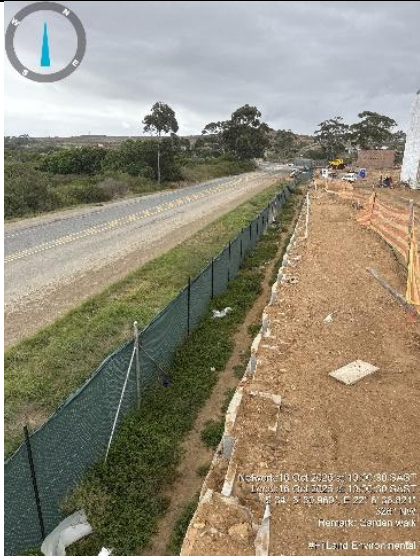
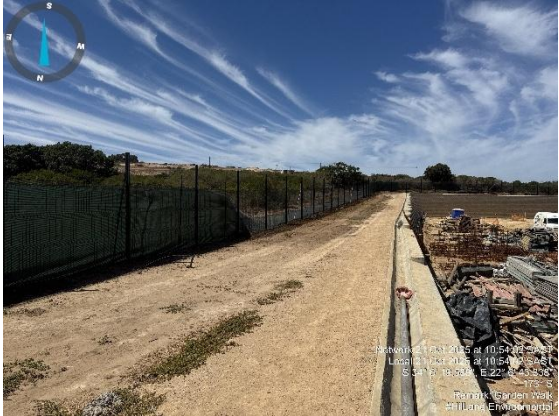
| <p>No-Go areas will be required to be demarcated by the contractor to ensure that they are visible at all times, to all personnel.</p> <p>The total footprint of a building zone / phase should be demarcated with 1.5 m (height) shade cloth for the entire period of the construction.</p> | <p>Compliant</p> | <p>The working area is demarcated with a 1.8m wire fence and shade netting.</p> | <div><p>Demarcation of the working zone with green shade netting</p><p>Installation of the permanent clear-vu fence started</p></div> |

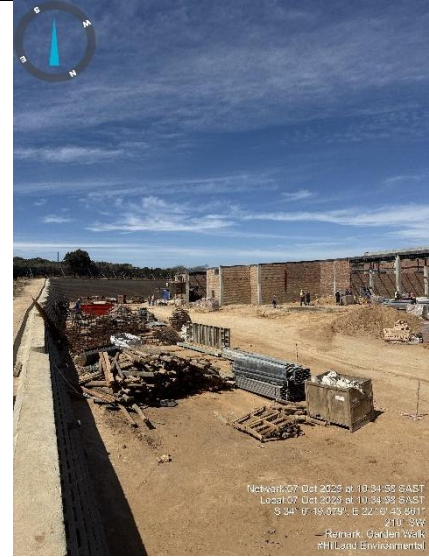
| Storage of Construction Material | | | |
|---|---|---|---|
| <p>All stockpile sites to be approved by the ECO and/or landowner, prior to the commencement of stockpiling.</p> <p>All stockpile sites within the development area are to be demarcated with silt-fences and/or danger tape, where necessary.</p> | Compliant & ongoing | <p>Current construction material stockpile area is within the demarcated zone.</p> <p>Topsoil stockpiled in Outeniquasbosch <b>(landowner approval letter to be submitted to the ECO for record keeping)</b>.</p> <p>The construction material stockpile in the development zone is demarcated with orange netting fencing.</p> | <p>Network: 07 Oct 2025 at 10:54:55 SAST<br/> Location: 07 Oct 2025 at 10:54:55 SAST<br/> S 34° 0' 19.079" E 22° 0' 43.891"<br/> 210.2W<br/> Remark: Garden Walk<br/> #Hilland Environmental</p> |

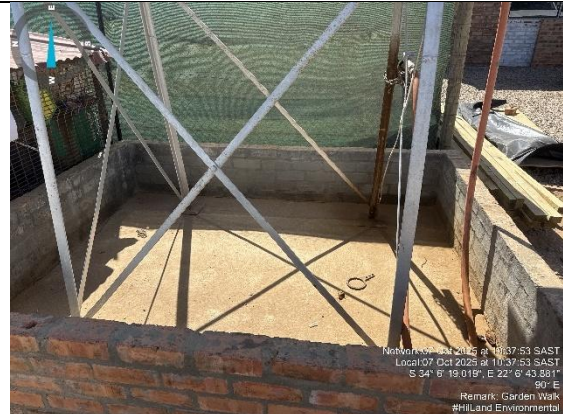
| Storage of Construction Material | | | |
|---|---|---|---|
| Written method statement for the storage of hazardous substances must be approved by the ECO. | Ongoing | <p>Method statement for hazardous substances has been submitted to the ECO and approved.</p> | <p>Network: 07 Oct 2025 at 10:57:53 SAST<br/> Location: 07 Oct 2025 at 10:57:53 SAST<br/> S 34° 0' 19.019" E 22° 0' 43.891"<br/> 90° E<br/> Remark: Garden Walk<br/> #Hilland Environmental</p> <p>Compliant with the method statement – no spillage noted.</p> |

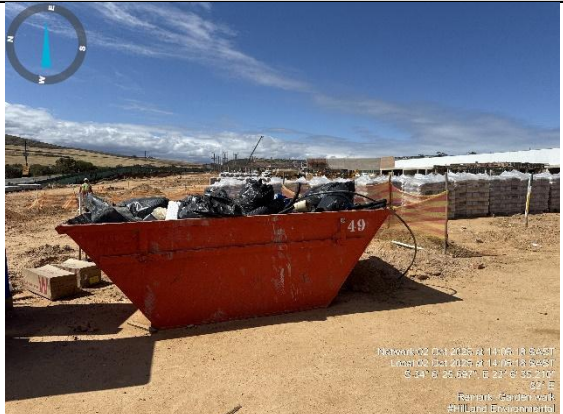
| Fire Protection | | | |
|---|---|---|---|
| It is <b>recommended</b> that an integrated waste management approach must be used that is based on waste minimisation and must include reduction, recycling, re-use and disposal where appropriate. | Compliant / Ongoing | <p>Keeping general waste separate from construction rubble. Scrap metal is stockpiled separately in a skip for recycling.</p> <p>Construction rubble stockpiles must not have litter (papers and plastic) – ongoing.</p> | <p>Photograph taken 2025-01-14 10:05:18 AEST<br/> Location: 34.120788, 150.961356551<br/> Camera: 25.6217, 0.217, 0.000000<br/> Camera: 25.6217, 0.217, 0.000000<br/> Camera: 25.6217, 0.217, 0.000000</p> |

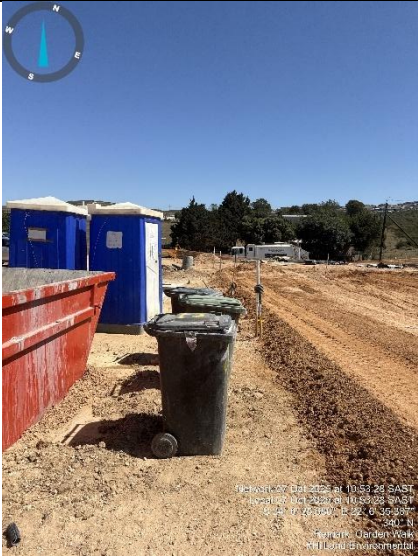
| | | | <p>waste bins/skips on site</p> |

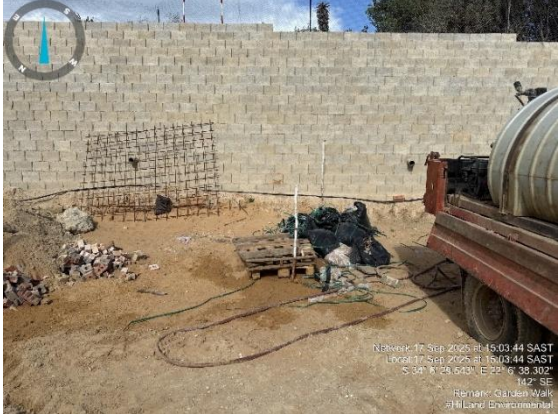
| Litter to be removed from the site on a daily basis and kept in closable bins. | Compliant & ongoing | <p>Litter noted during ECO site inspection(s) have been reported to the contractor and are actioned accordingly – this will be ongoing.</p> <p>Regular litter picking is done.</p> | <p>Network 12 Sep 2025 at 15:03:44 SAST<br/> UTM: 12 Sep 2025 at 15:03:44 SAST<br/> S 04° 1' 25.6431" E 22° 6' 38.302"<br/> 147 SE<br/> Renham Garden Walk<br/> 241 Lany Environmental</p> <p>Litter picking</p> |

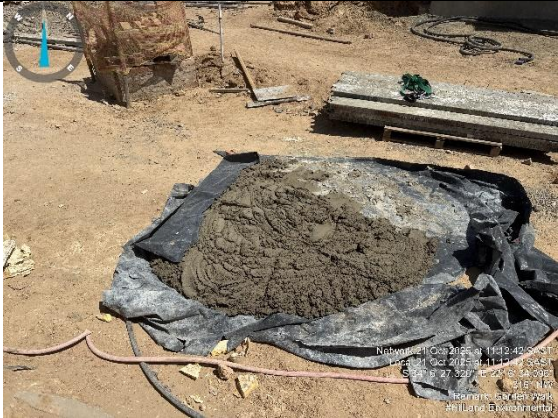
| Any concrete batching plant areas are to be approved by the ECO prior to utilisation. | Ongoing | Mixing are being done within development footprint (transformed area) and as agreed with the ECO. Suitable bunding must always be in place to avoid contaminated water runoff. | <p>Network 21 Oct 2025 at 11:12:43 SAST<br/> UTM: 21 Oct 2025 at 11:12:43 SAST<br/> S 04° 1' 25.6431" E 22° 6' 38.302"<br/> 147 SE<br/> Renham Garden Walk<br/> 241 Lany Environmental</p> |

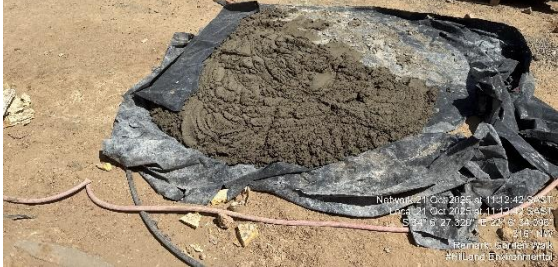
| No ready-mix trucks are permitted to rinse their tanks on site or along the access roads to and from the site. | Ongoing | No non-compliance noted during site inspections. | <p>Network 21 Oct 2025 at 11:12:43 SAST<br/> UTM: 21 Oct 2025 at 11:12:43 SAST<br/> S 04° 1' 25.6431" E 22° 6' 38.302"<br/> 147 SE<br/> Renham Garden Walk<br/> 241 Lany Environmental</p> |

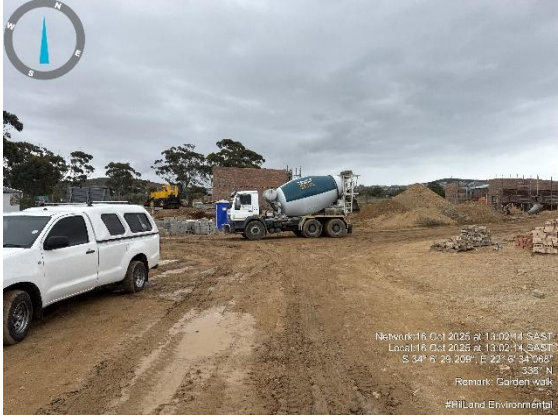
| <p>Bunding through the use of sandbag walls around any mixing areas is recommended.</p> <p>All concrete must be mixed on trays / on thick plastic and not on the soil.</p> | Ongoing | <p>Suitable bunding must always be in place to avoid contaminated water runoff.</p> <p>Ready-mix is used for the bulk concrete works.</p> | <p>Ready mix</p> |

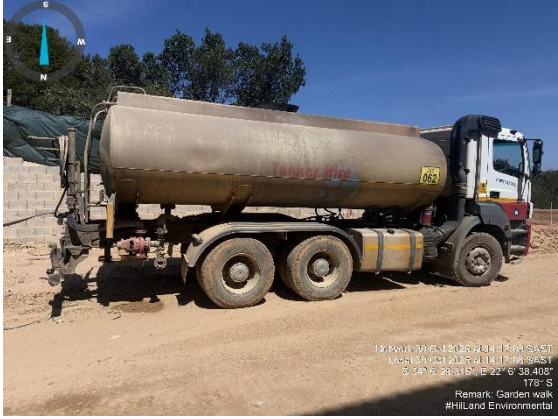
| <p>Dust mitigation measures should be implemented as required.</p> | Ongoing | <p>Dust nuisance complaint(s) are recorded in environmental file – <b>no new complaints received.</b></p> <p>Regular dust suppression is done – watering exposed areas and dust mitigation record sheet is kept in the environmental file.</p> <p>October has been exceptionally windy and dust mitigation was required almost daily. Record is kept by the contractor of dust suppression.</p> | <p>Water truck on site</p> |

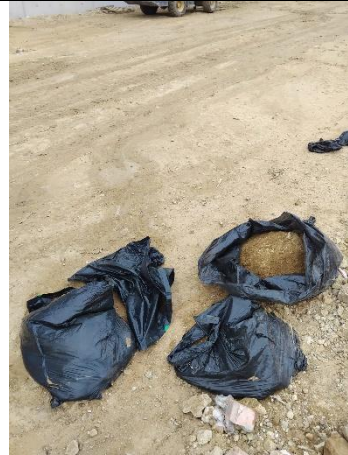
| Contaminated soil must be disposed of at an approved landfill site. | Yes | <p>Rehabilitation will be completed once construction is complete.</p> <p>DEO reported to the ECO that there was a minor fuel spill (after hours as a result of fuel theft), the contaminated soil (layer works) has been removed and disposed appropriately.</p> | <p>Fuel contaminated soil removed and disposed</p> |

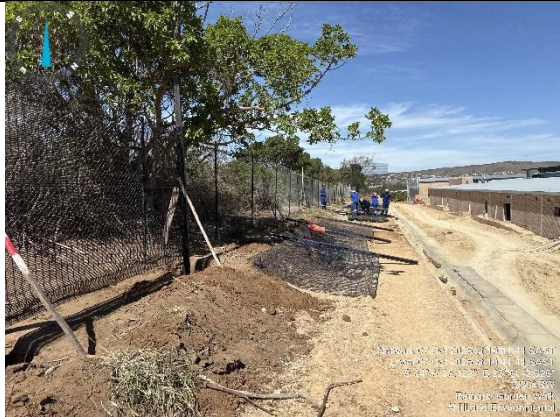
| Reinstate the vegetation in accordance with the Landscape Master Plan. | Ongoing | <p>Rehabilitation / revegetation of the retaining wall / embankment can now start.</p> <p>Landscape master plan was circulated to the ECO.</p> <p>Landscaping above the retaining wall will start in due course.</p> | <p>Area above the retaining wall / embankment</p> |
